Inspection Photos
Location Name: Energy Minerals Unit B1
Location ID: 318873

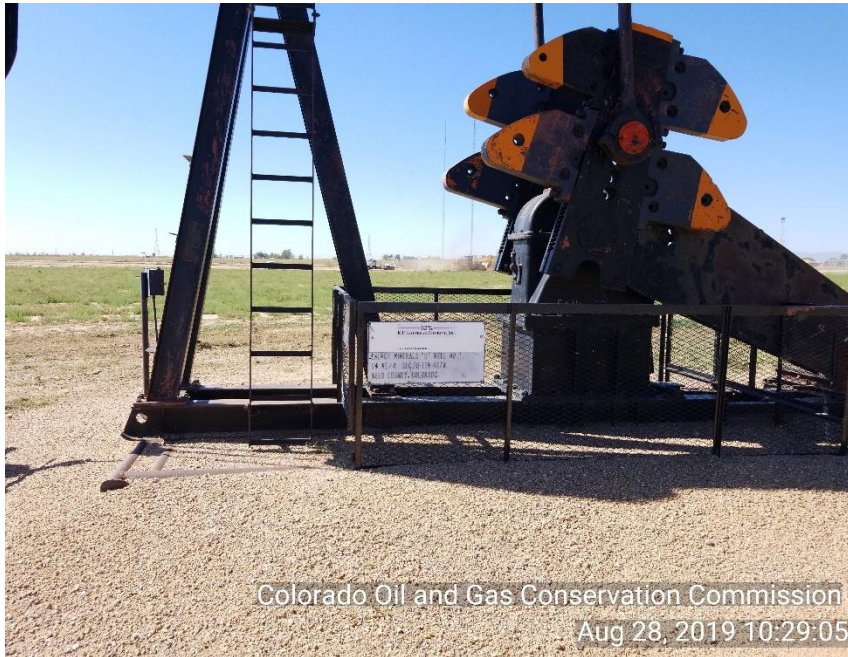
Photo 1 WH sign has new sticker installed

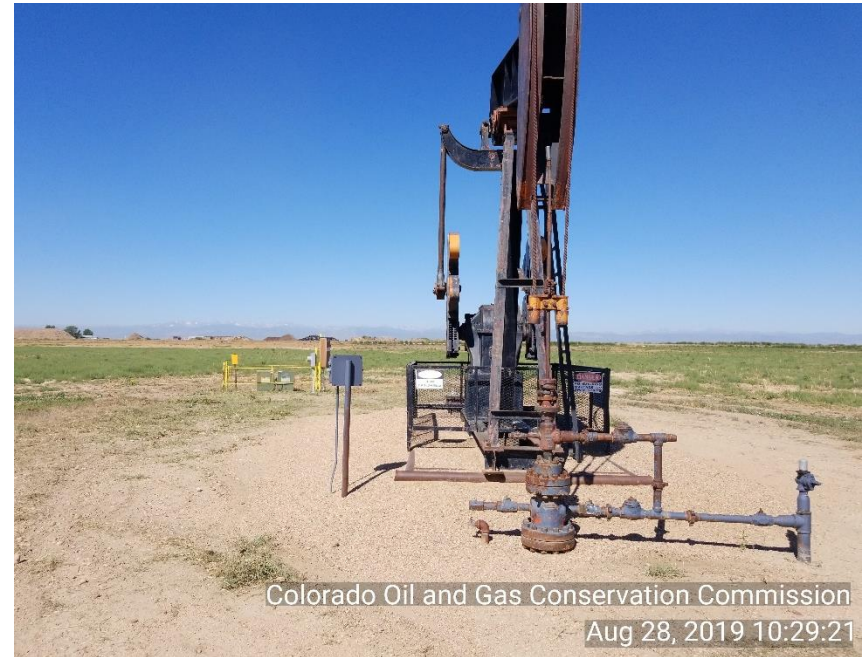
Photo 2 WH and weeds have been removed

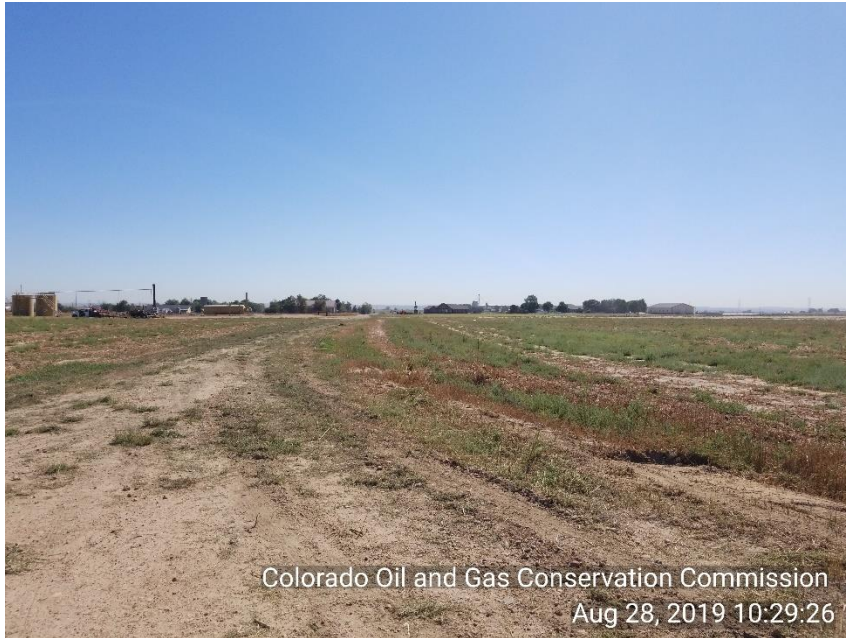
Photo 3 Weeds on access road have been cut

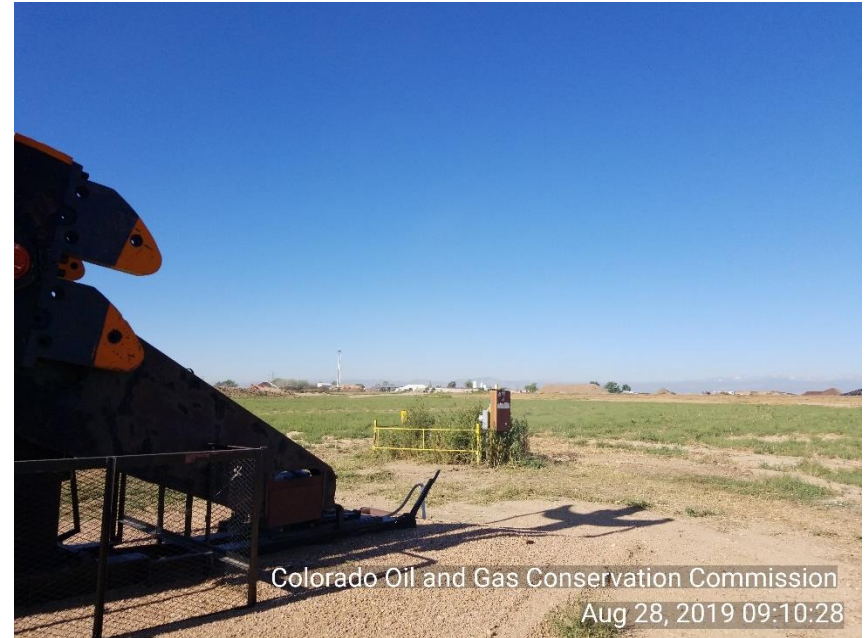
Photo 4 Crew cutting weeds at time of inspection

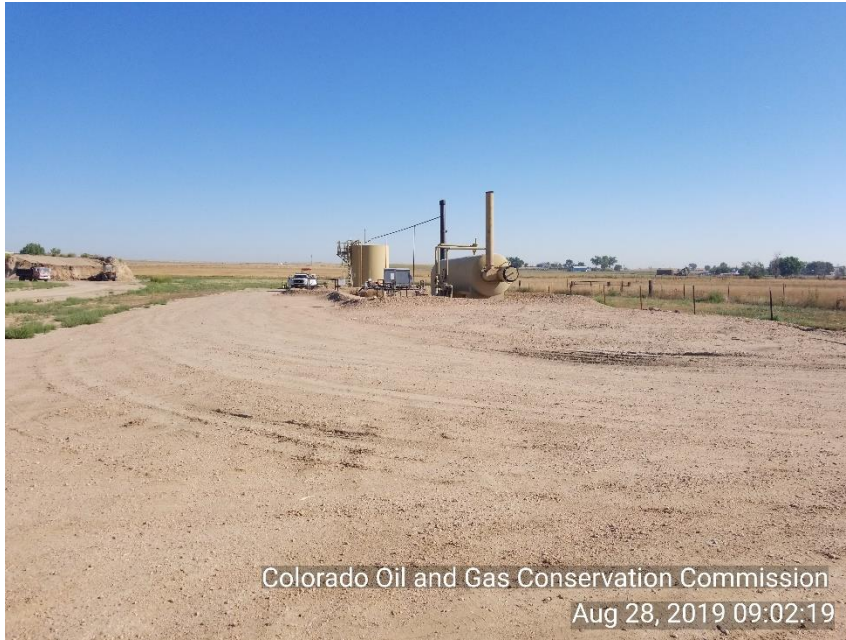
Photo 5 Crew on site cutting weeds and starting to remove small stained soil spots

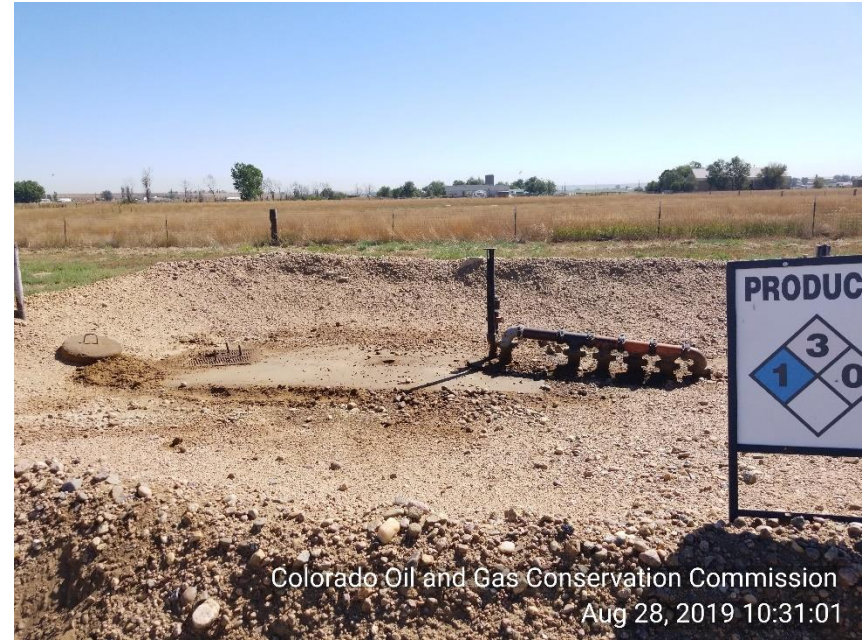
Photo 6 Crew tried to start removing strained soil from spill around produced water tank.

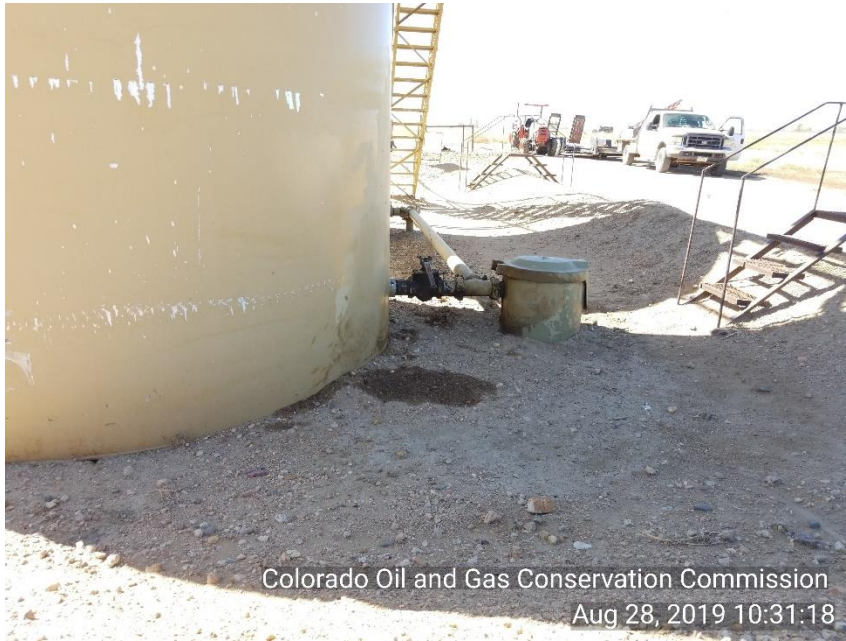
Photo 7 Stained soil around crude oil tank.

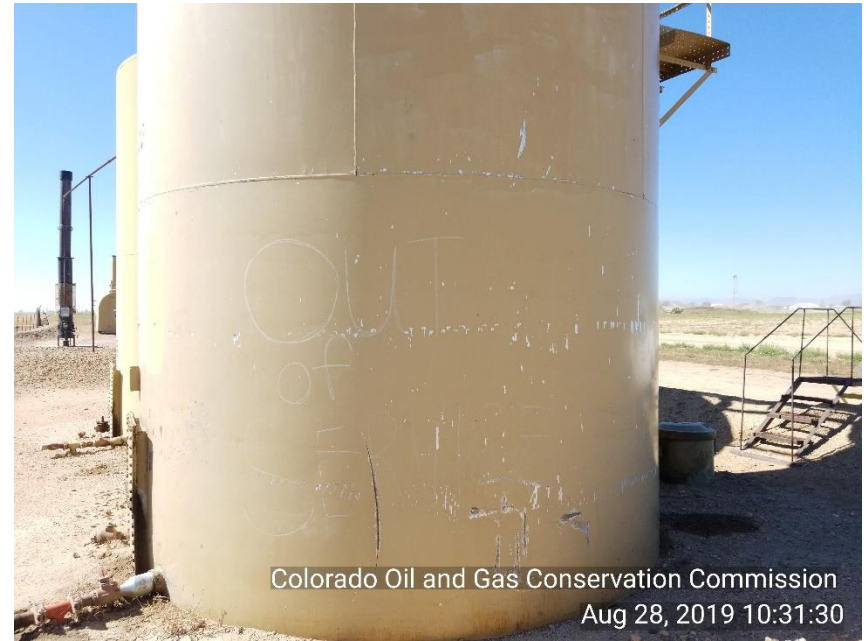
Photo 8 North crude oil tank states in multiple spots OUT OF SERVICE

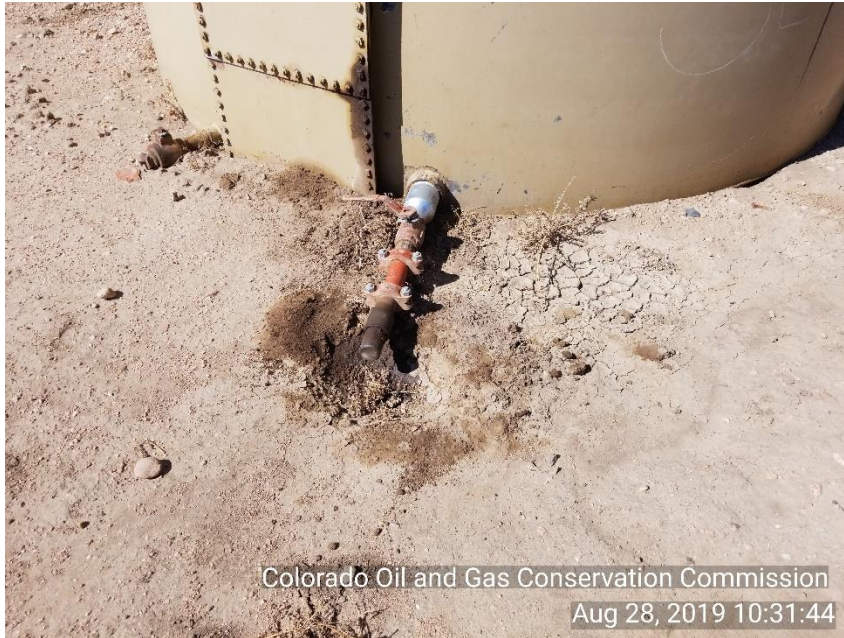
Photo 9 Stained soil and mechanical issue 2" load lines on crude oil tank.

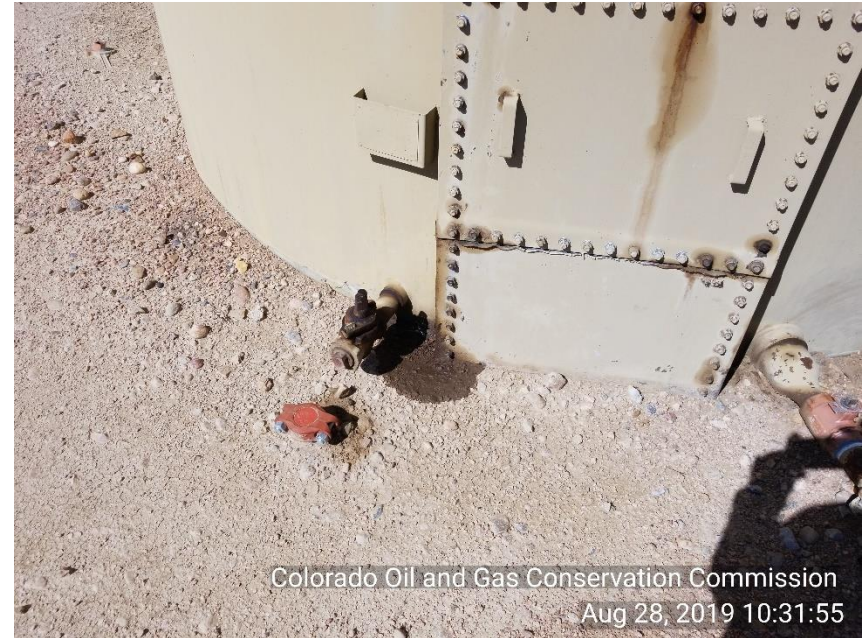
Photo 10 Stained soil and mechanical issue crude oil load line and inspection hatch

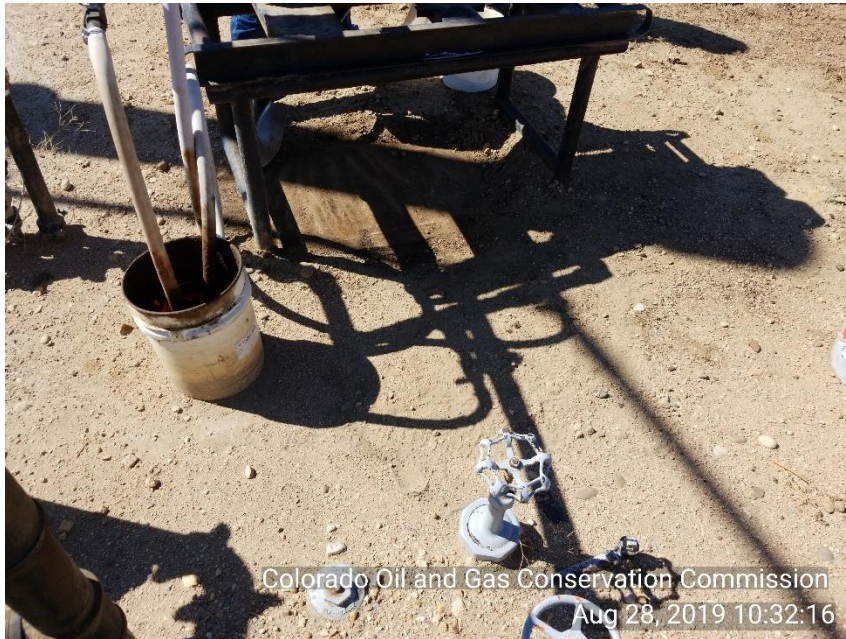
Photo 11 Crew cleaning stained soil under recirc pump

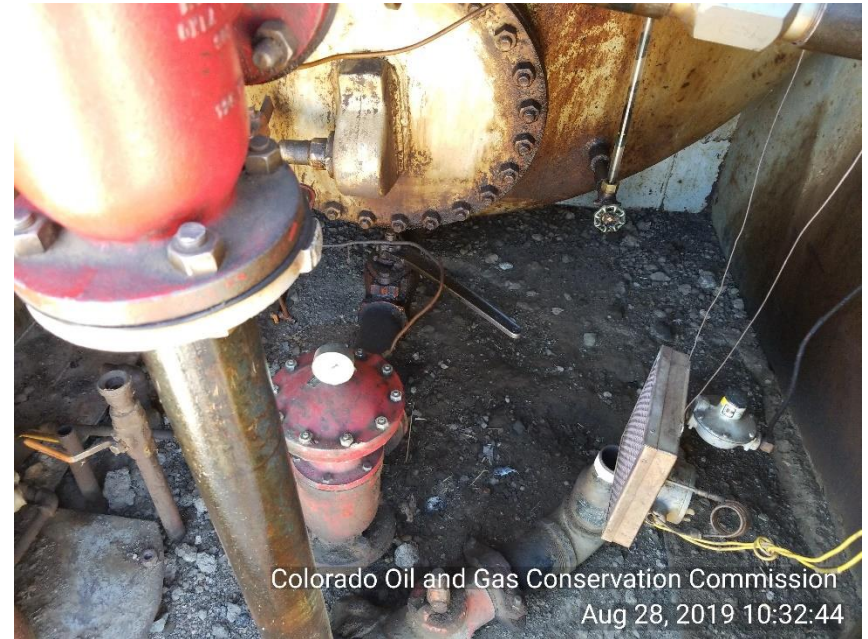
Photo 12 Stained soil under piping in separator

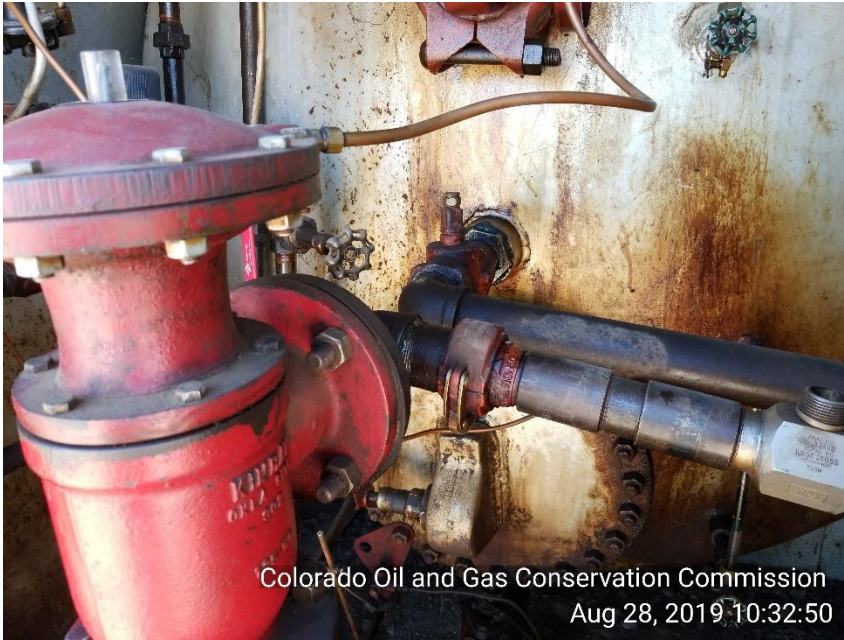
Photo 13 mechanical issue piping inside separator house appears to be leaking causing stained soil.
