Inspection Photos
Location Name: MOUNTAIN JAY 31-19
API#: 05-071-06579
INSP. #: 695101252

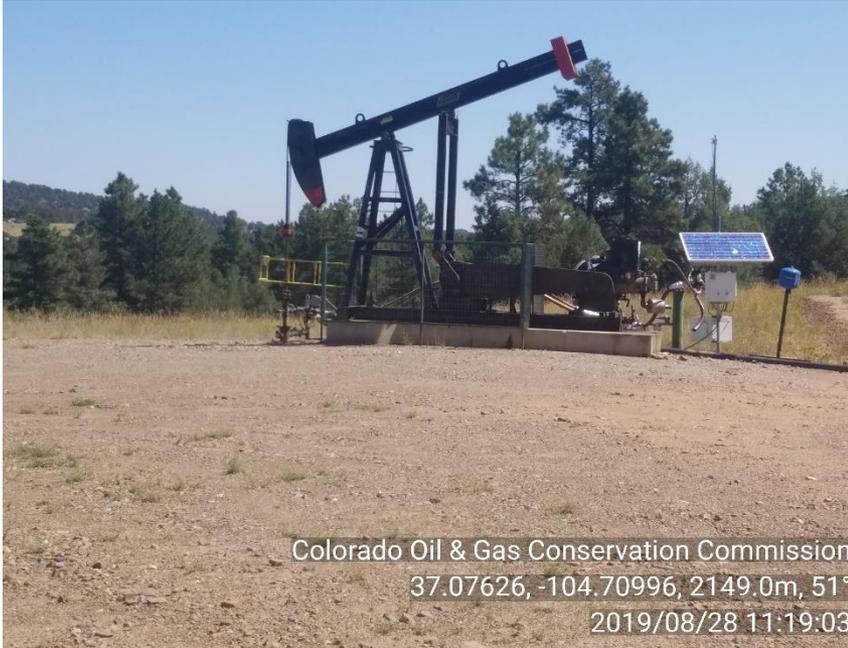
PHOTO 1: WELLHEAD

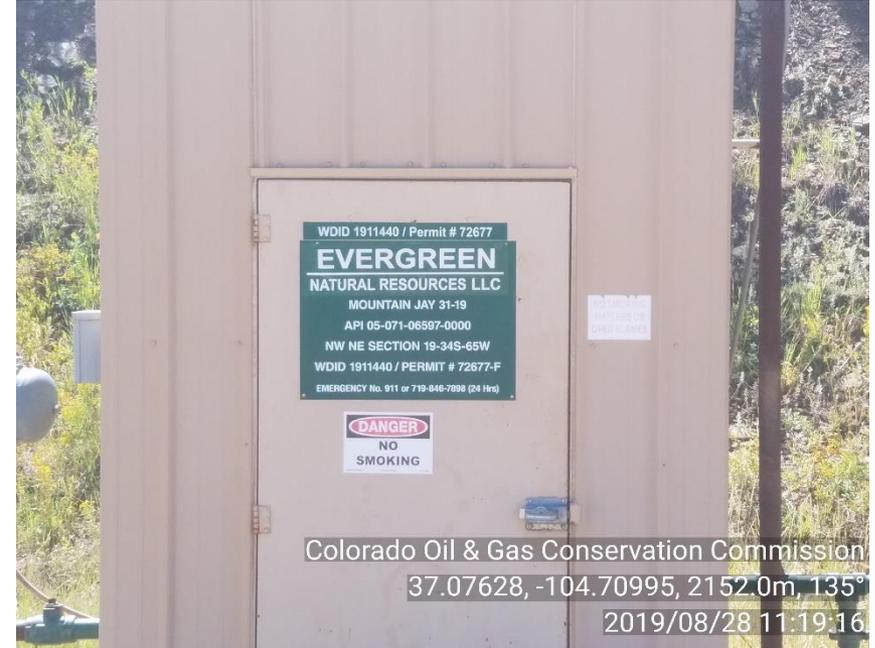
PHOTO 2: WELL SIGN

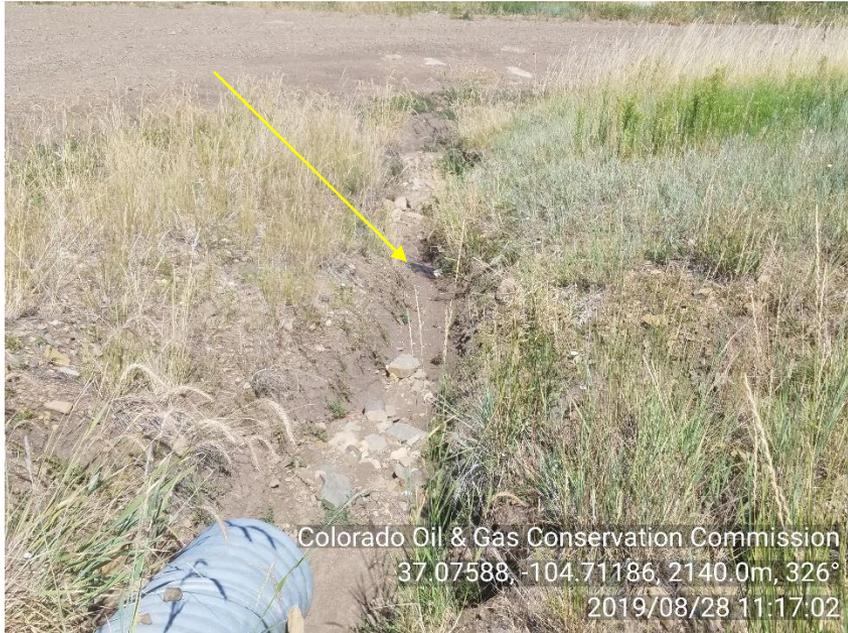
PHOTO 3: EROSION DOWN GRADE FROM CULVERT AT THE ENTRANCE OF ROW, STORMWATER EROSION HAS EXPOSED WHAT APPEARS TO BE A GAS GATHERING LINE. **Install or repair required BMPs per Rule 1002.f. CA DATE 9-28-19**

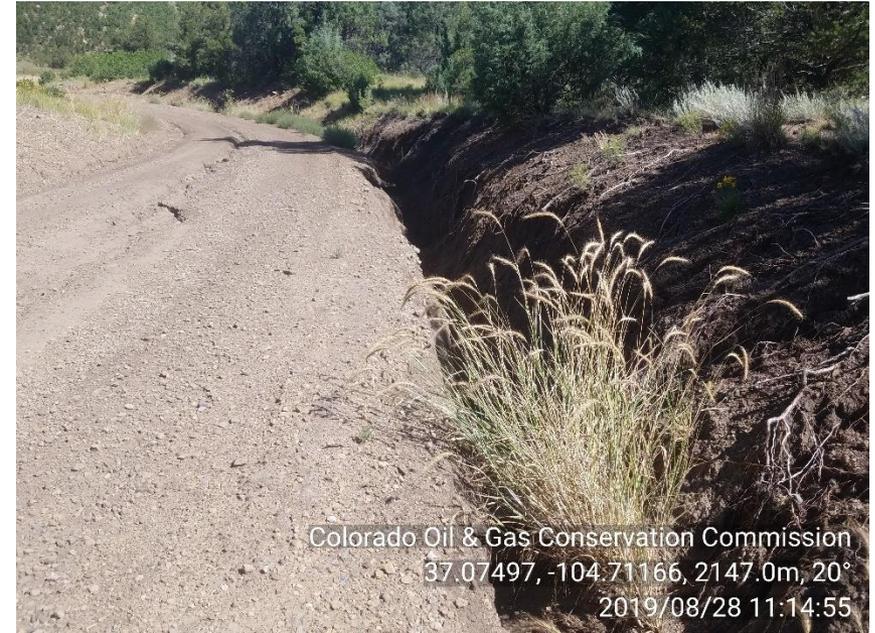
PHOTO 4: EROSION ON UP GRADE SIDE OF MAIN ROW SOUTH OF LOCATION ROW ENTRANCE. **Install or repair required BMPs per Rule 1002.f. CA DATE 9-28-19**

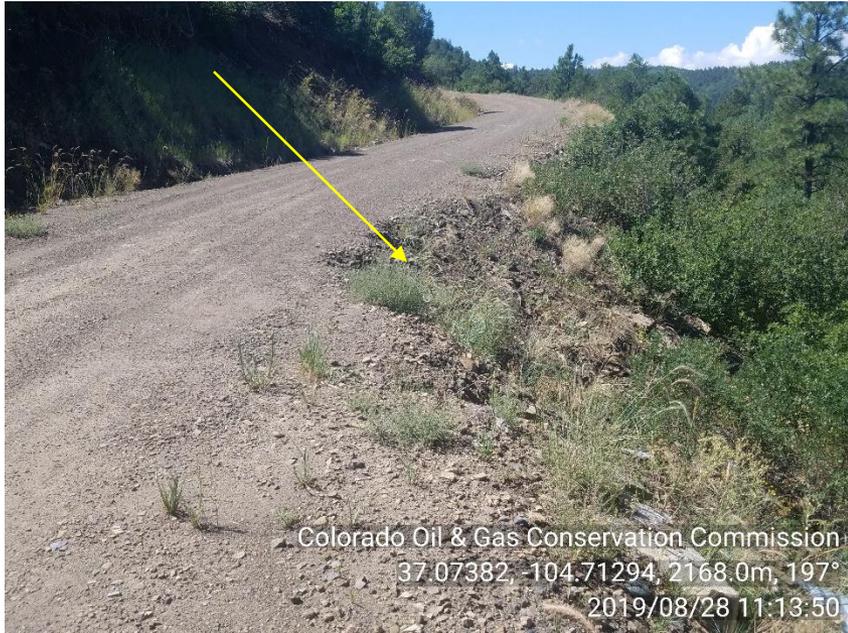
PHOTO 5: EROSION DOWN GRADE SIDE OF MAIN ROW SOUTH (UP THE HILL) OF LOCATION ROW ENTRANCE. Install or repair required BMPs per Rule 1002.f. CA DATE 9-28-19

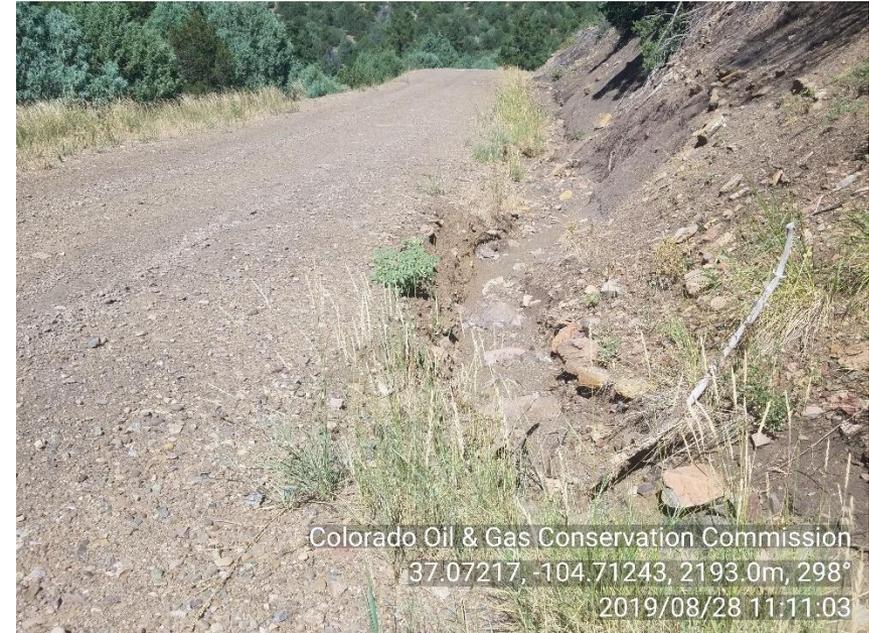
PHOTO 6: VIEW OF ANOTHER ARE OF EROSION ON UP GRADE SIDE OF MAIN ROW SOUTH OF LOCATION ROW ENTRANCE. Install or repair required BMPs per Rule 1002.f. CA DATE 9-28-19

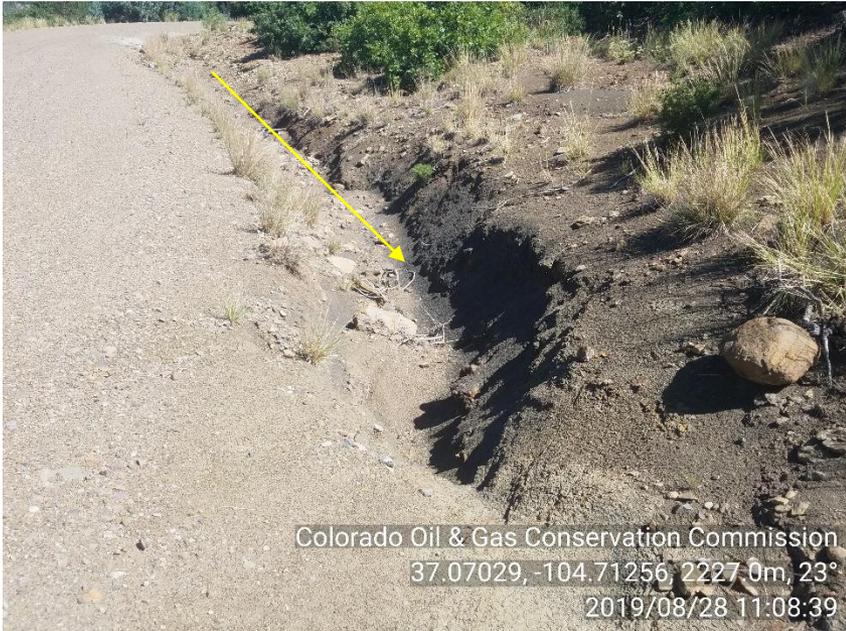
PHOTO 7: VIEW OF ANOTHER ARE OF EROSION ON UP GRADE SIDE OF MAIN ROW SOUTH OF LOCATION ROW ENTRANCE. **Install or repair required BMPs per Rule 1002.f. CA DATE 9-28-19**

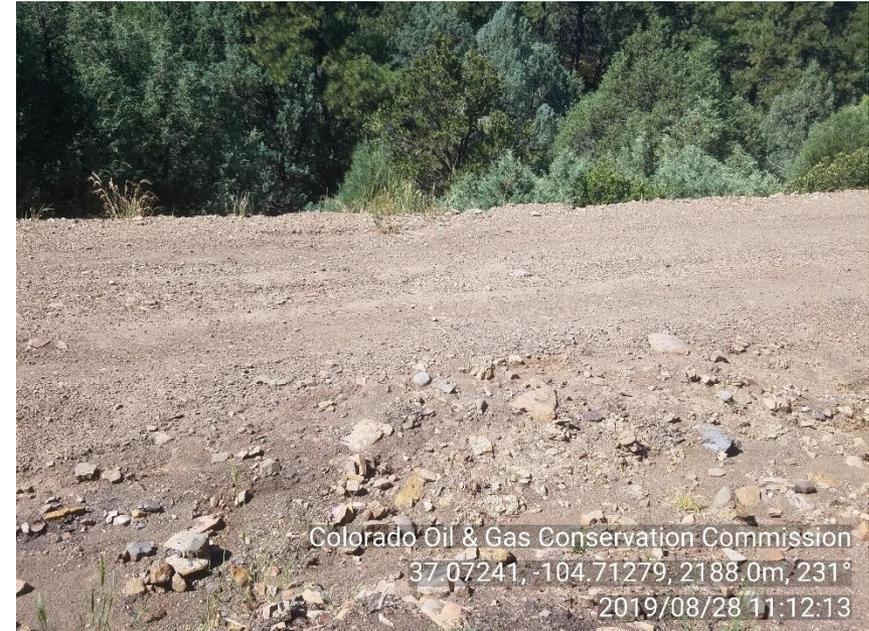
PHOTO 8: CULVER IS PLUGGED. **Install or repair required BMPs per Rule 1002.f. CA DATE 9-28-19**
