# *Inspection Photos*

*Loc#416625*

*Operator: Sandridge*

Inspection Photos: Sandridge Surprise Damfino Loc#416625

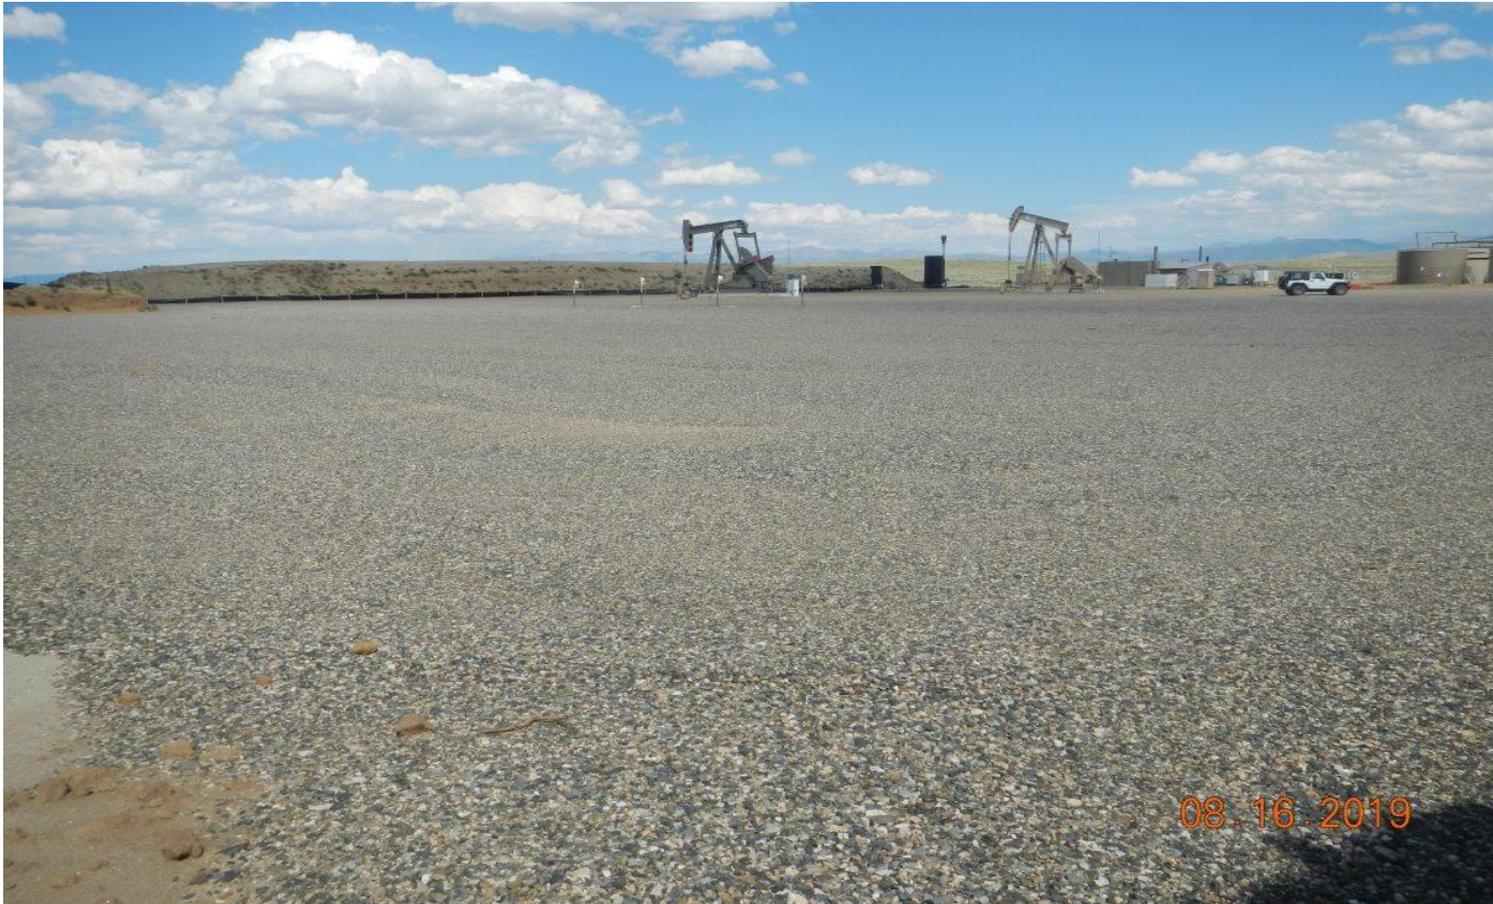
Photo#1:  
Overview of Location.

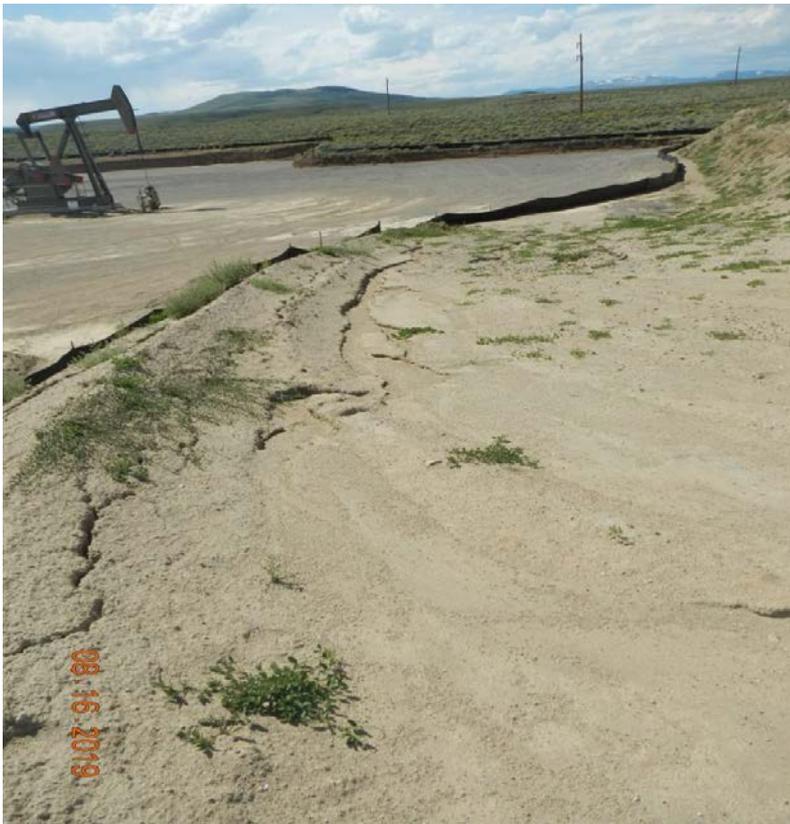
Photo#2:  
Newly installed silt fence failed.

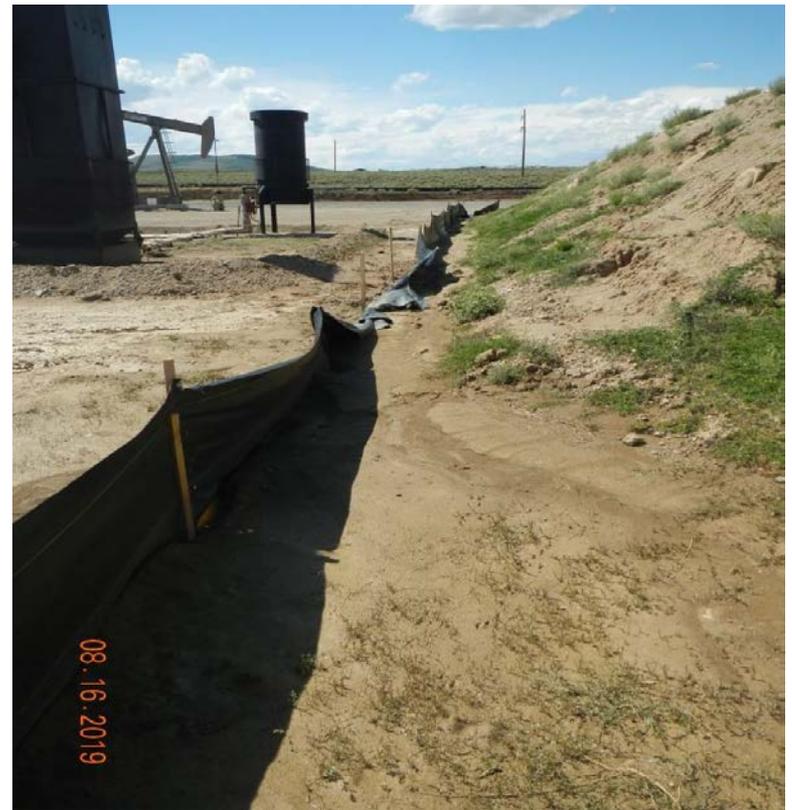
Photo#3:  
Newly installed silt fence failed.

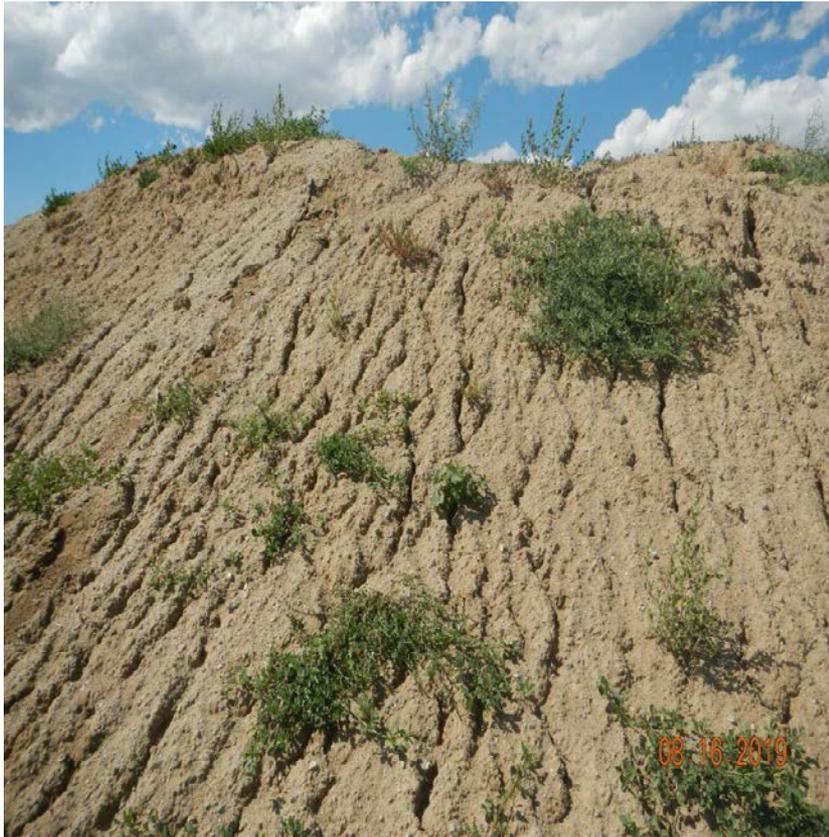
Photo#4:  
Erosion of stockpile.

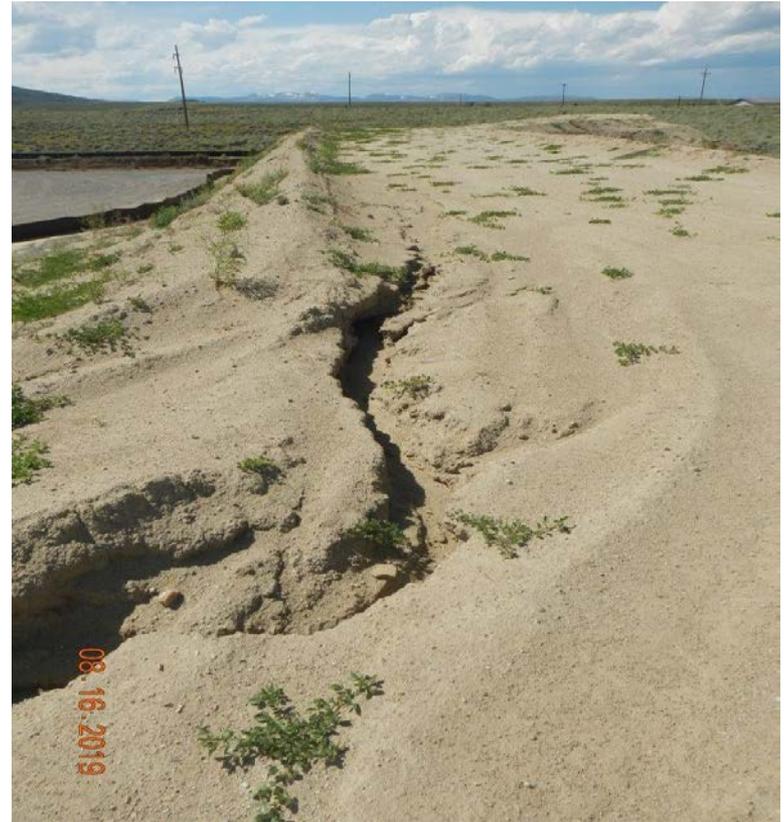
Photo#5:  
Erosion of stockpile.

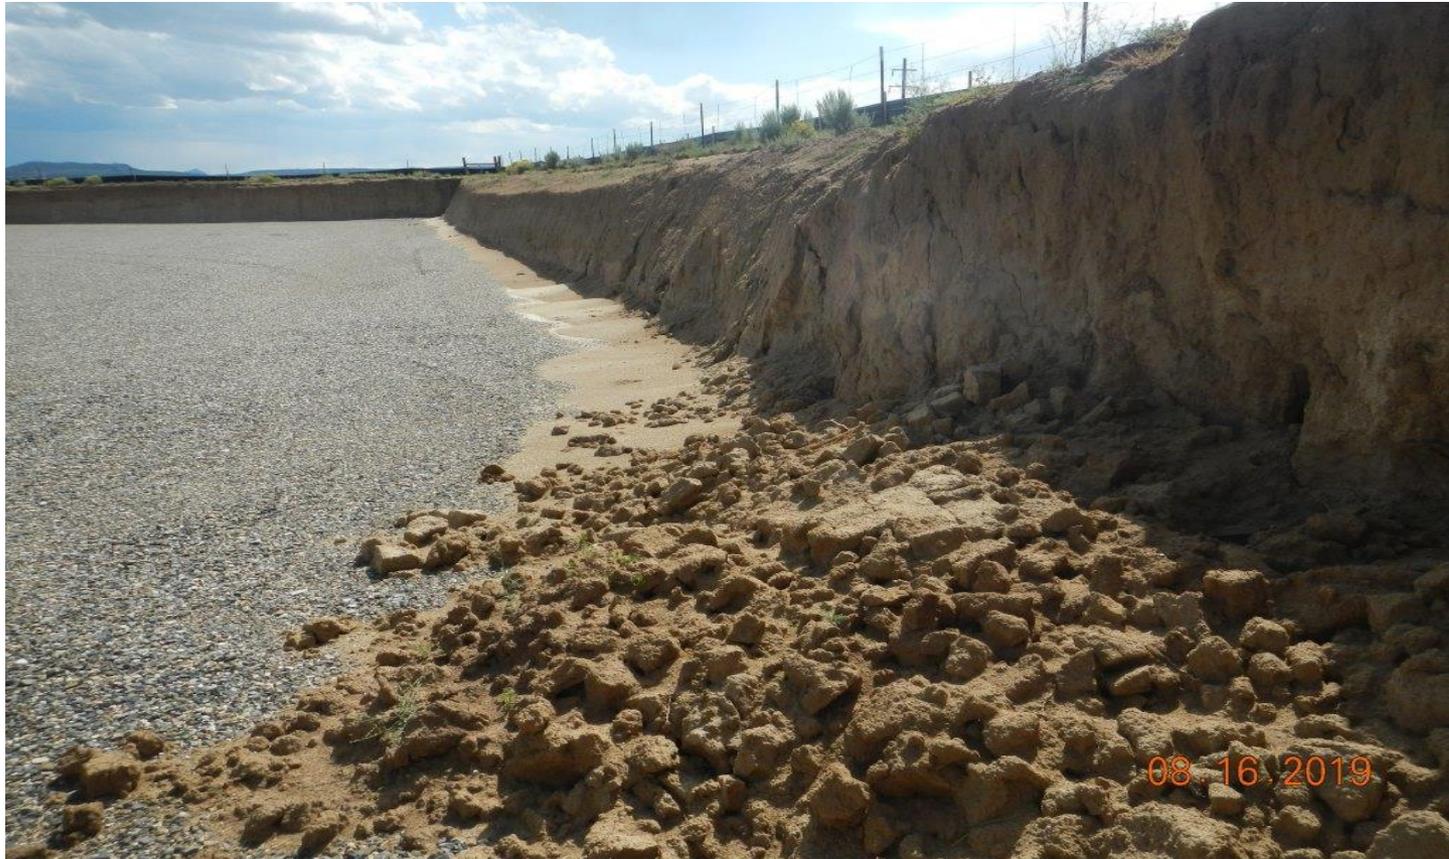
Photo#6:  
Further sloughing and erosion of Cut is occurring.

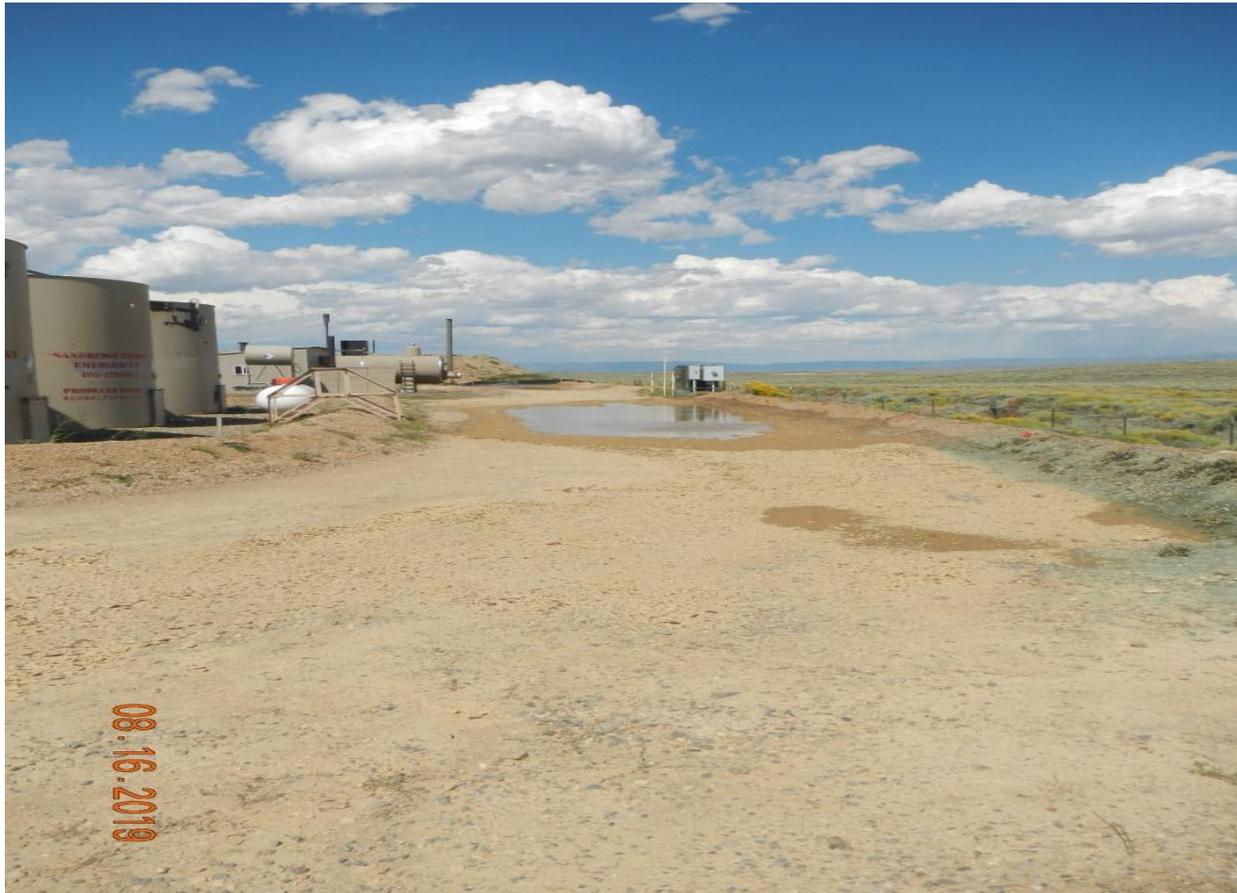
Photo#7:  
Stormwater is improperly ponding on East side of site.
