# Inspection Photos

08/16/2019

Operator: SUNBURST INC - 83555

Location ID: 318773

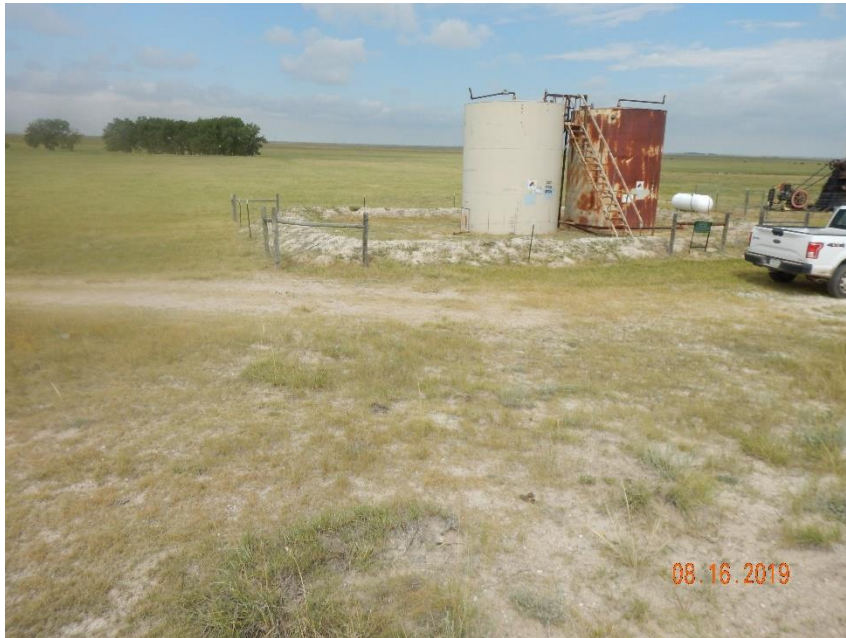
**Photo 1:** Photo taken from the southeast end of the location, facing west. Photo provides an overview of the location.

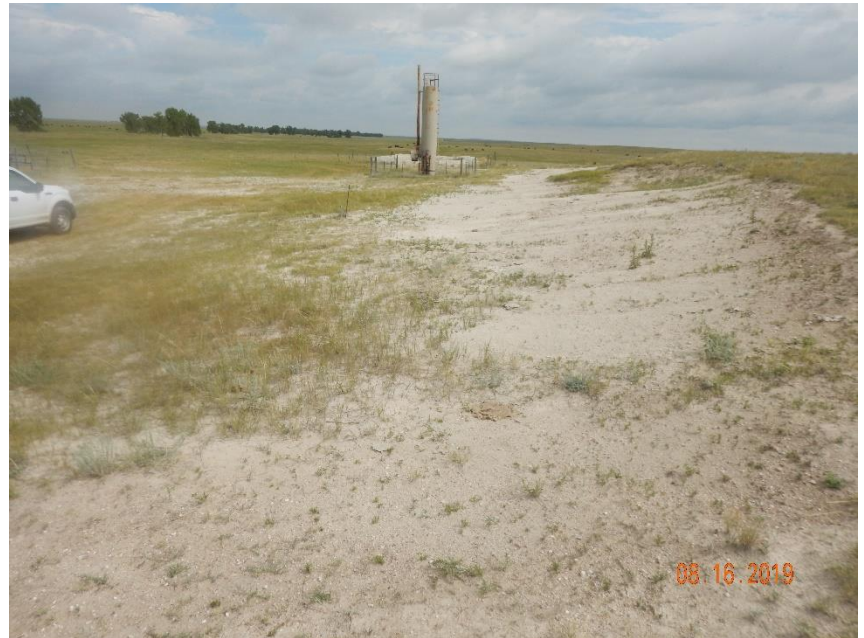
**Photo 2:** Photo taken from the southeast end of the location, facing north. Photo provides an overview of the location.

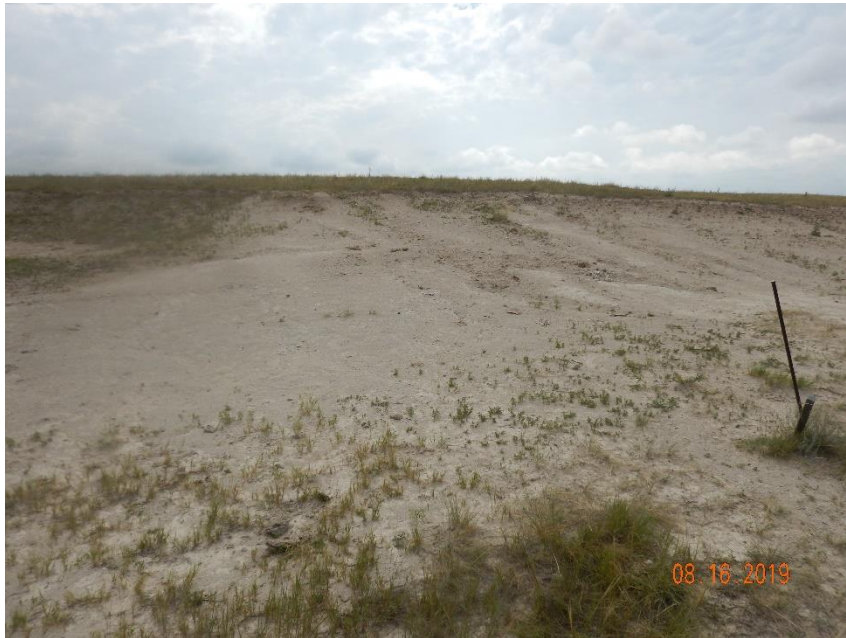
**Photo 3:** Photo taken from the east end of the location, facing southeast. Photo shows exposed soils with erosion degradation at the cut slopes. Previous inspections required operator to install or repair required BMPs by 12/4/2017. Operator has failed to comply with corrective actions and with rule 1002.f.

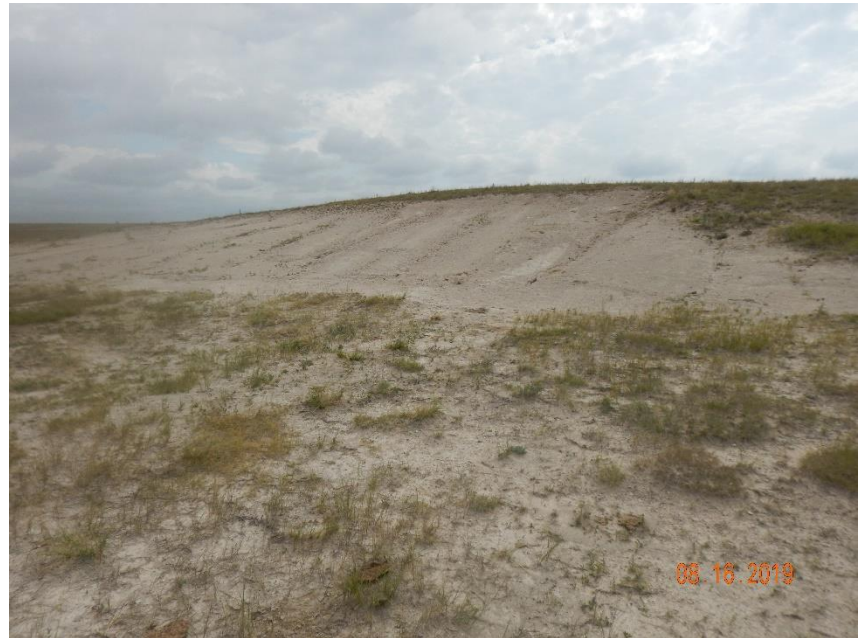
**Photo 4:** Photo taken from the east end of the location, facing northeast. Photo shows exposed soils with erosion degradation at the cut slopes.

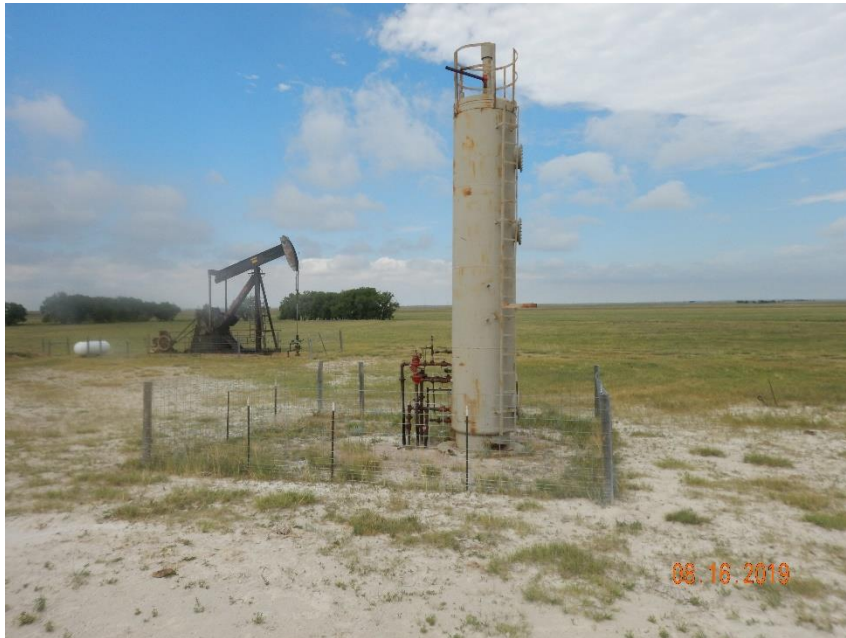
**Photo 5:** Photo taken from the northeast end of the location, facing west. Photo of equipment on location.

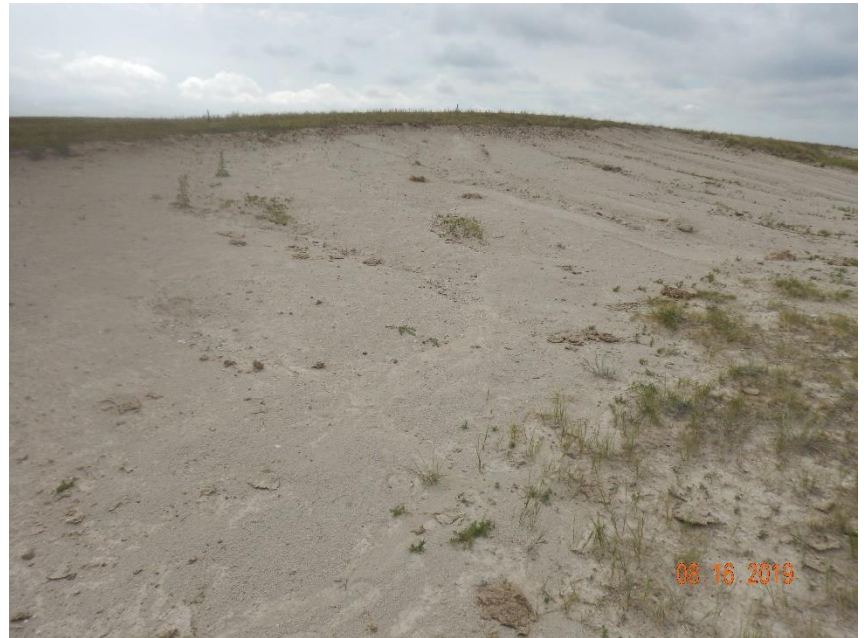
**Photo 6:** Photo taken from the northeast end of the location, facing southeast. Photo shows exposed soils with erosion degradation at the cut slopes. Previous inspections required operator to install or repair required BMPs by 12/4/2017. Operator has failed to comply with corrective actions and with rule 1002.f.

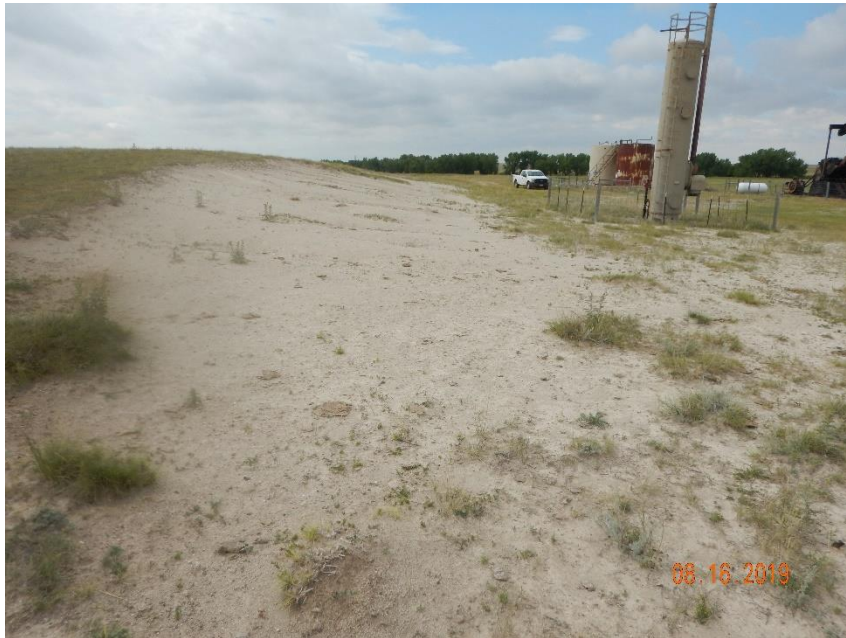
**Photo 7:** Photo taken from the northeast end of the location, facing west. Photo shows exposed soils and erosion degradation along the east end of the location.

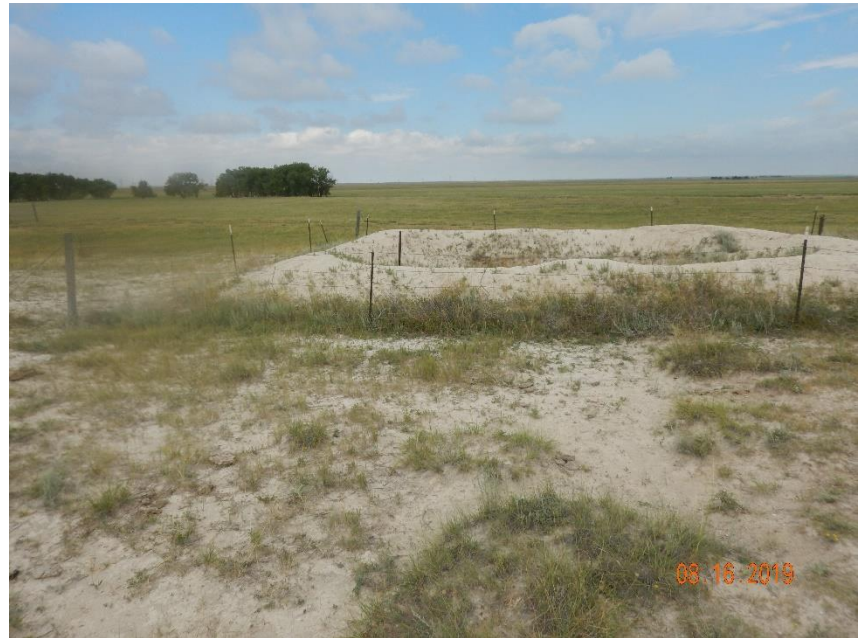
**Photo 8:** Photo taken from the northeast end of the location, facing west. Photo shows pit on location. Inspection #696101187 documented weed encroachment at pit on location and required operator to remove, manage and control weeds. Photo shows vegetative establishment within, and on the pit. Vegetation compromises the integrity of the pit walls/berms

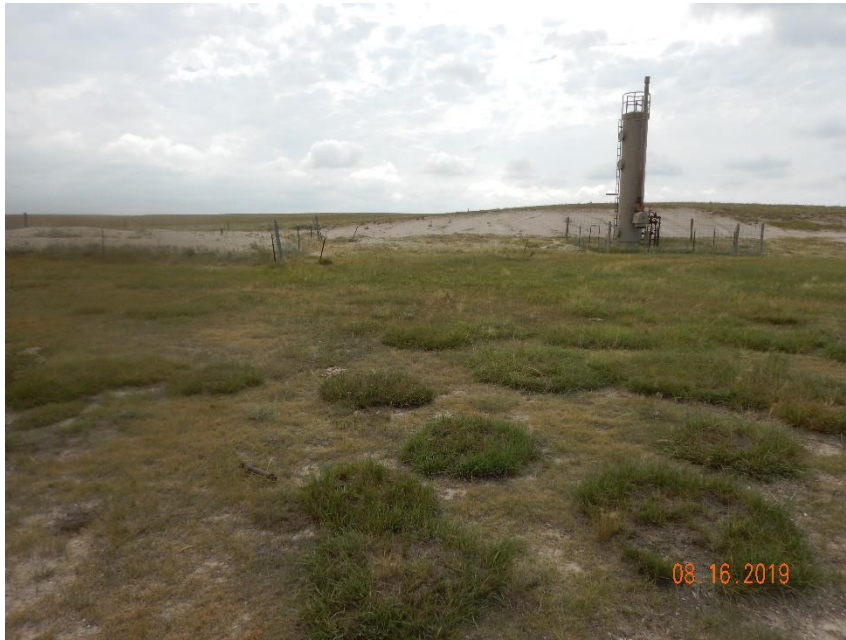
**Photo 11:** Photo taken from the northwest corner of the location, facing west. Photo provides an overview of the location.

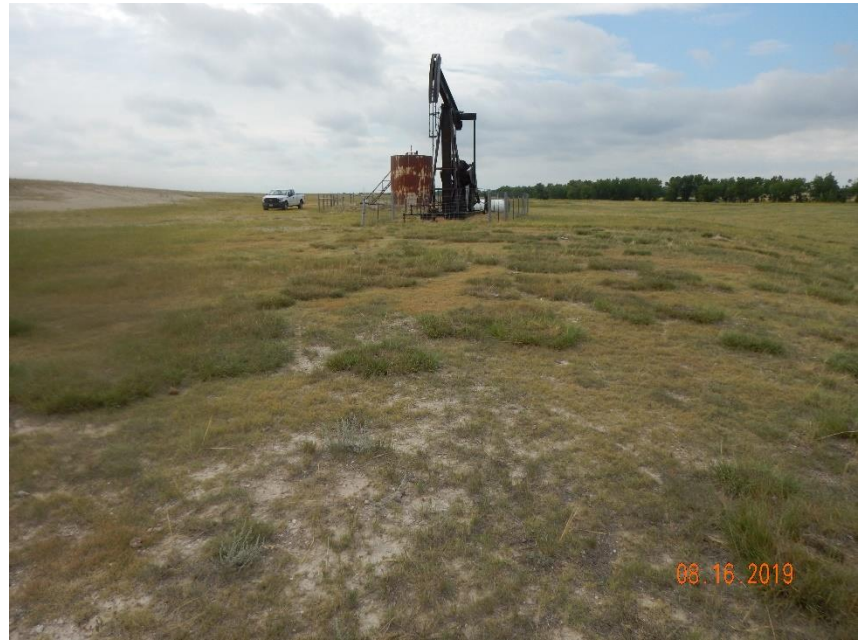
**Photo 12:** Photo taken from the northwest corner of the location, facing south. Photo provides an overview of the location.

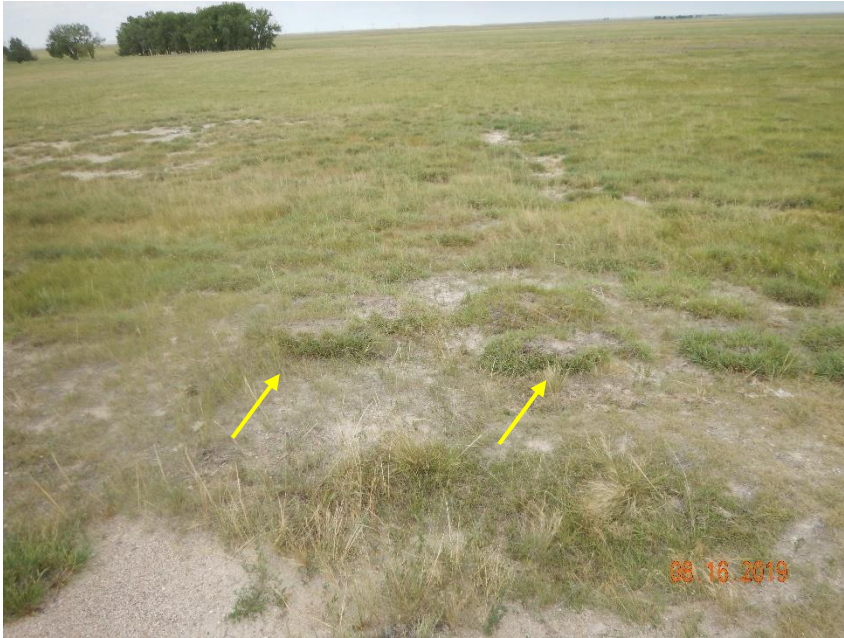
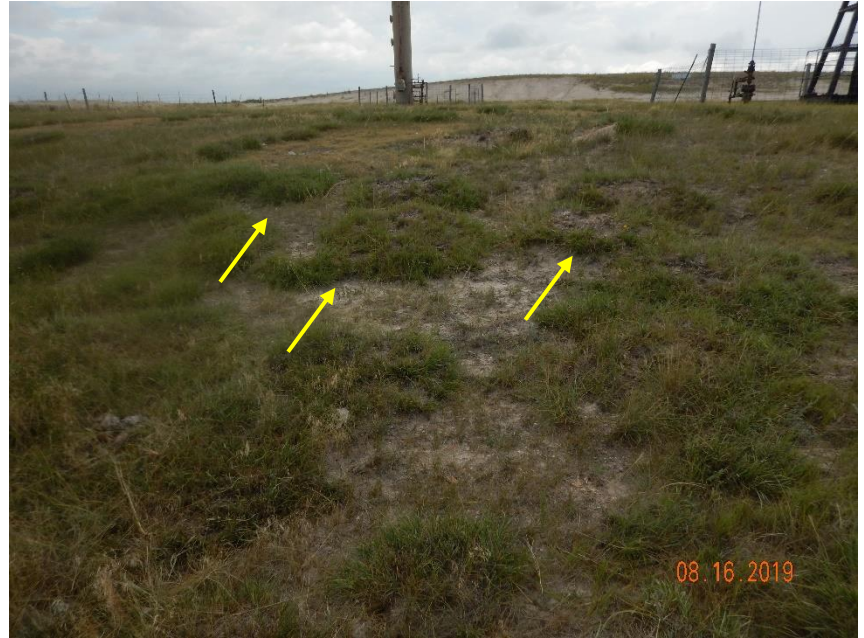
**Photo 13:** Photo taken from the west end of the location, facing west. Photo shows pedestal formations due to stormwater degradation. Pedestals form when stormwater erodes away un-stabilized areas of soil around vegetation.

**Photo 14:** Photo taken from the west end of the location, facing east. See comments under photo 13.

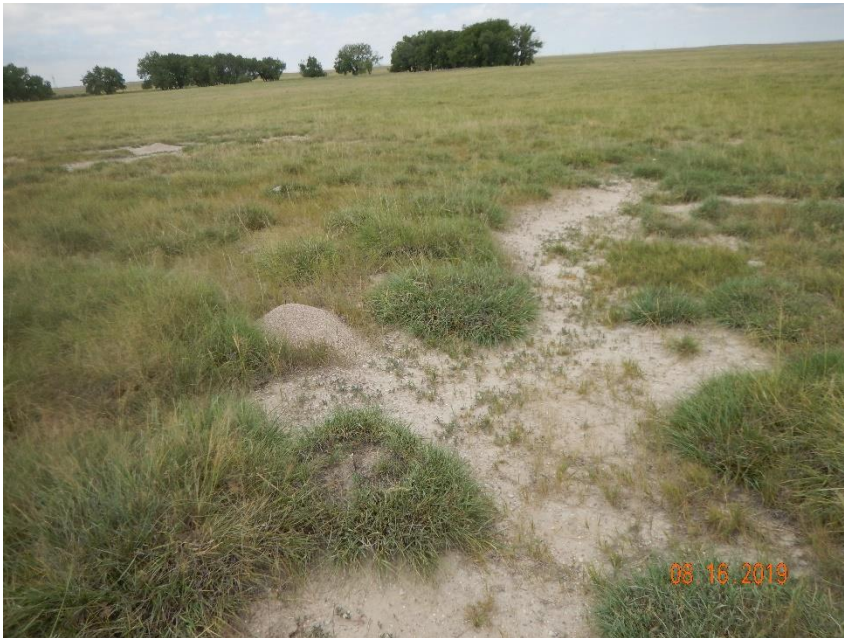
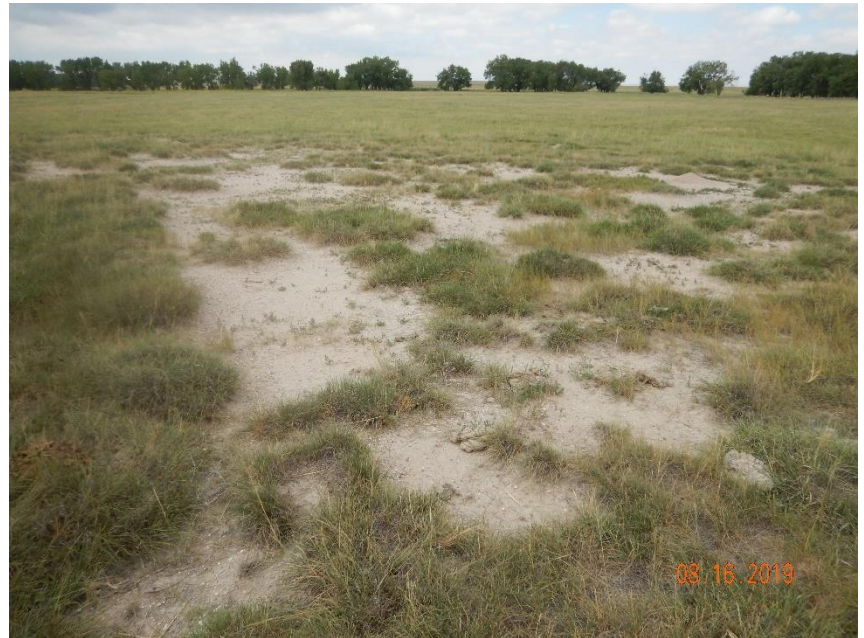
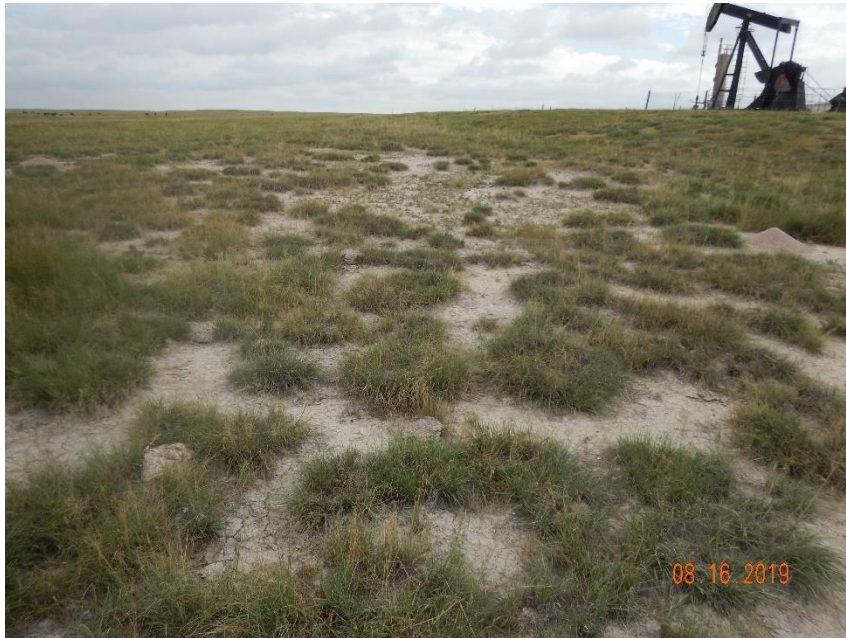
**Photo 15:** Photo taken from the west end of the location, facing west. Photo shows areas on the west end of the location where pit, or a spill, appears to have historically existed. Disturbance does not pre-exist the oil and gas location. See photos 29-32 for additional details

**Photo 16:** Photo taken from the west end of the location, facing west. See comments under photo 15.

**Photo 17:** Photo taken from the west end of the location, facing east. See comments under photo 15..

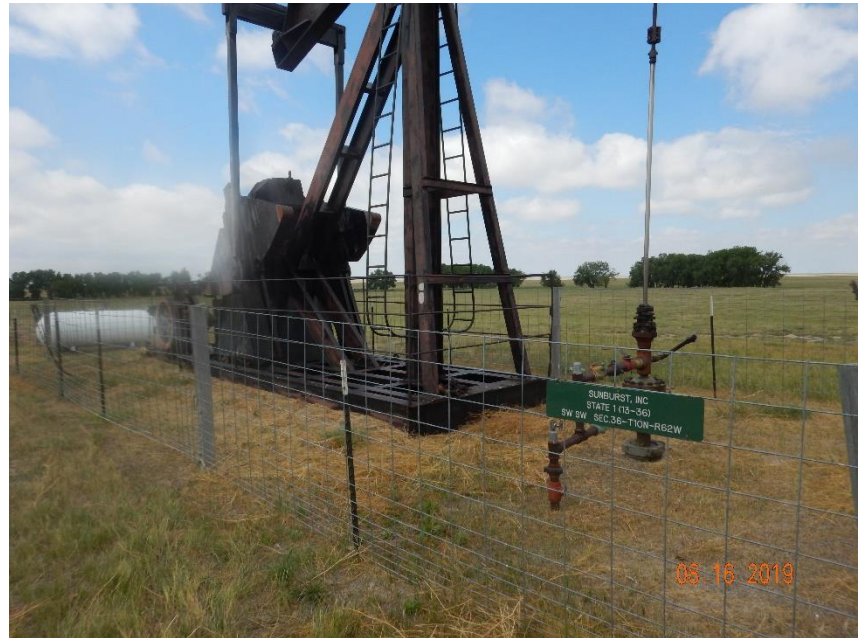
**Photo 18:** Inspection #696101187 documented weed encroachment at equipment on location and required operator to remove, manage and control weeds. Photo shows vegetation around well appears to have recently mowed, however, vegetation has not been removed from area of equipment. Vegetative growth and accumulation around equipment/wellhead is considered a fire hazard.

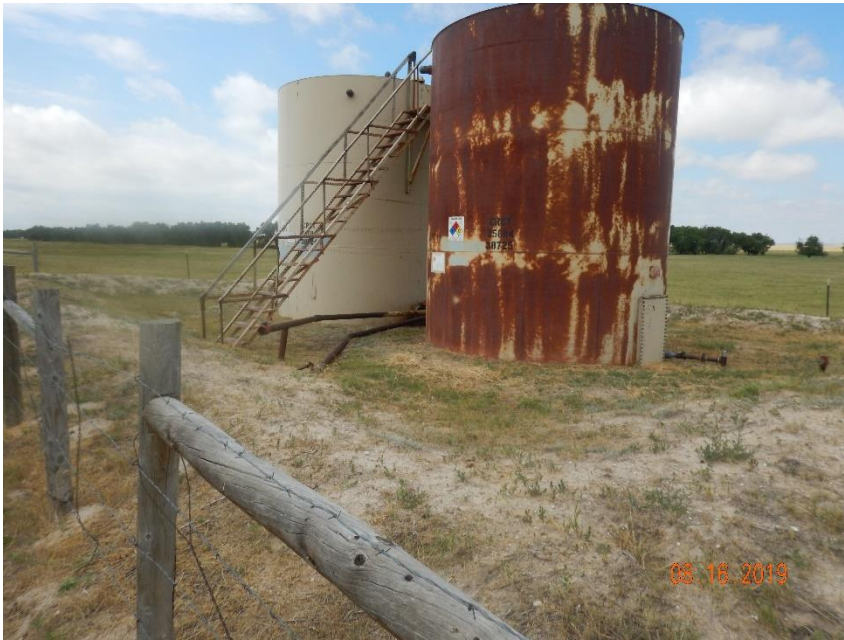
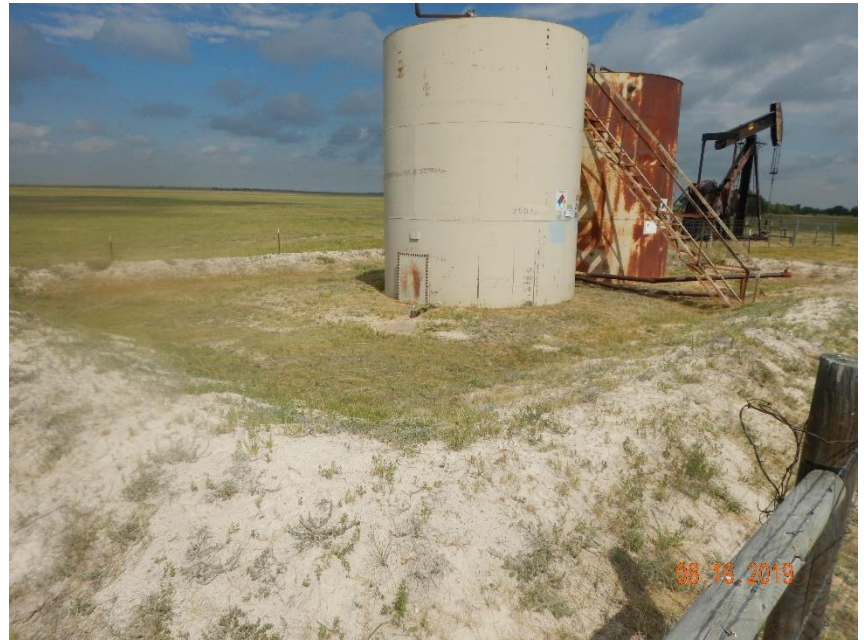
**Photo 19:** Inspection #696101187 documented weed encroachment at equipment on location and required operator to remove, manage and control weeds. Photo taken from the tank battery on the south end of the location, facing southwest. Photo shows vegetative establishment within, and on the secondary containment (berms). Vegetation compromises the integrity of the secondary containment

**Photo 20:** Photo taken from the tank battery on the south end of the location, facing northwest. See comments under photo 19.

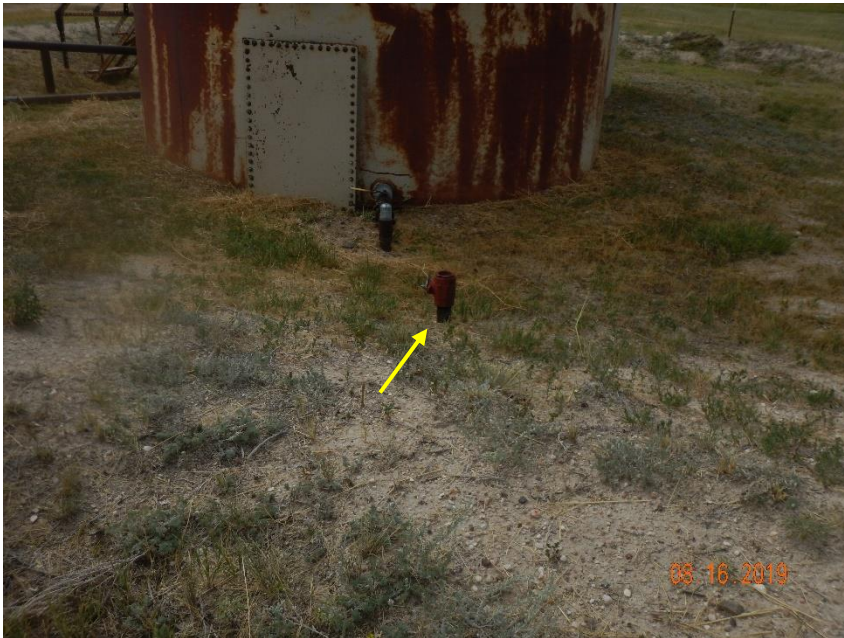
**Photo 21:** Photo taken from the north end of the tanks. Photo of riser. Riser does appear to be abandoned and is considered equipment not needed for production. Additionally, riser has not been "locked out/tagged out".

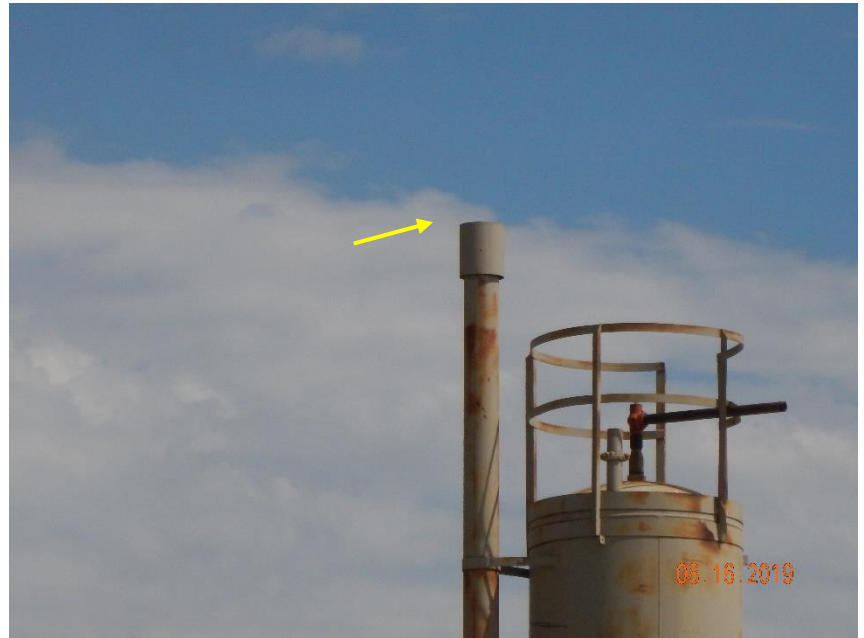
**Photo 22:** Inspection #696101187 documented that no wildlife protection screen observed on heated treated stack. Photo shows wildlife protection screen does not appear to have been installed per 605.b.(7)

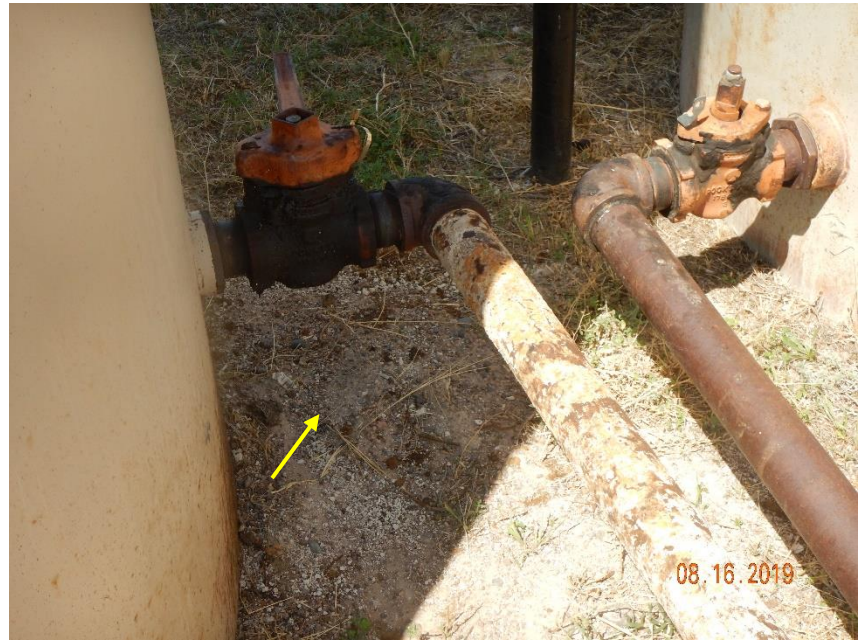
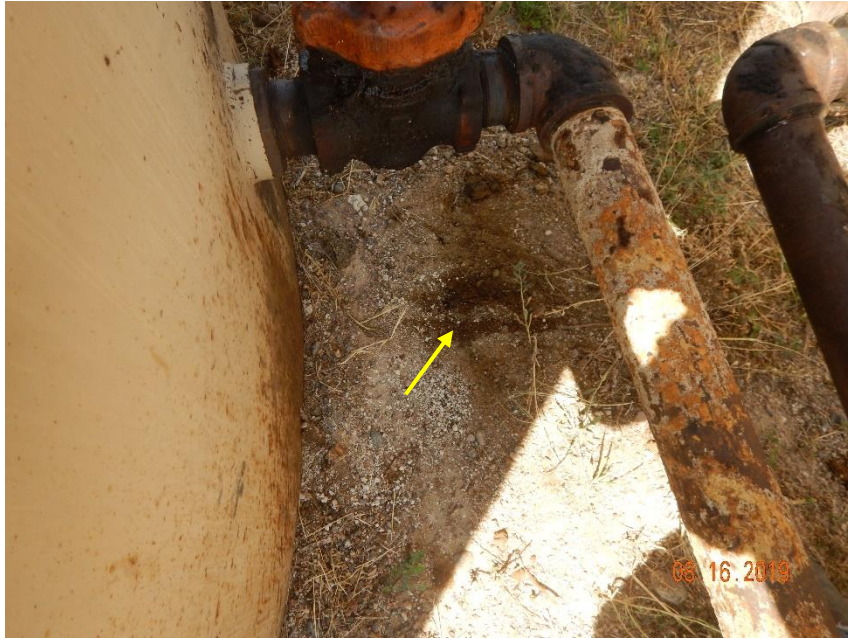
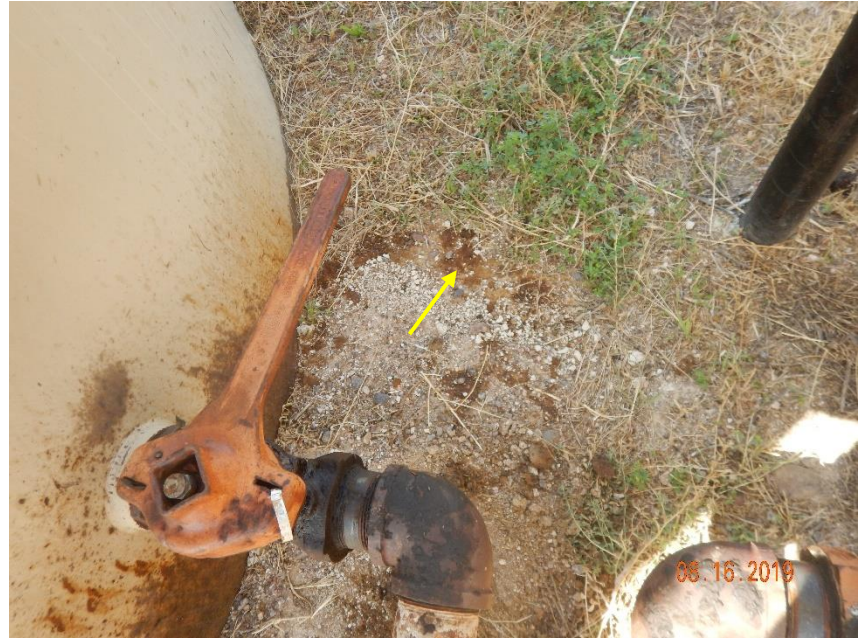
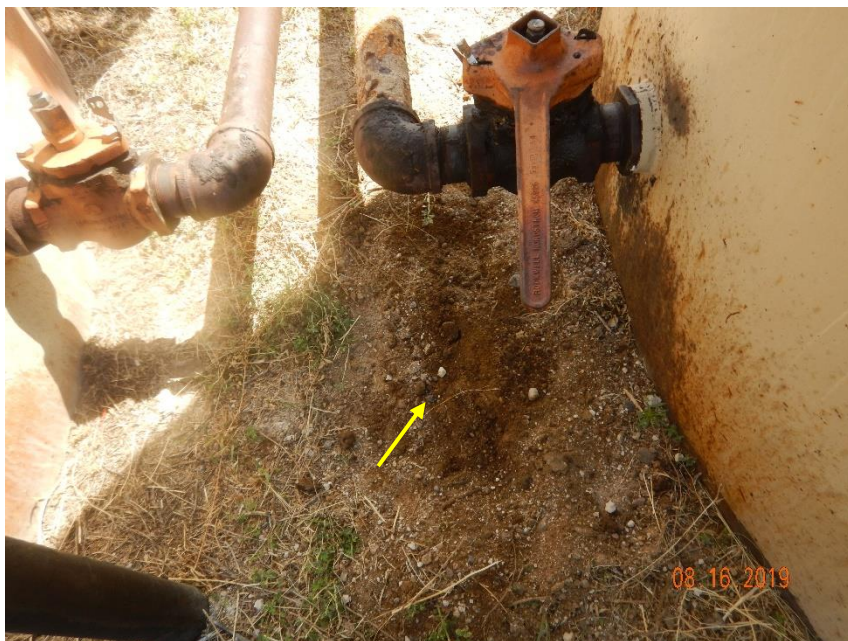
**Photo 24:** Inspection #696101187 documented and required operator to remove and/or remediate stained soil beneath south crude oil tank loadout. Photo shows area where stained soils were observed in inspection #696101187. It appears during initial observations that the stained soils have been removed or remediated. However, upon closer inspection, it appears as though clean soil has been placed to cover the stained soils (see photos 25-7)

**Photo 25:** Continued from photo 24. Photo shows that once inspector scrapes the surface, it becomes clear that stained soils have not been removed and or/remediated.

**Photo 26:** Continued from photo 24.

**Photo 27:** Continued from photo 24.

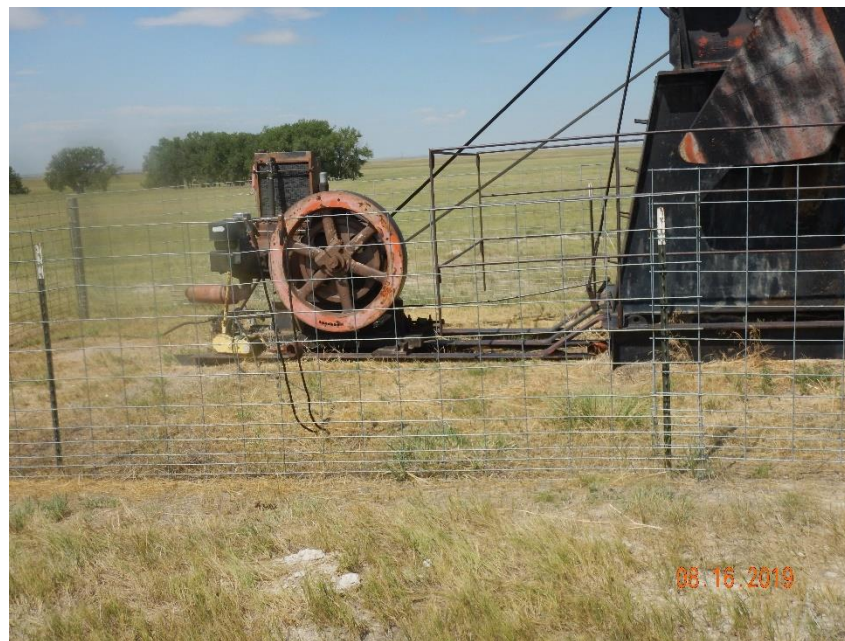
**Photo 28:** Inspection #696101187 documented trash behind the engine and required removal. Photo shows trash debris appears to have been removed.

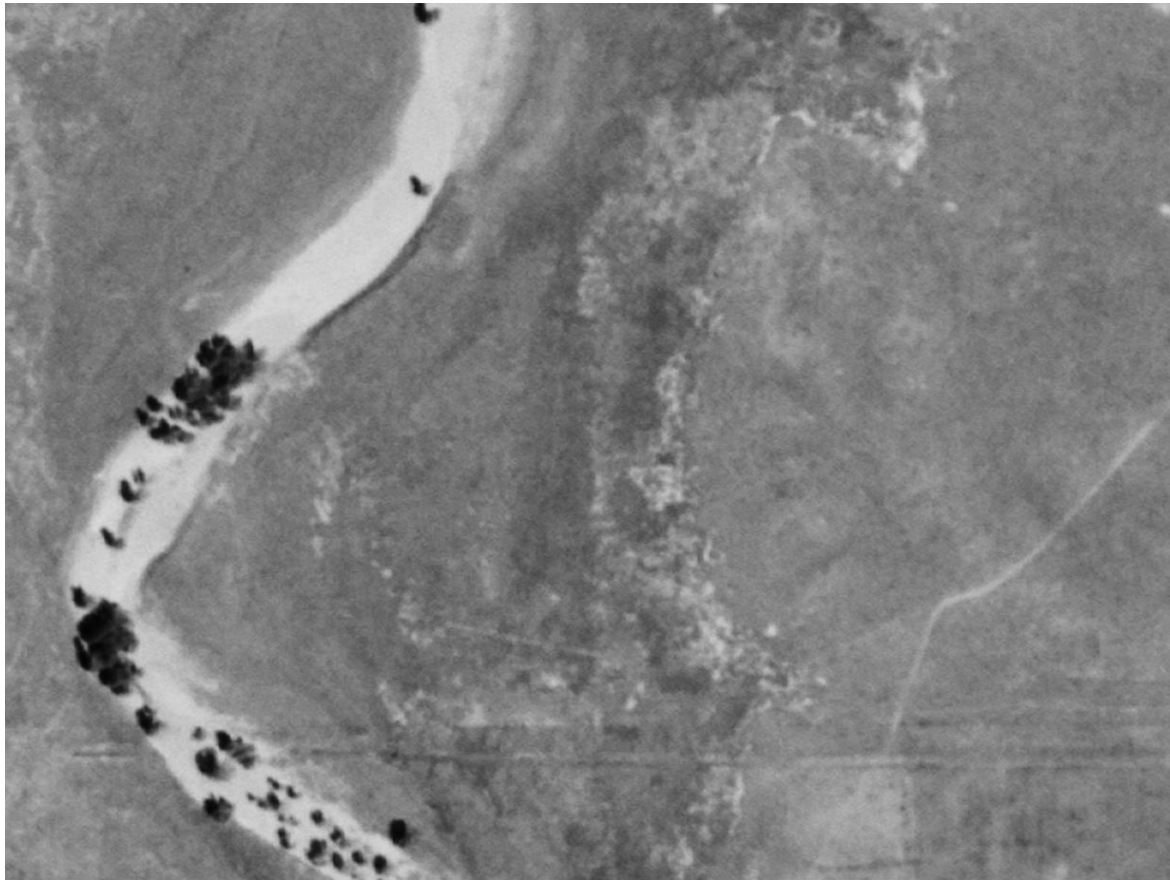
**Photo 29:** 1971 USGS Aerial imagery. Photo shows area prior to oil and gas disturbances.

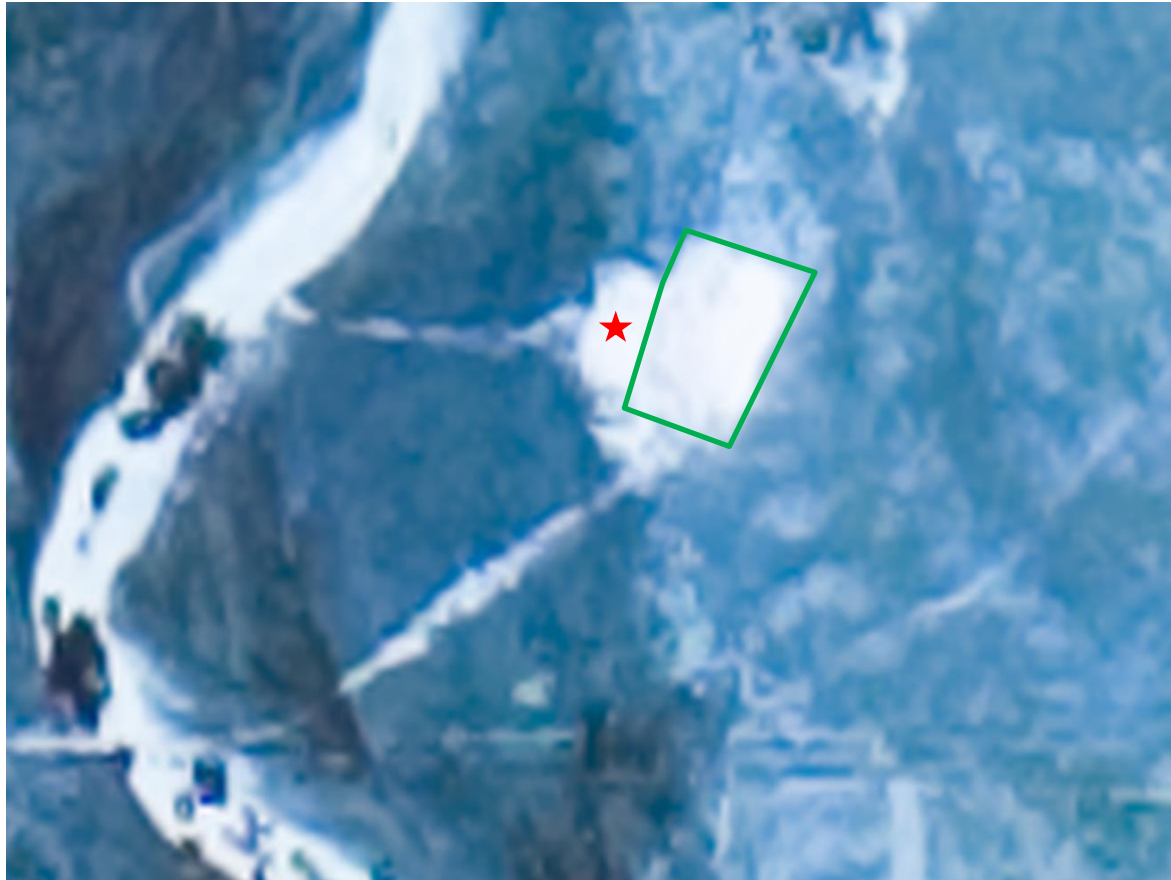
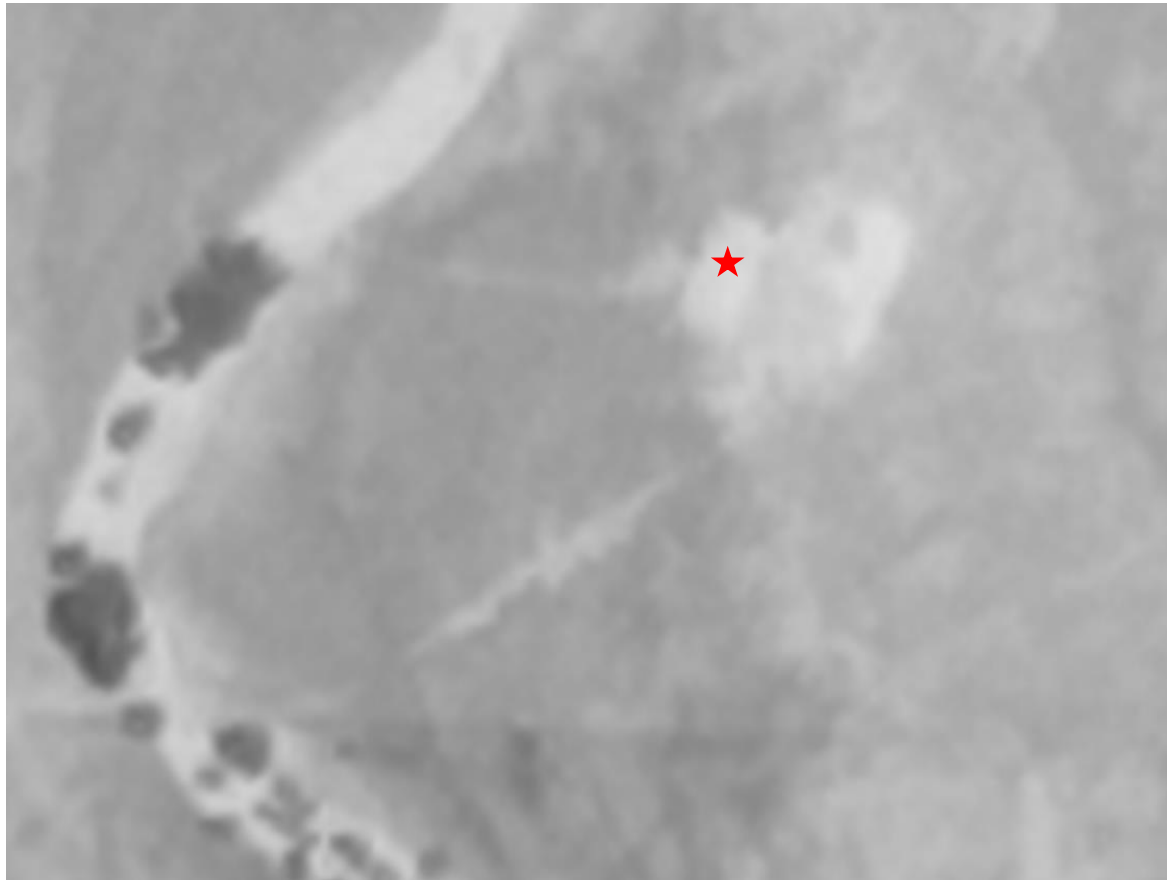
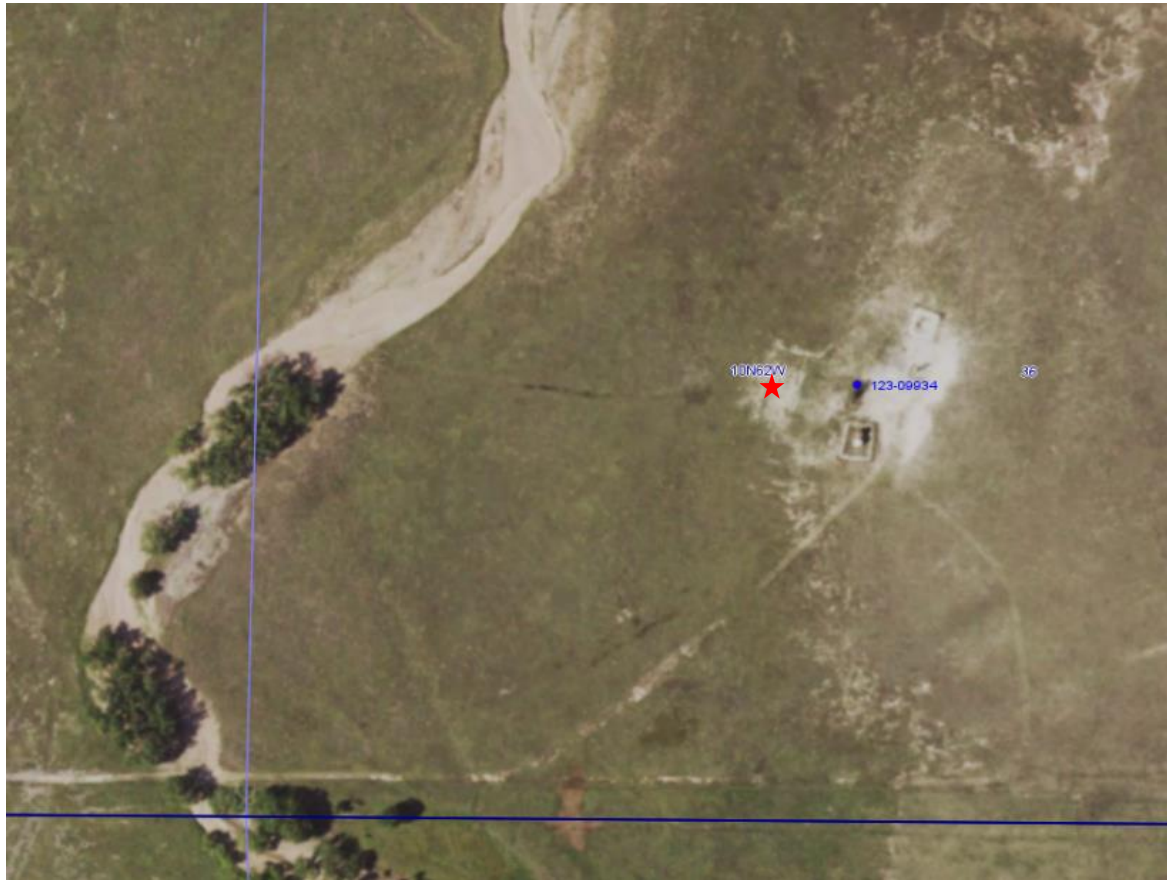
**Photo 30:** 1988 USGS aerial image. Location was constructed and well spud in 1982. Photo shows location (green) and areas on the west end (star) of the location where a pit, or possibly a spill is evident.

**Photo 31:** 1988 USGS aerial image. See comments under photo 30.

**Photo 32:** 2017 COGCC COGIS Aerial imagery. Image is the most recent imagery available. See comments under photo 30 , and related photos 15-17
