# Inspection Photos

Operator: P O & G OPERATING LLC - 10634

Well Location ID: 324938

Kit Carson County, CO

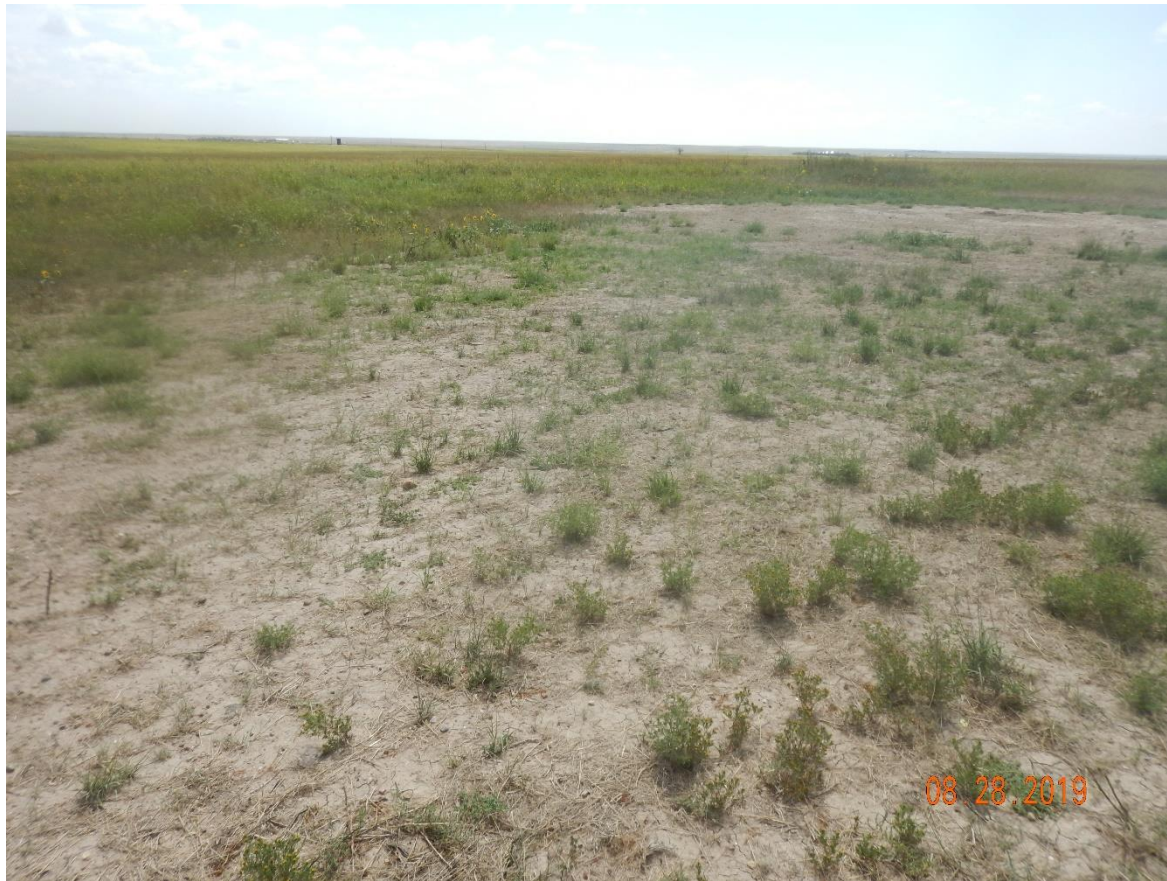
**Photo 1:** Photo taken from the north end of the location, facing southeast. Photo shows the reclamation of the location.

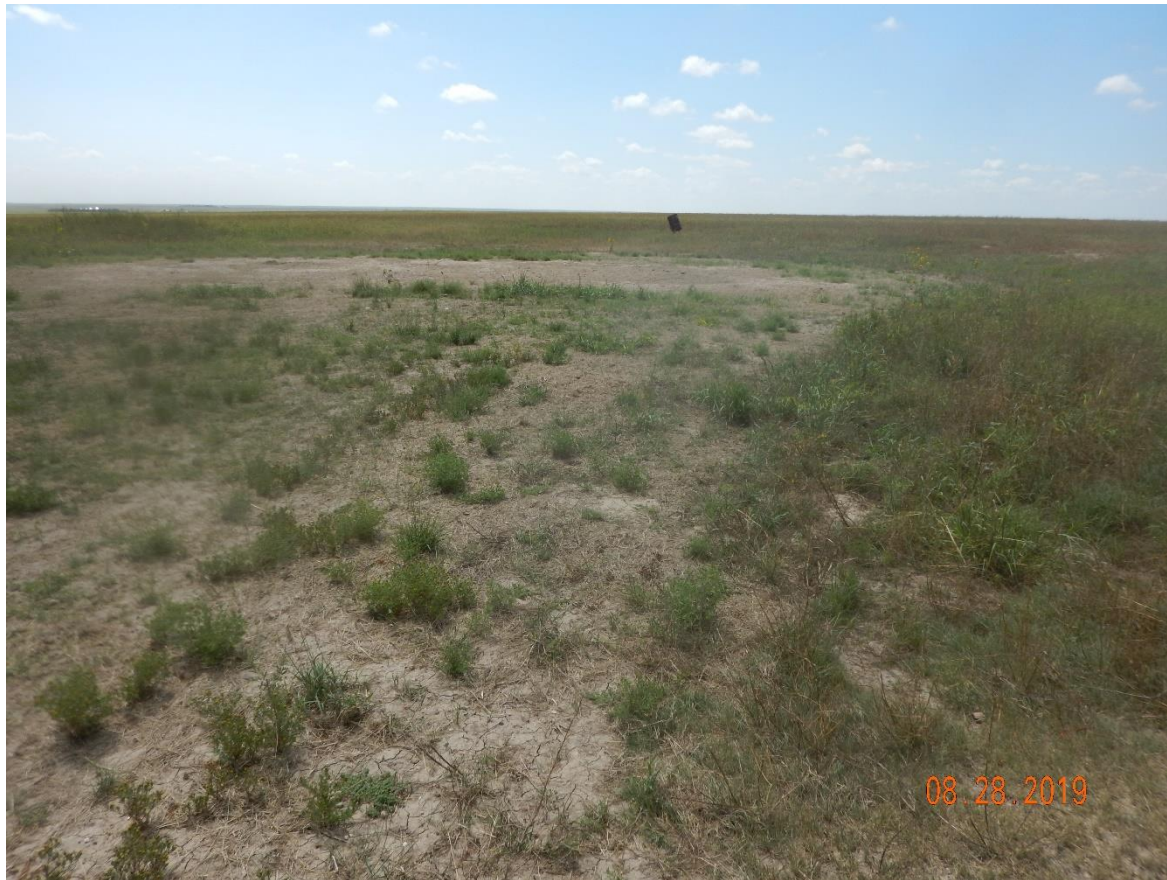
**Photo 2:** Photo taken from the north end of the location, facing south. Photo shows the reclamation of the location.

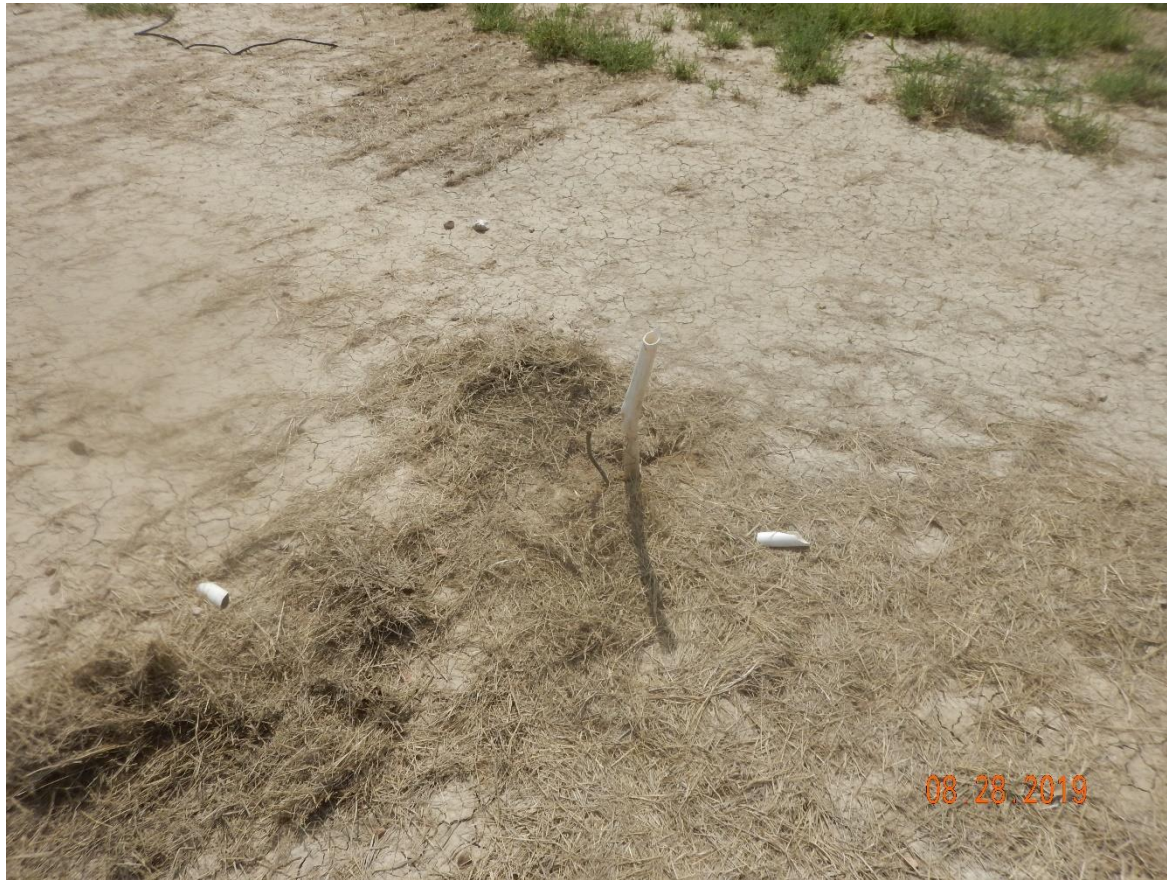
**Photo 3:** Photo taken from the location. Photo shows trash debris (PVC pipe, cable) remaining on location.

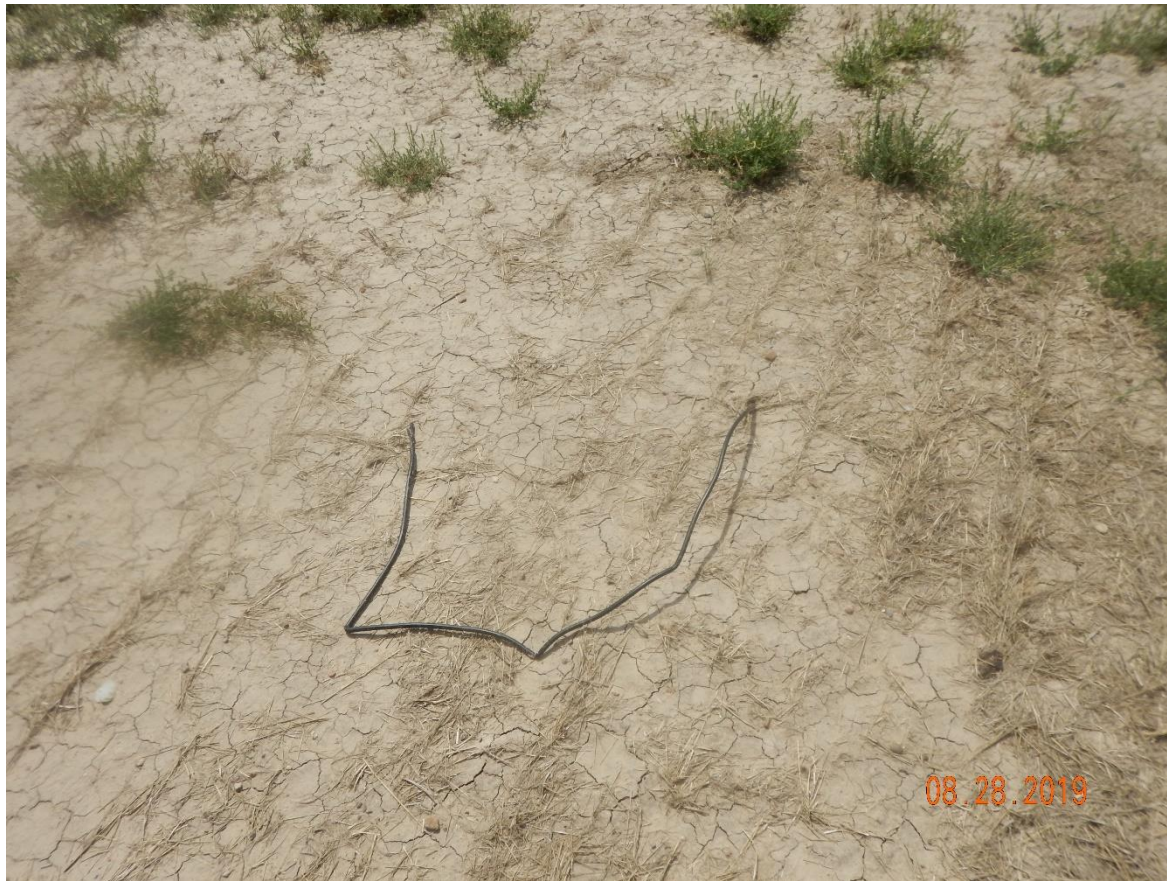
**Photo 4:** Photo taken from the location. Photo shows trash debris remaining on location and partially buried.

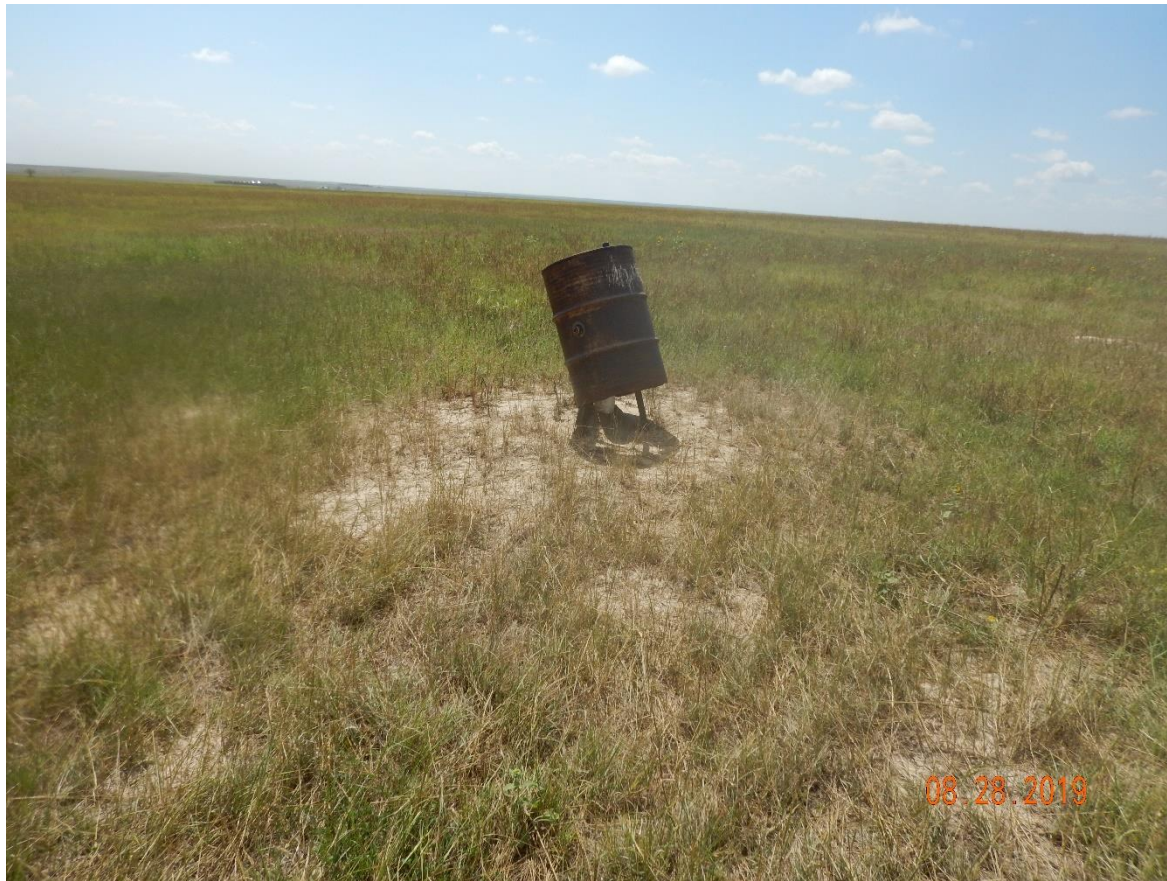
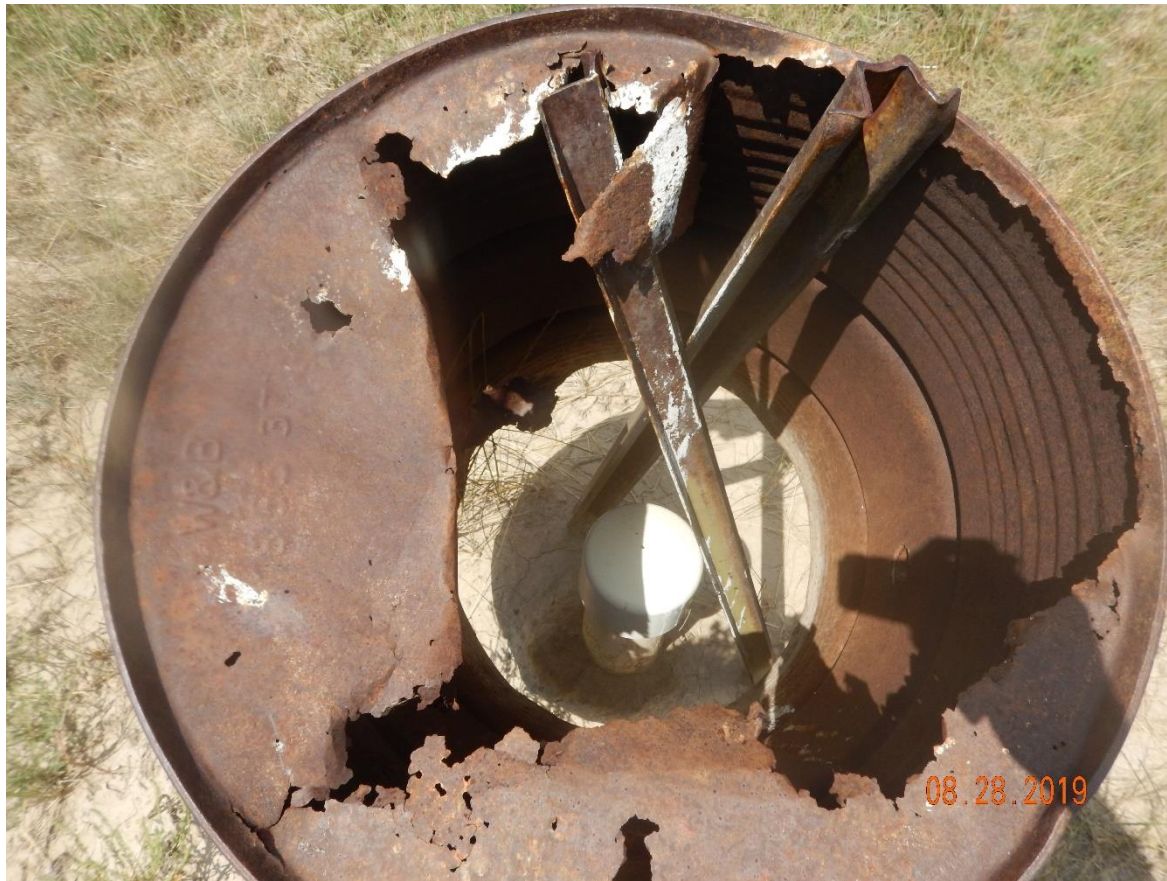
**Photo 5:** Photo taken from the south end of the location, facing south. Photo shows a barrel covering a plastic pipe on location.

**Photo 6:** Continued from photo 5.

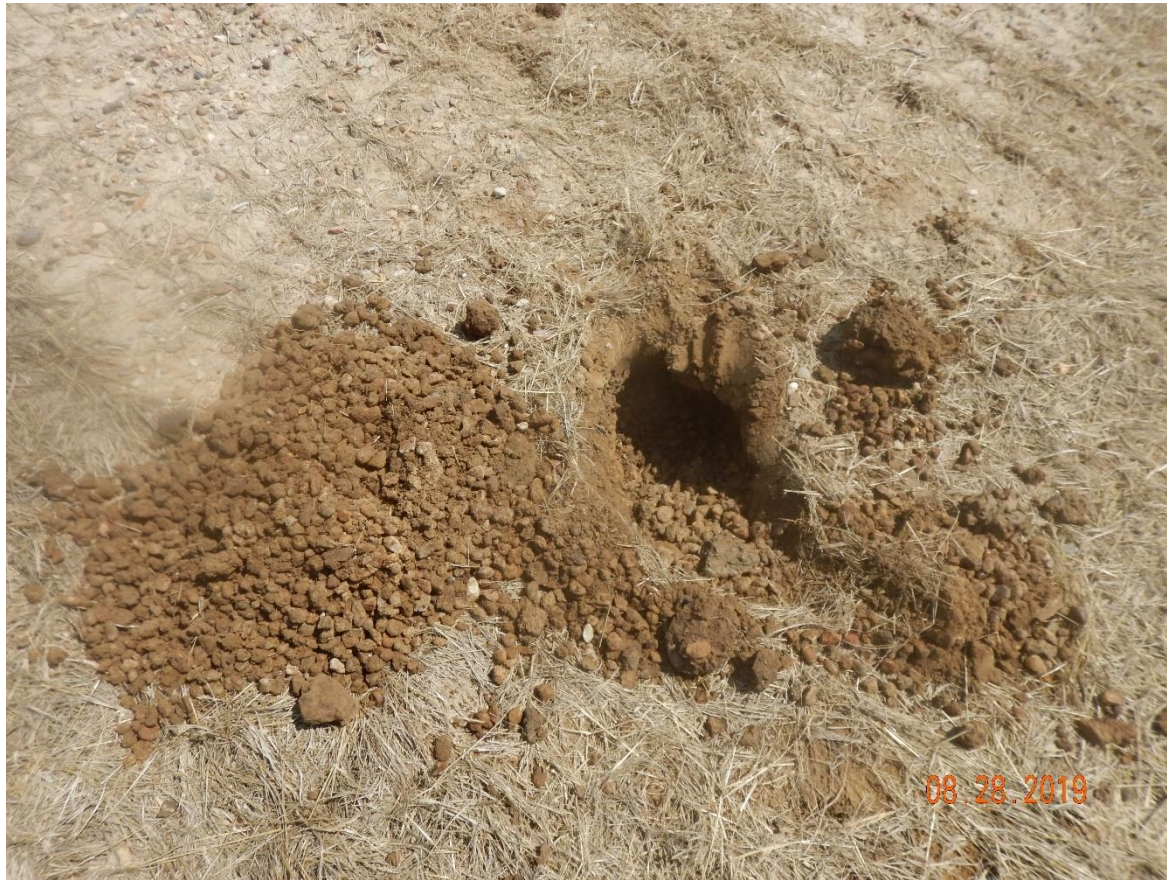
**Photo 7:** Photo taken from the location. Reclamation specialist conducted a test pit for both compaction and soil concerns. Reclamation specialist observed large quantities of gravel a few inches subsurface.

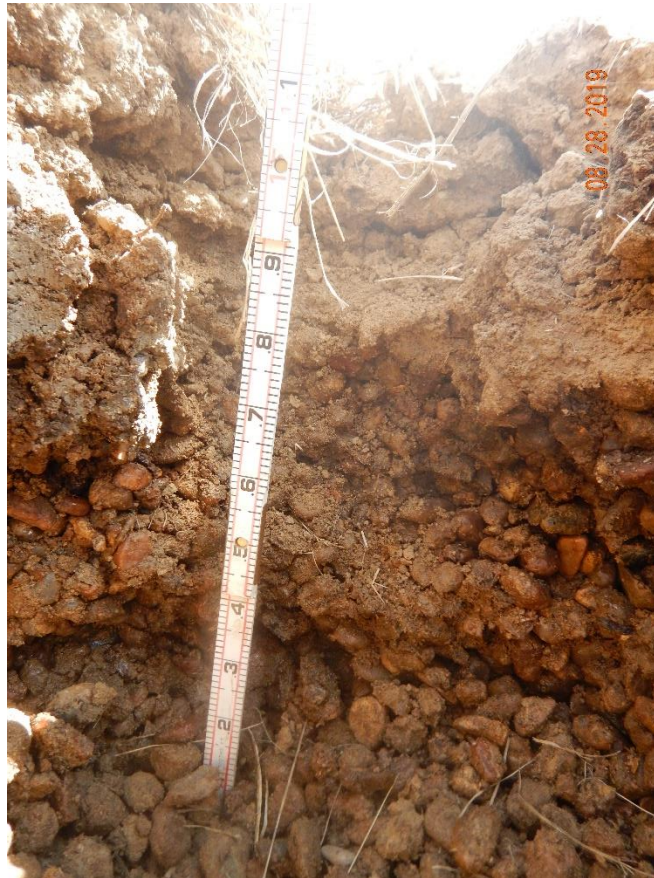
**Photo 8:** Continued from photo 7. Photo shows quantities of gravel ~4 inches subsurface. A liquid sheen and a chemical smell was also noticed in the gravel.

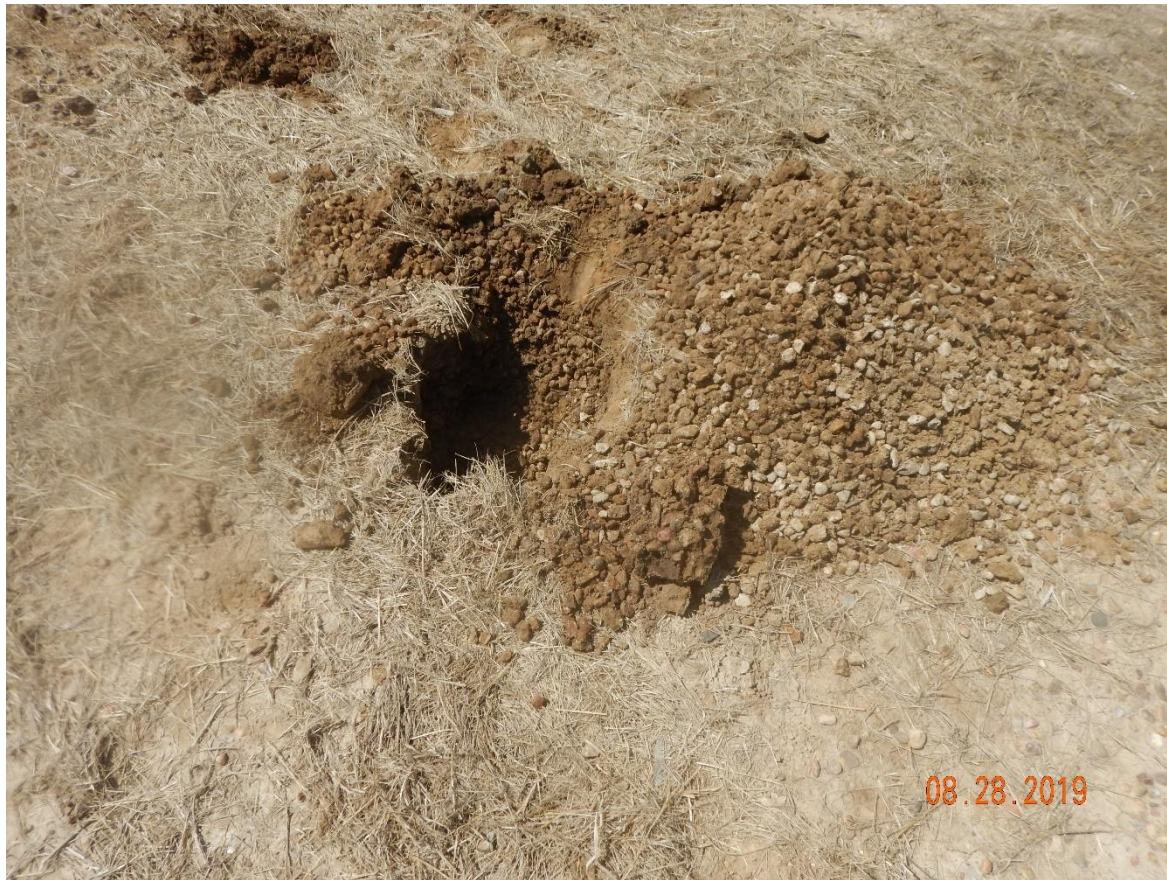
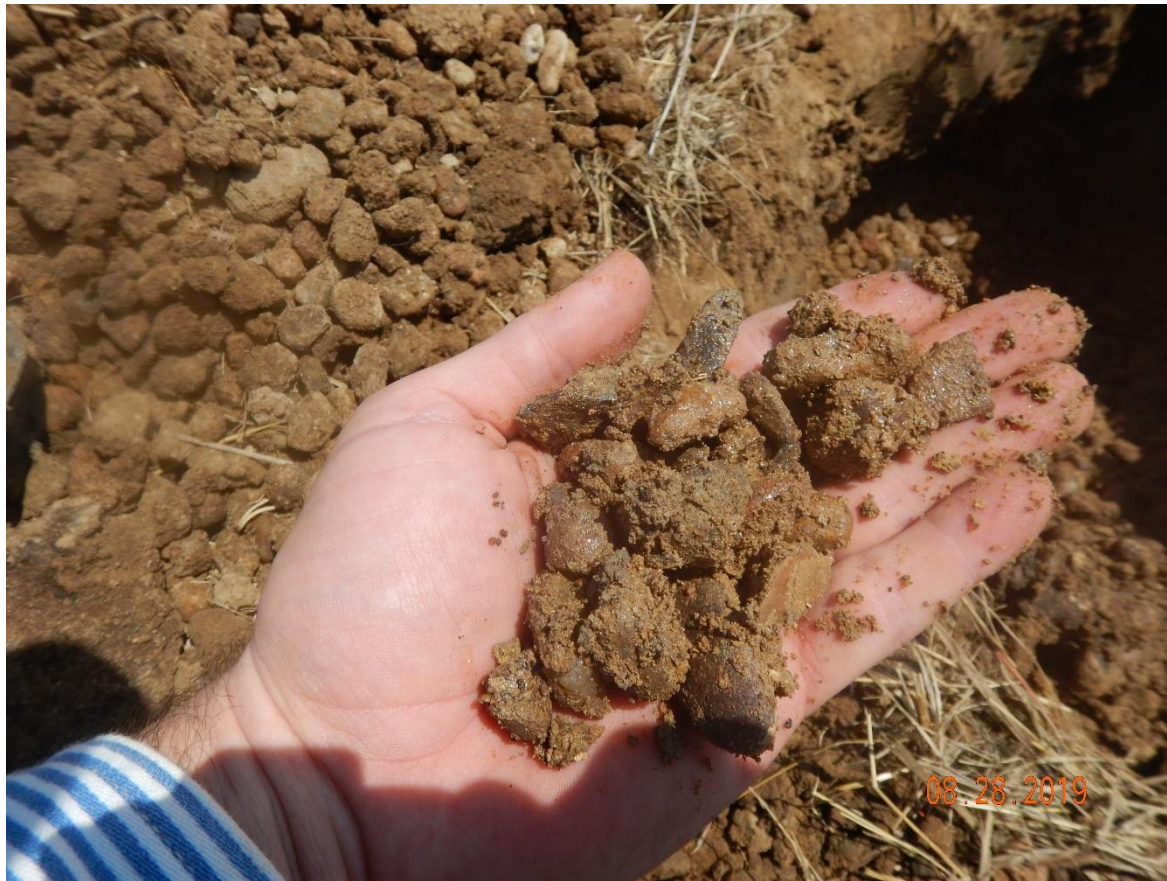
**Photo 9:** Photo shows gravel material with a chemical smell that was excavated from the test pit.

**Photo 10:** See comments under photo 10.

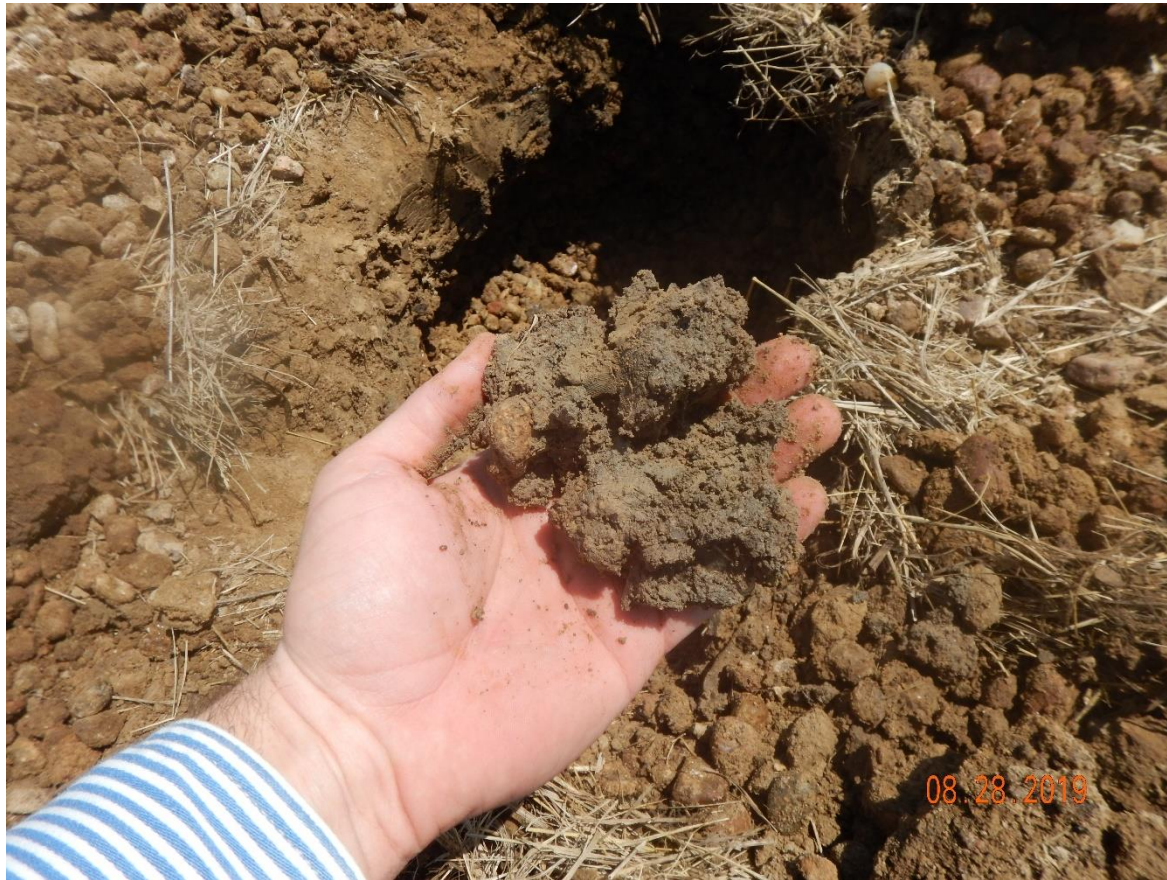
**Photo 11:** Photo shows additional soils excavated from the test pit. Similar to the gravel, soils also had a liquid sheen and a chemical smell.

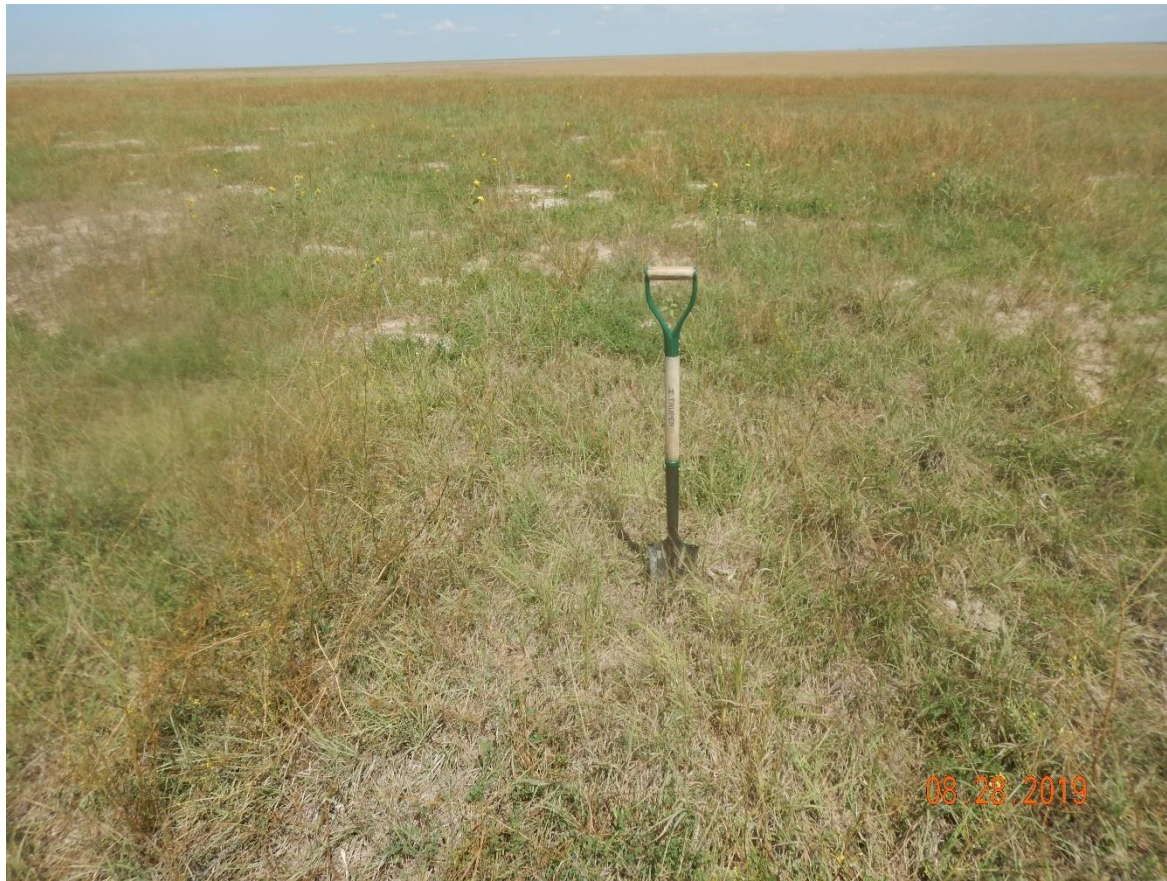
**Photo 12:** Photo taken from the adjacent reference areas. Photo shows reclamation specialist was able to easily penetrate the top 12-15 inches of soil. Compaction concerns appear evident on location. Reclamation specialist dug a test pit within the reference to compare soils observed on location.

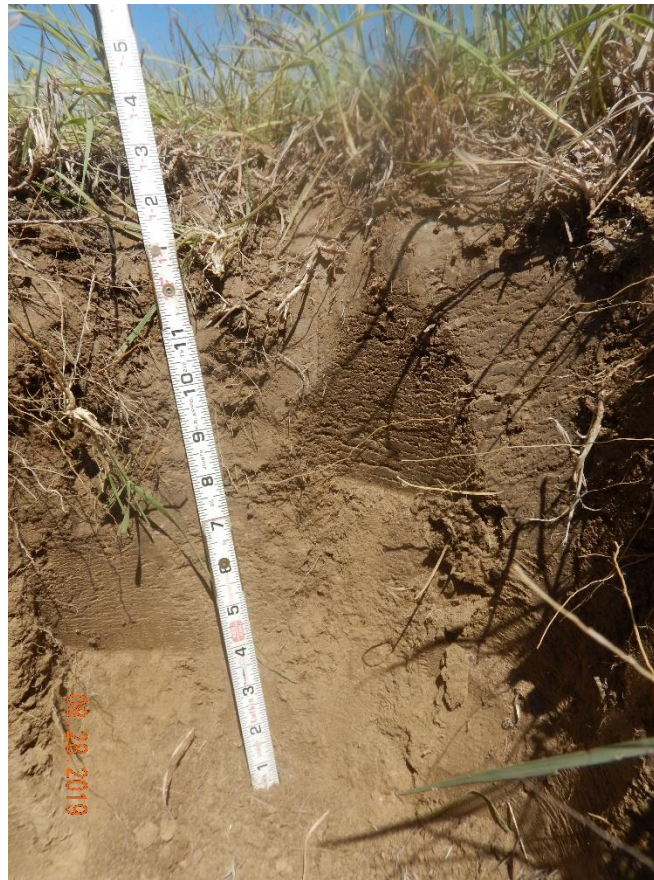
**Photo 13:** Photo of test pit from the reference area. Photo shows soils observed on the location are not reflective of soils on the adjacent reference area. Soils in the reference did not contain a chemical smell detected in the soils on the location.

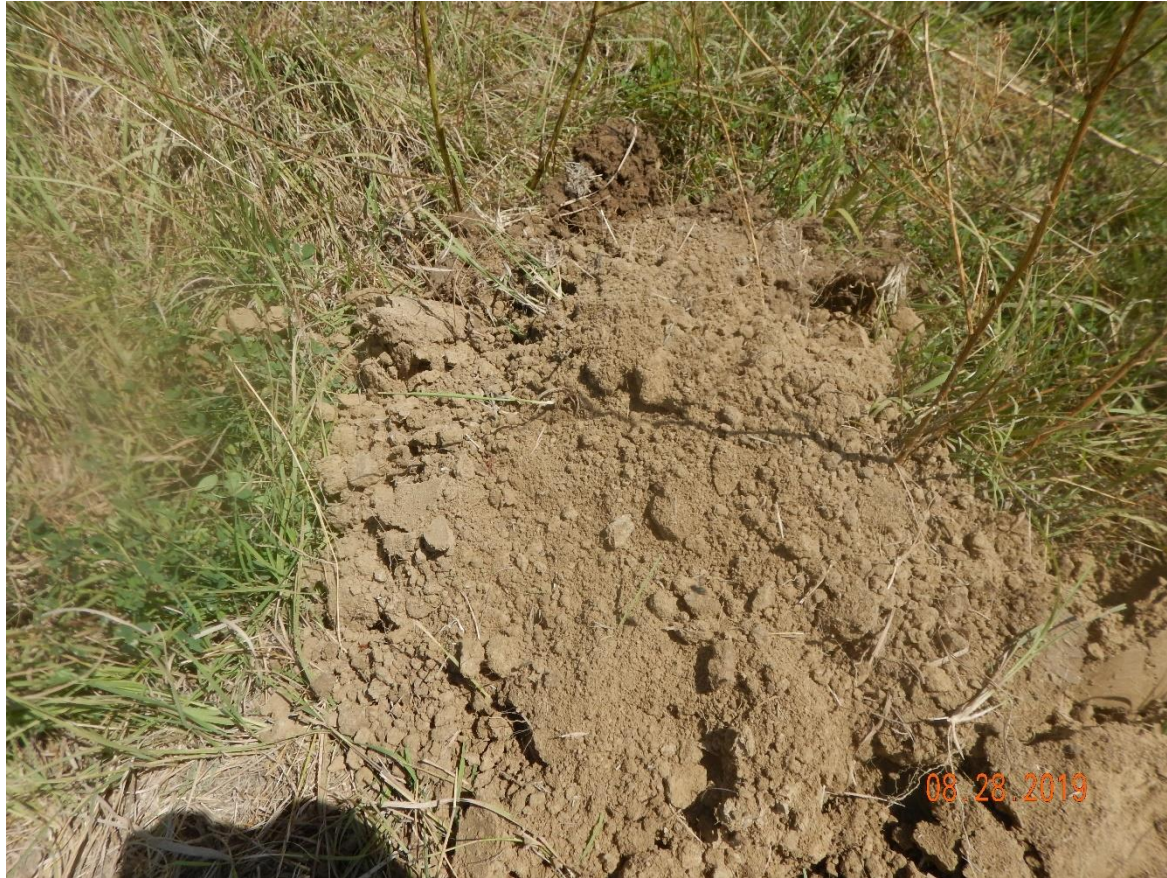
**Photo 14:** Photo of soils excavated from the reference area. Photo shows soils observed on the location are not reflective of soils on the adjacent reference area.

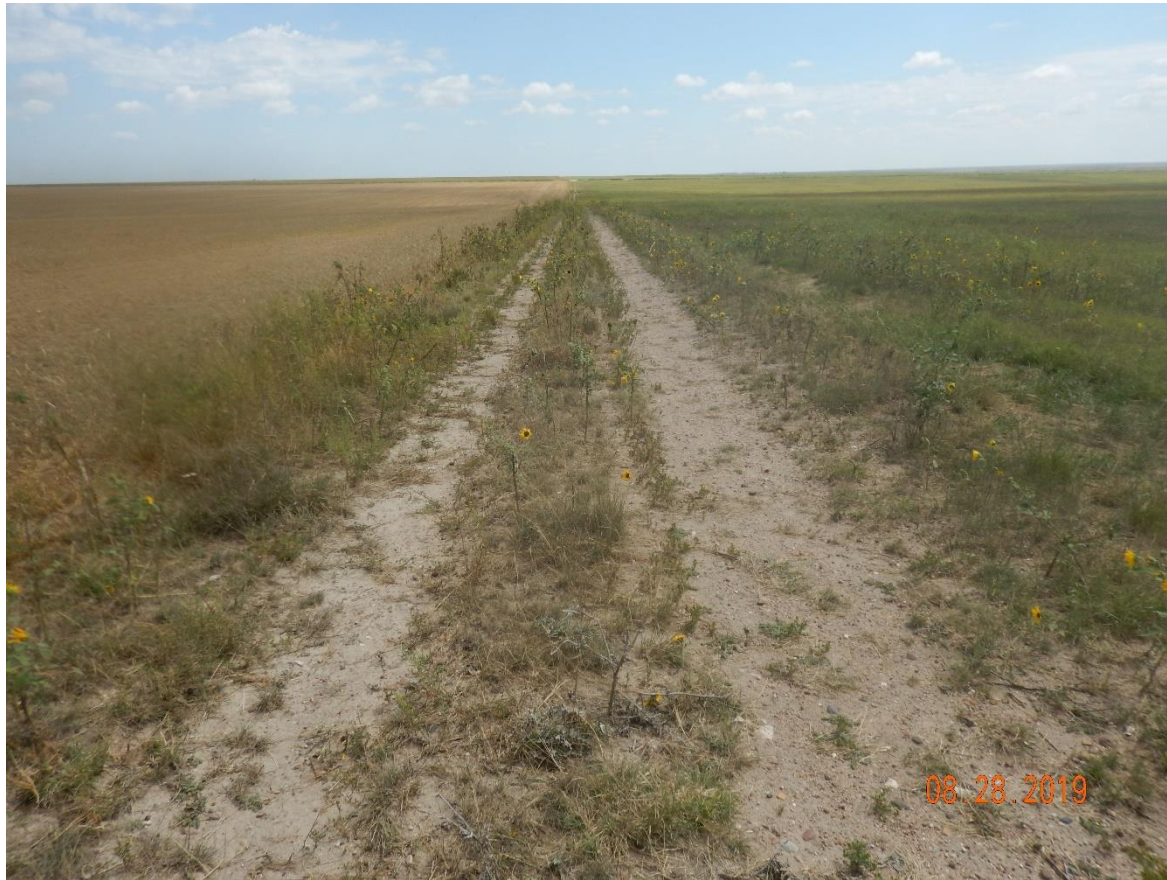
**Photo 15:** Photo taken the east/west access road north of the location. Photo shows Operator has not conducted final reclamation activities on the east/west section of access road.

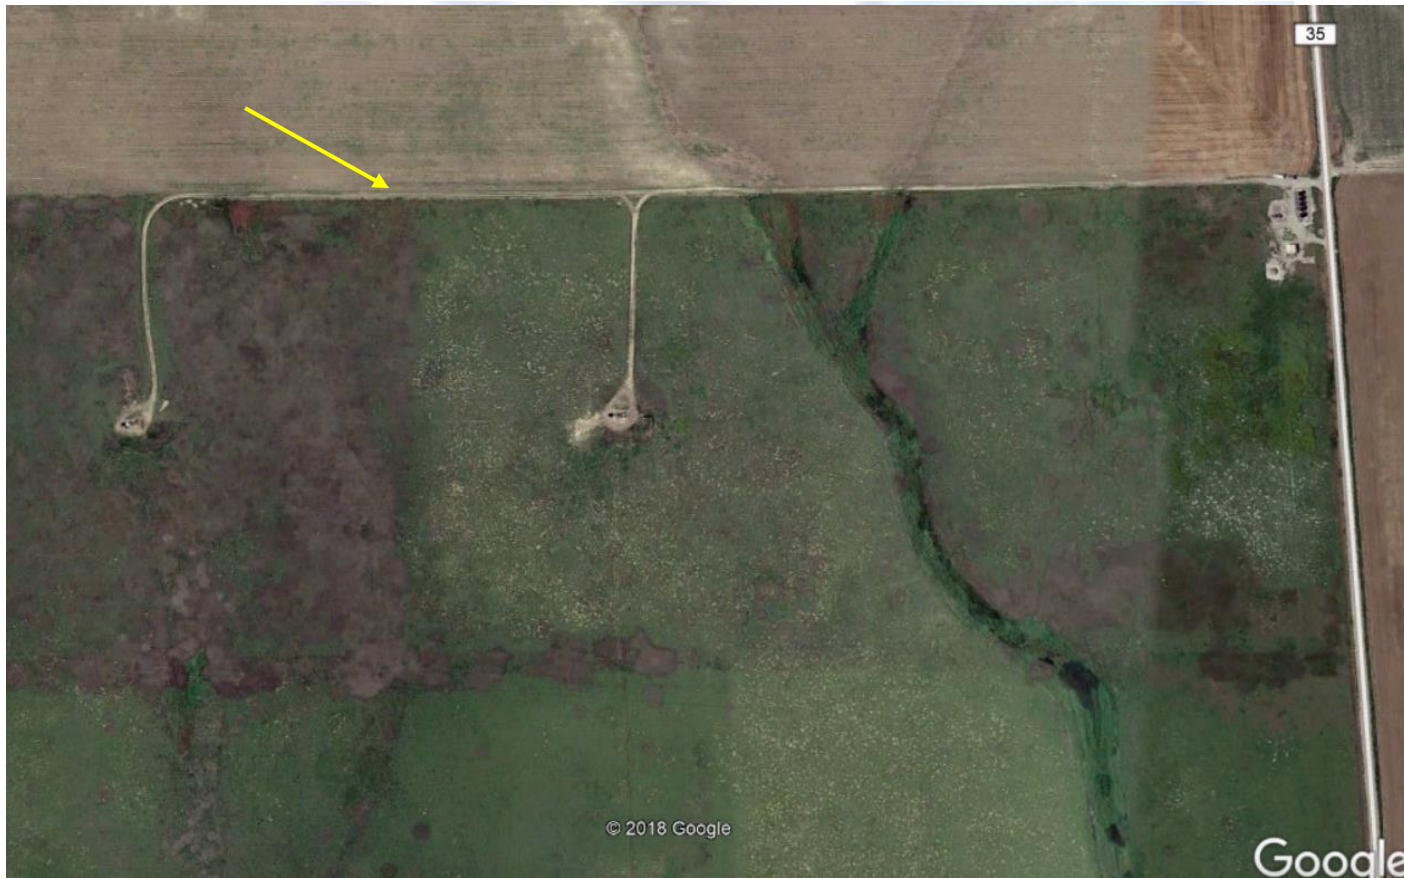
**Photo 16:** Current available Google Earth aerial imagery (2016). Photo shows Sundance Energy's well locations, battery facility and access roads. Operator has not conducted reclamation on the east/west section of access road (yellow arrow) in accordance with COGCC 1004 rules.

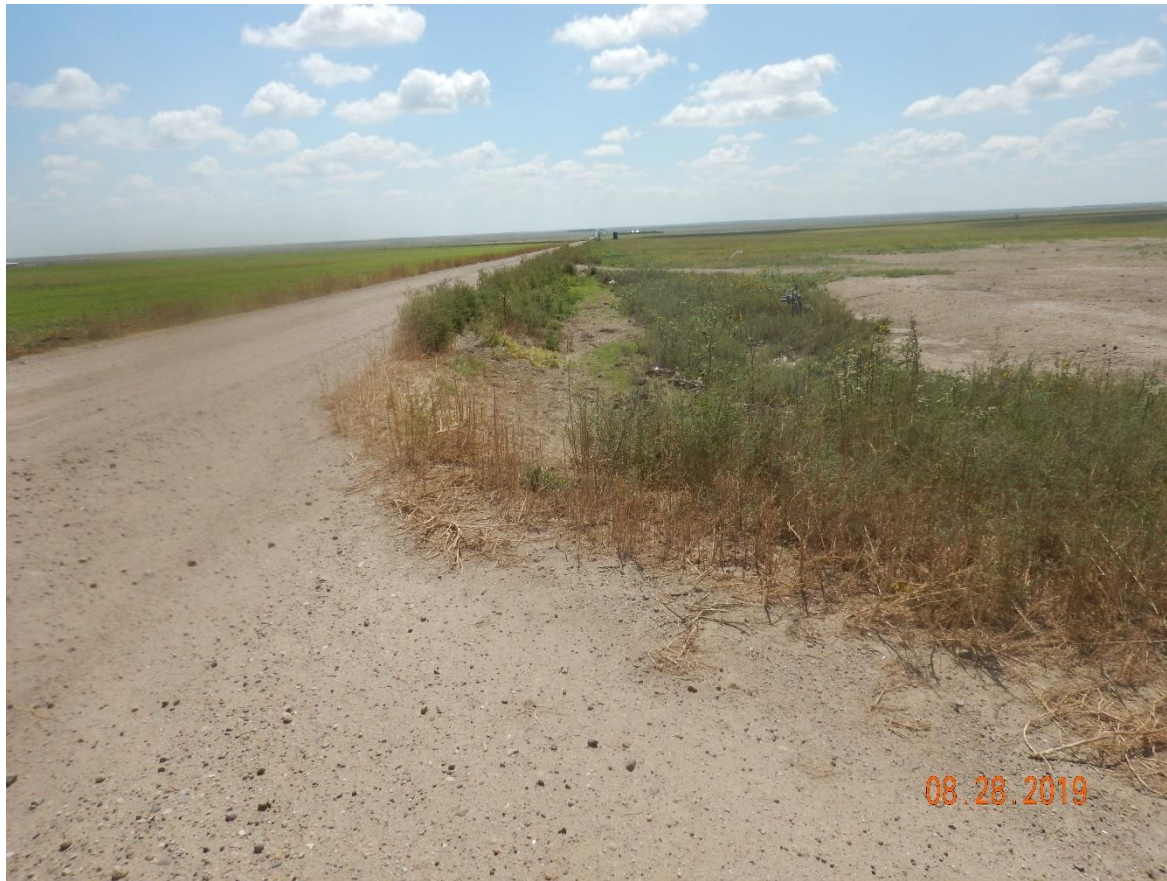
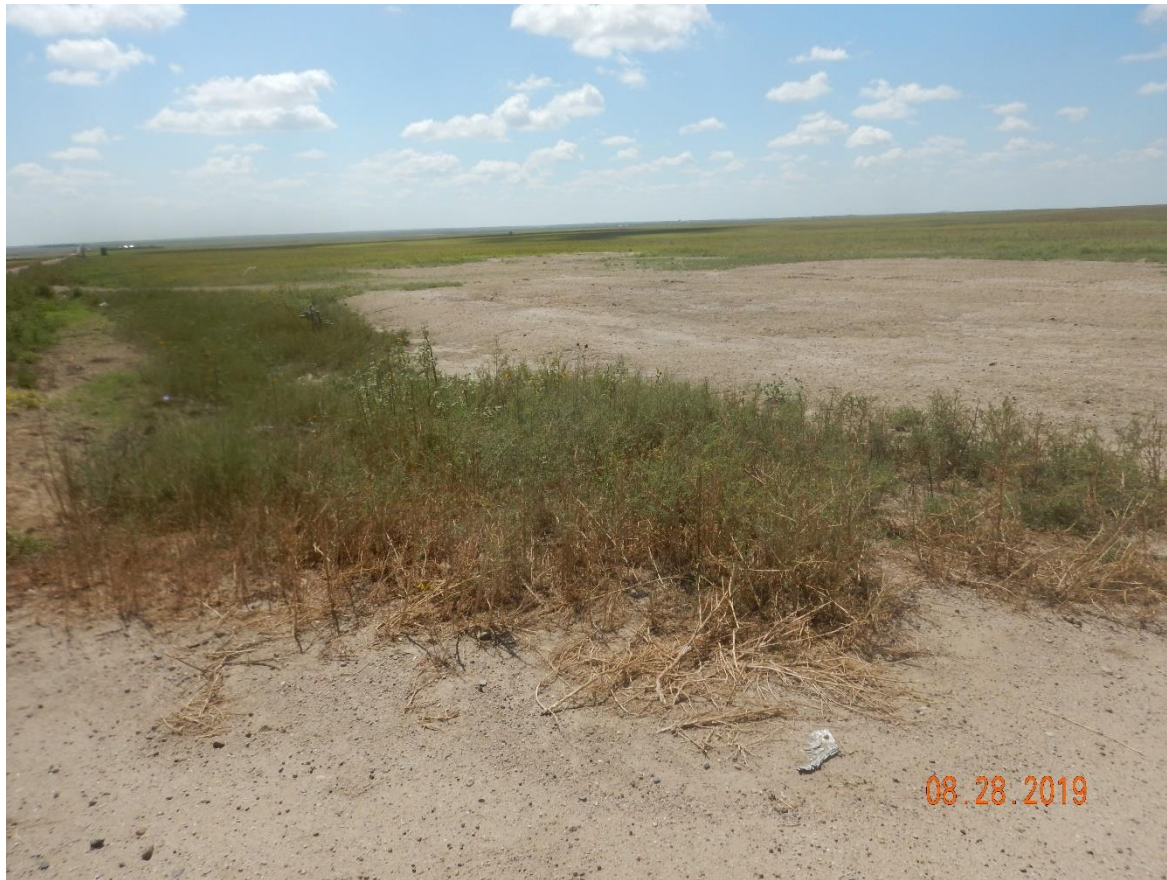
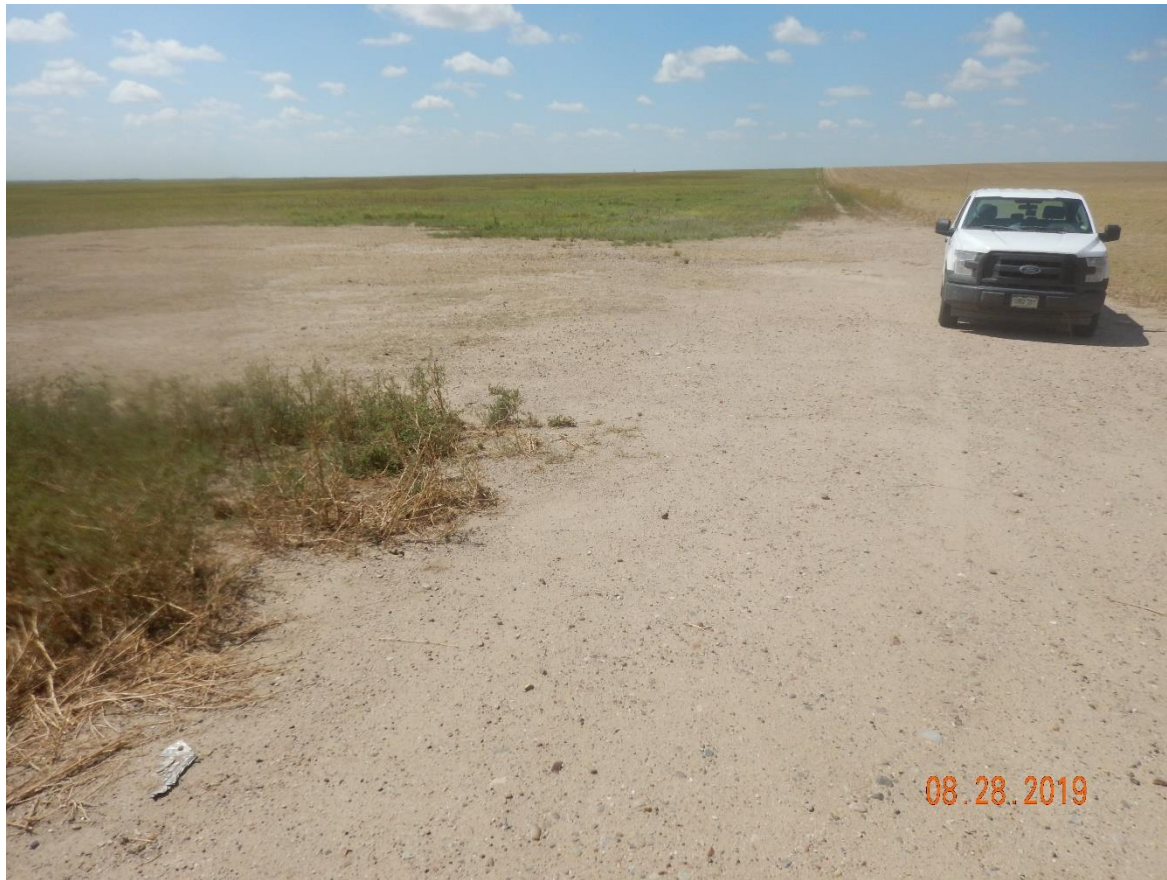
**Photo 18:** Photo taken from the northeast corner of the battery facility. Photos 18-20 provide an overview of the location from south, southwest to west.

**Photo 19:** See comments under photo 18.

**Photo 20:** See comments under photo 18.

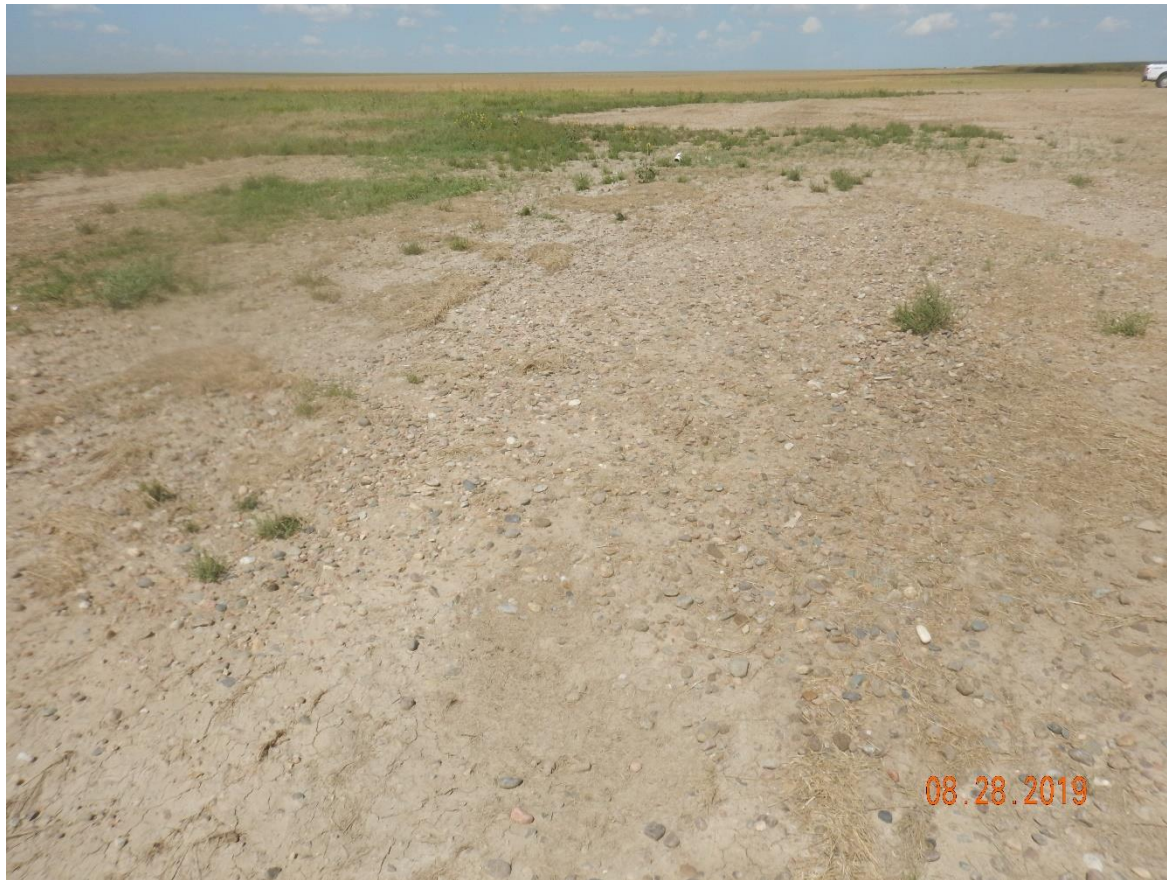
**Photo 22:** Photo taken from the southern end of the facility location, facing north. Photo shows gravel/road base remaining on location.

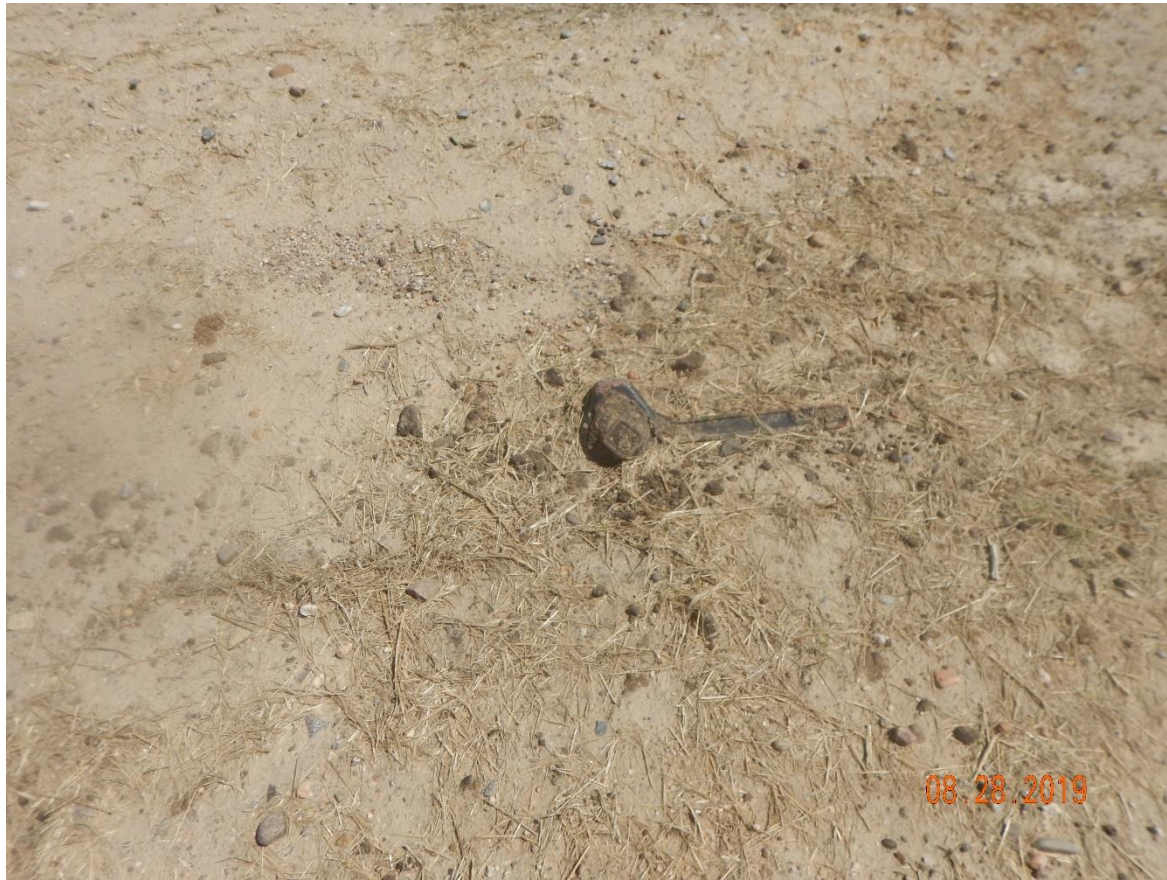
**Photo 23:** Photo shows trash debris observed on location.

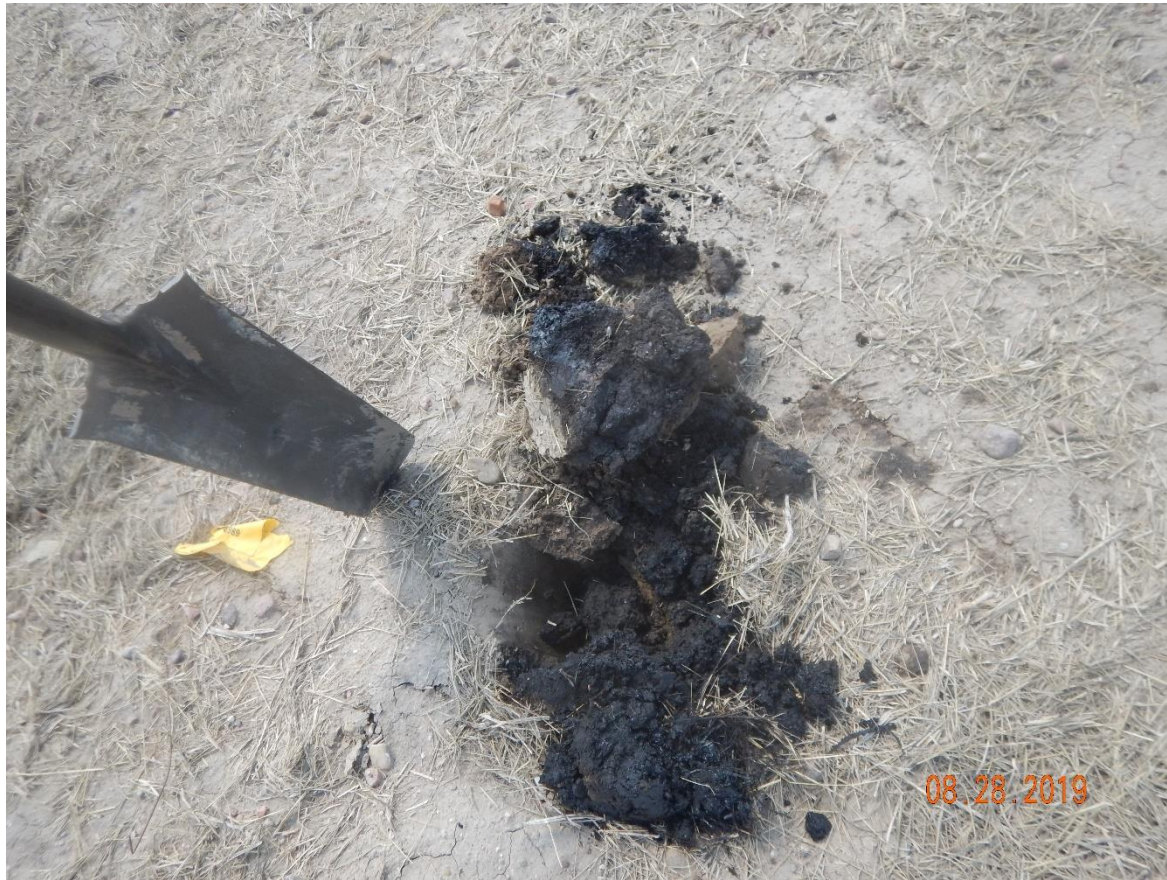
**Photo 24:** Photo shows stained soils observed on the facility location.
