# Inspection Photos

Operator: P O & G OPERATING LLC - 10634

Well Location ID: 324938

Kit Carson County, CO

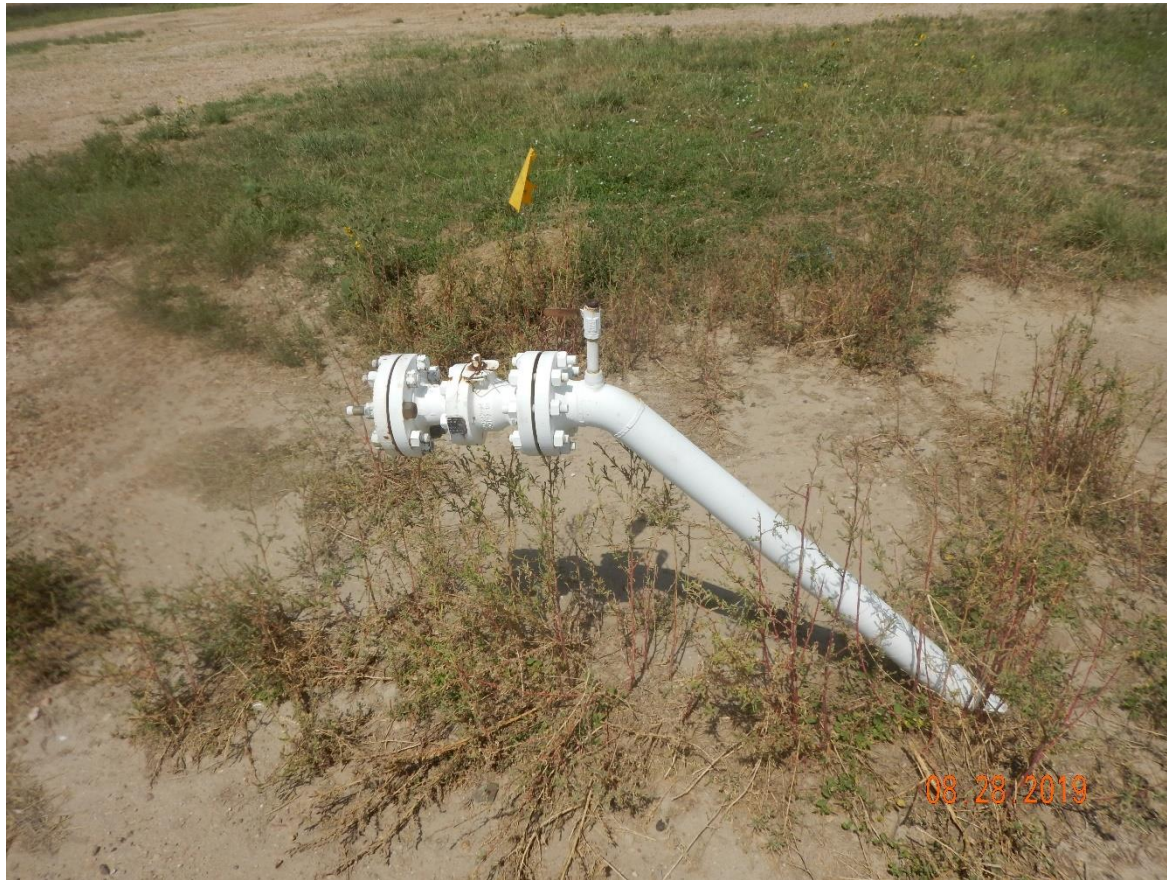
**Photo 25:** Photo taken from the southeast end of the facility location. Photo shows a riser remaining on location. Riser appears to be associated with midstream. This riser is considered associated oil and gas equipment no longer needed on PO&G's location, and is required to be removed and reclaimed. It is the COGCC's expectation that PO&G will collaborate with the midstream company in removing the equipment.

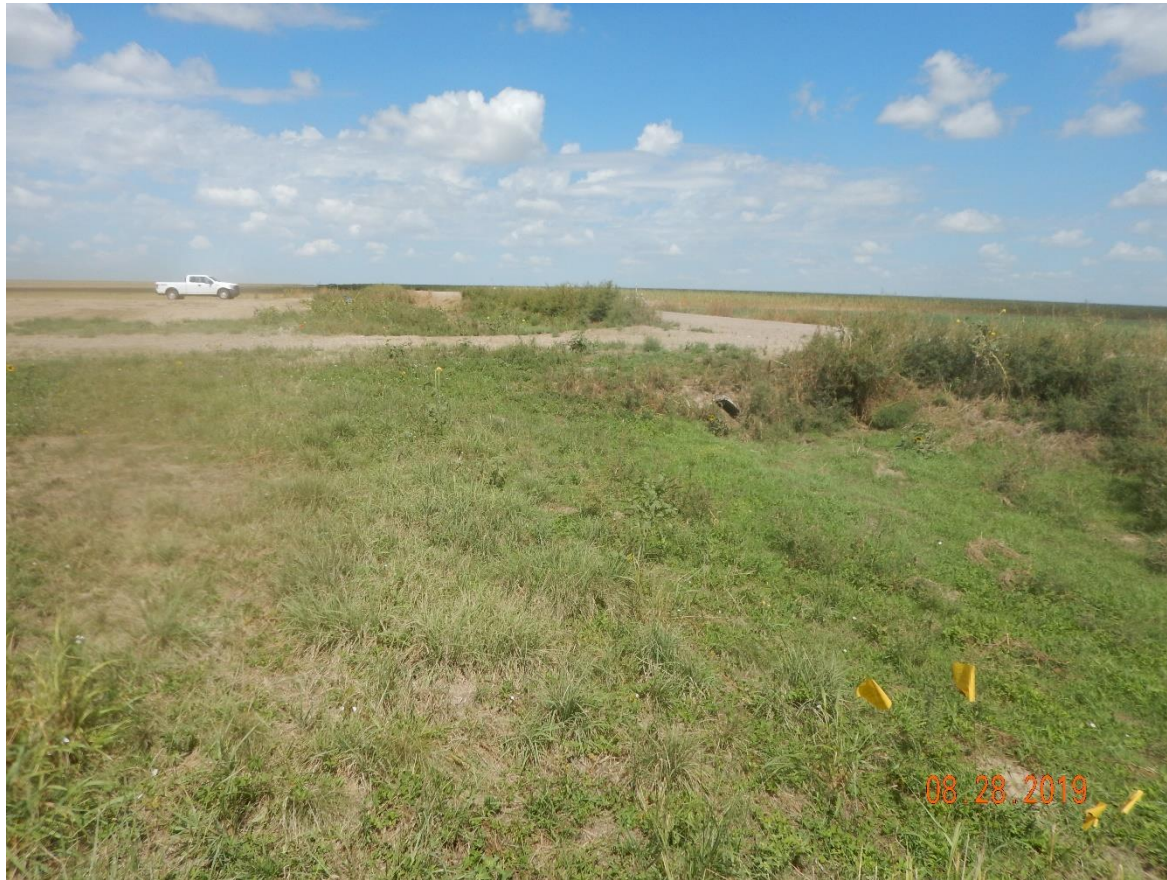
**Photo 26:** Photo taken from the southeast end of the facility location, facing north. Photo shows culverts and areas of access that have not been removed and reclaimed.

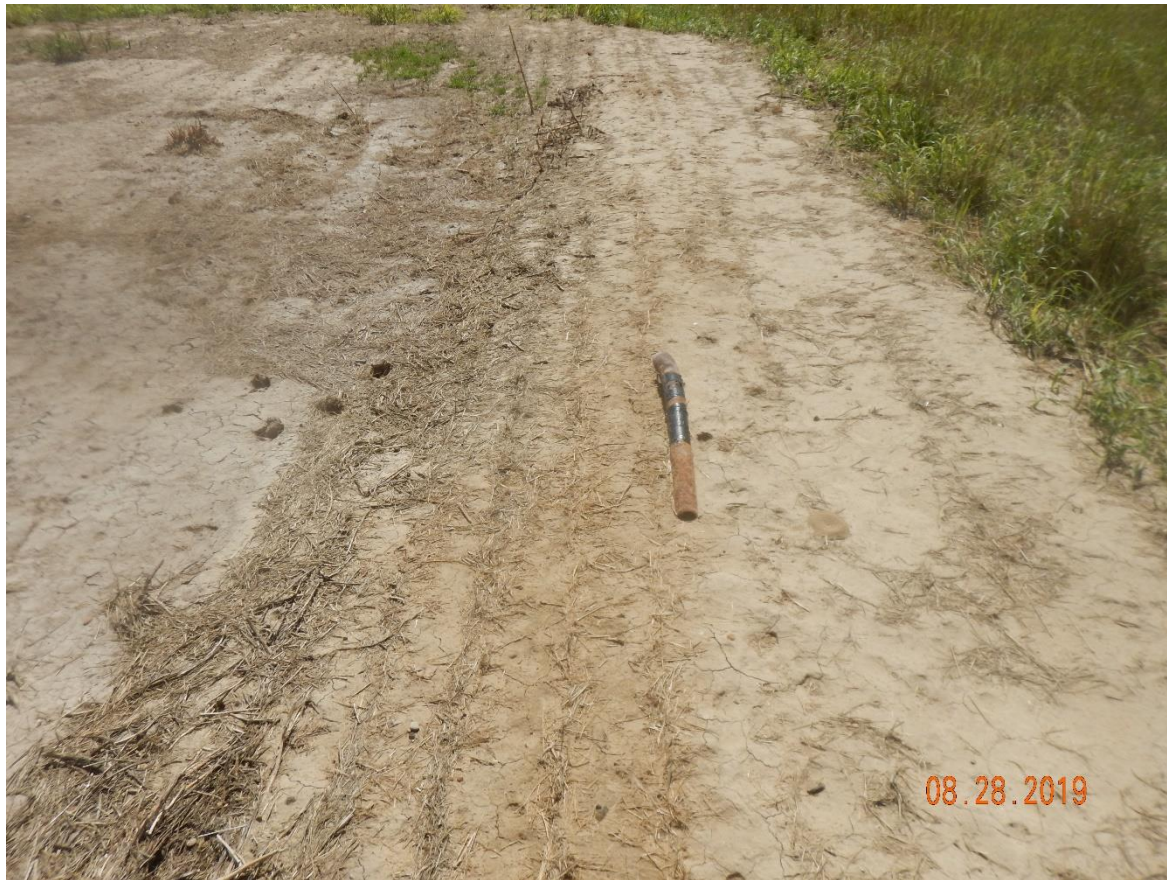
**Photo 27:** Photo shows trash debris remaining on the facility location.

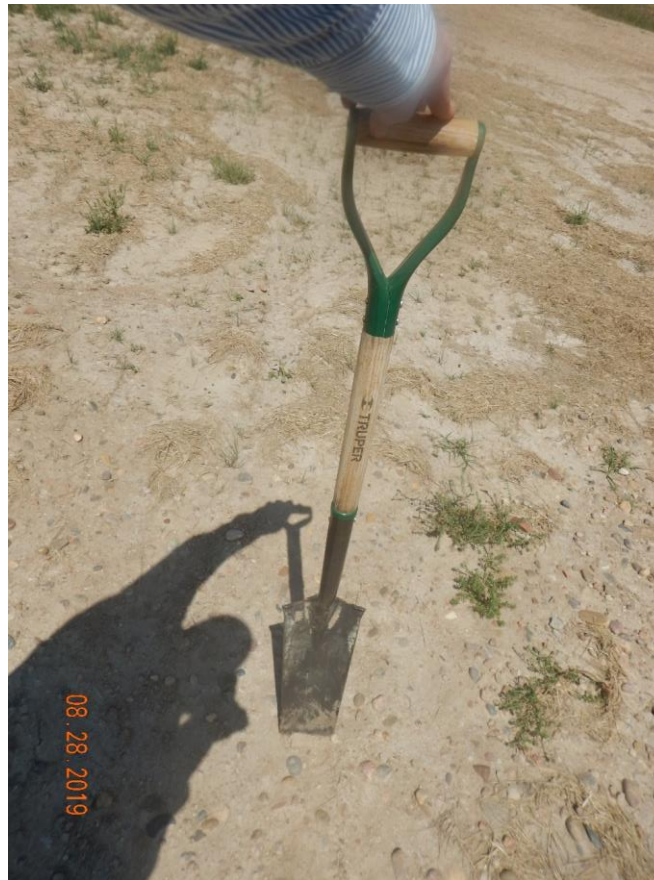
**Photo 28:** Photo taken from the facility location. Photo shows reclamation specialist tested the location for compaction concerns. Photo shows reclamation specialist was only able to penetrate the top few inches of soil with east. Compaction concerns appear evident

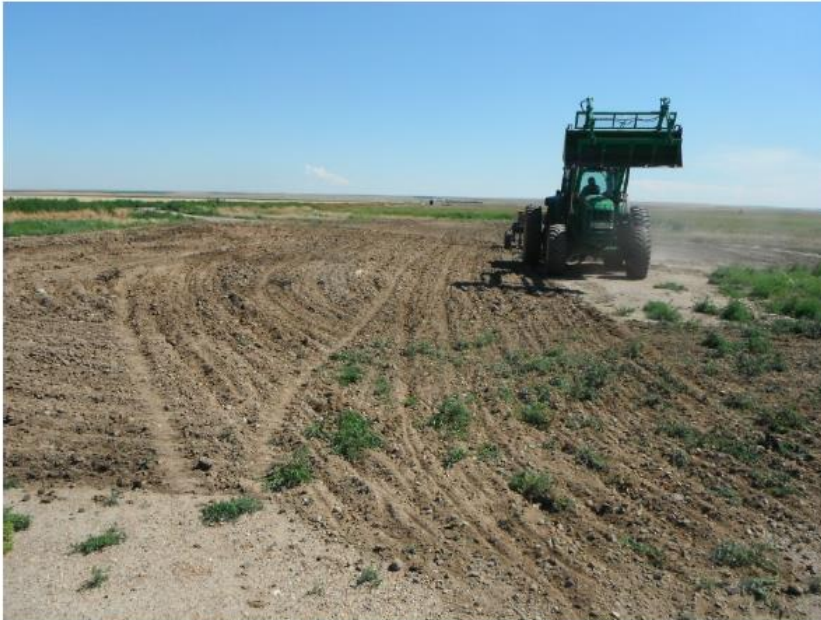
**Deep ripping of former tank battery**

**Photo 29:** The photos above were taken from attachments within Sundry doc. #402119982. Photos show what the Operator is calling “deep ripping”. Reclamation Rule 1003.c requires that compaction alleviation on locations/access roads, is conducted by cross ripping at a minimum depth of 18 inches. Based on photos provided, Operator only appears to have lightly disked the surface of the soils and has not complied with reclamation rules.

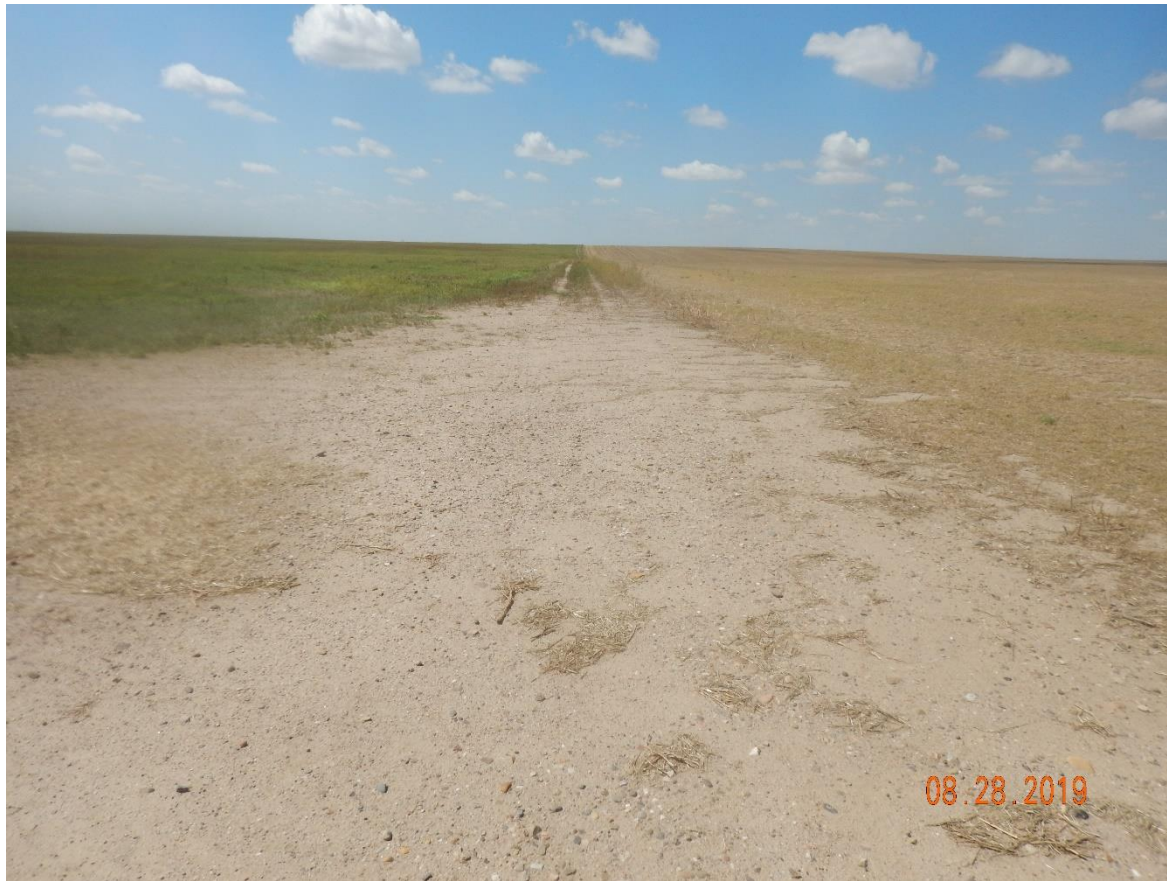
**Photo 30:** Photo taken from the north end of the facility location, facing north. Photo no reclamation appears to have been conducted on the east/west access road
