Inspection Photos

08/28/2019

Operator: P O & G OPERATING LLC - 10634

Well Location ID: 324936

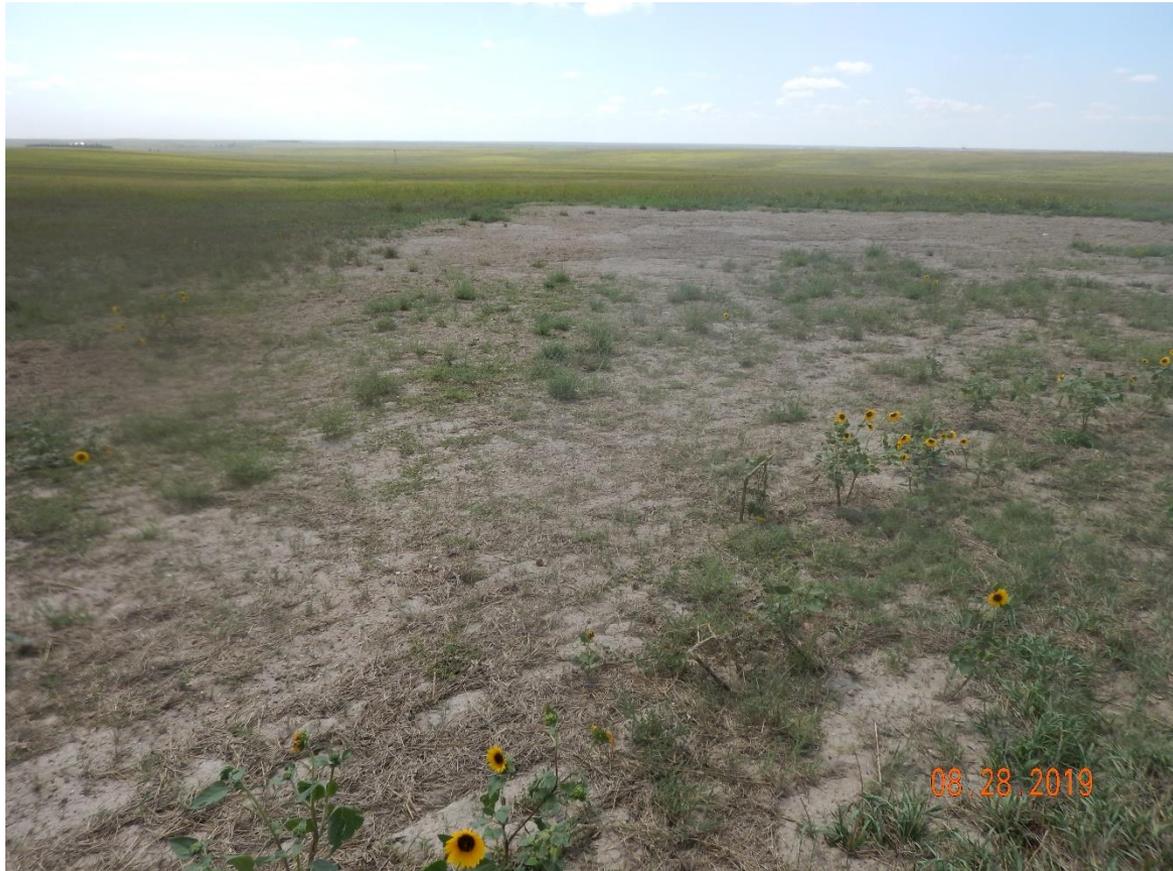
Photo 1: Photo taken from the north end of the location, facing south. Photo shows the reclamation of the location.

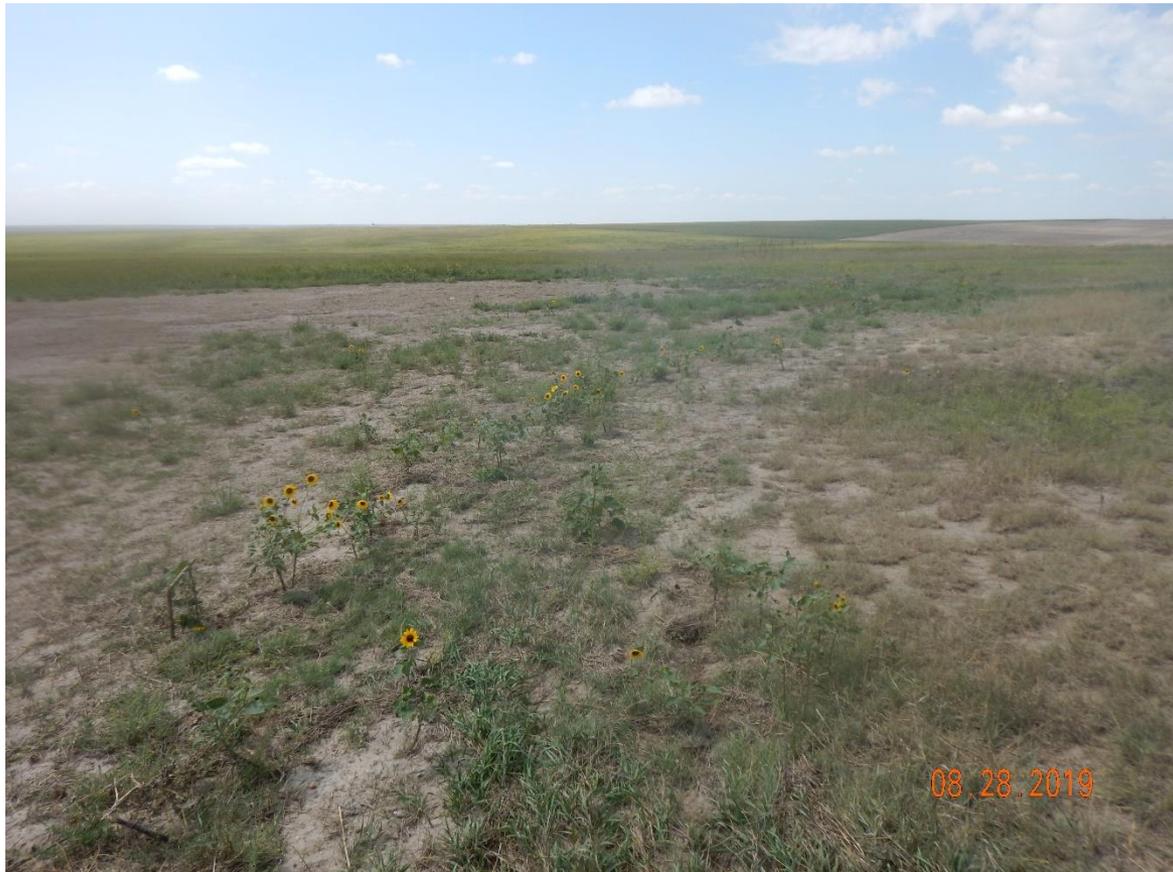
Photo 2: Photo taken from the north end of the location, facing southwest. Photo shows the reclamation of the location.

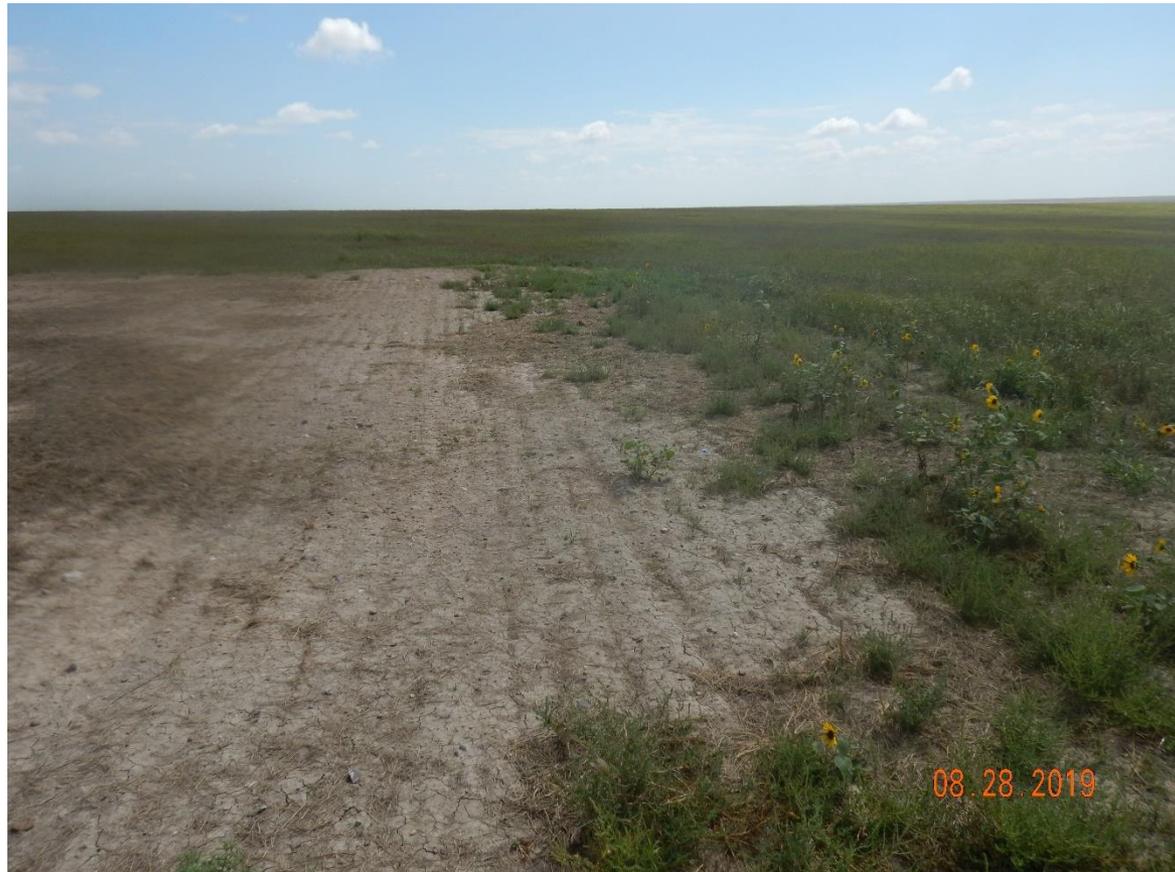
Photo 3: Photo taken from the southwest end of the location, facing east. Photo shows the reclamation of the location.

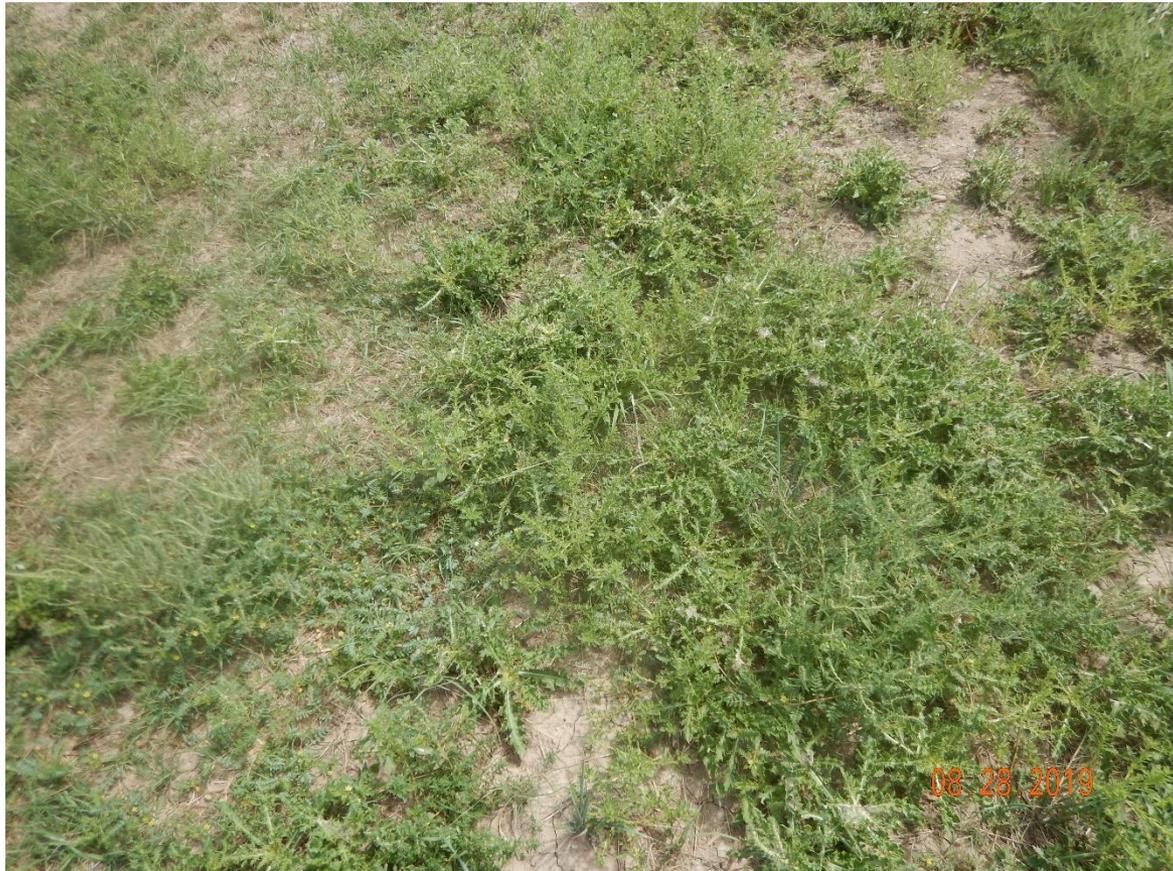
Photo 4: Photo taken from the south end of the location. Photo shows was appears to be Canada thistle plants establishing on the south end of the location.

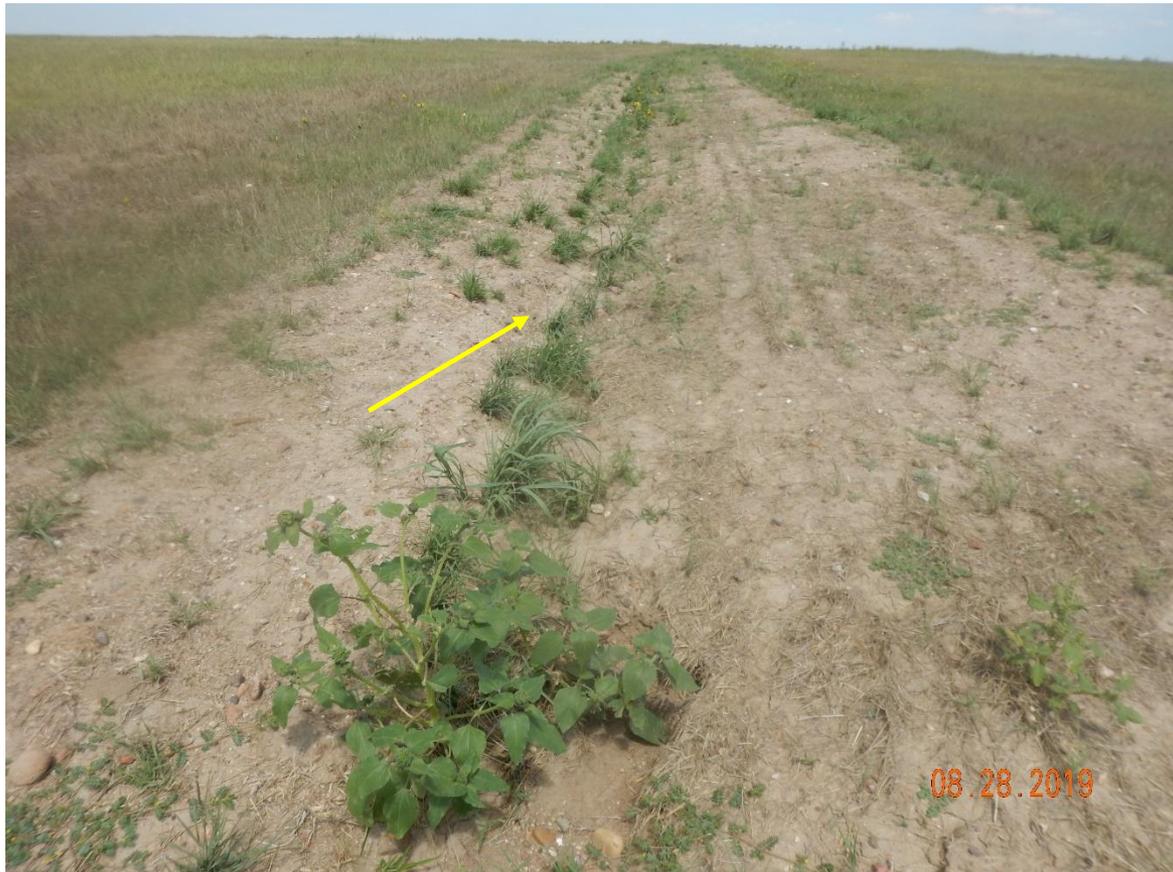
Photo 5: Photo taken from the access road north of the location. Photo shows stormwater erosion degradation is beginning to incise the access road.

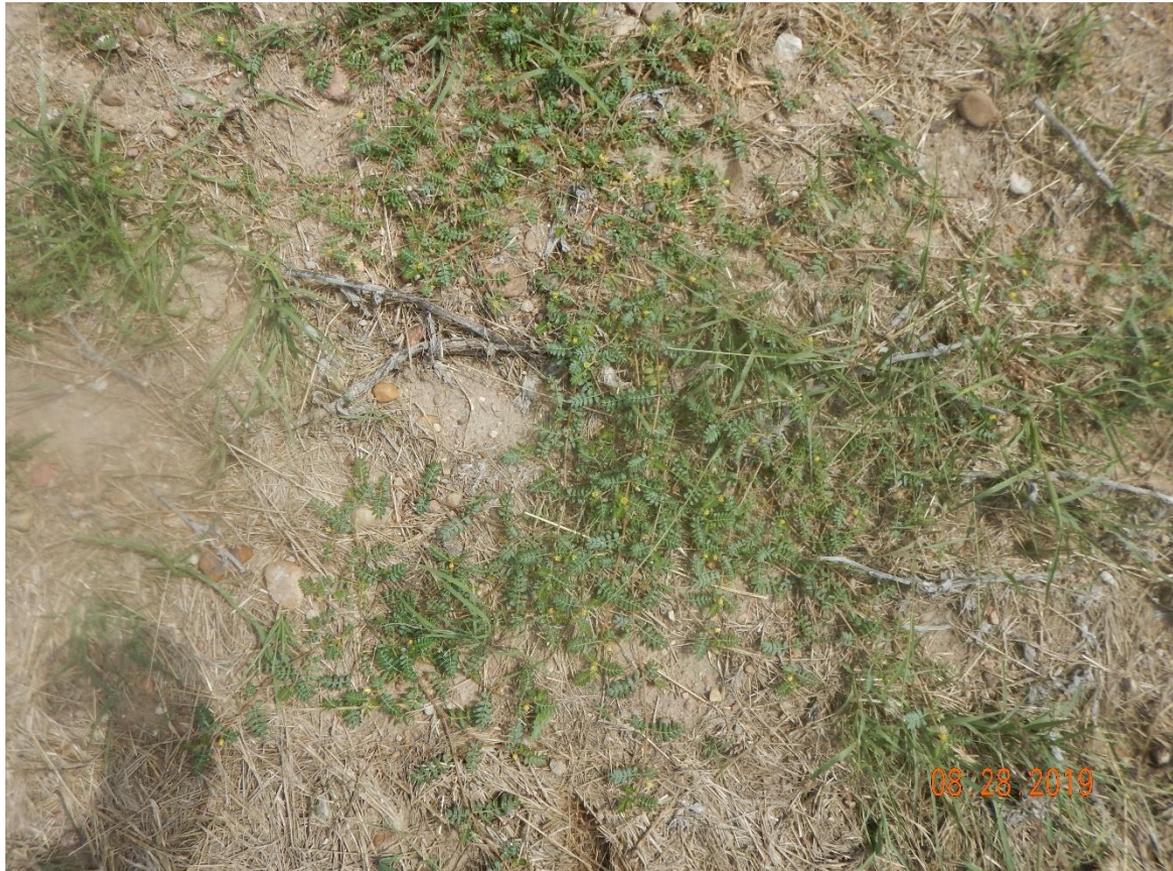
Photo 6: Photo taken from the location. Photo shows puncture vine establishing on location.

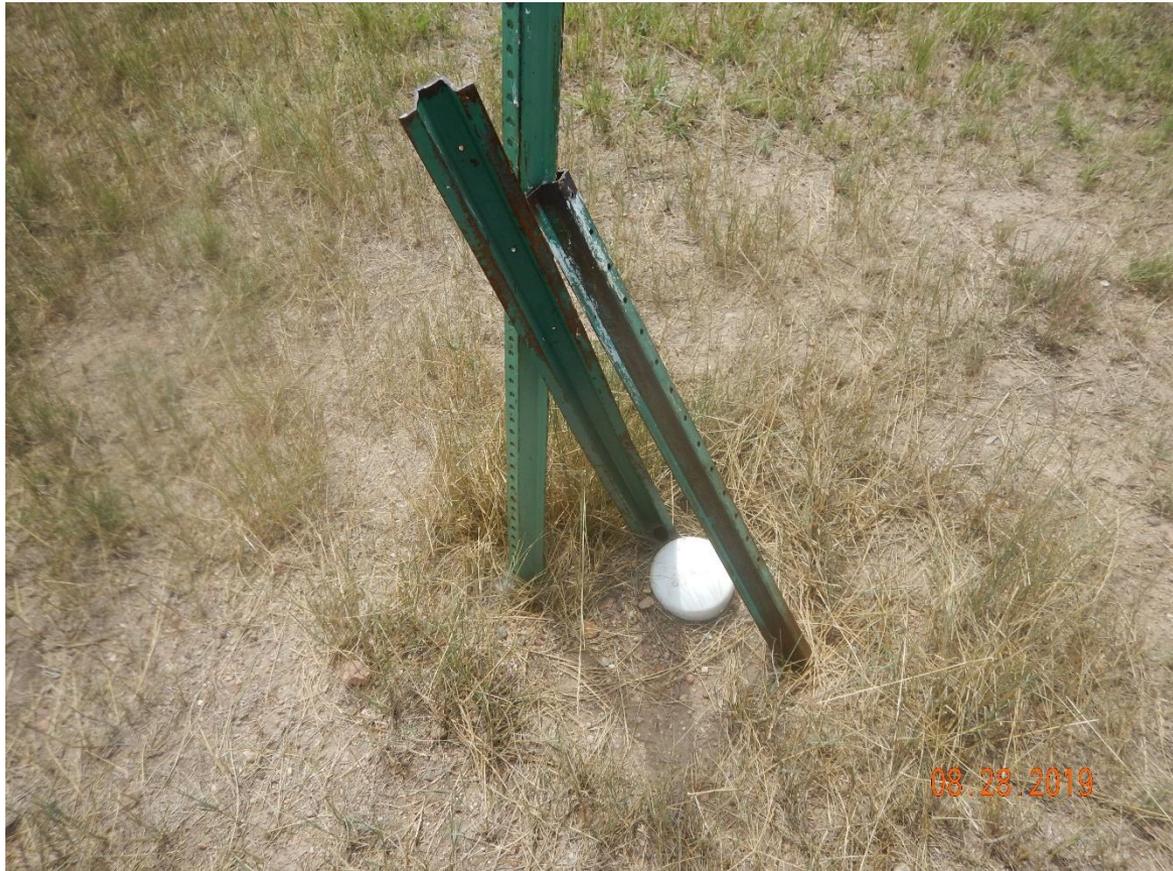
Photo 7: Photo taken from the northeast corner of the location. Photo shows t-posts and a plastic pipe remaining on location.

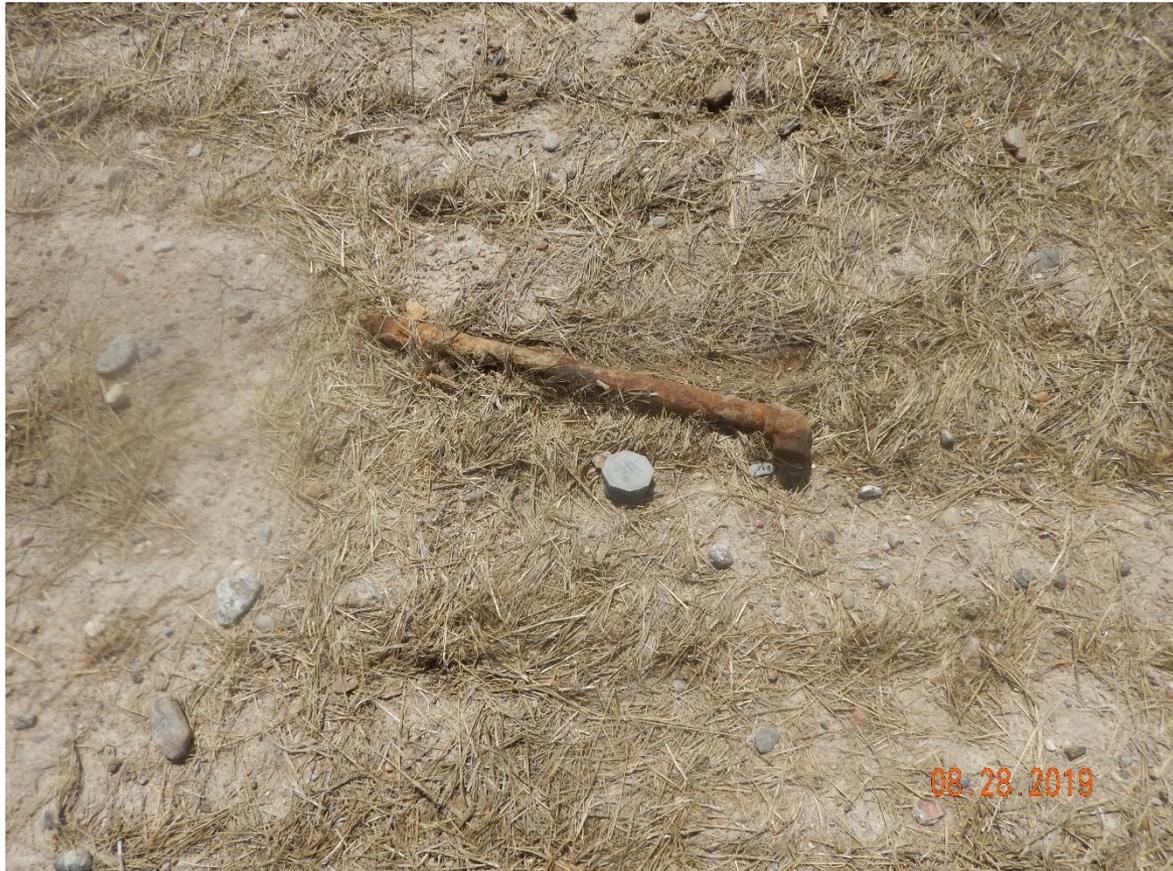
Photo 8: Photo taken from the location. Photo shows trash debris remaining on location.

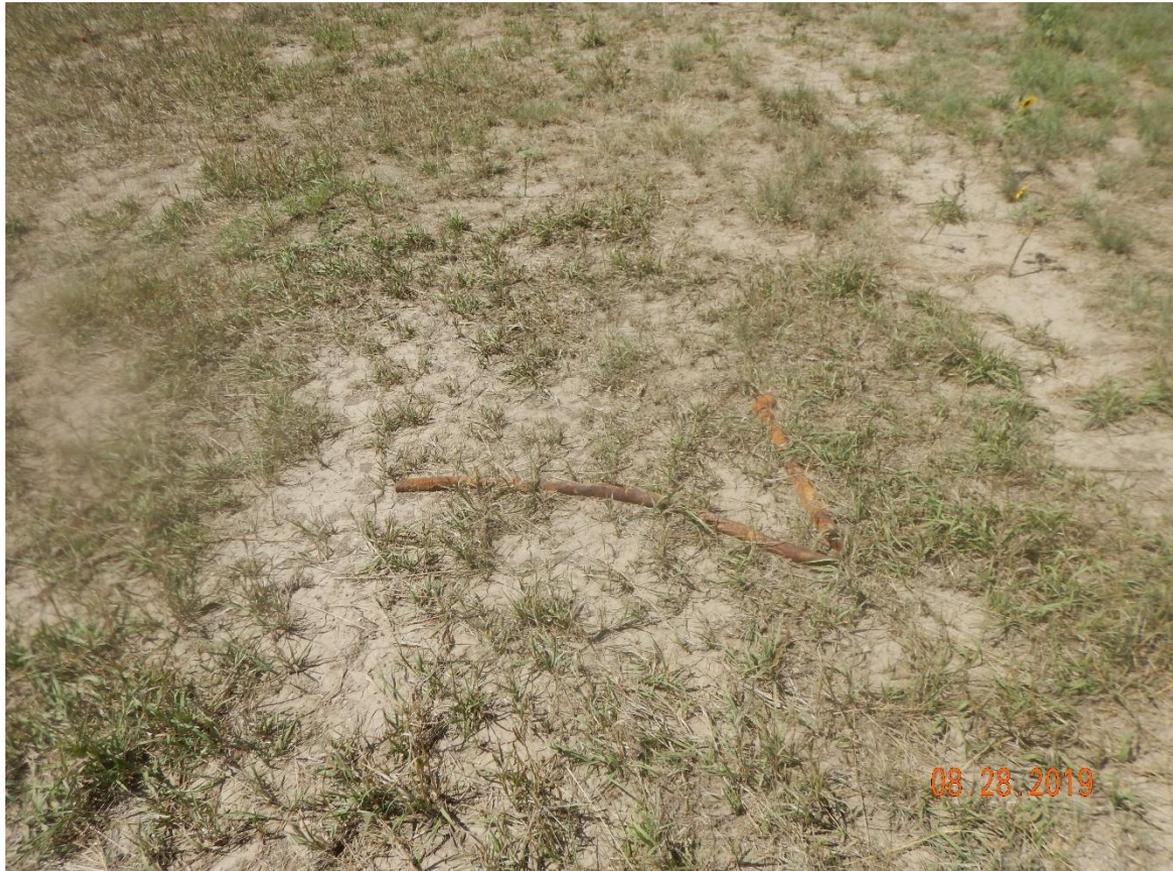
Photo 9: Photo taken from the location. Photo shows trash debris remaining on the location.

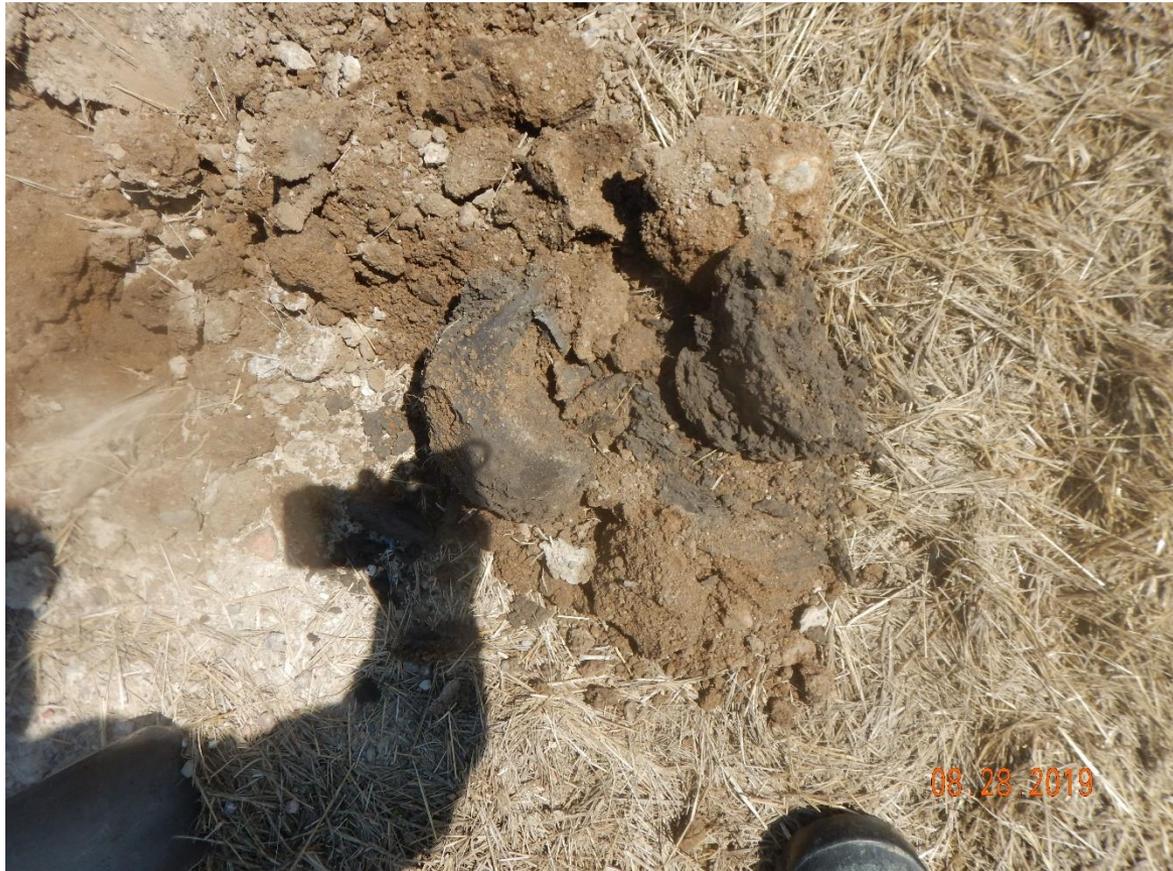
Photo 10: Photo taken from the location. Reclamation specialist observed areas of stained soil and conducted a test pit for both compaction and soil concerns. Photo shows stained soils observed at the surface.

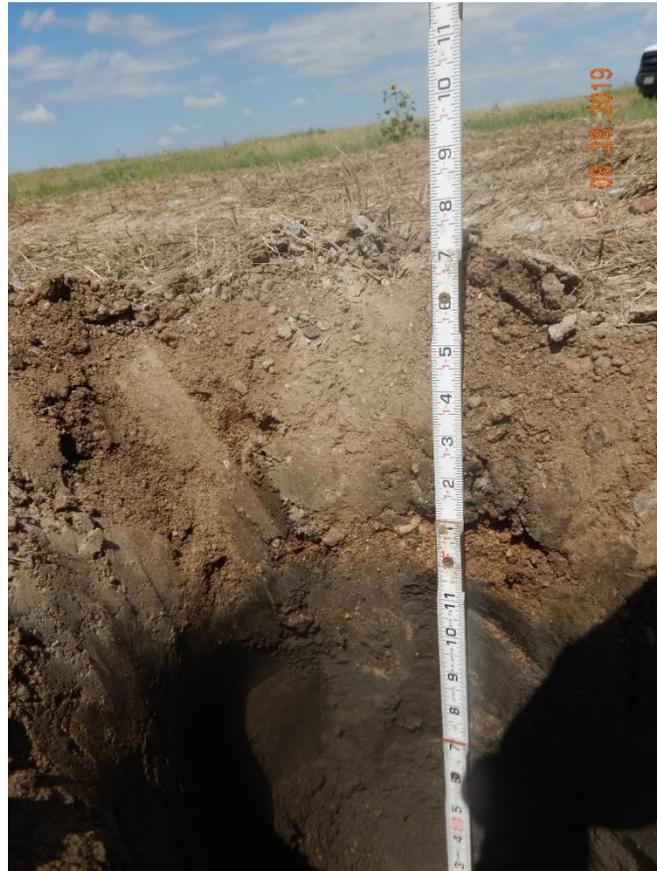
Photo 11: Photo of test pit dug on location. Reclamation specialist observed areas of stained soil and conducted a test pit for both compaction and soil concerns. Photo shows dark colored soils observed from soil surface to at least two feet sub-surface. Soils had a chemical smell and appears to exceed two (2) feet below ground.

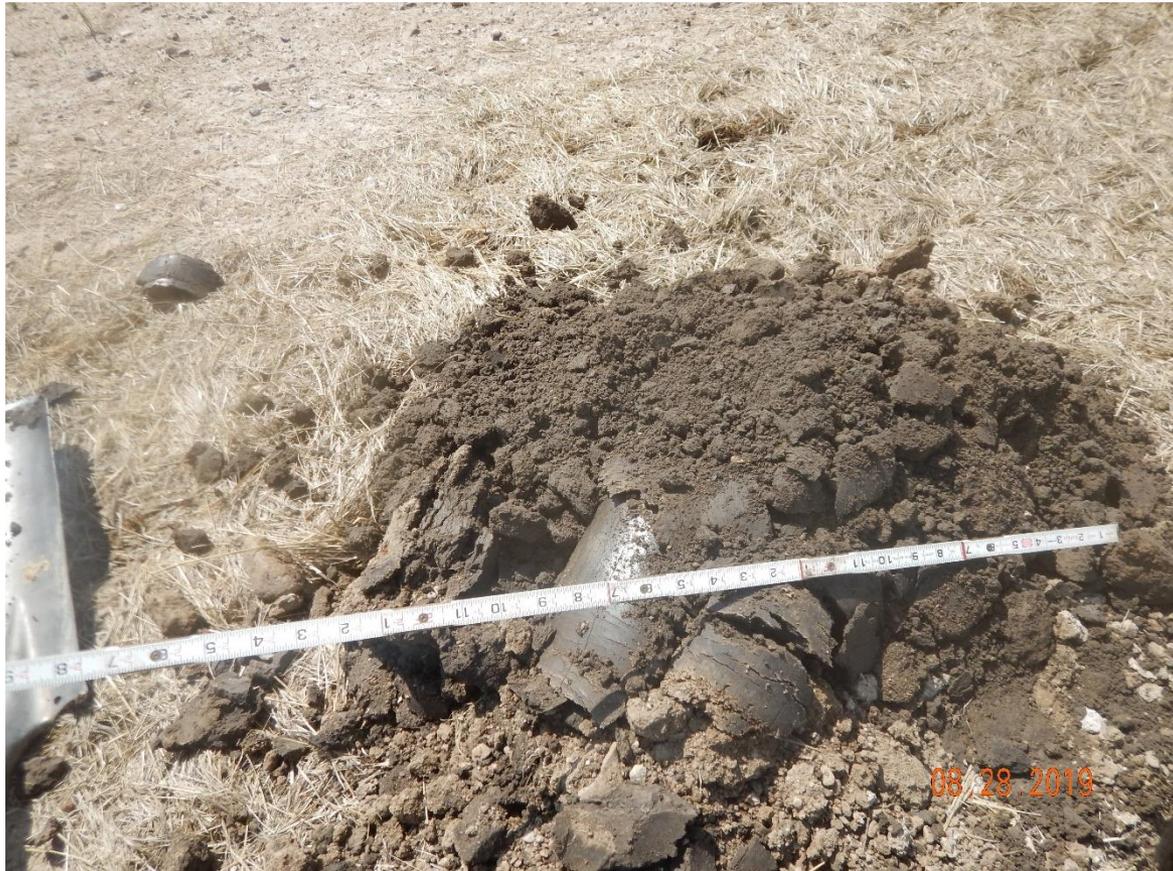
Photo 13: Photo shows dark colored soils with a chemical smell that was excavated from the test pit.

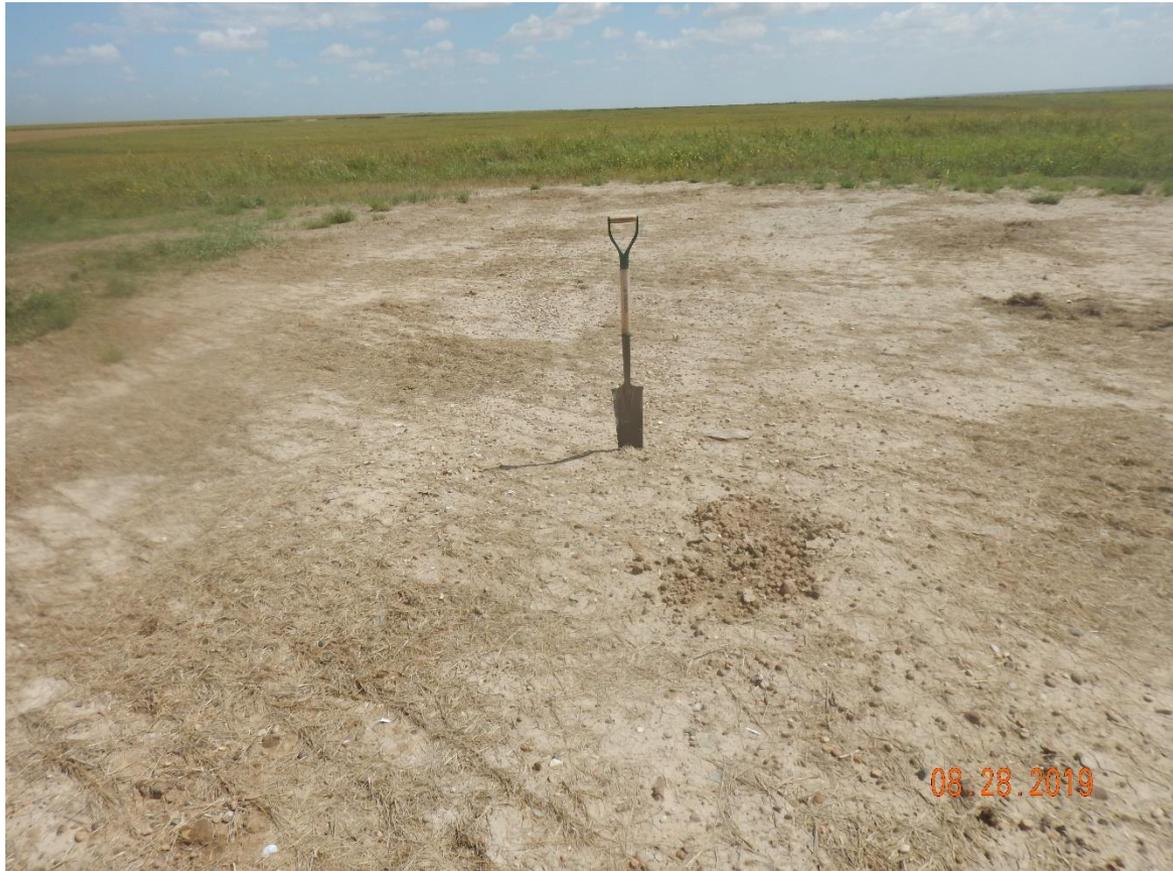
Photo 14: Photo taken from the location. Photo shows reclamation specialist tested the location for compaction concerns. Photo shows reclamation specialist was only able to penetrate the top few inches of soil with east. Compaction concerns appear evident

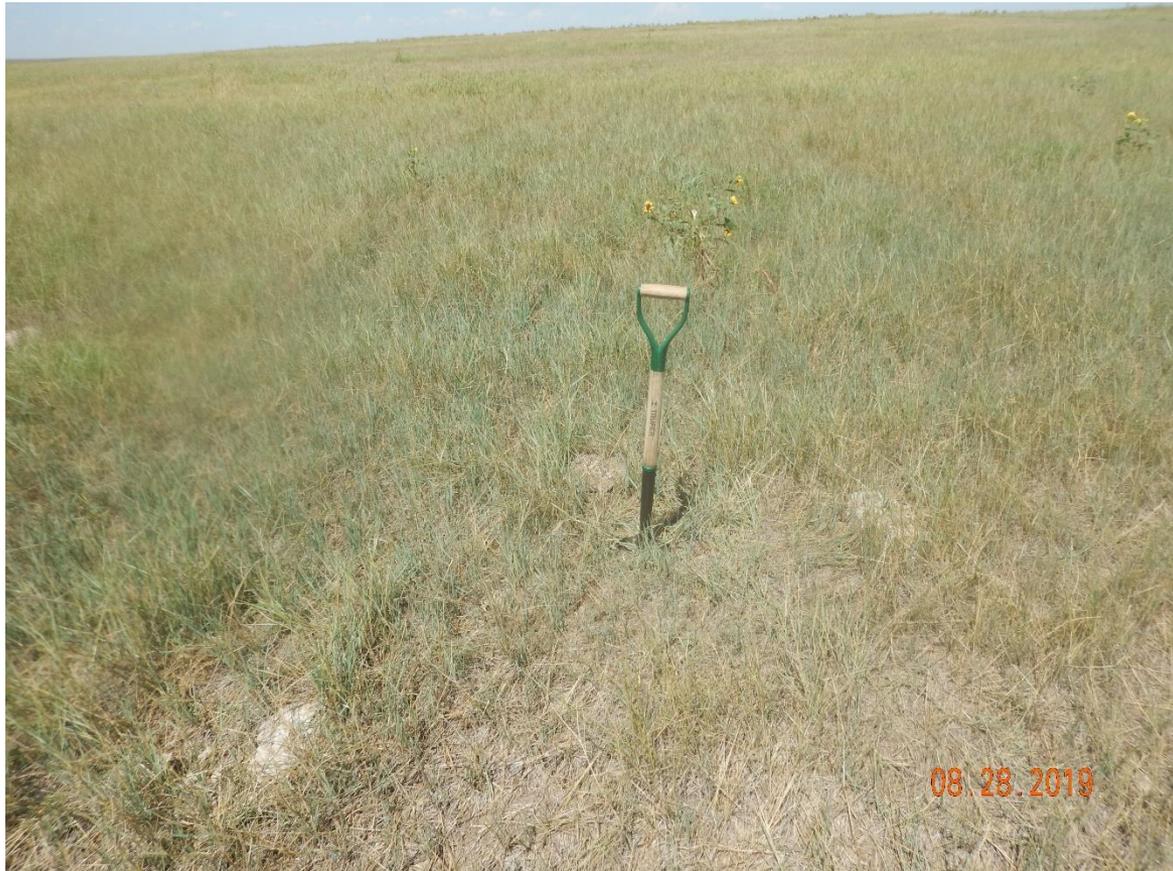
Photo 14.b: Photo taken from the adjacent reference areas. Photo shows reclamation specialist was able to easily penetrate the top 15 inches of soil. Compaction concerns appear evident on location. Reclamation specialist dug a test pit within the reference to compare soils observed on location.

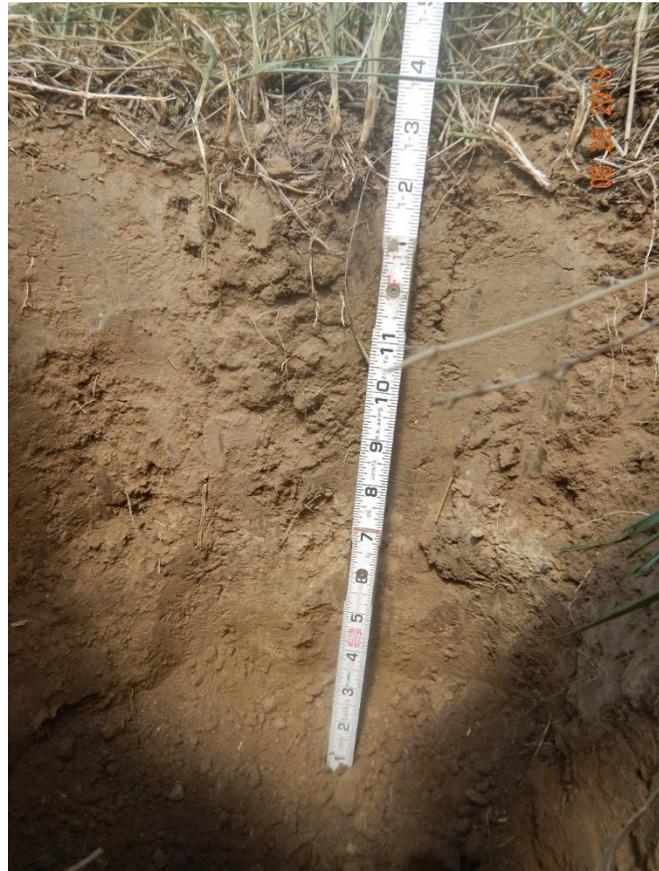
Photo 15: Photo of test pit from the reference area. Photo shows soils observed on the location are not reflective of soils on the adjacent reference area. Soils in the reference did not contain a chemical smell detected in the soils on the location.

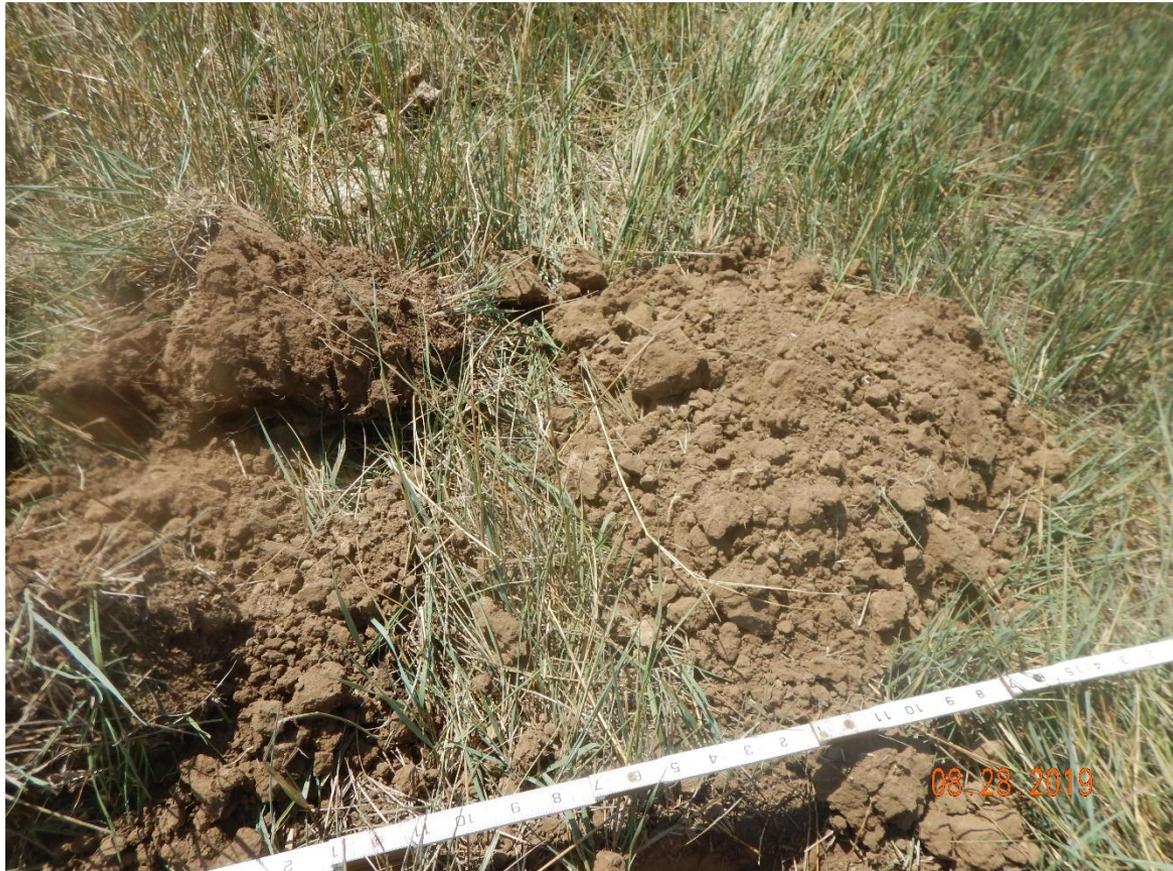
Photo 16: Photo of soils excavated from the reference area. Photo shows soils observed on the location are not reflective of soils on the adjacent reference area.

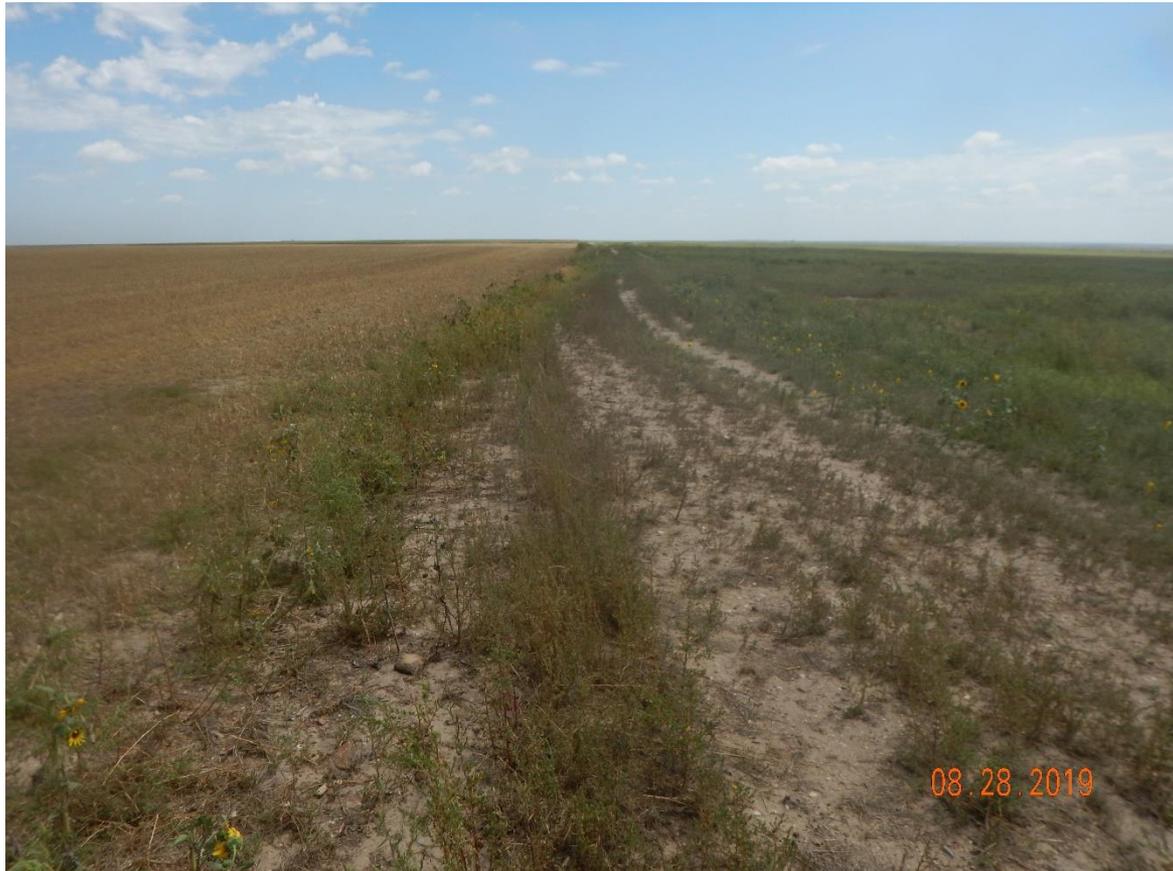
Photo 17: Photo taken the east/west access road north of the location. Photo shows Operator has not conducted final reclamation activities on the east/west section of access road.

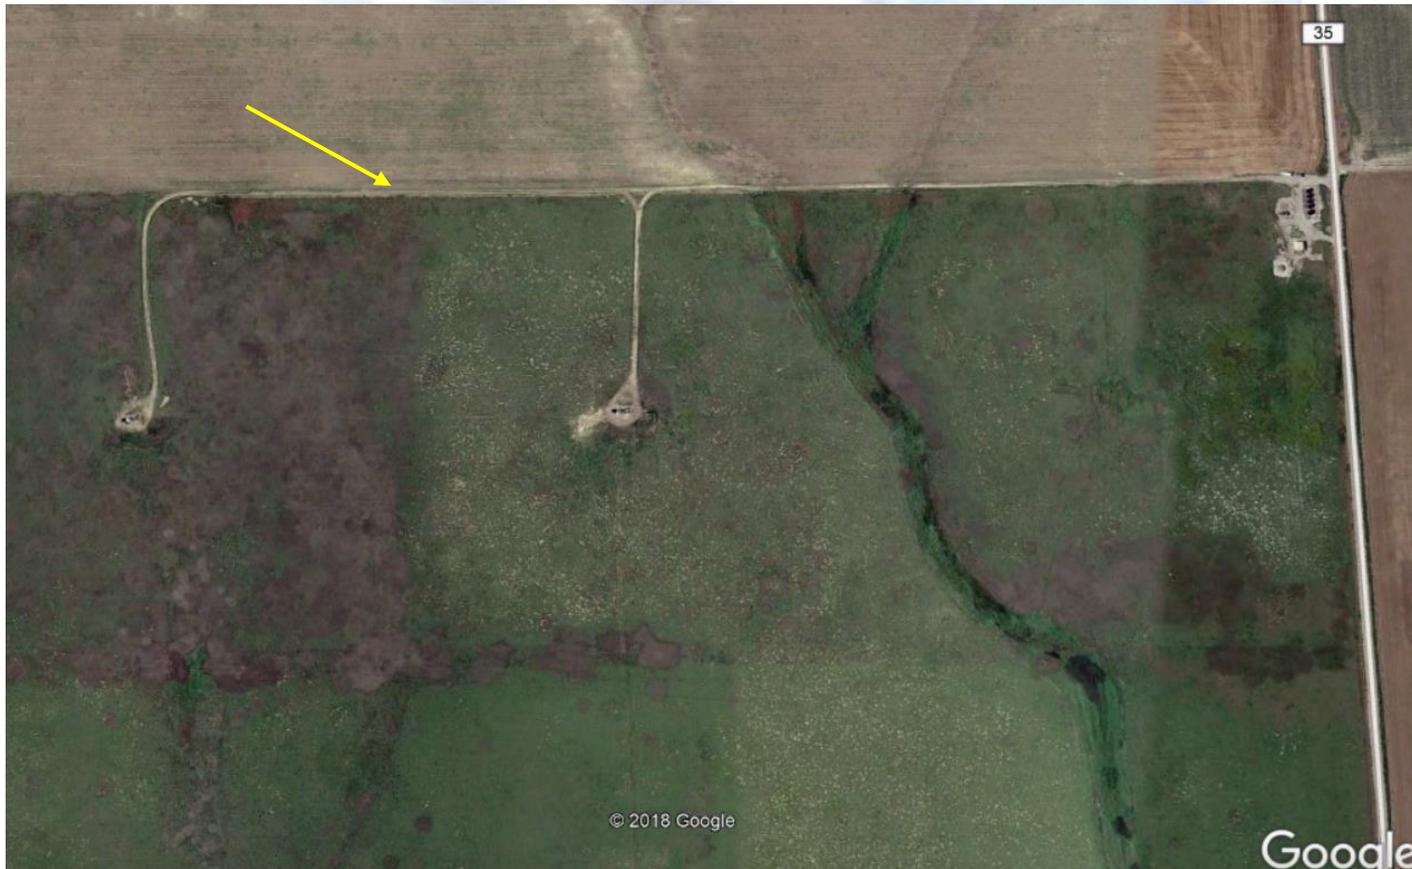
Photo 19: Current available Google Earth aerial imagery (2016). Photo shows Sundance Energy's well locations, battery facility and access roads. Operator has not conducted reclamation on the east/west section of access road (yellow arrow) in accordance with COGCC 1004 rules.
