MARALEX RESOURCES, INC.– 53255
API# 05-045-06288 USA #1-24DF
Inspection Date : 8/28/2019

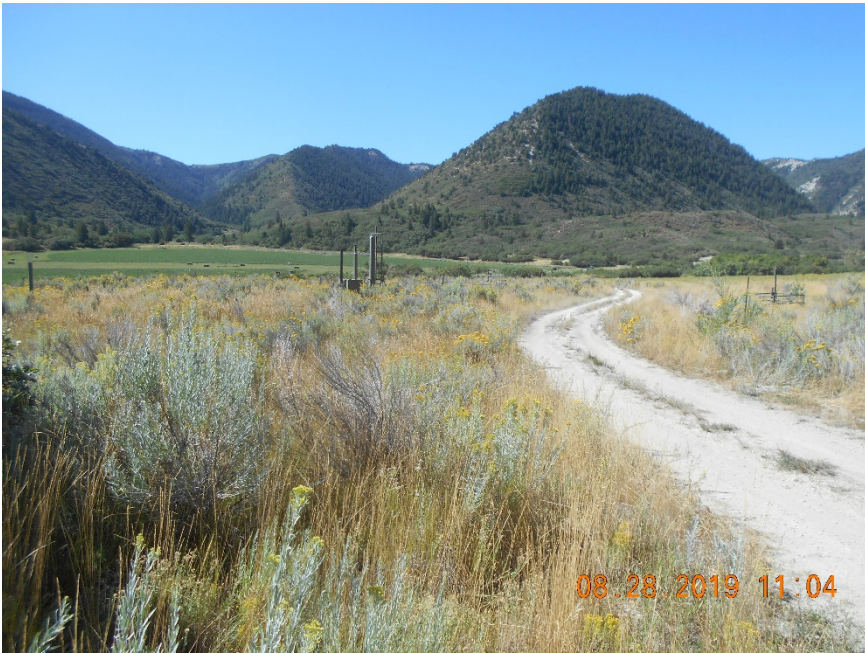
Location overview looking S.

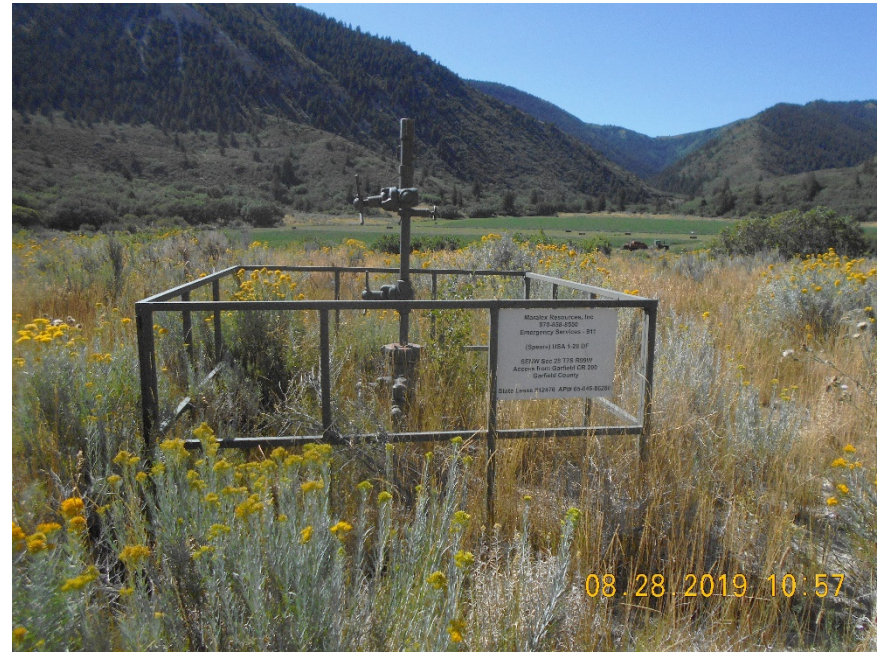
Wellhead with fence and sign - Temporarily Abandoned.

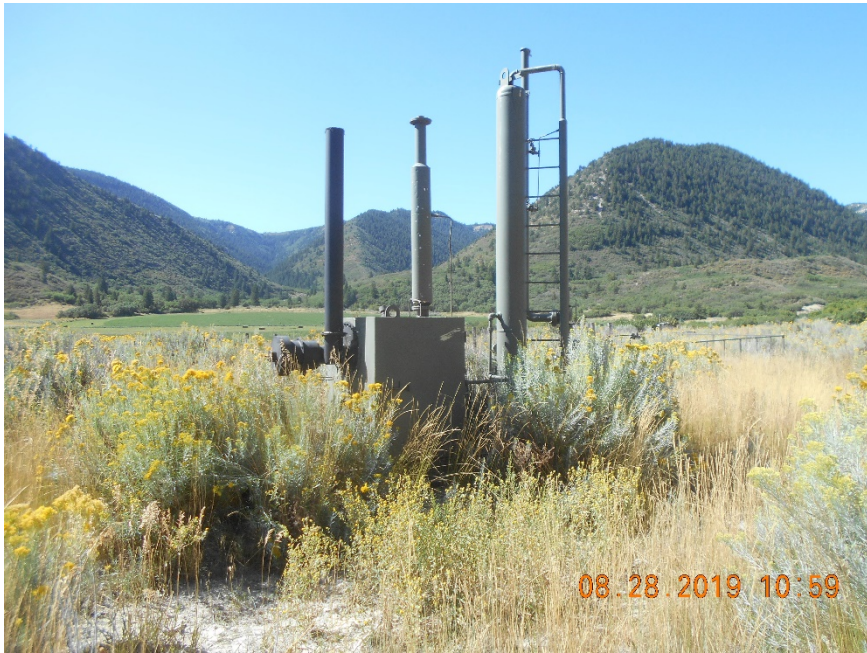
Separator overgrown with vegetation.

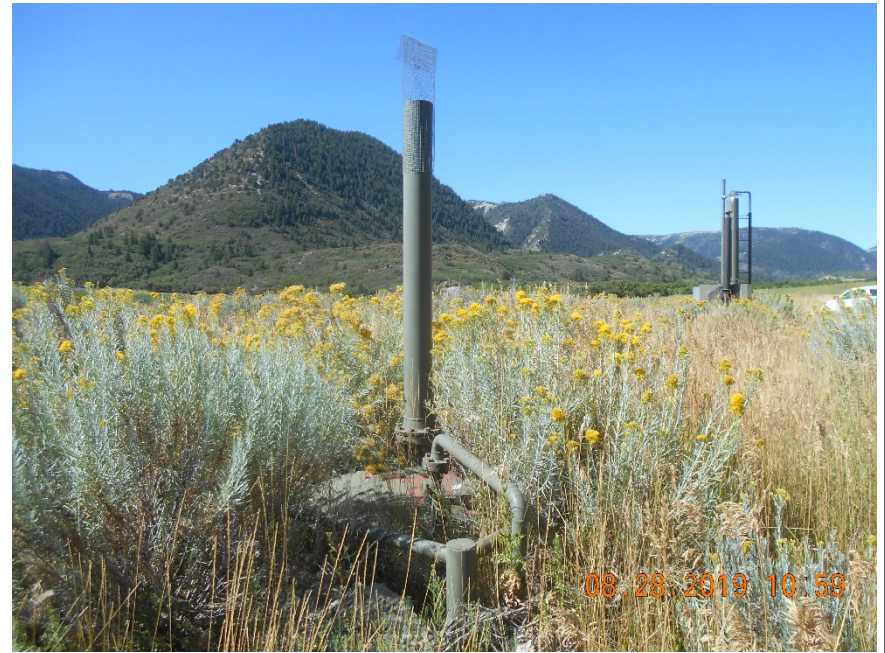
Partially buried tank with no berms or labels. Overgrown with vegetation

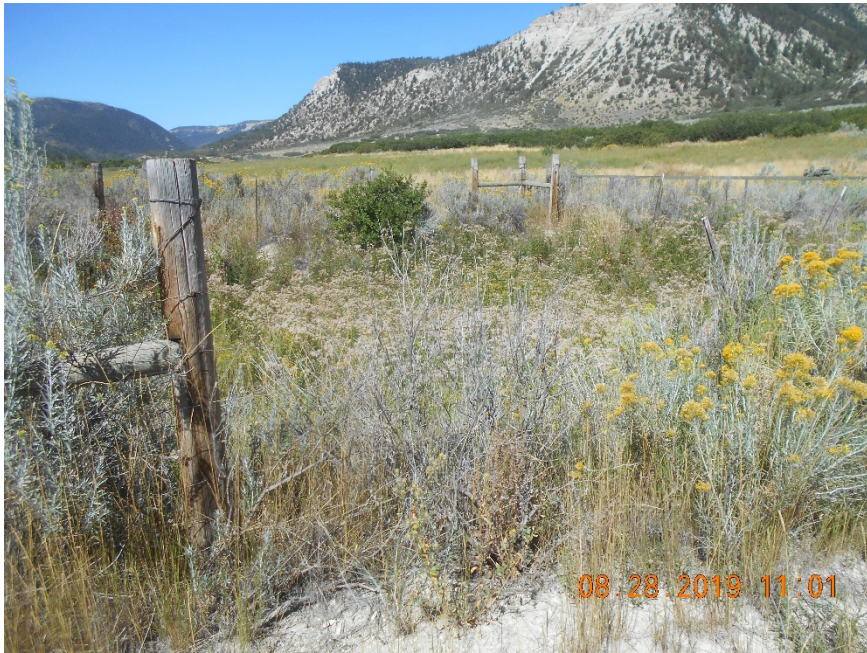
Pit with livestock fencing. Overgrown with vegetation.

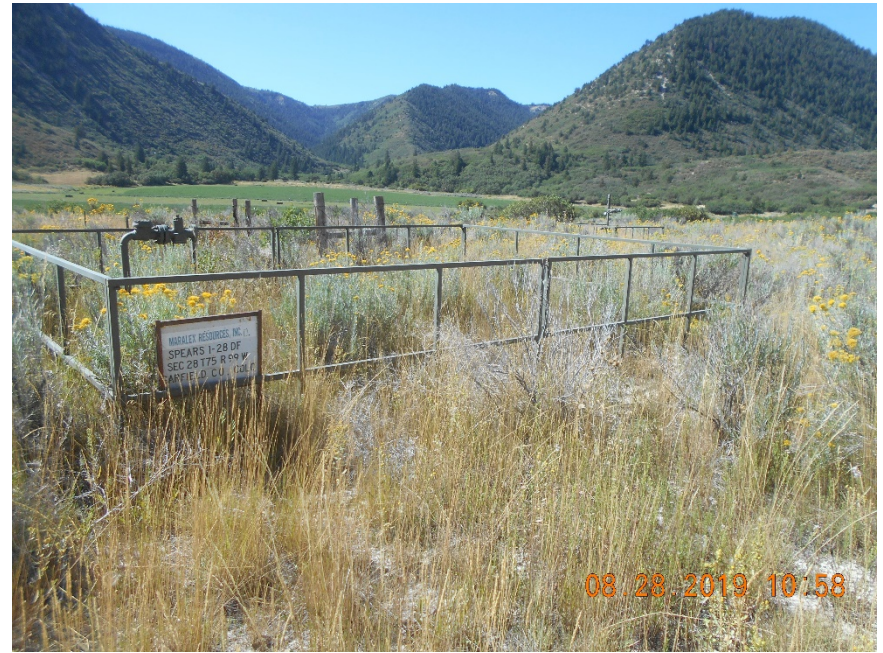
Unused riser in fenced area. Not locked out/tagged out. No blind flange on open end.

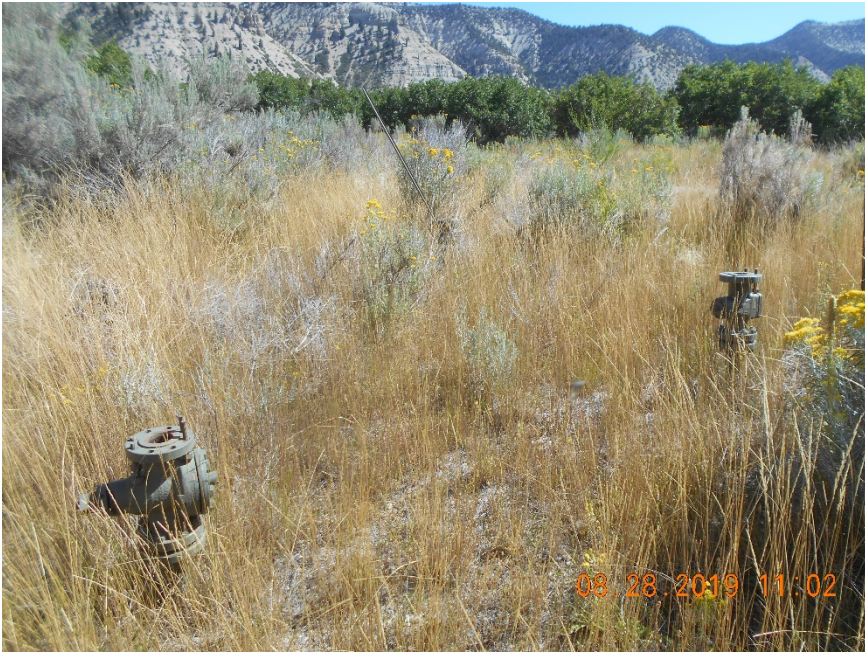
Multiple unused risers. Not locked out/tagged out. No blind flange on open end

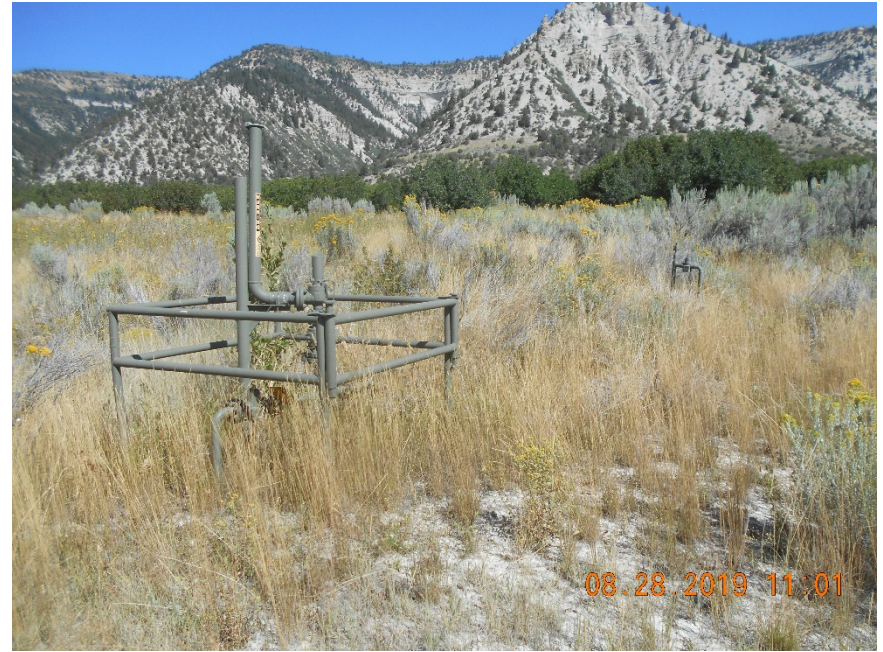
Unused riser in fenced area.
