Inspection Photos
Location Name: TELNA 24-22 TR
API#: 05-071-08304
INSP. #: 695101297

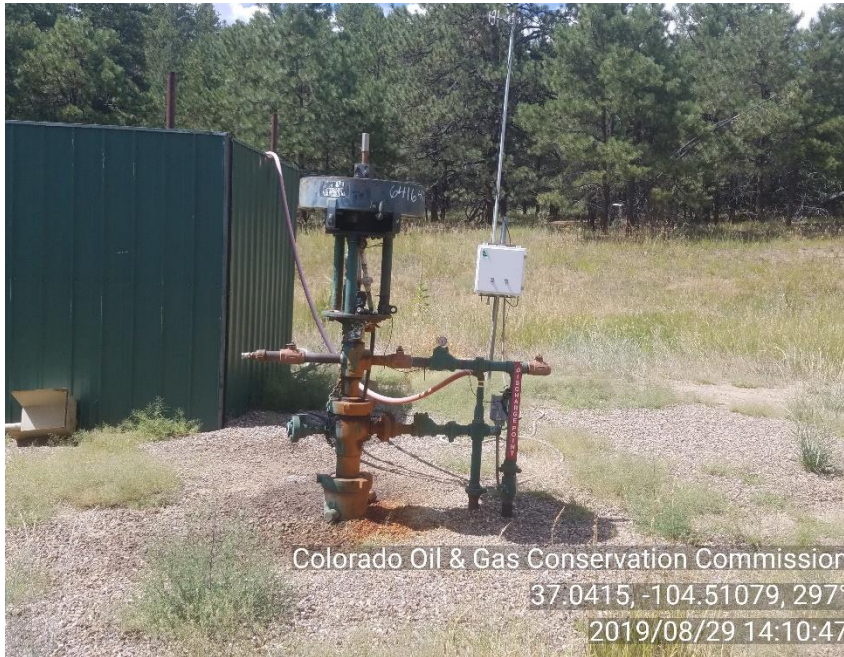
PHOTO 1: WELLHEAD

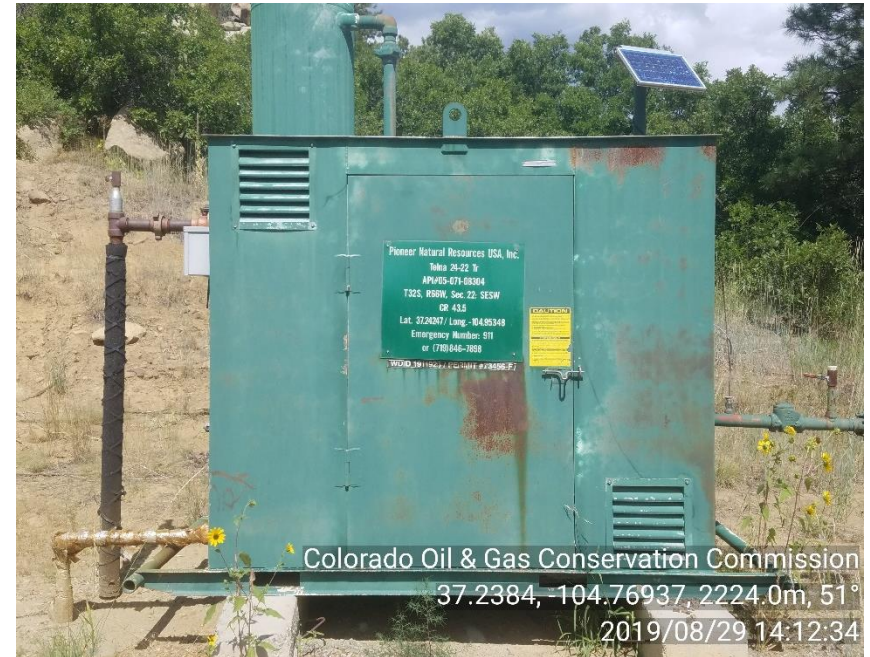
PHOTO 2: WELL SIGN

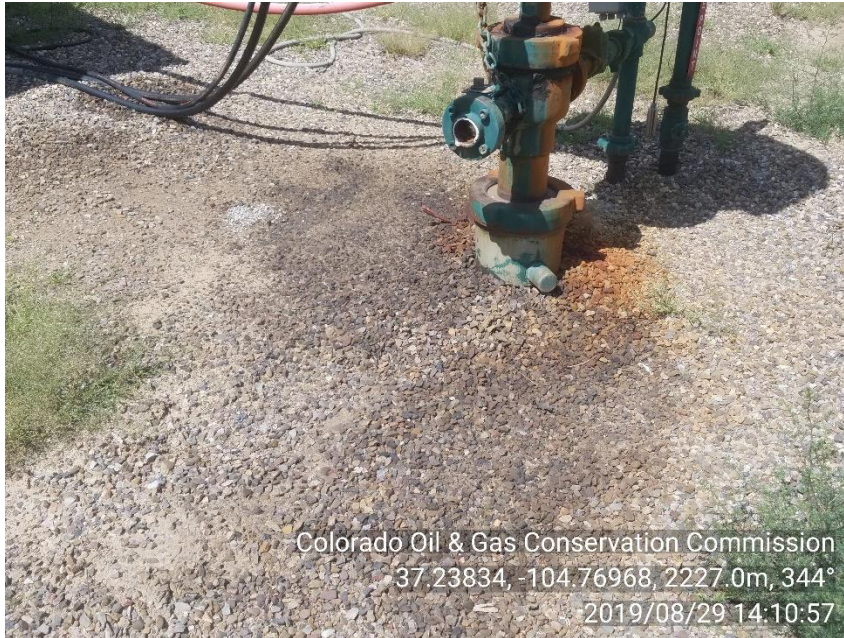
PHOTO 3: AREA OF IMPACTED SOIL AROUND WELLHEAD. Remove and dispose impacted material in approved manner, service and maintain equipment and self inspect to prevent recurrence of conditions per 1002.f(2) and 907. CA DATE 9-29-19

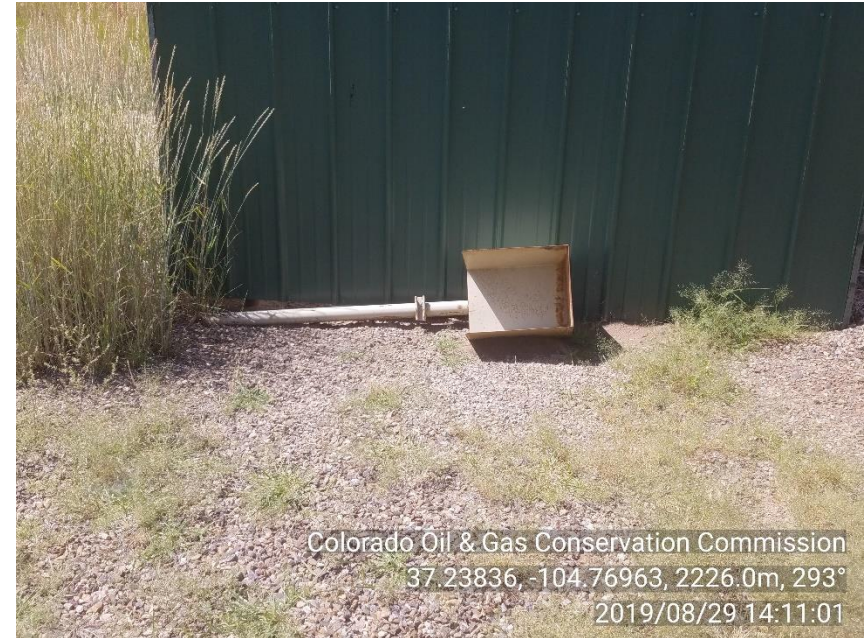
PHOTO 4: UNUSED EQUIPMENT STORED ON LOCATION. REMOVE UNUSED EQUIPMENT, COMPLY WITH RULE 603.f. CA DATE 9-29-19

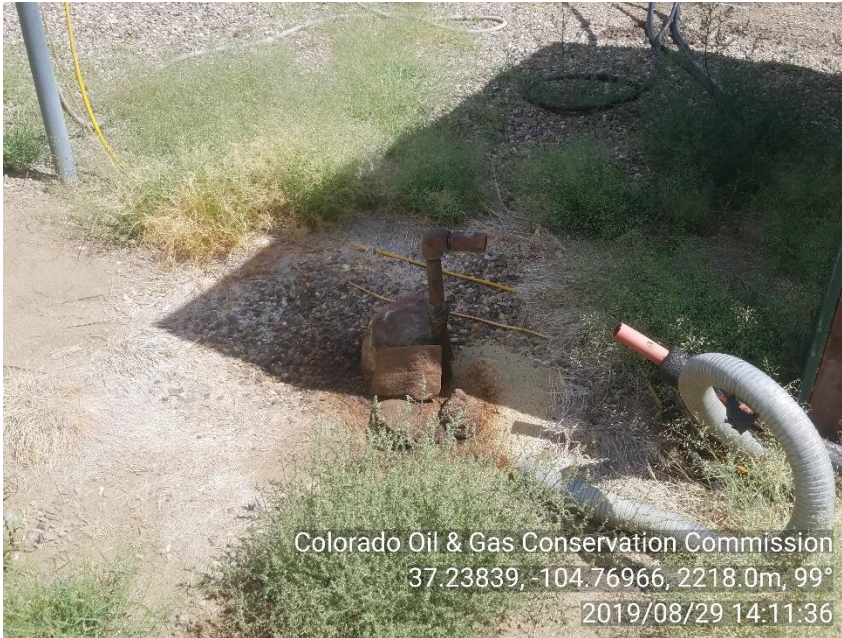
**PHOTO 5: UNUSED EQUIPMENT (1" RISER). REMOVE
UNUSED RISER, COMPLY WITH RULE 603.f. FOR
UNUSED EQUIPMENT AND NTO FOR UNUSED
RISERS. CA DATE 9-29-19.**
