**Inspection Photos**  
**Location Name: Chevron Wilson Creek**  
**CE&P Facility ID 149002**

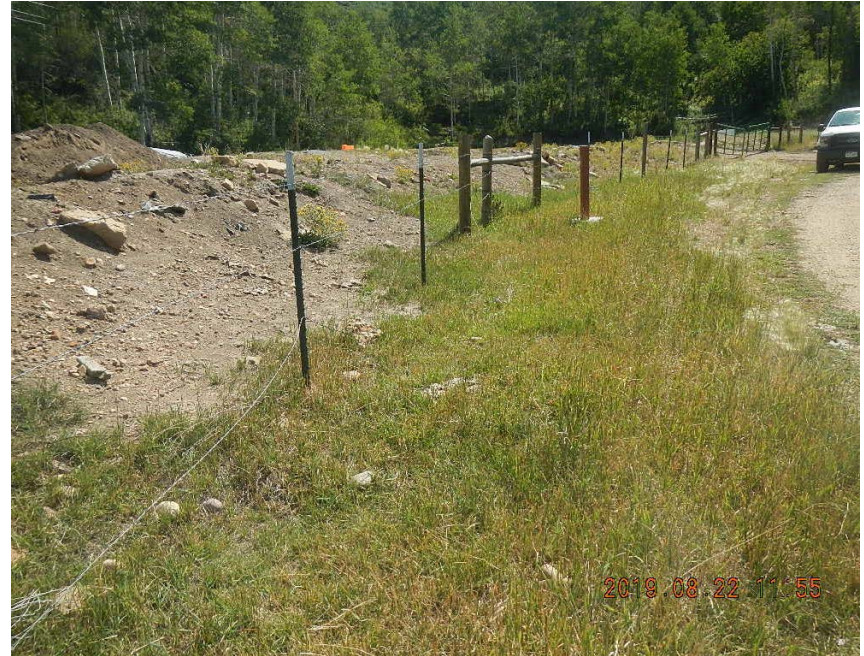
**Fence in disrepair along access road.**

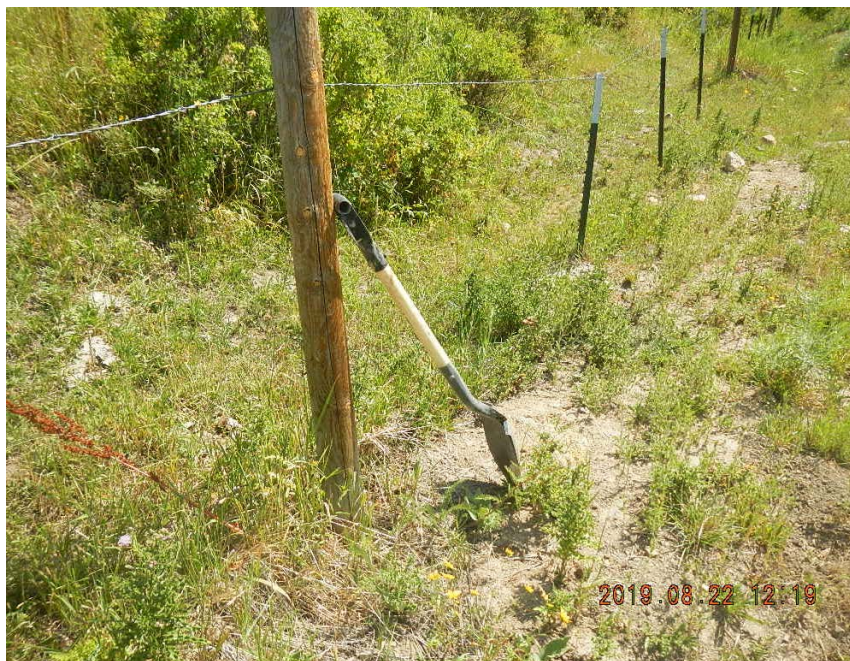
**Fence in disrepair along northern side of the Facility.**

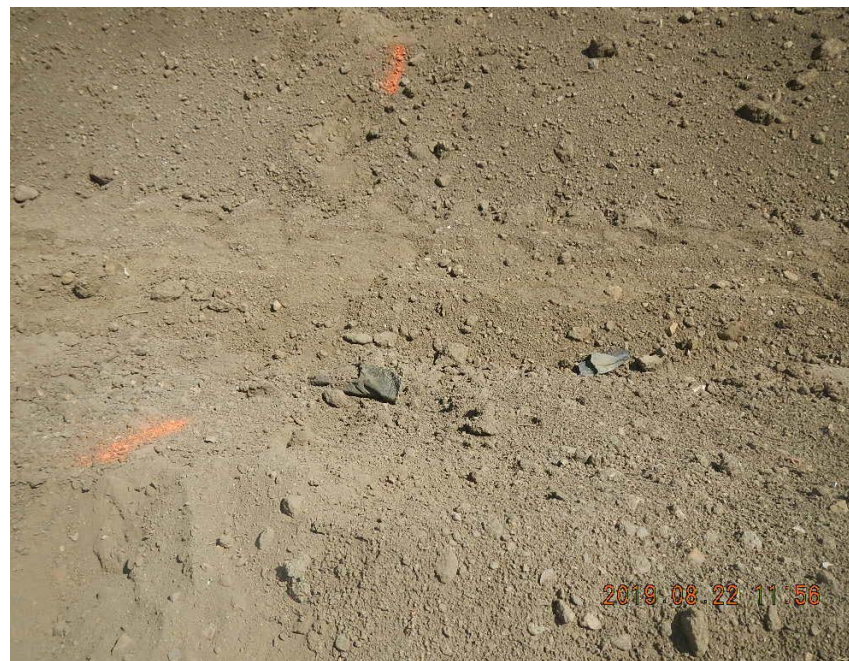
**Liner pieces in land treatment cell.**

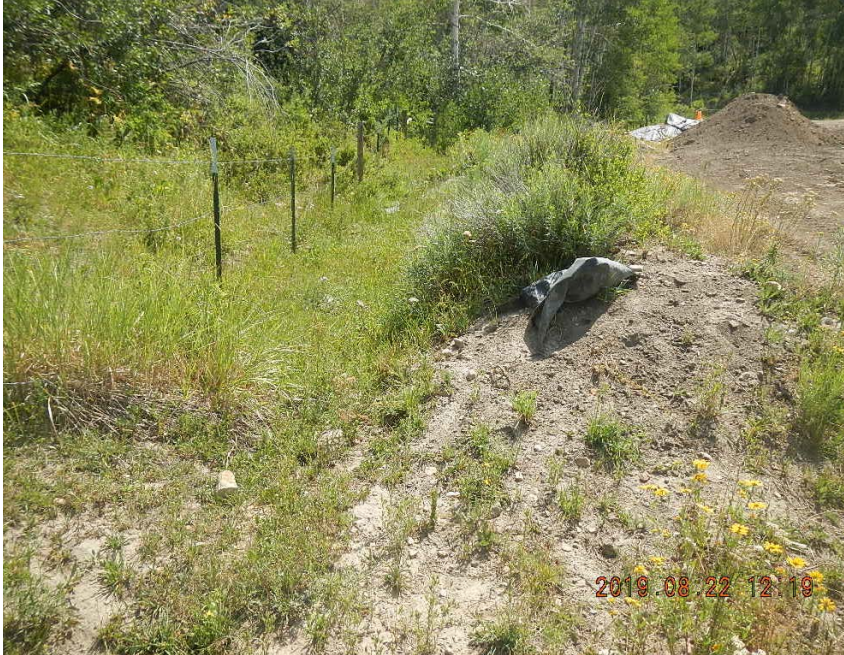
**Liner pieces along northern side of Facility.**

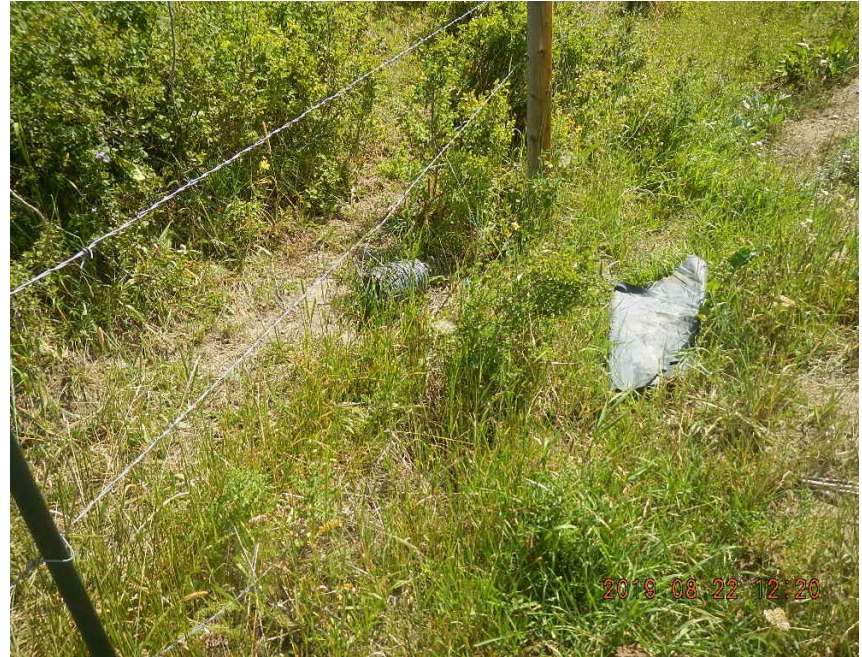
**Liner pieces and barbed wire roll along northern side of Facility.**

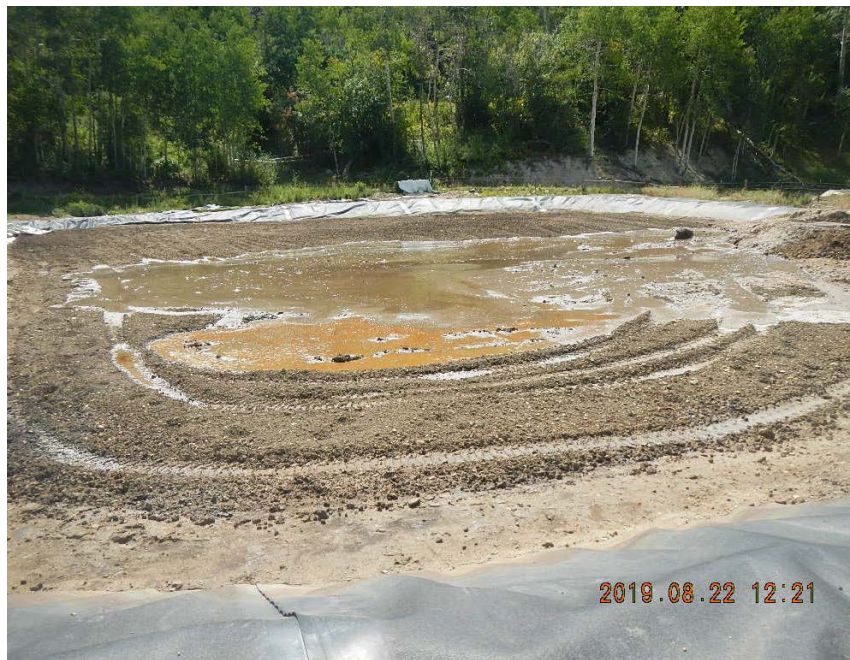
**Fluid and apparent hydrocarbon accumulation in the northeast corner of the Facility.**

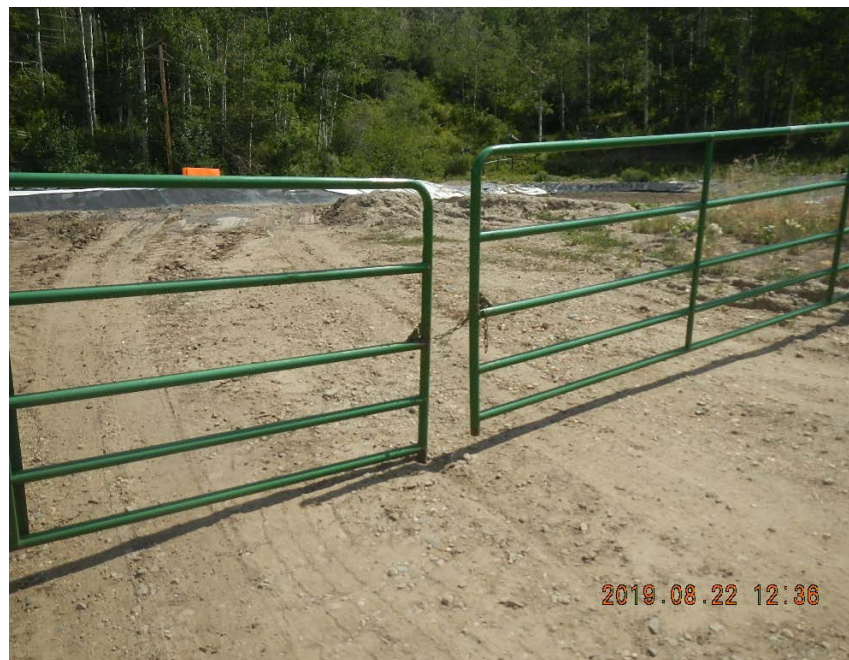
**Vehicular entrance into the Facility.**

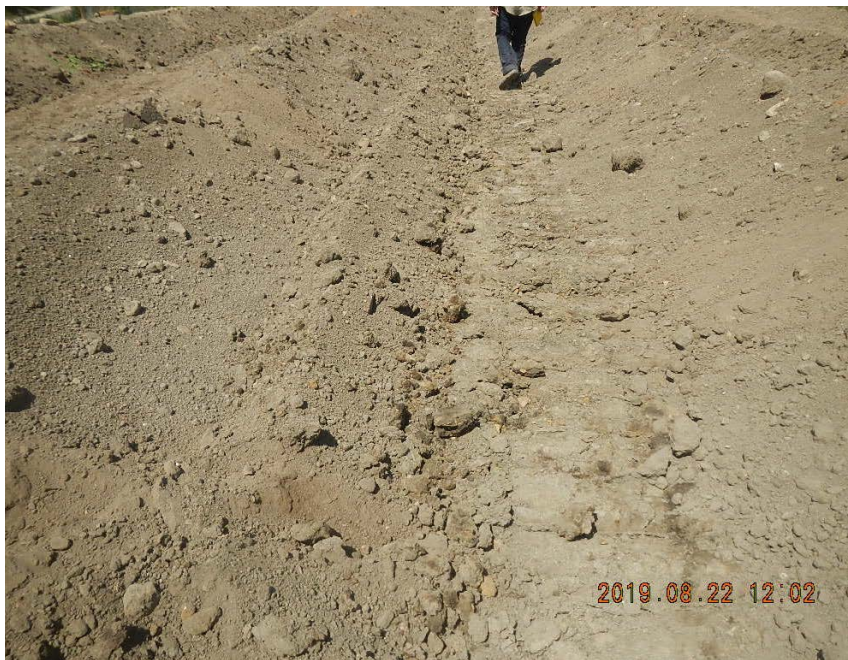
**Wind rowed treatment cell.**

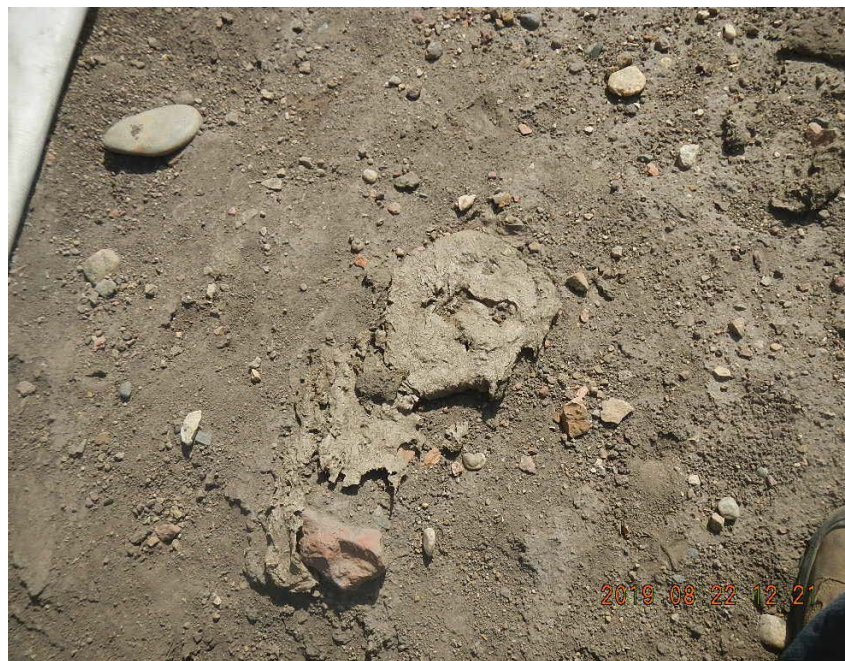
**Evidence of livestock accessing Facility.**
