Inspection Photos

Location: 428531

Inspection Date: 8/26/2019

**COLORADO**  
Oil & Gas Conservation  
Commission  
Department of Natural Resources

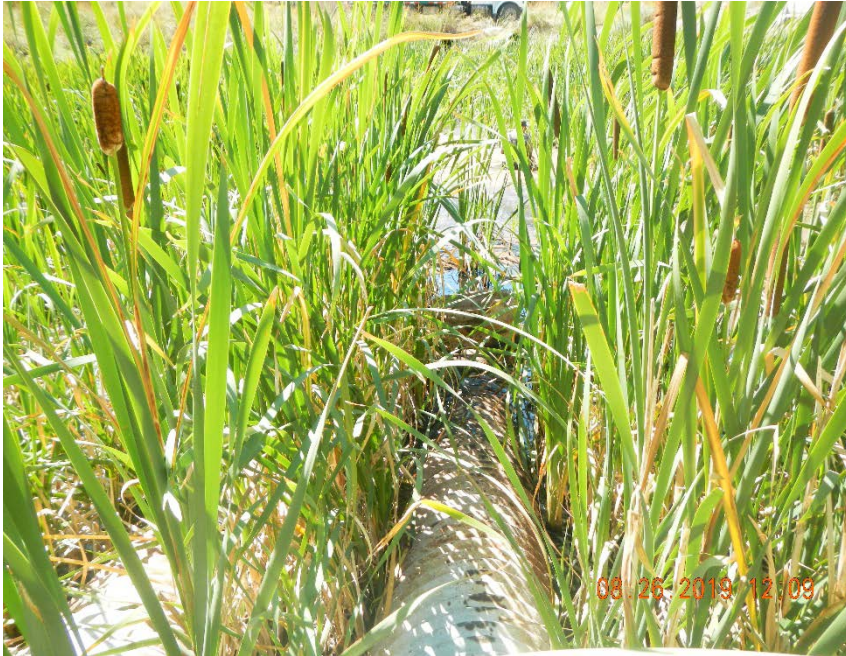
Photo #1 culverts that (passively) control level of water in upper pit, they flow to the lower pit

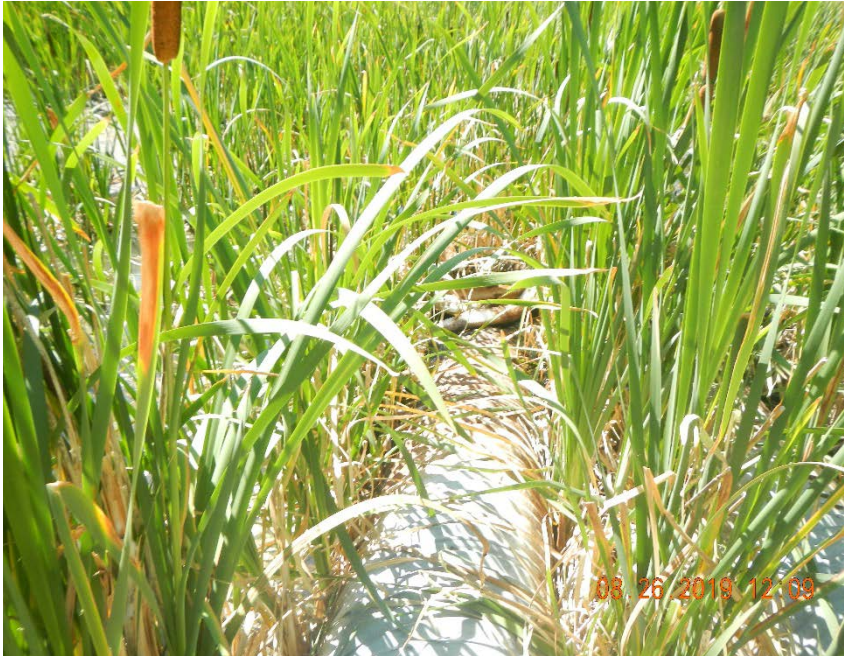
Photo #2 culverts that (passively) control level of water in upper pit, they flow to the lower pit

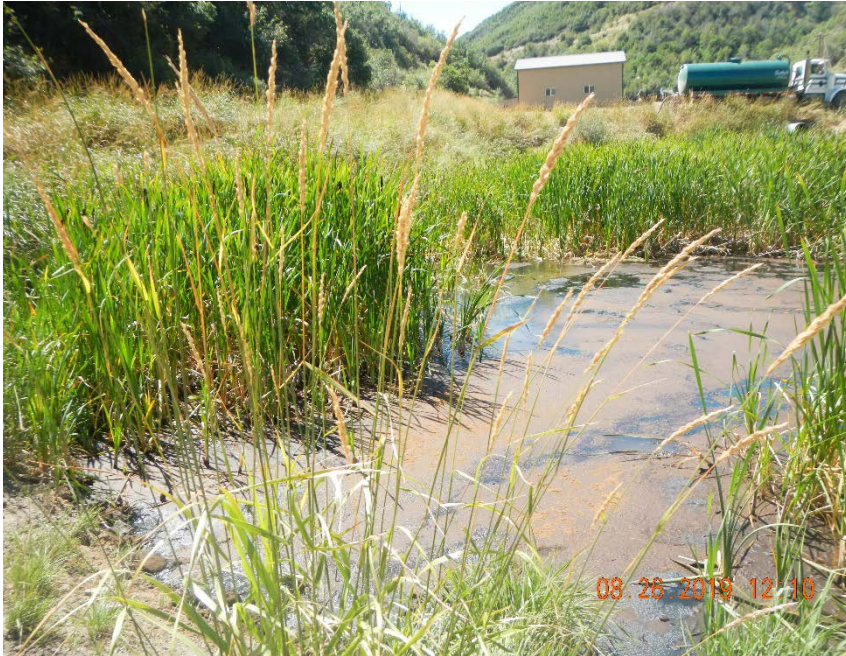
Photo #3 Upper pit. Photo taken standing on berm between pits. Oil on water in pit had “sphag sorb” applied, it shows up as brown on surface of water and was intended to absorb and encapsulate free oil on water surface.

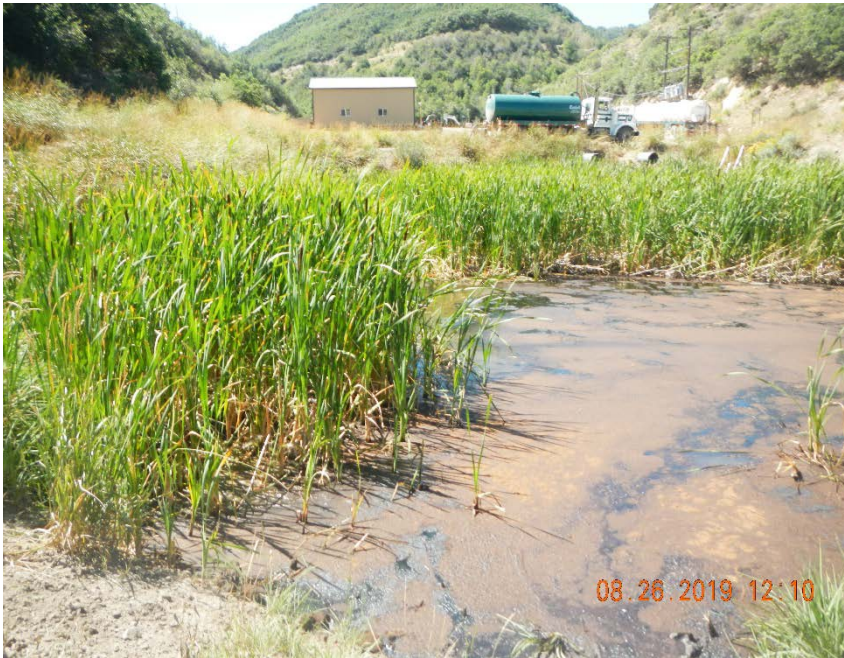
Photo #4 Upper pit. Photo taken standing on berm between pits. Oil on water in pit had “sphag sorb” applied, it shows up as brown on surface of water and was intended to absorb and encapsulate free oil on water surface.

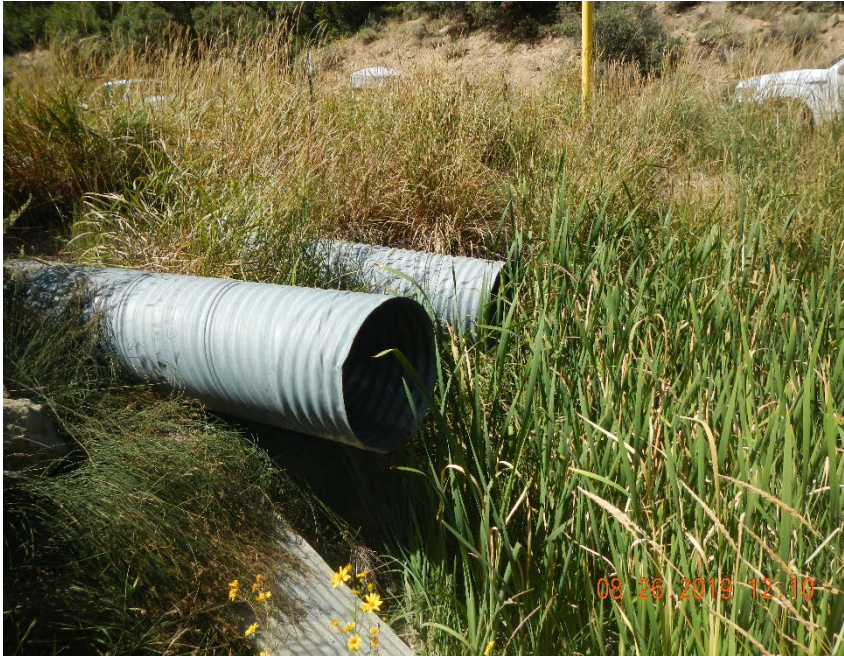
Photo #5 outfall from lower pit, no hydrocarbon was observed below lower pit or through these culverts.

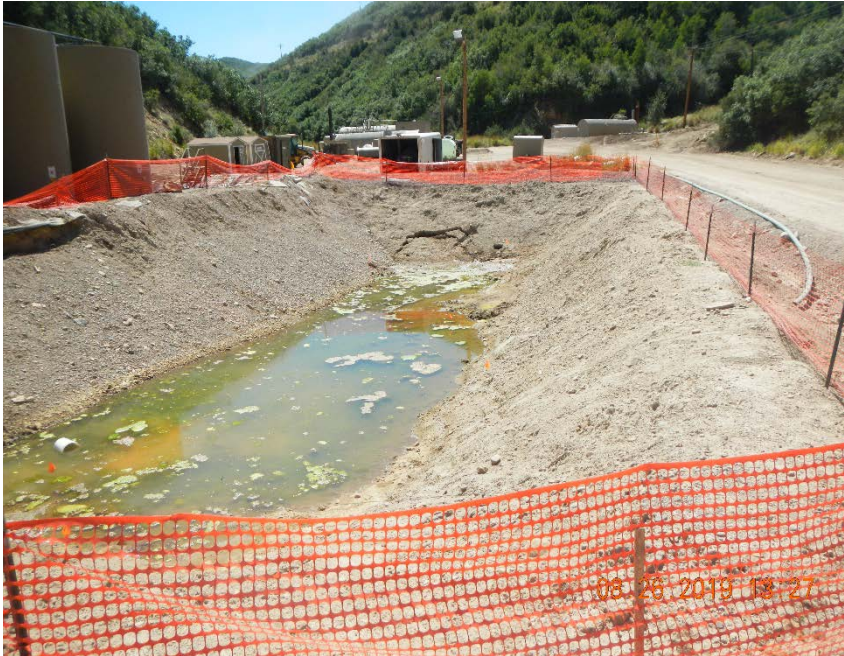
Photo #6 Pit is in process of closure, a part of REM project #10268.

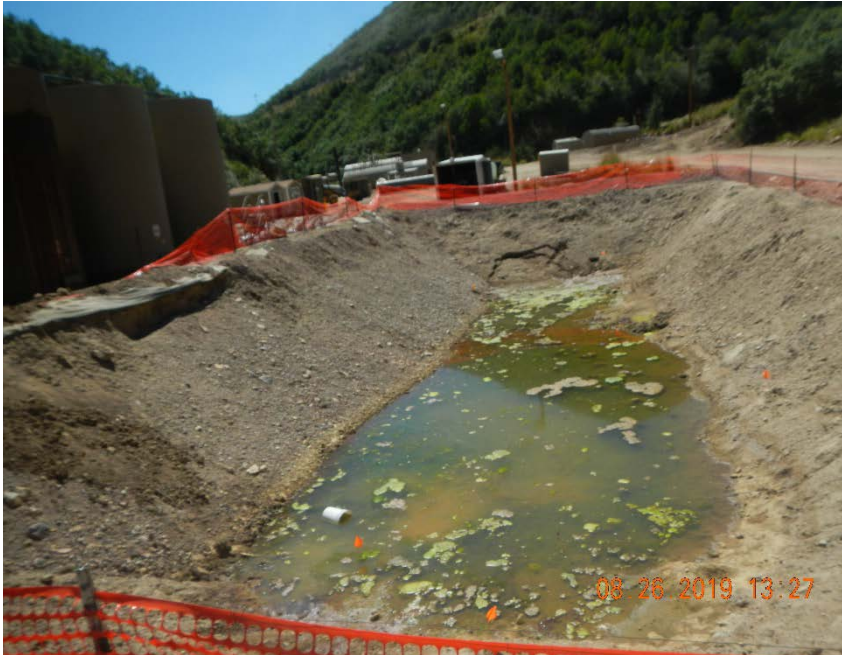
Photo #1 Pit is in process of closure, a part of REM project #10268.

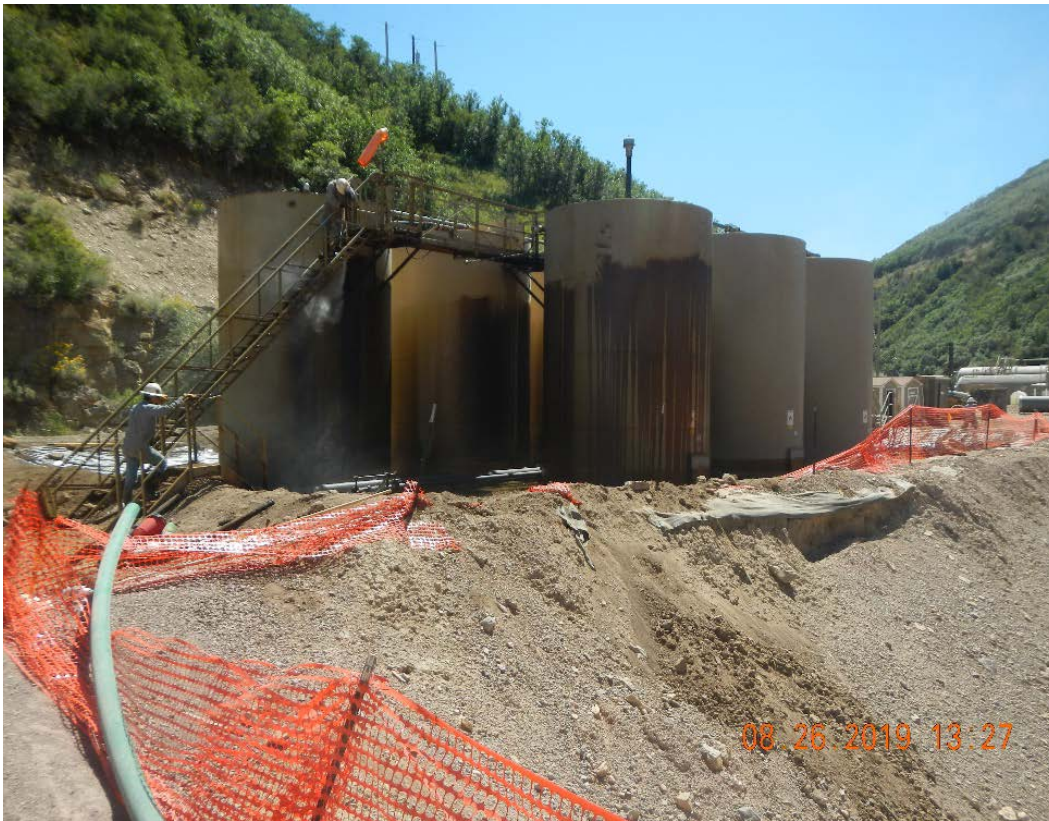
Photo #8 Tanks being cleaned. This was the source of spill. Pit is in process of closure is in foreground and right of photo.

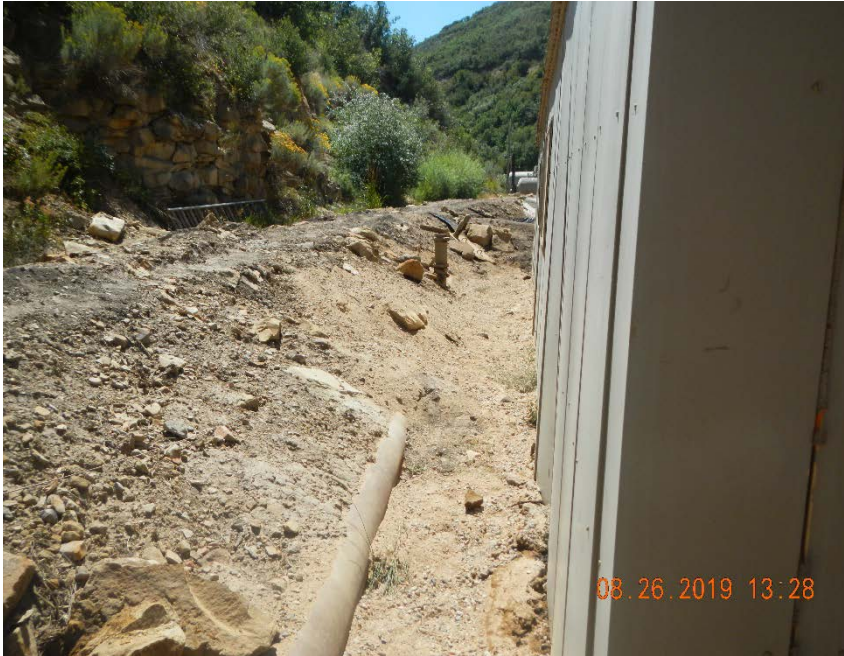
Photo #9. Injection Pump shed on right of photo. Photo is taken looking up grade (south), the tank battery (out of view) is behind the pump house. Spill path flowed between berm (at left of photo) and pump house. Fluid also went through the pump house.

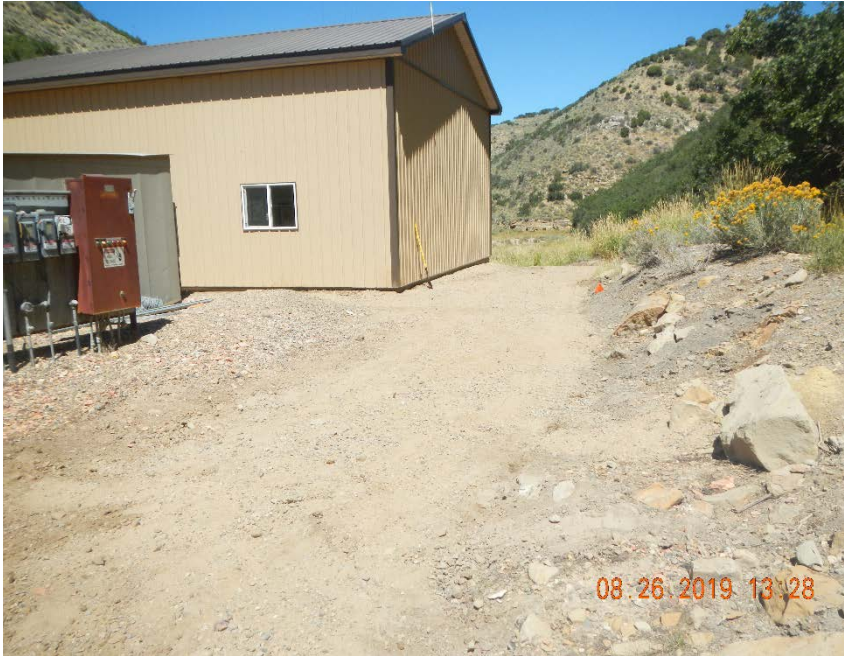
Photo #10 shop in background of photo, Pits are located behind shop. The injection Pumphouse is out of the photo behind and to the left of camera. Spilled fluid flowed between shop and bermed area on right.

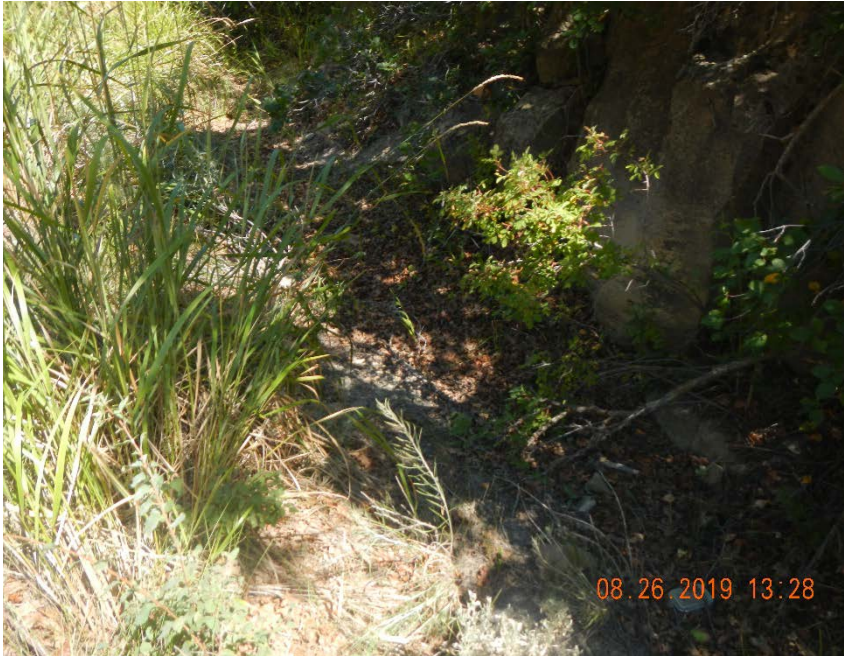
Photo #11 is a close up of the bermed drainage. The drainage was dry at the time of inspection.

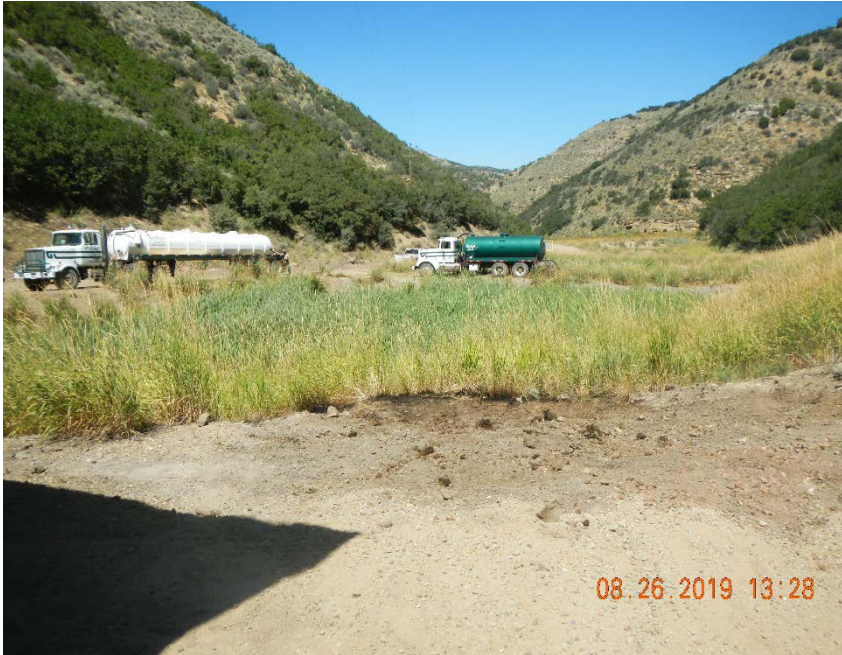
Photo #12 shadow on left of photo is shop. Impacted area is visible in foreground and is where the fluids entered the pits. Photo is an overview of upper the pit. Green pump truck is parked between the upper and lower pits.

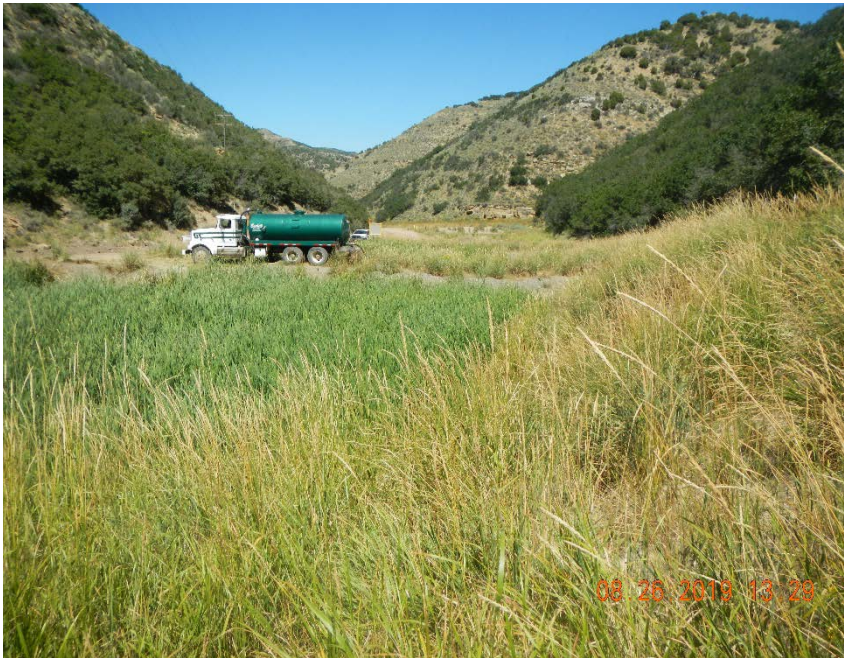
Photo #13 Photo is an overview of upper the pit. Green pump truck is parked between the upper and lower pits.

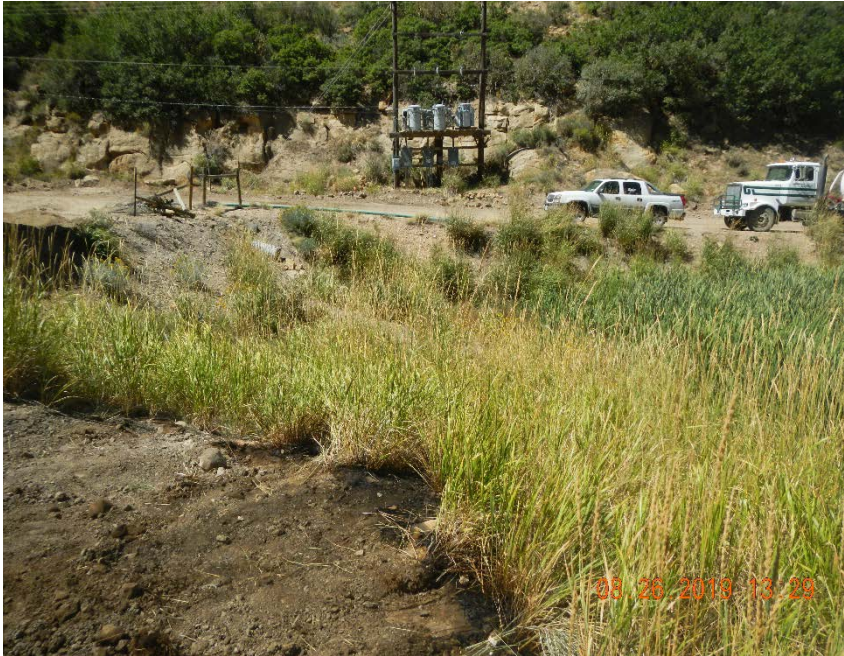
Photo #14 Photo is of upper pit. Observable impact in foreground is where the fluids entered the pit.

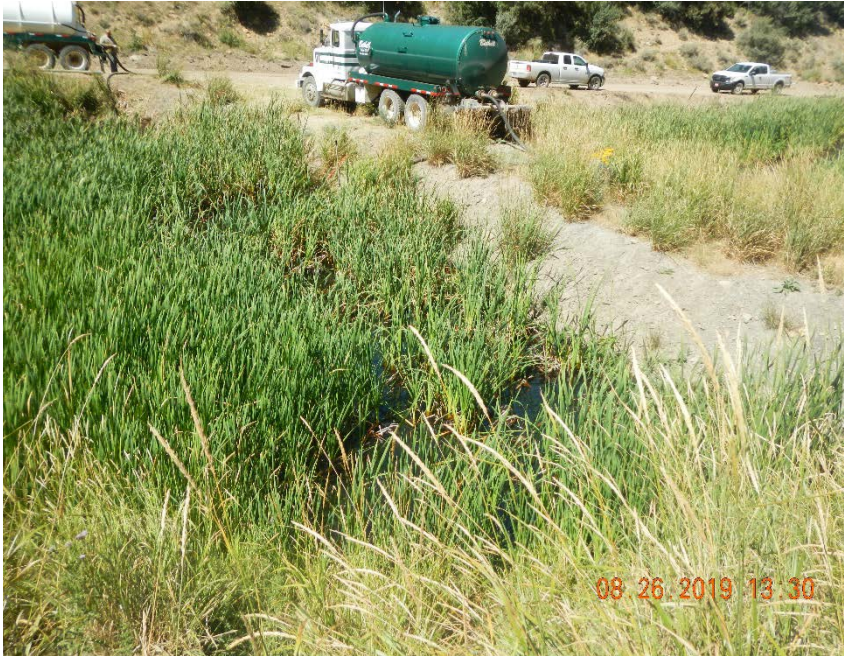
Photo #15 Photo of upper pit, the (grey colored) bank in photo is dividing the upper and lower pit. Culverts are located in the cattails.

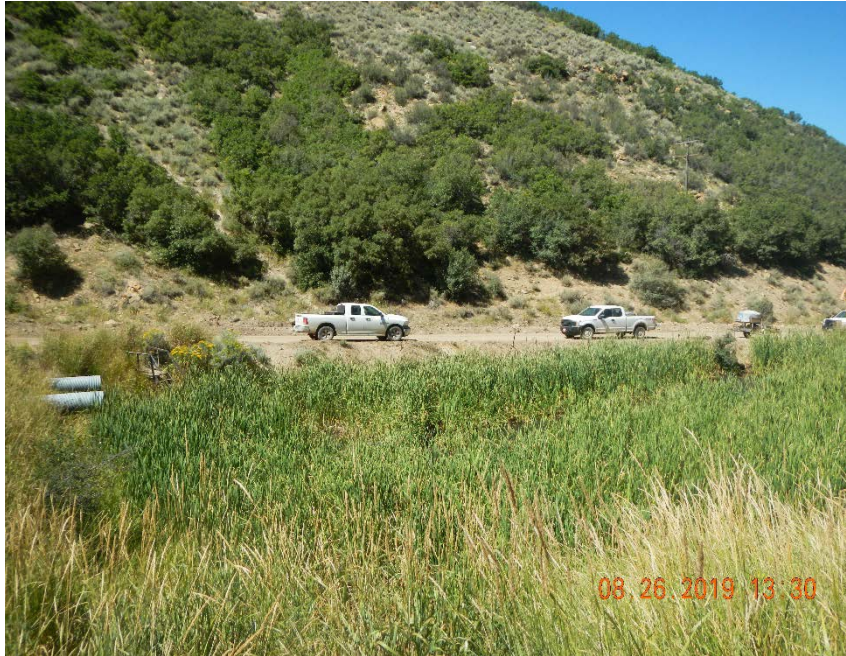
Photo #17 Overview of lower pit. Note culvert, this is used to convey fluid from upper to lower pit.

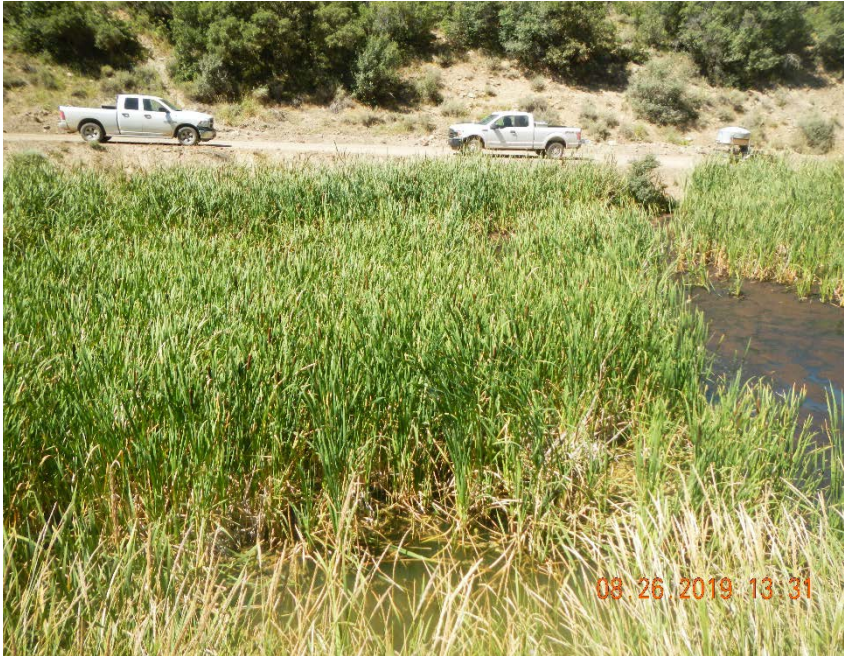
Photo #18 Photo of lower pit. Oil on water in pit had “sphag sorb” applied, it shows up as brown on surface of water and was intended to encapsulate free oil on water surface.

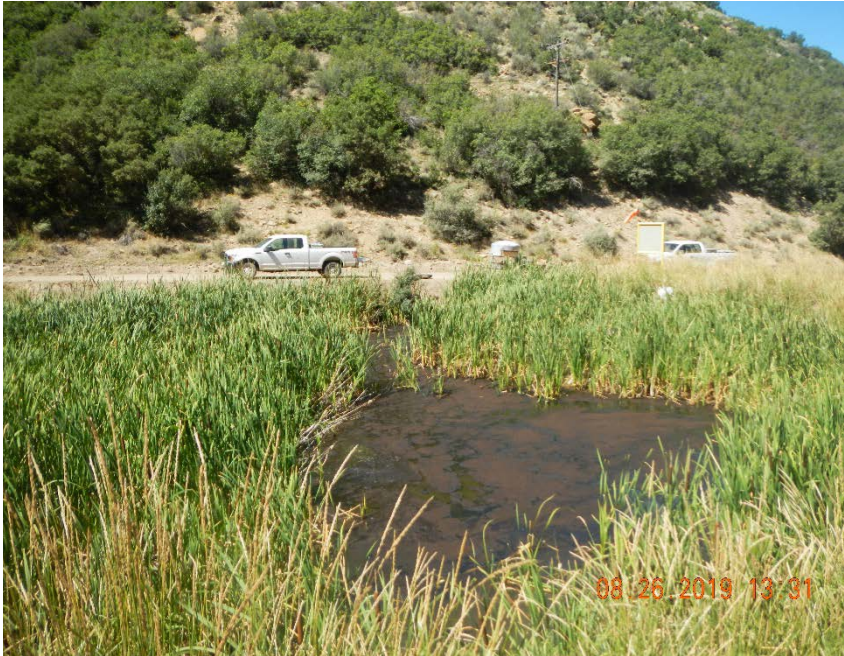
Photo #19 Photo of lower pit. Oil on water in pit had “sphag sorb” applied, it shows up as brown on surface of water and was intended to encapsulate free oil on water surface.

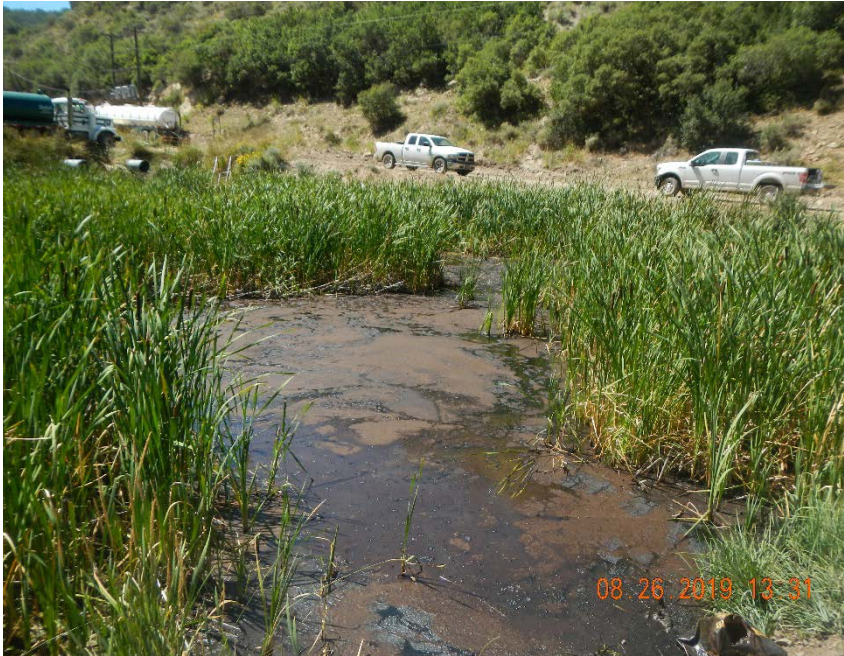
Photo #20 Photo of lower pit. Oil on water in pit had “sphag sorb” applied, it shows up as brown on surface of water and was intended to encapsulate free oil on water surface.

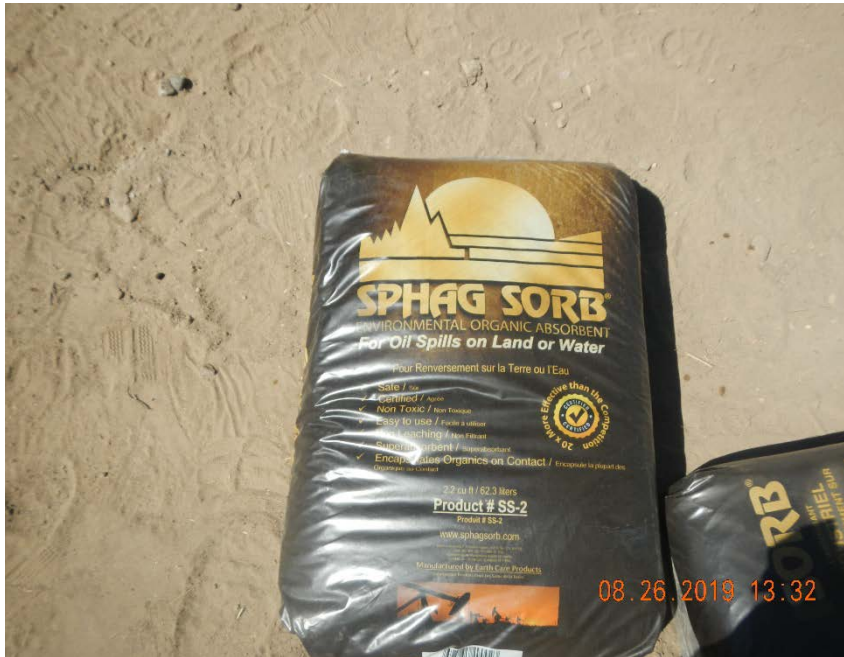
Photo #21 Sphag Sorb, peat fiber material that was applied to water surface.

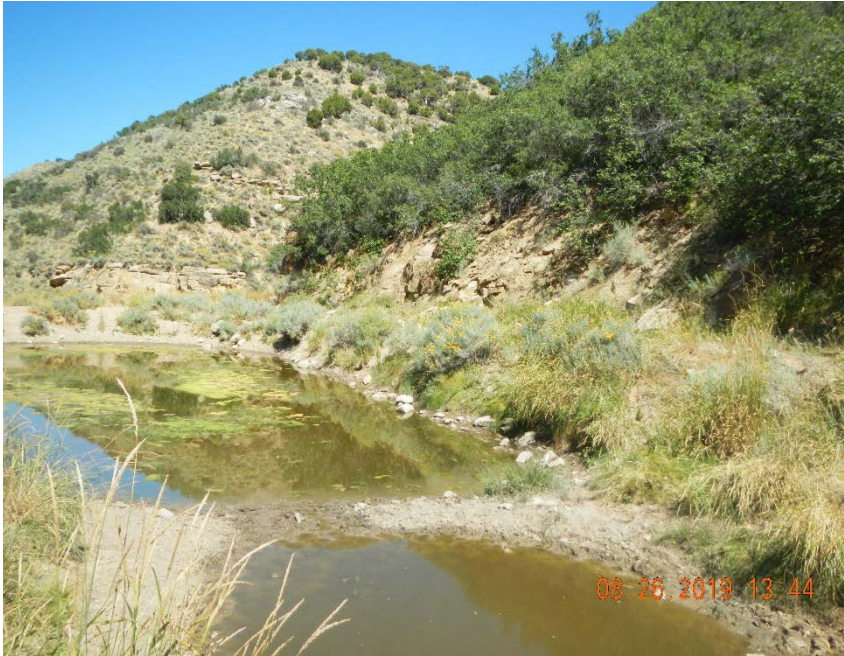
Photo #23 Water impoundment downgrade (40.288324,-108.024621) from 2 upper pits, no hydrocarbon was observed in this impoundment.

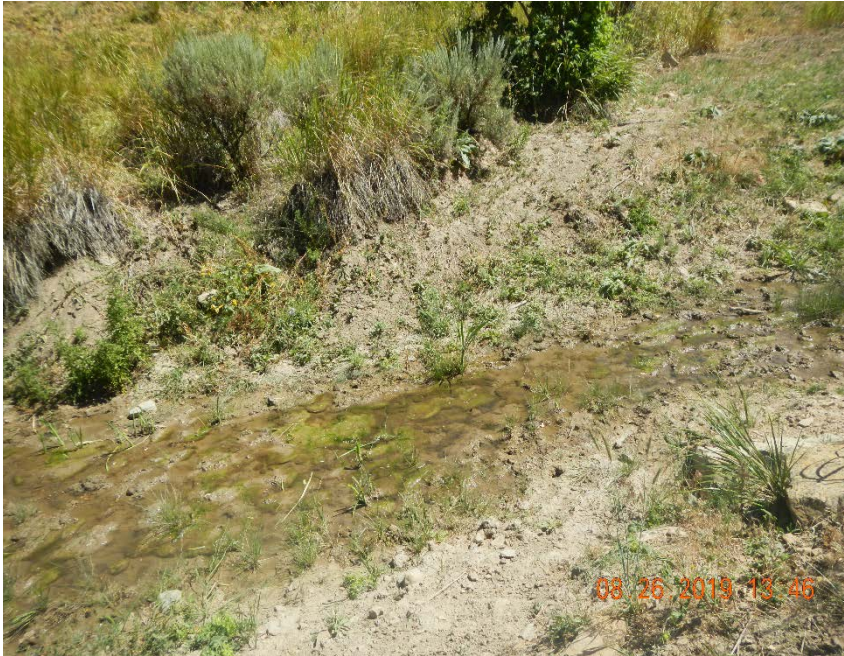
Photo #24 Straight Gulch below pits and facility, 40.289840,-108.024958. No hydrocarbon was observed in Straight Gulch

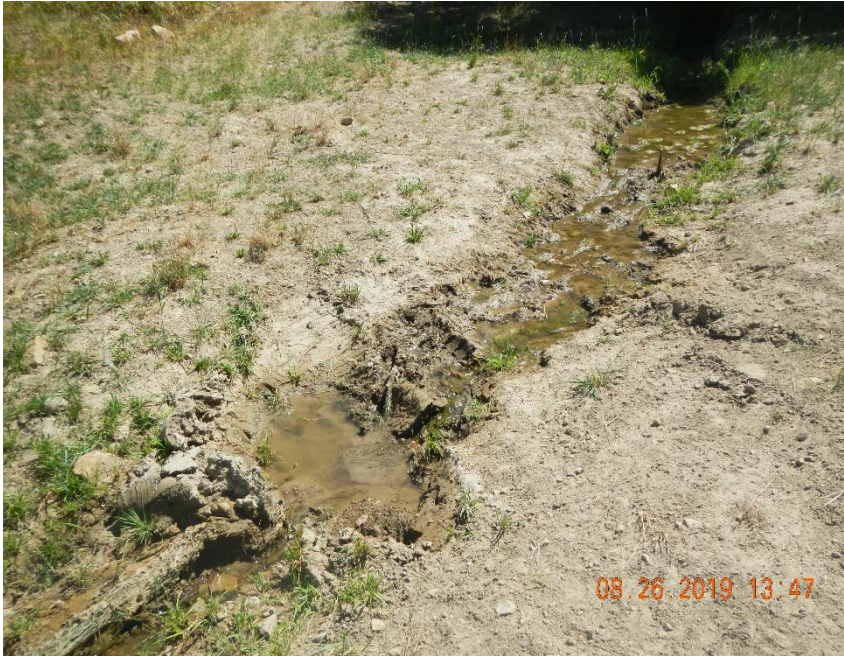
Photo #25 Straight Gulch below pits and facility, 40.289758,-108.024972. No hydrocarbon was observed in Straight Gulch
