# Inspection Photos

09/03/2019

Operator: BAYSWATER EXPLORATION &  
PRODUCTION LLC - 10261

Location ID: 433247

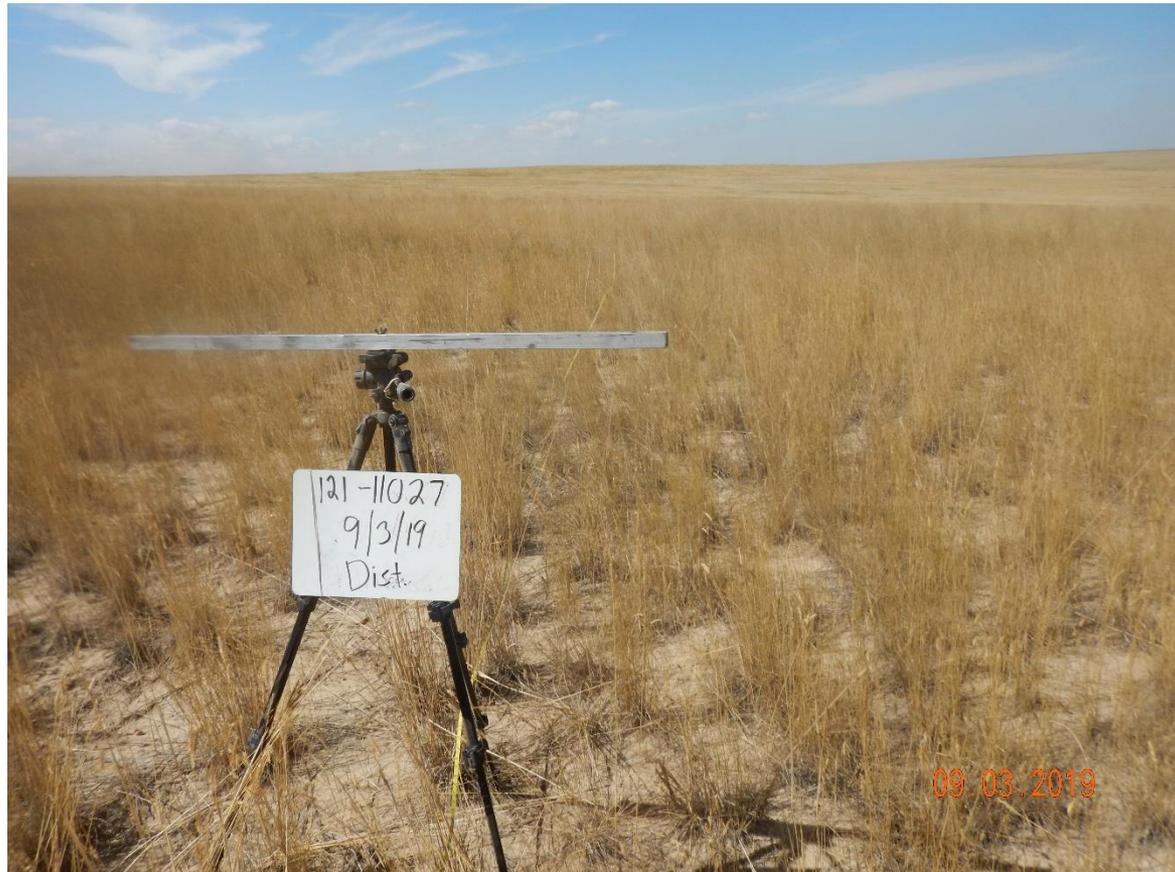
**Photo 1:** Photo taken from the location, facing northwest. Photo shows starting point for the **disturbance area** transect. Photo shows vegetation over the disturbance area.

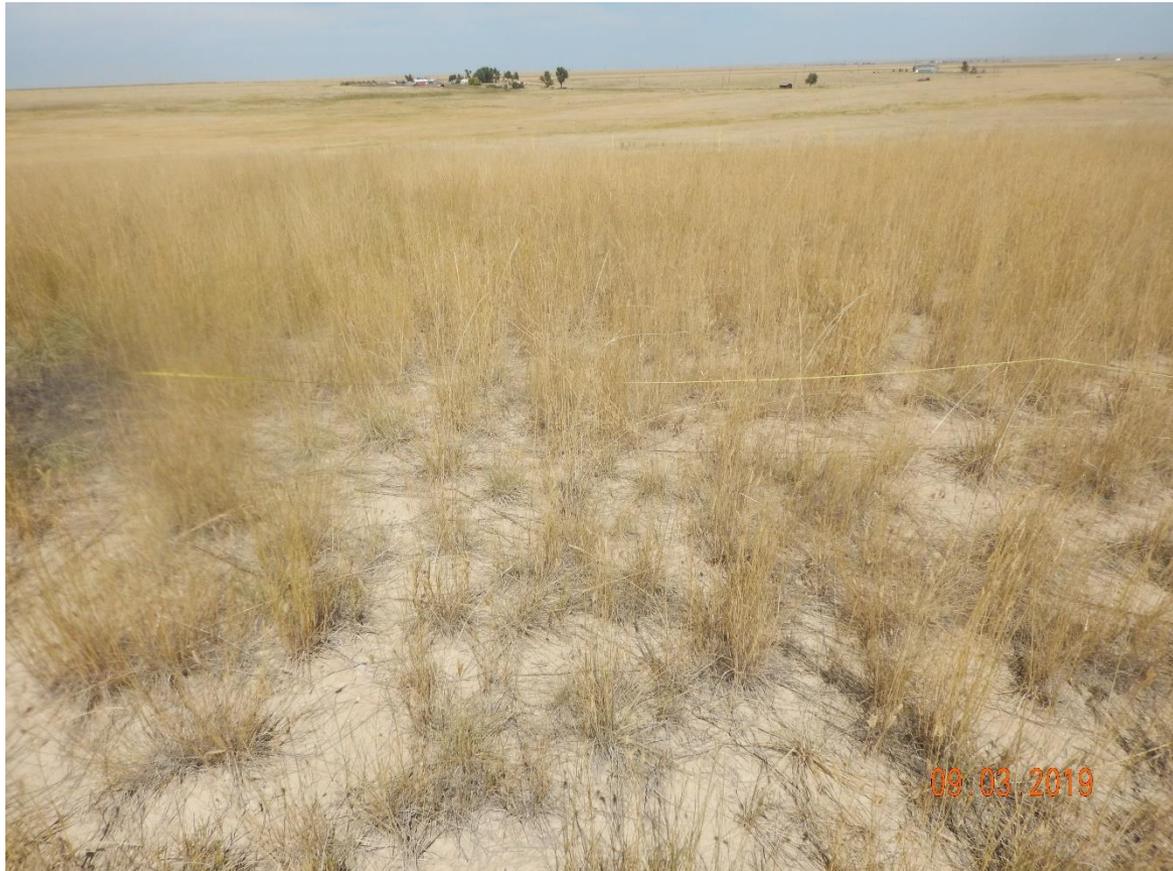
**Photo 2:** Photo of the 50<sup>th</sup> point for the **disturbance area** transect, facing northeast. Photo shows vegetation over the disturbance area.

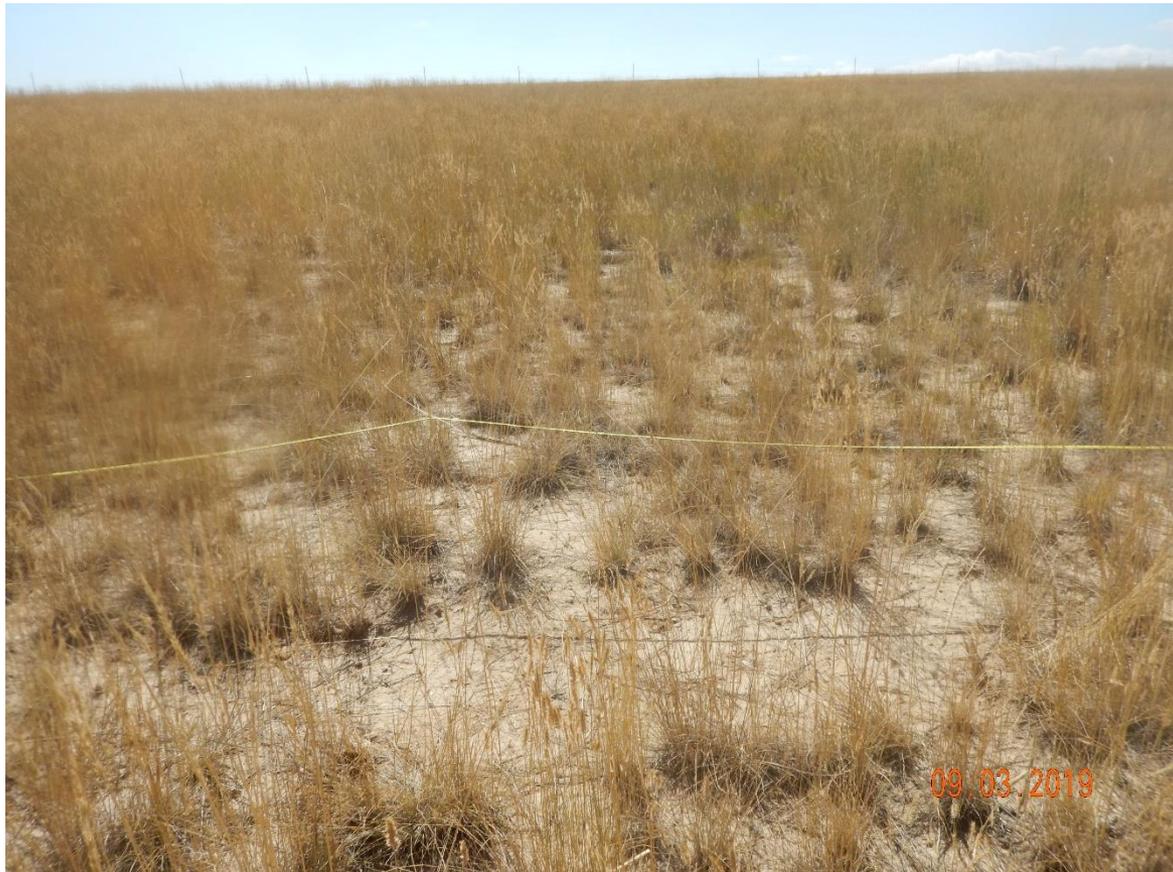
**Photo 3:** Photo of the 50<sup>th</sup> point for the **disturbance area** transect, facing southwest. Photo shows vegetation over the disturbance area.

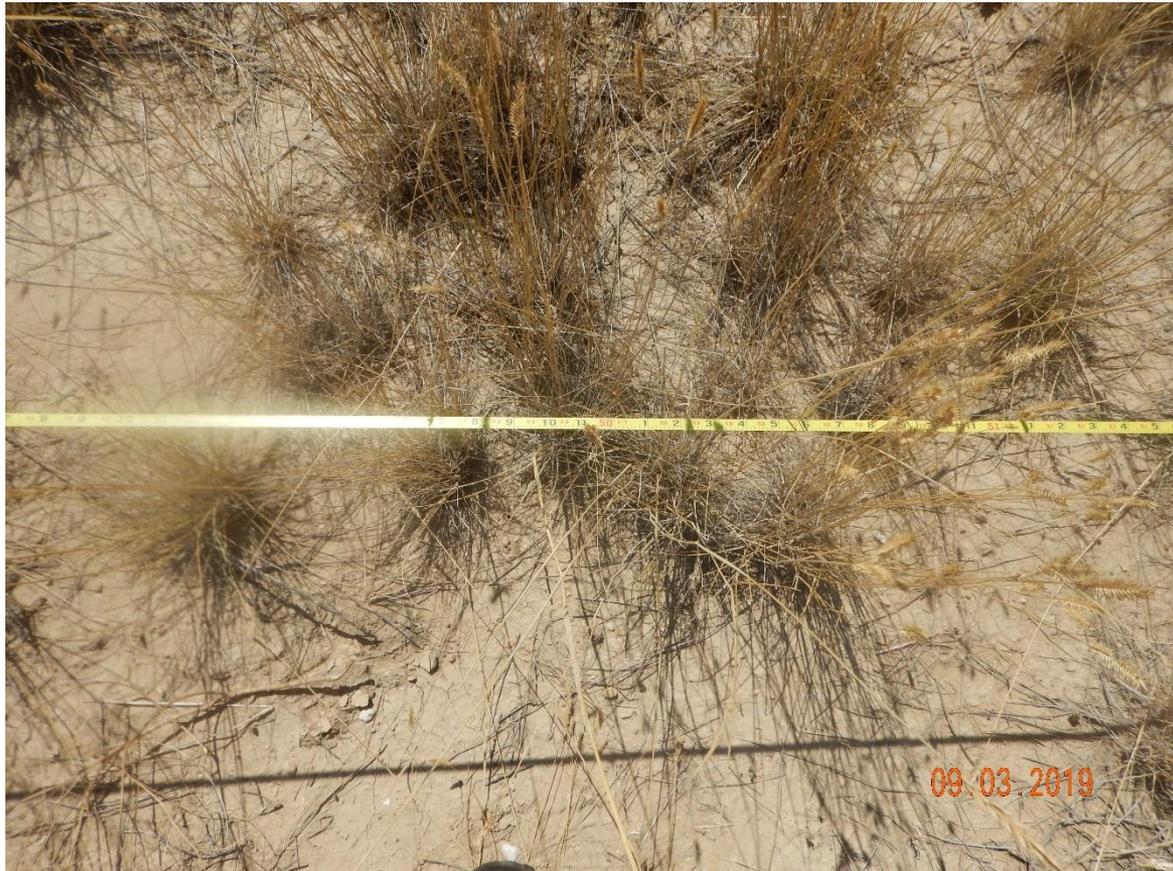
**Photo 4:** Photo of the 50<sup>th</sup> point for the **disturbance area** transect. Photo shows vegetation over the disturbance area.

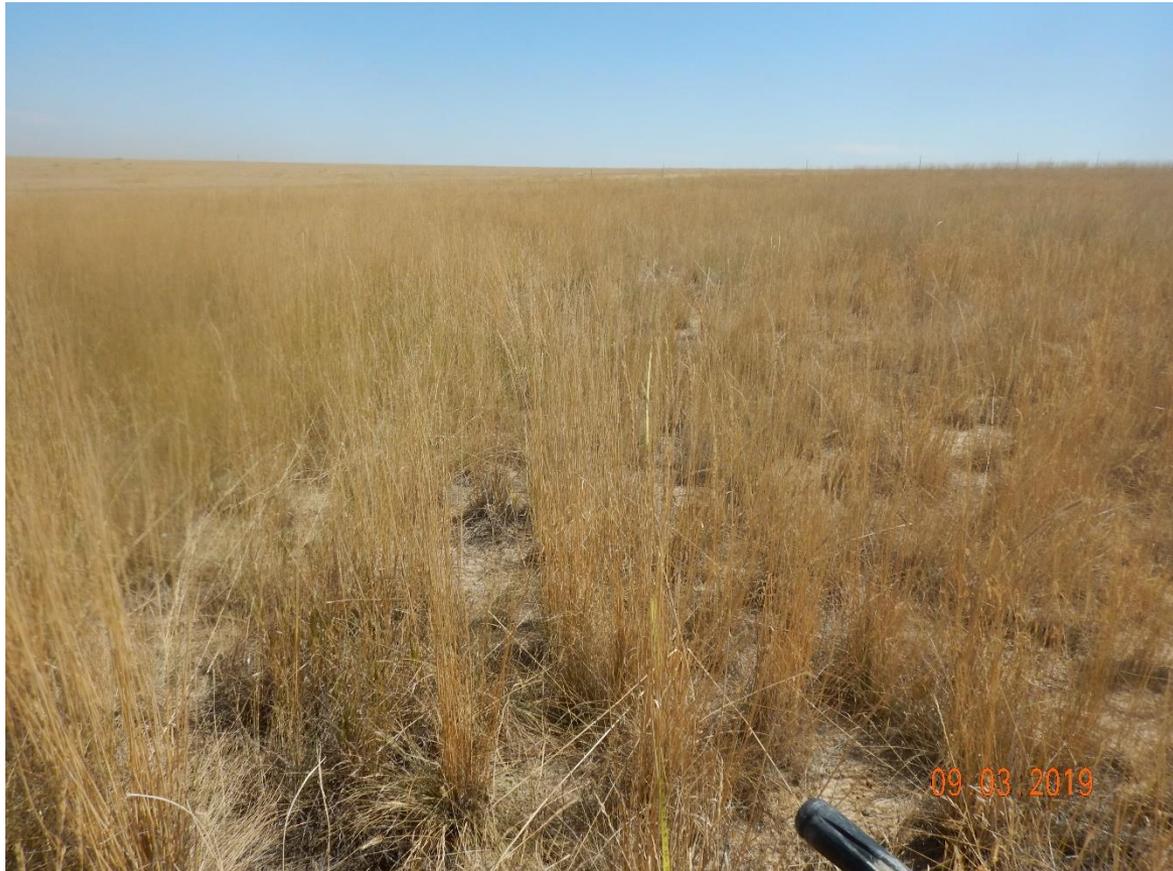
**Photo 5:** Photo taken from the location, facing southeast. Photo shows end point for the **disturbance area** transect. Photo shows vegetation over the disturbance area.

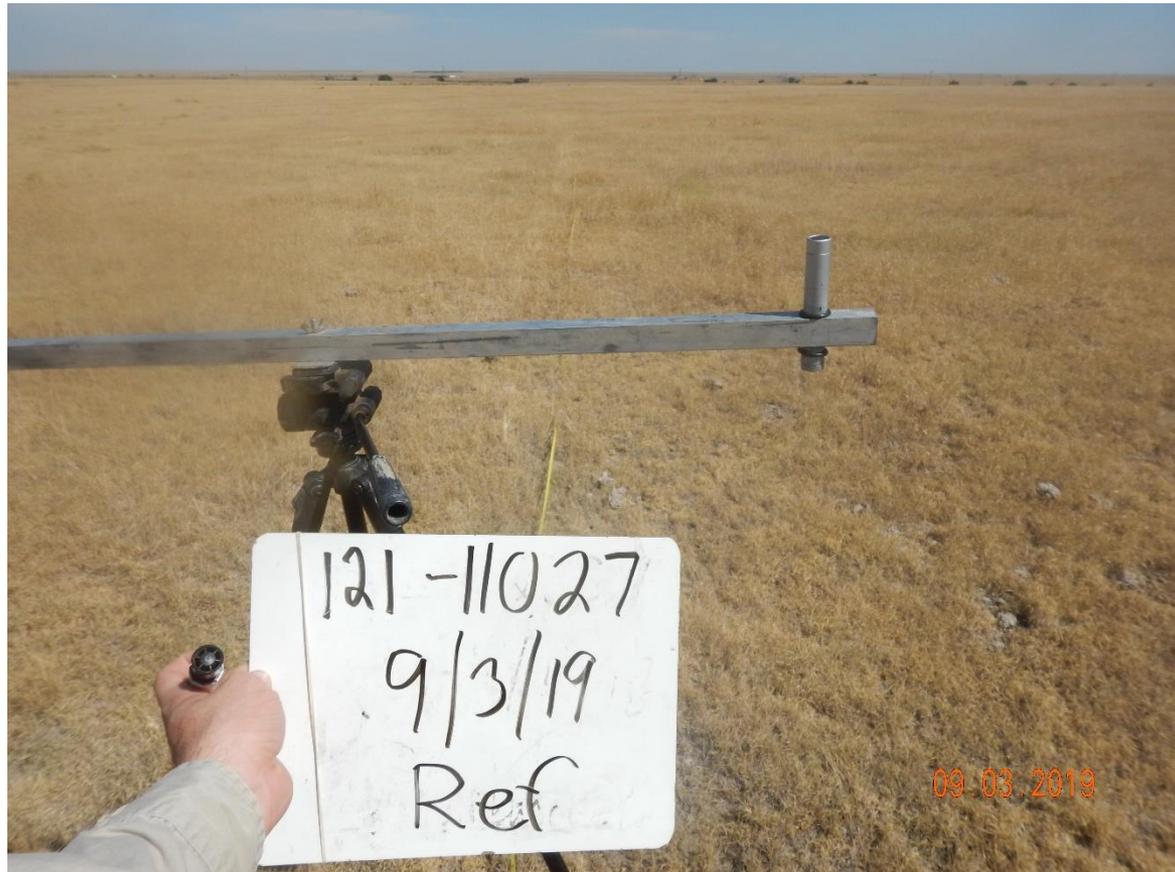
**Photo 6:** Photo taken from the adjacent reference area, facing east. Photo shows starting point for the **reference area** transect. Photo shows vegetation over the reference area.

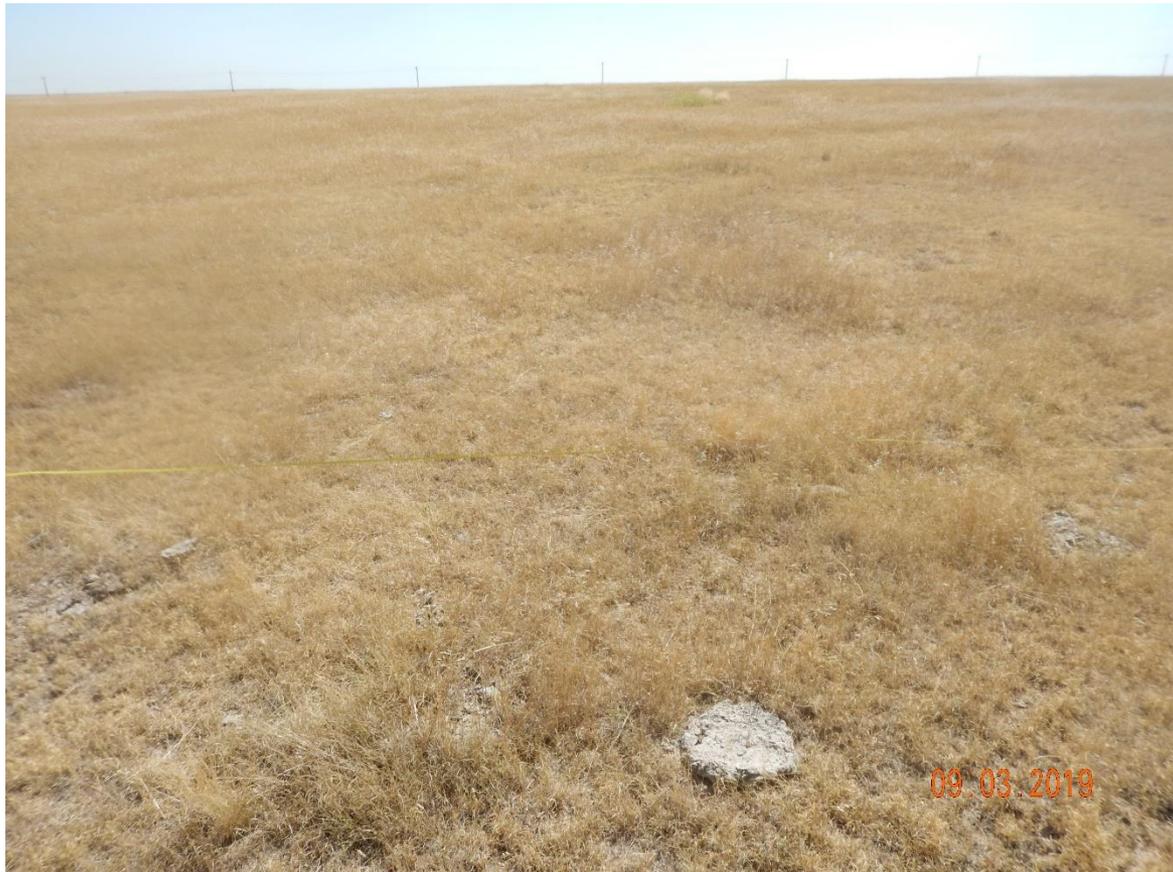
**Photo 7:** Photo of the 50<sup>th</sup> point for the **reference area** transect, facing south. Photo shows vegetation over the reference area.

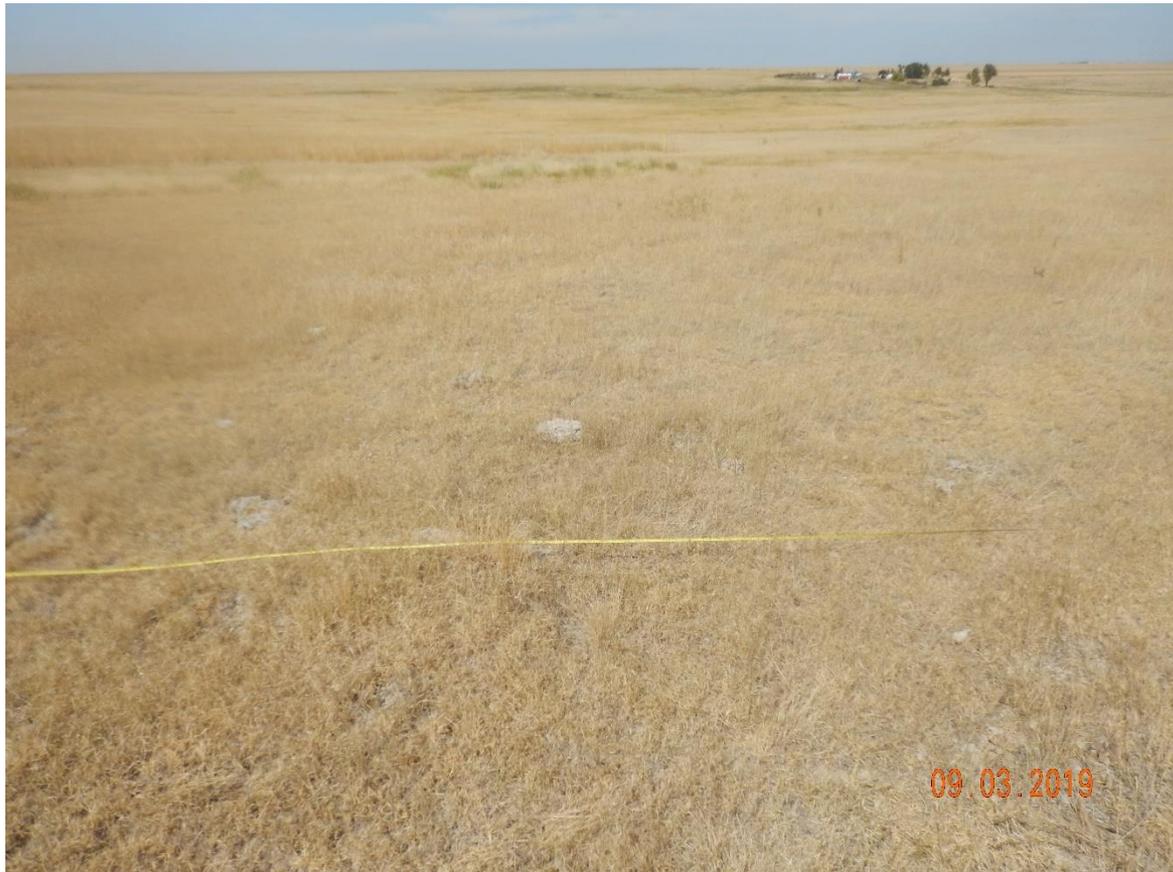
**Photo 8:** Photo of the 50<sup>th</sup> point for the **reference area** transect, facing north. Photo shows vegetation over the reference area.

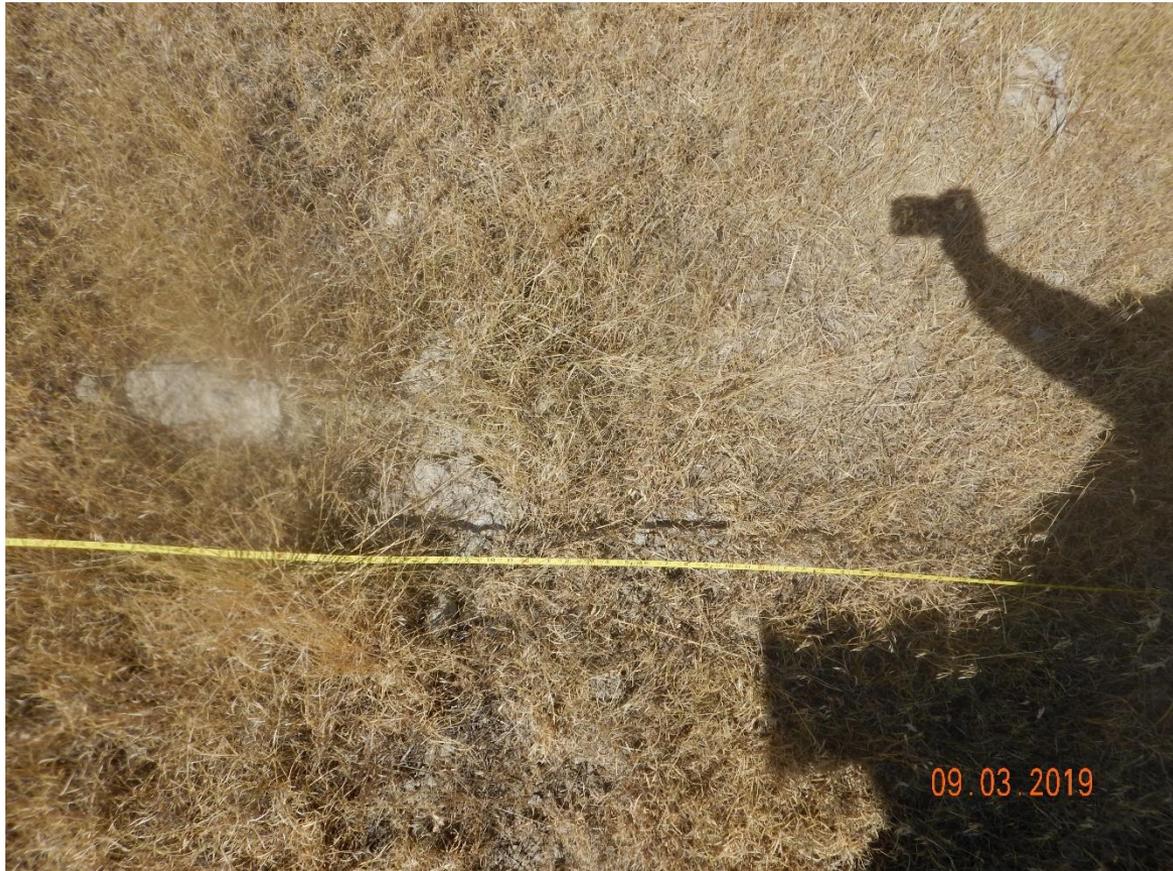
**Photo 9:** Photo of the 50<sup>th</sup> point for the **reference area** transect. Photo shows vegetation over the reference area.

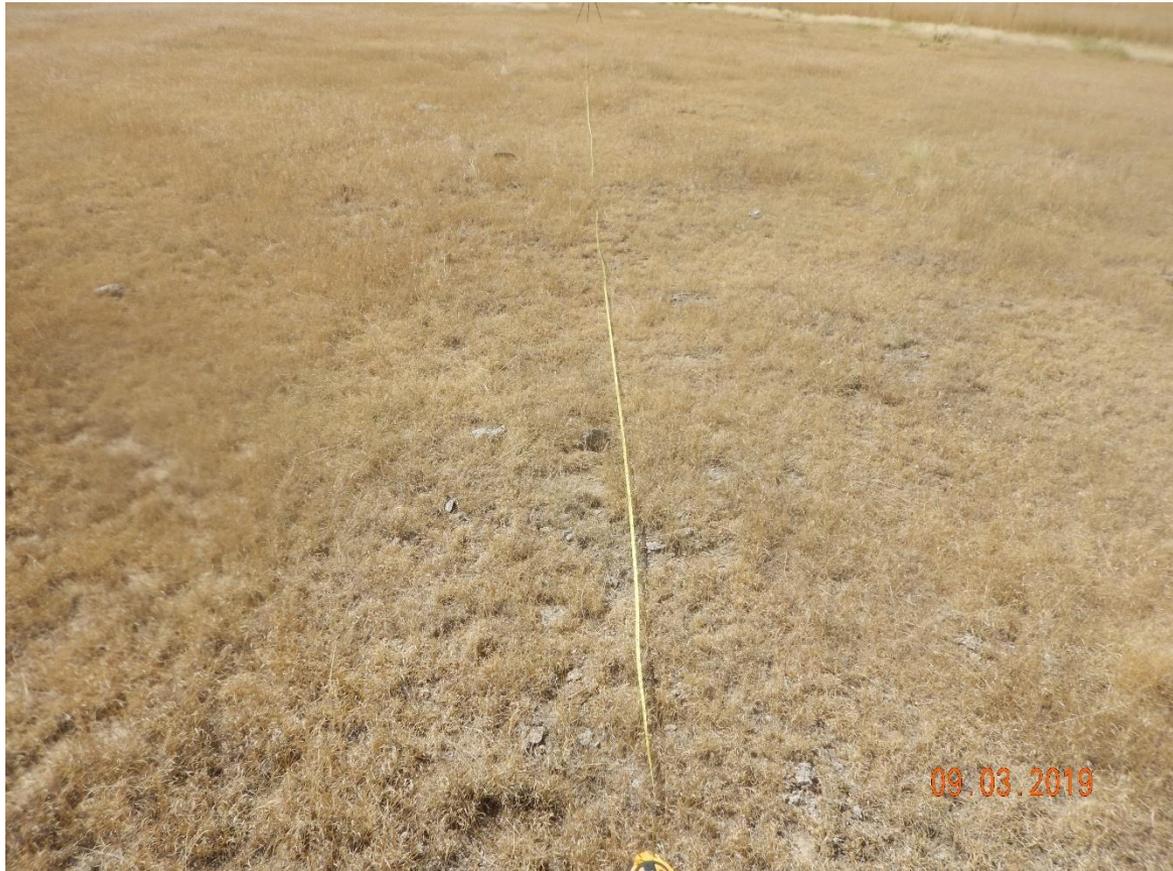
**Photo 10:** Photo taken from the adjacent reference area, facing west. Photo shows the end point for the **reference area** transect. Photo shows vegetation over the reference area.

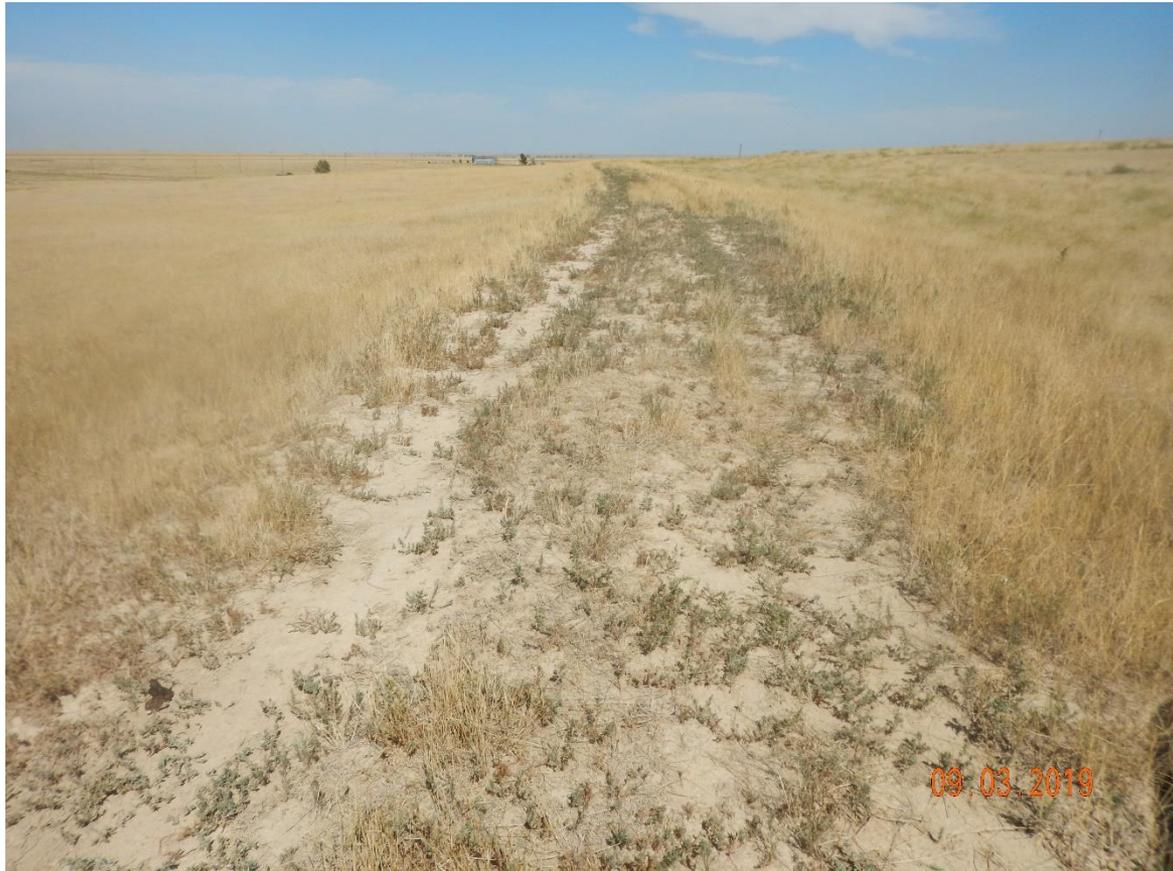
**Photo 11:** Photo taken from the access road, facing east. Photo shows large sections of the access road remains bare and exposed soil.
