Location Name: Foundation Energy Management – Sooner Unit - Pit ID 112069
Inspection Date: 08/28/2019

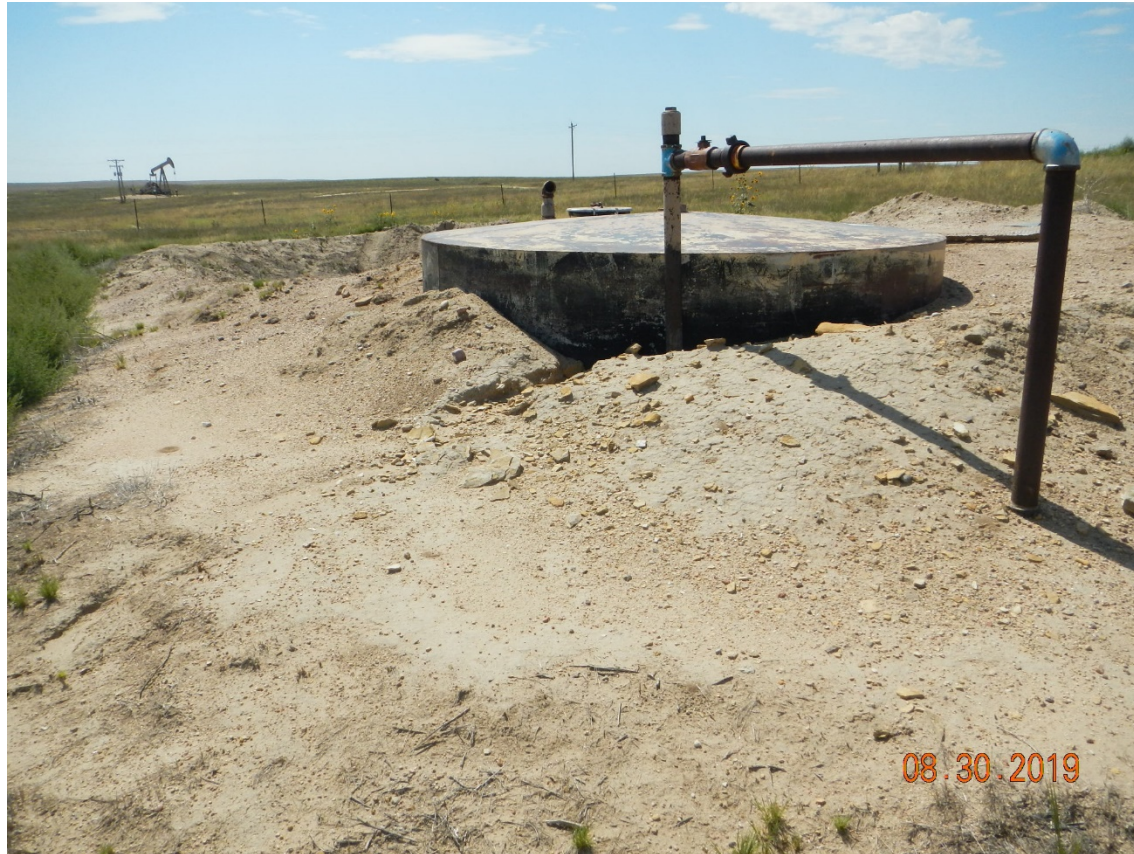
Photo # 1 – Partially buried oil slim tank with inadequate secondary containment on north side of Pit ID 112069

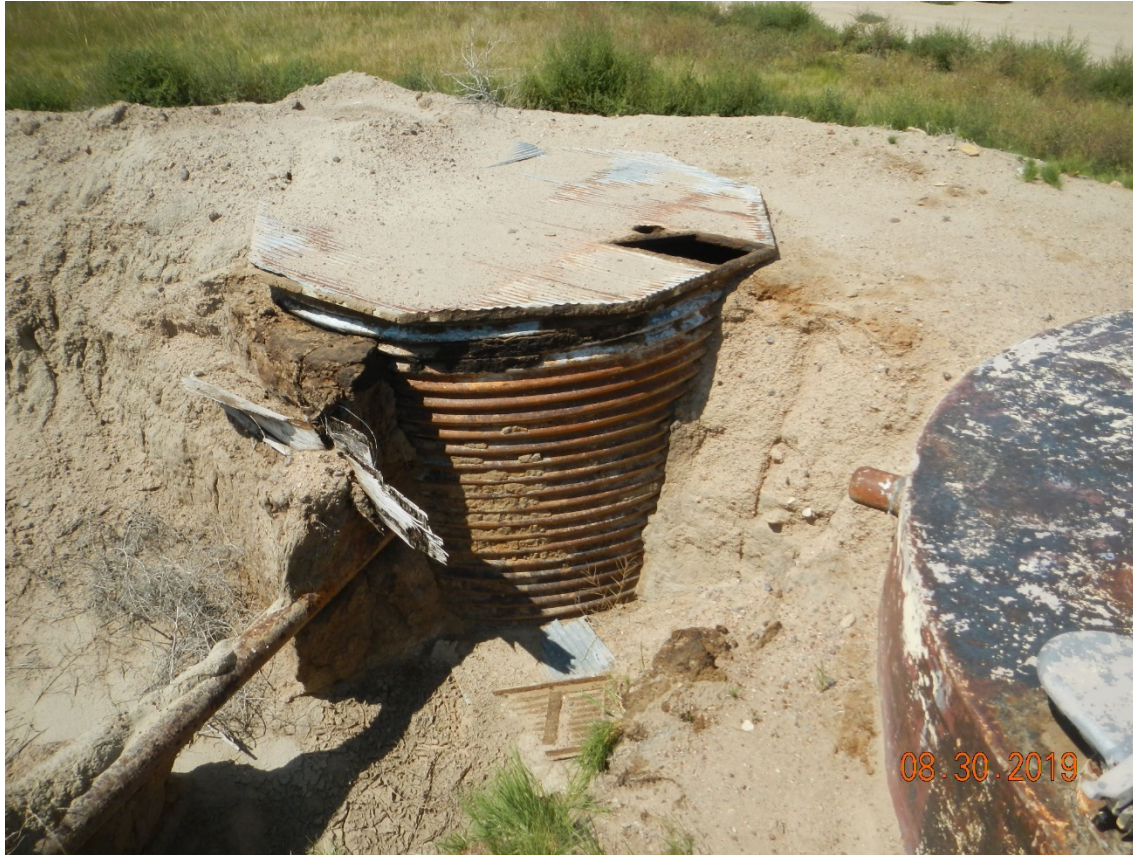
Photo # 2 – Culvert (tin horn) requiring closure under an approved eForm 27.

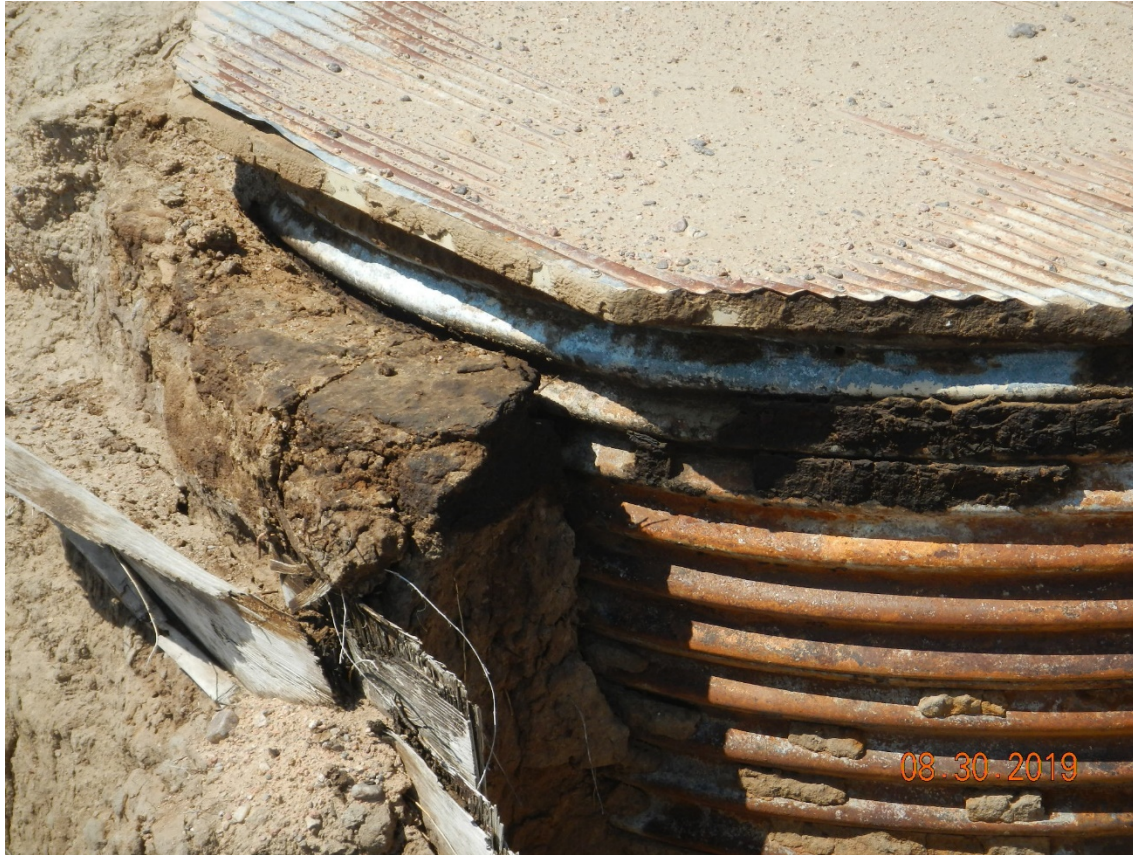
Photo # 3 – Petroleum impacted soil near culvert (tinhorn) requiring closure under an approved eForm 27.

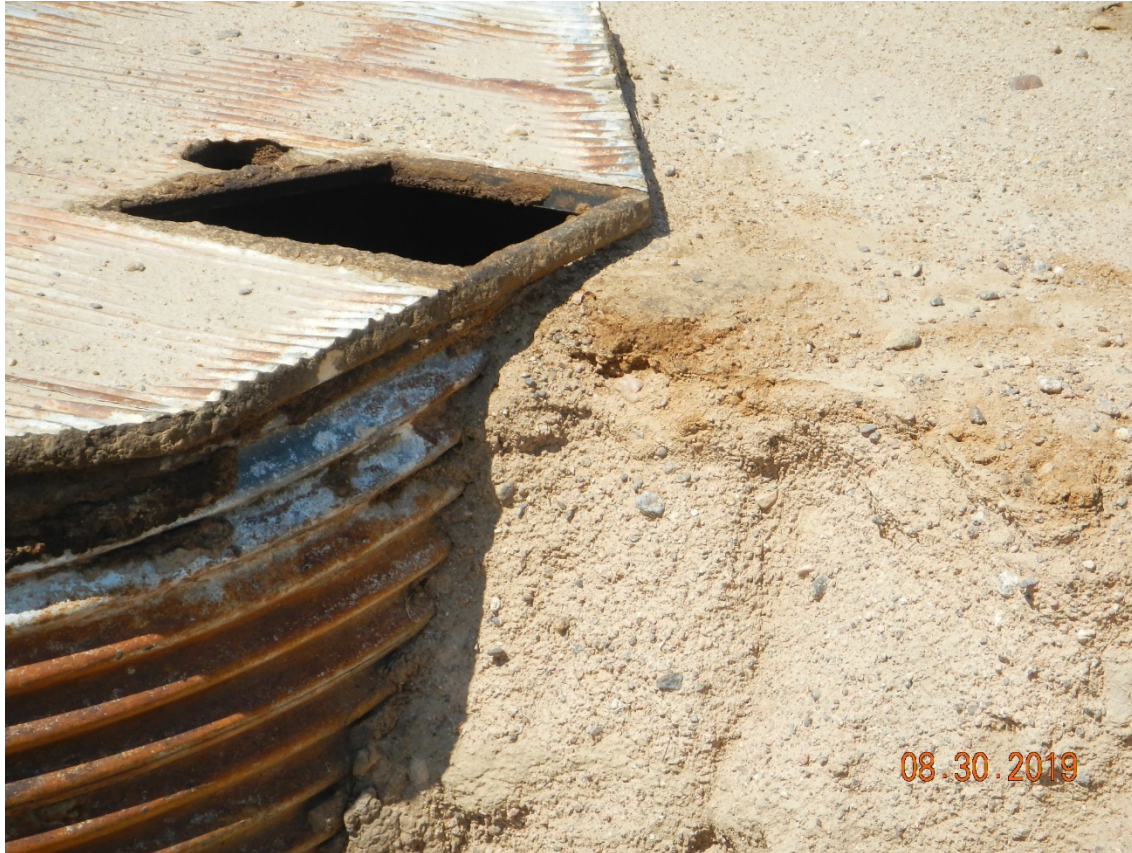
Photo # 4 – Petroleum impacted soil near culvert (tin horn) requiring closure under an approved eForm 27.
