Inspection Photos
Location Name: Jacobucci 23-32
Location ID: 333139

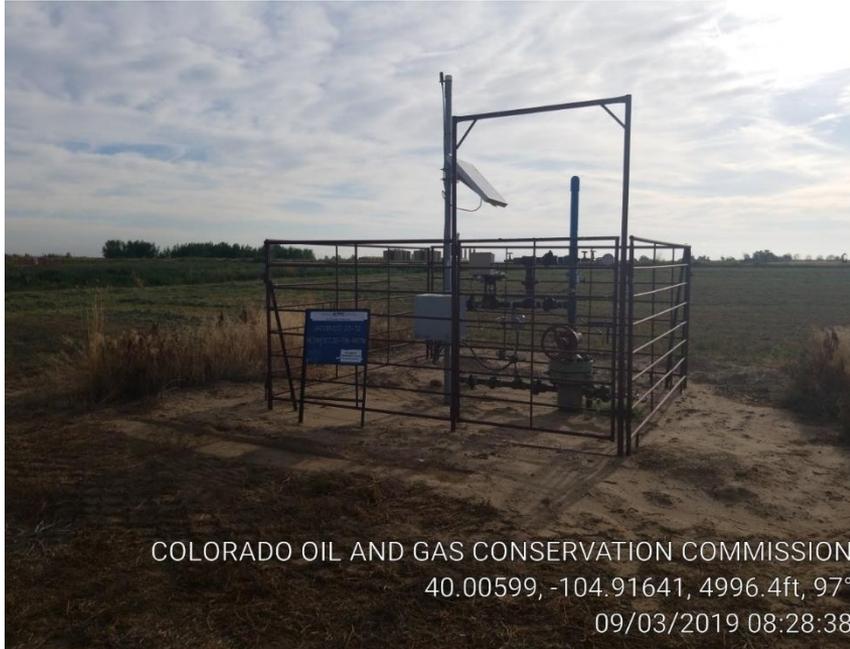
Pic 1 wrong operator number, and name

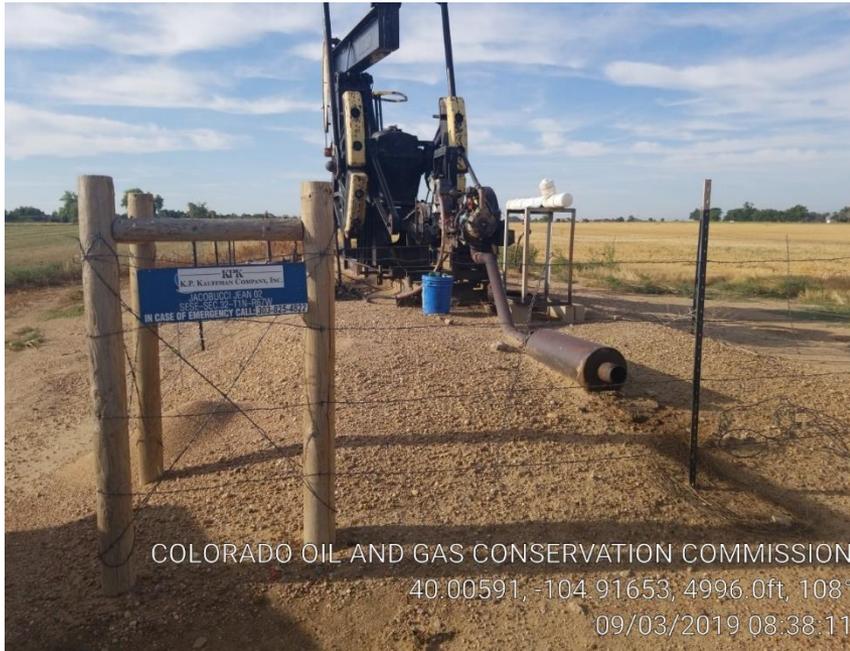
Pic 3 wrong operator and number, stained soil near muffler, blue bucket not in containment/trash

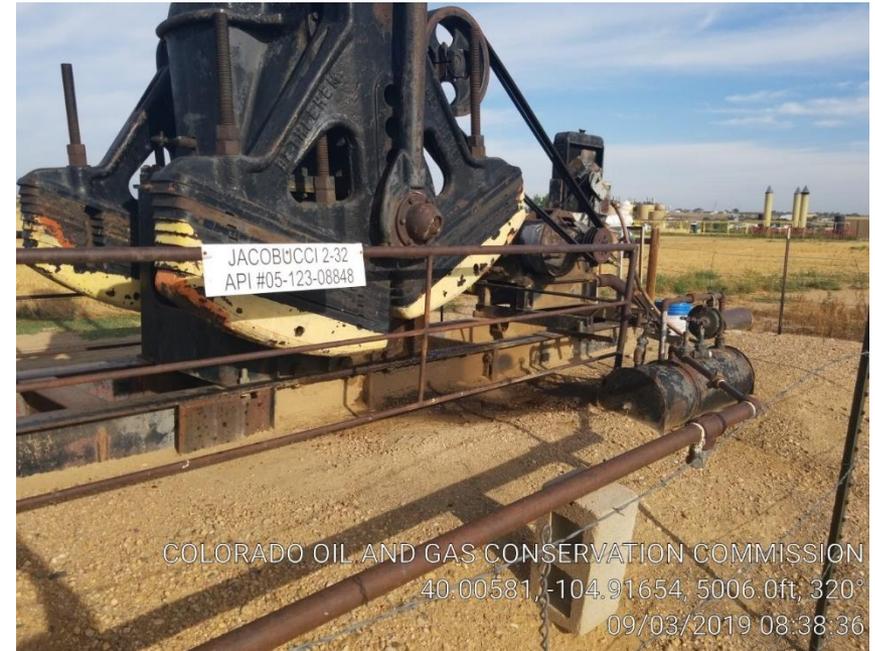
Pic 4 stained sil by pumping unit motor, and below counterweight.
