**Inspection Photos**  
**Location Name: Marvin E Schutt Unit #1**  
**Location ID: 318480**

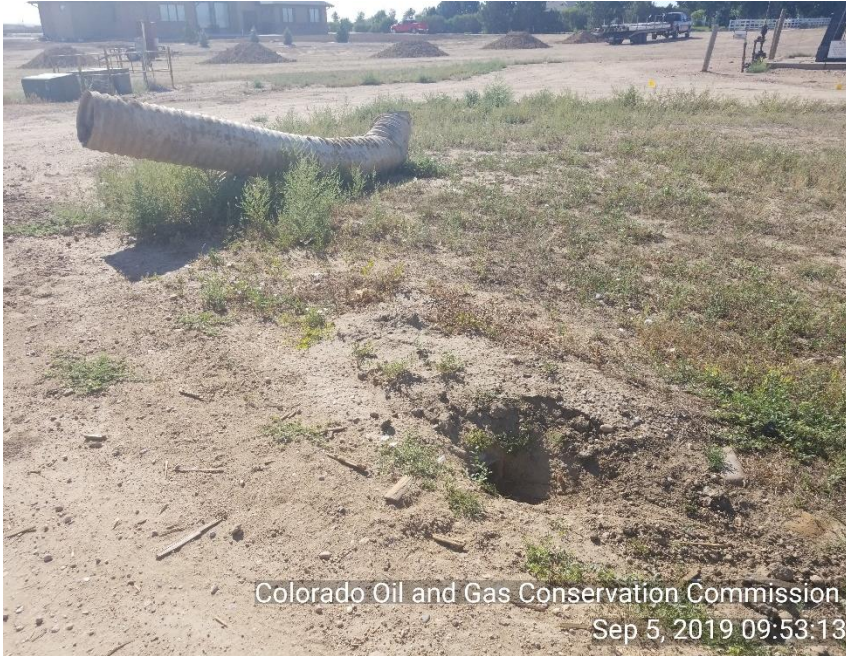
**Photo 1 Culvert to access road to location inlet appears to be plugged and ditch not maintained to culvert. Part of culvert has been removed.**

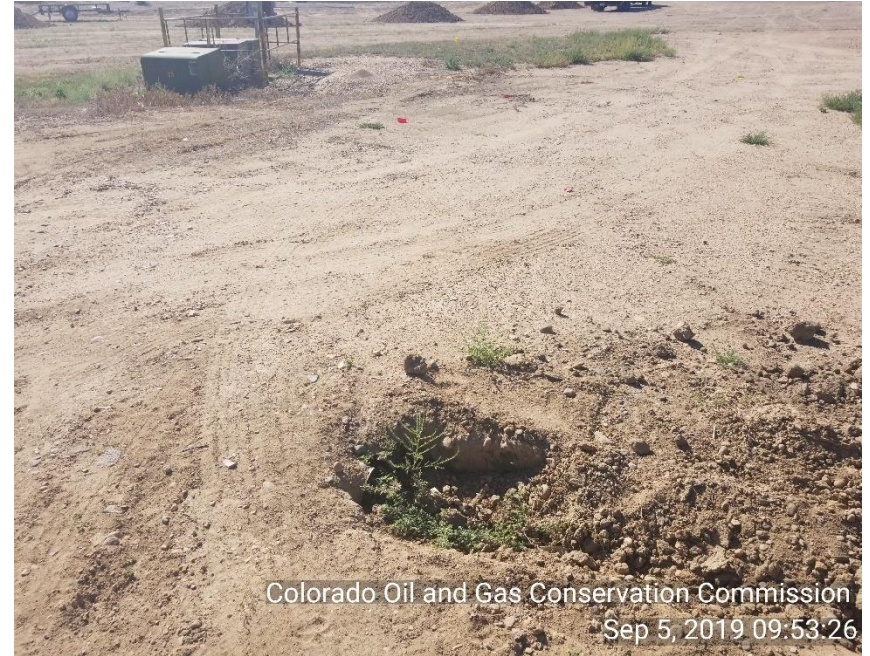
**Photo 2 middle of culvert had been damaged prior to part of culvert being removed clearly see weeds growing in culvert.**

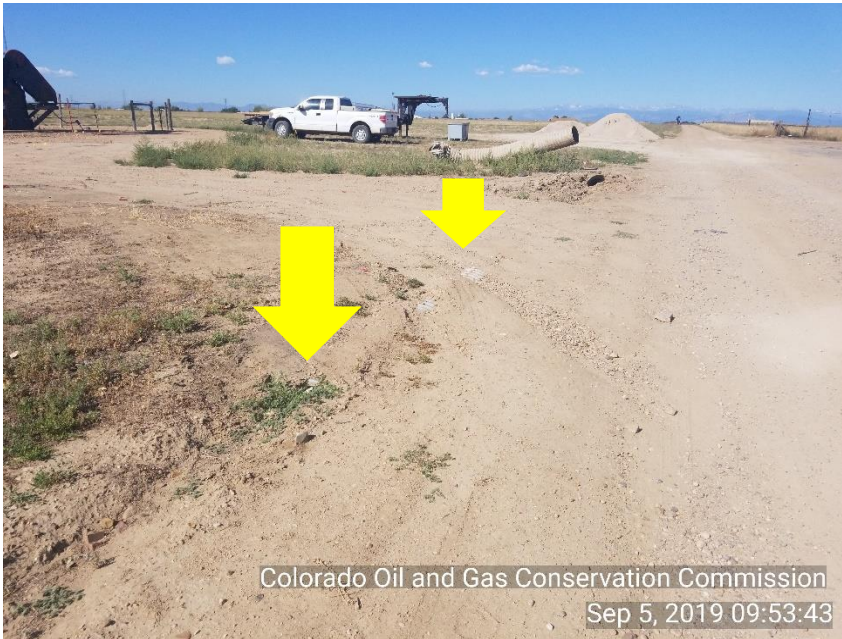
**Photo 3 Culvert to access road to location outlet is plugged and exposed culvert not properly covered.**

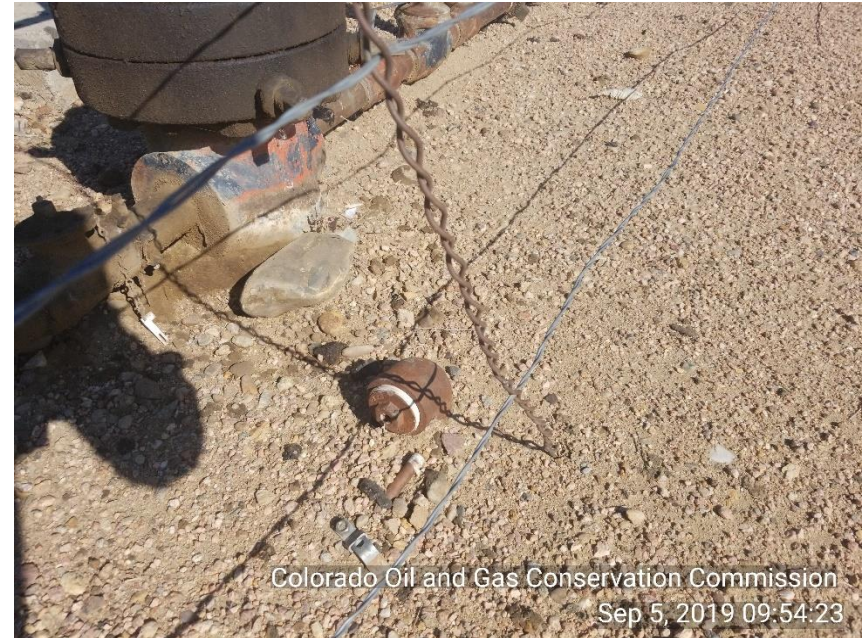
**Photo 4 What appears to be the Braden head piping Mechanical issue: 1/4 inch line has been removed and is laying on ground.**

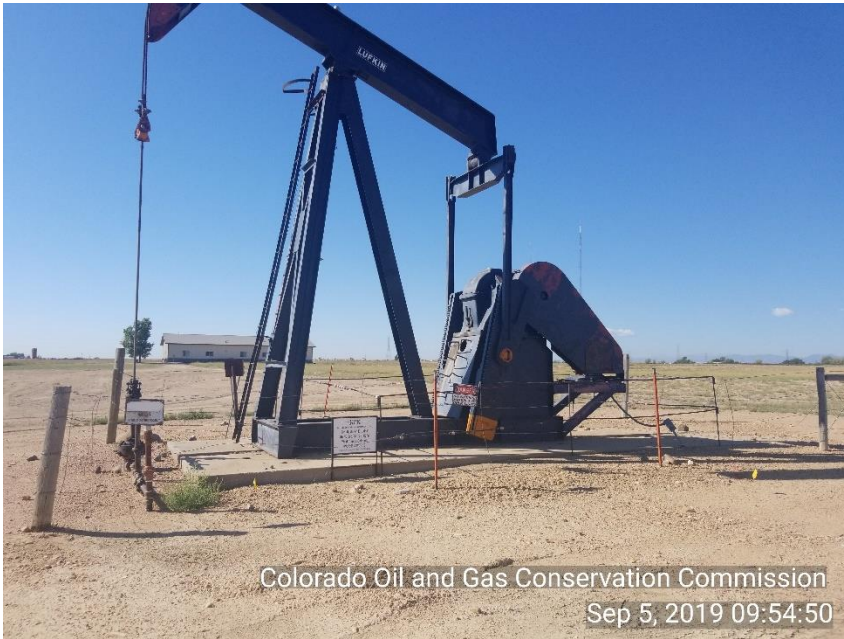
**Photo 5 PU and WH sign**

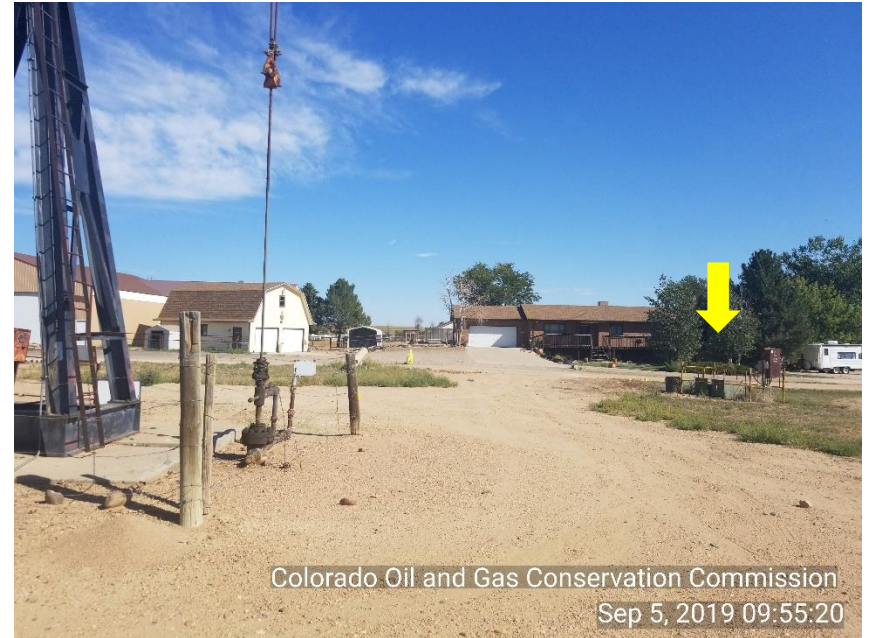
**Photo 6 WH is approx. 90 ft from resident to the North and approx. 45ft from electric panel. Debris: dead weeds around electric panel.**

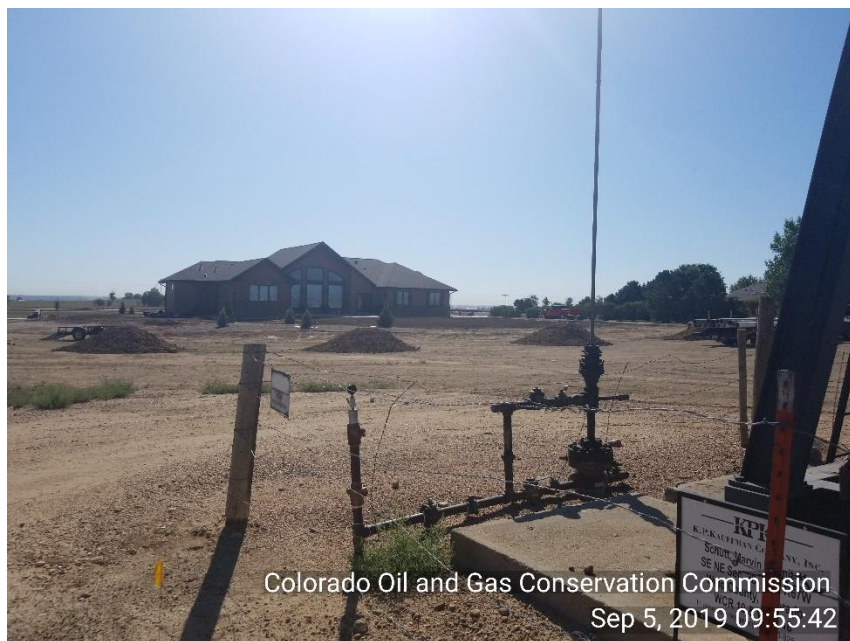
**Photo 7 WH is approx.. 115ft from resident to the east.**

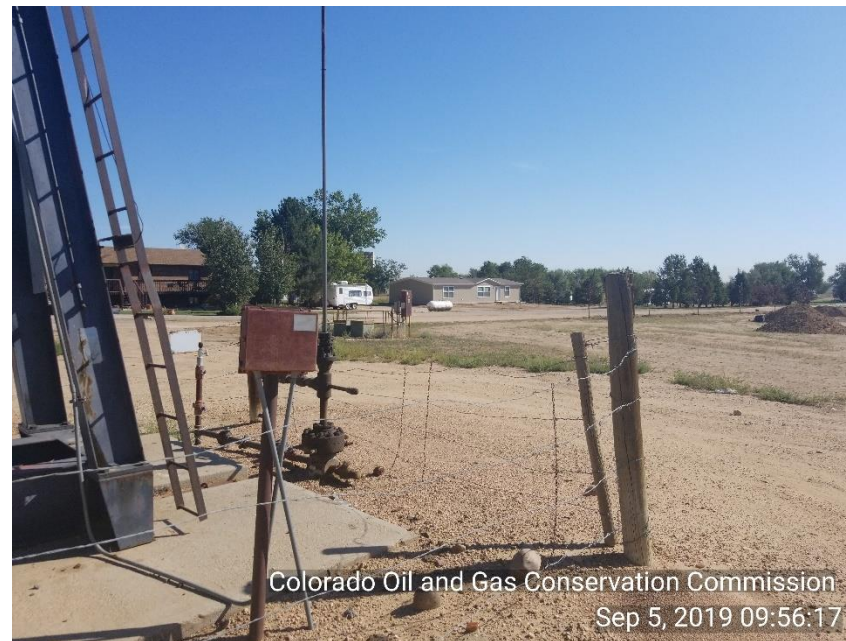
**Photo 8 WH is approx.. 200ft from resident to the North east.**

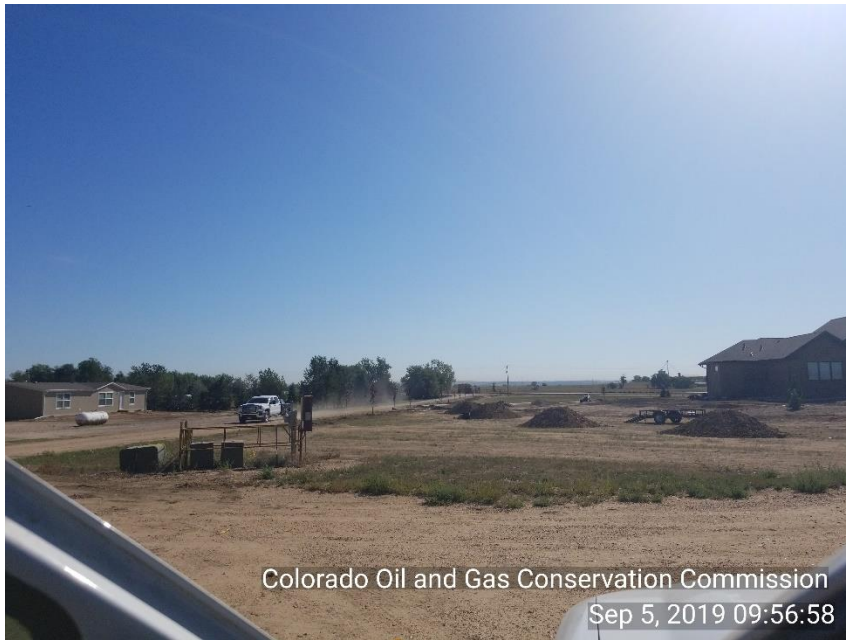
**Photo 9 Access road to location.**

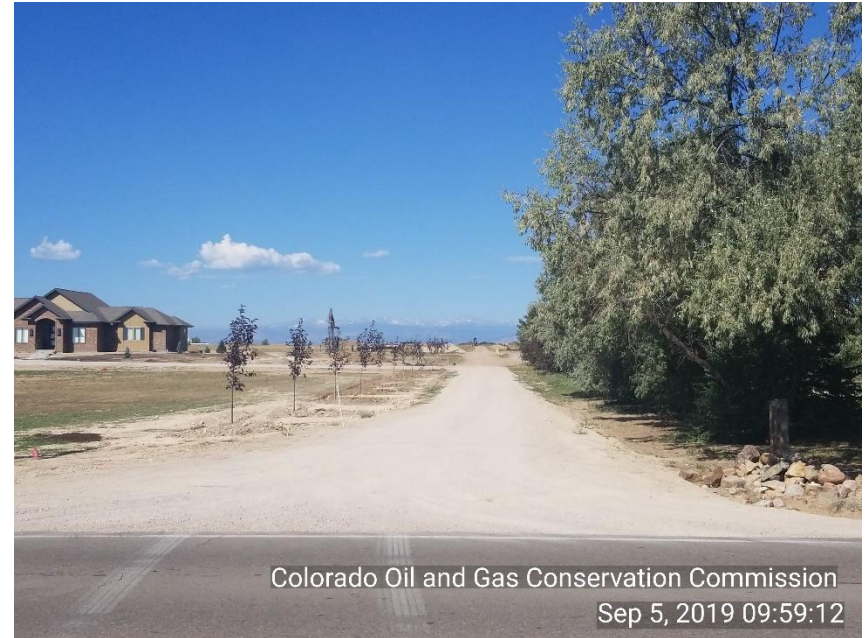
**Photo 10 Access road from county road to location.**
