COGCC Inspection Photos 08/29/2019 & 9/3-4/2019

Location: Held 12-1418 Off Location Flowline

Well API 123-18653

Spill ID # 467174

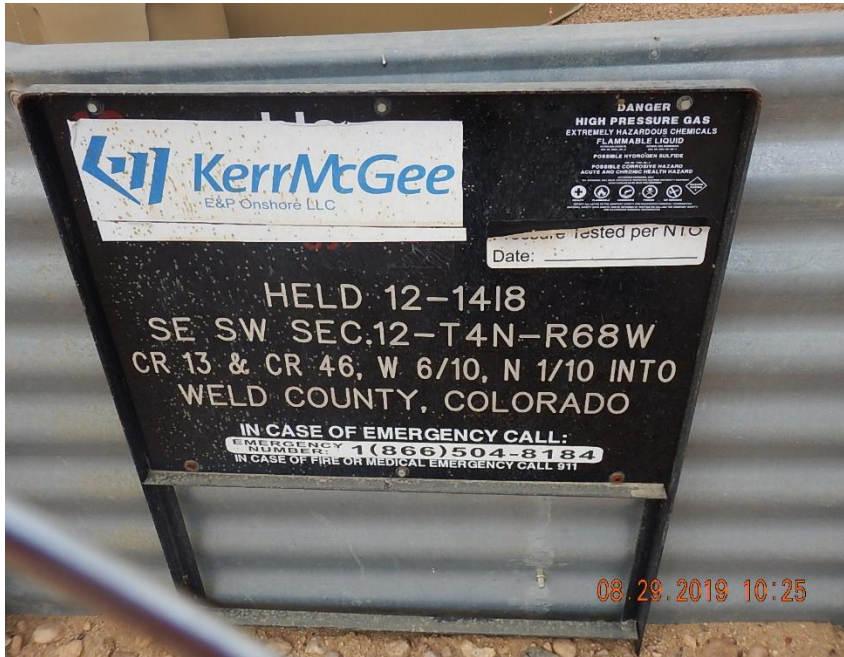
Signage at tank battery.

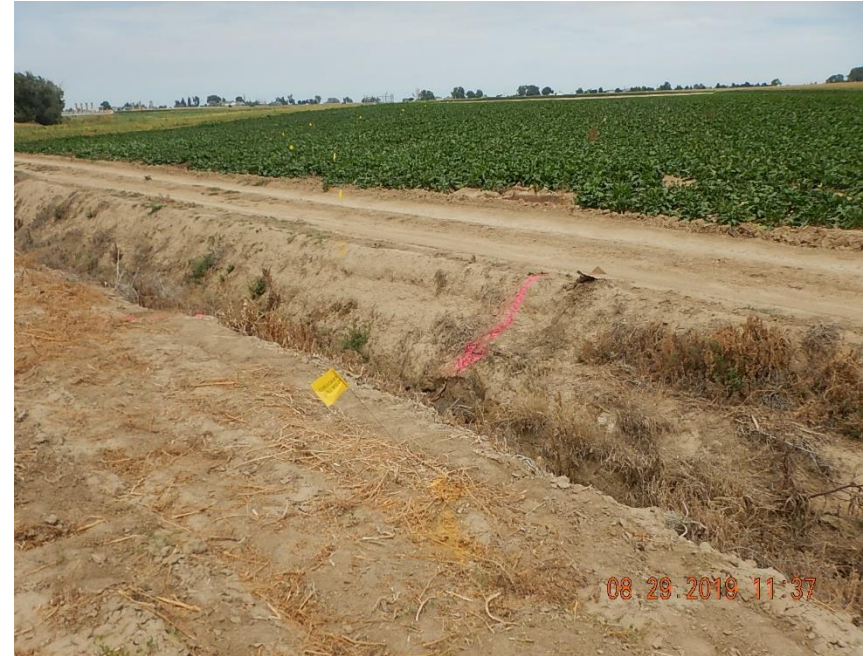
View release point marked at irrigation ditch; off location flowline marked with pin flags. View NW toward wellhead.

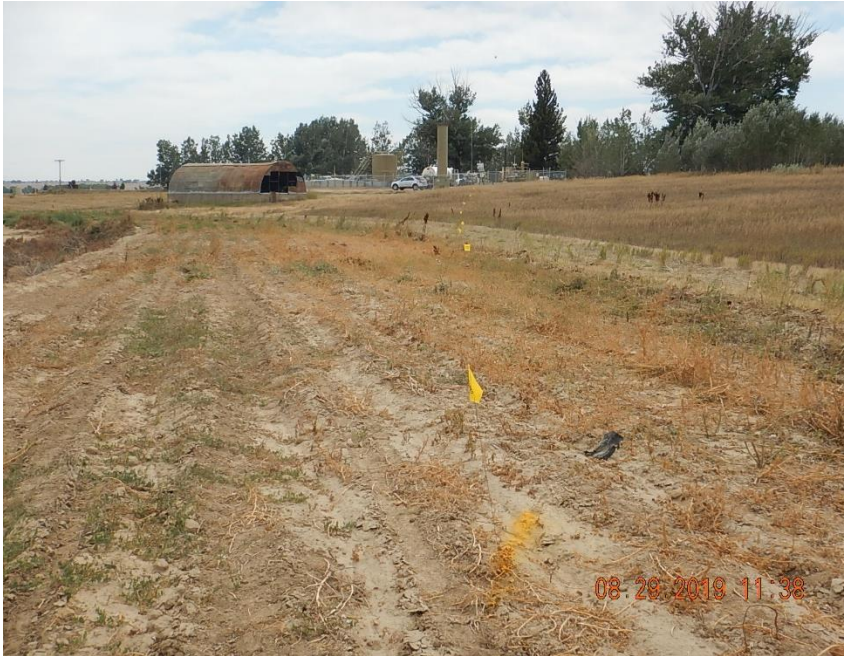
Off location flowline marked with pin flags; View SE toward battery from spill point at irrigation ditch.

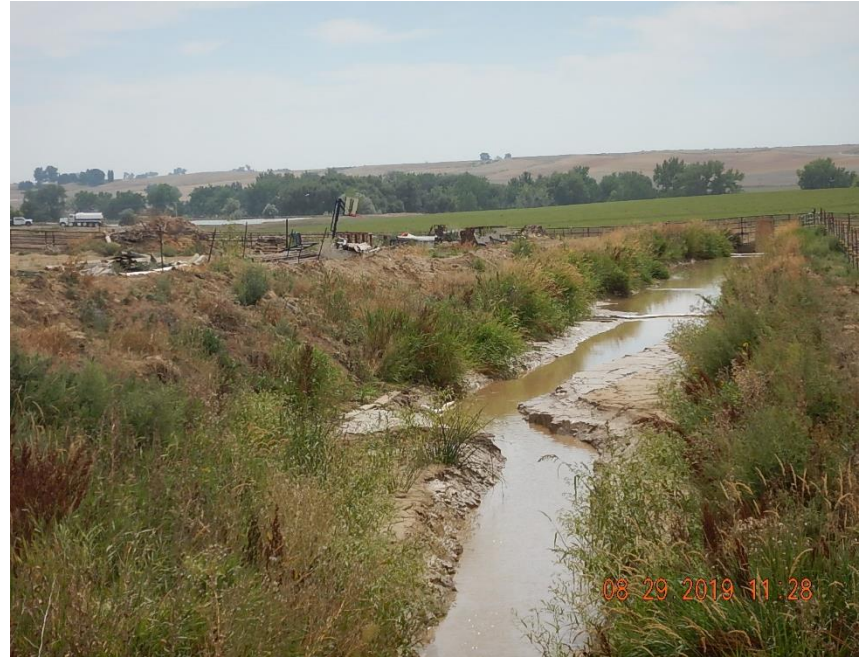
Impacted irrigation ditch from spill; booms deployed. View South from WCR 46.

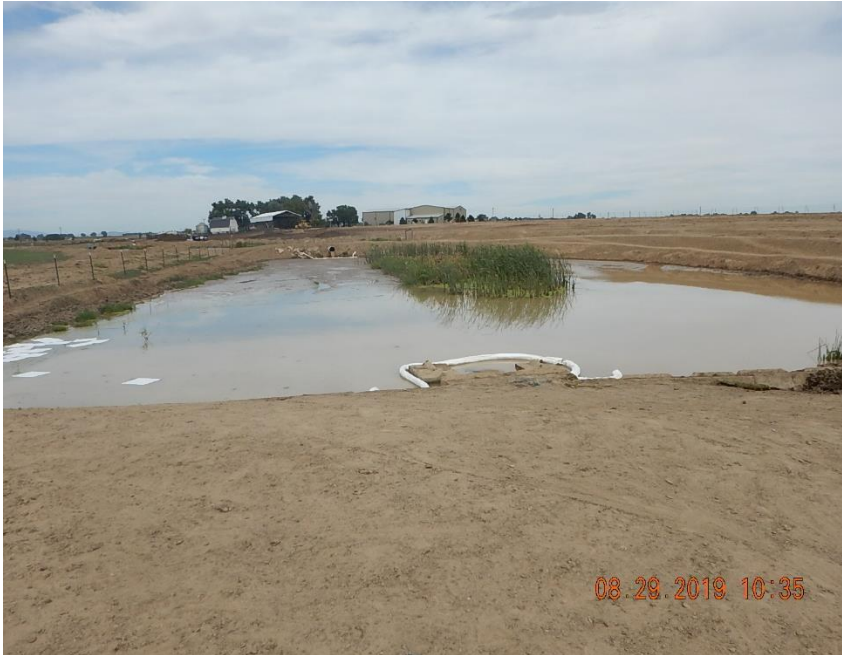
Impacted stock pond; booms deployed. View North toward WCR 46.

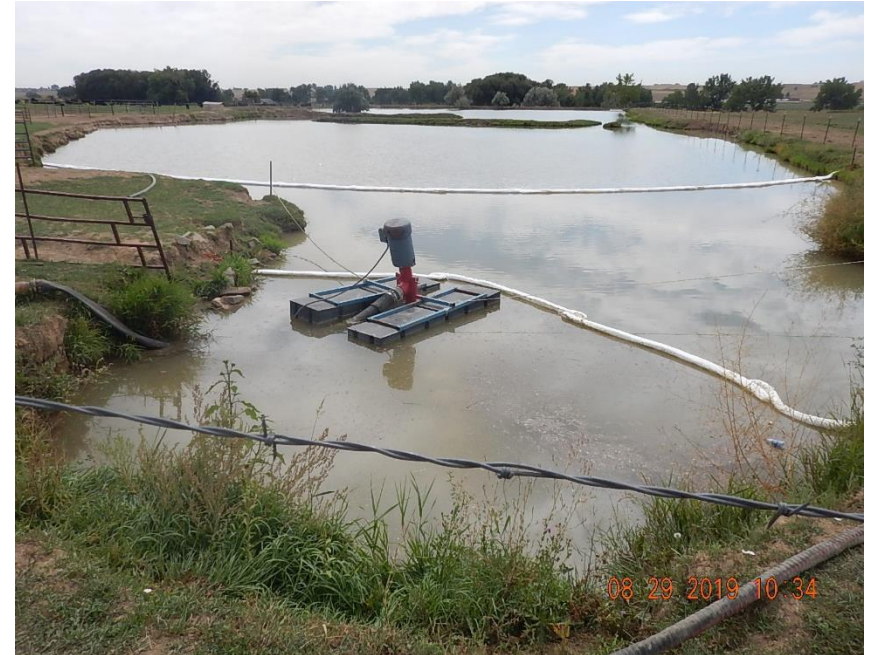
Spill response in progress; Impacted stock pond; booms deployed. View South toward Hillsboro Ditch.

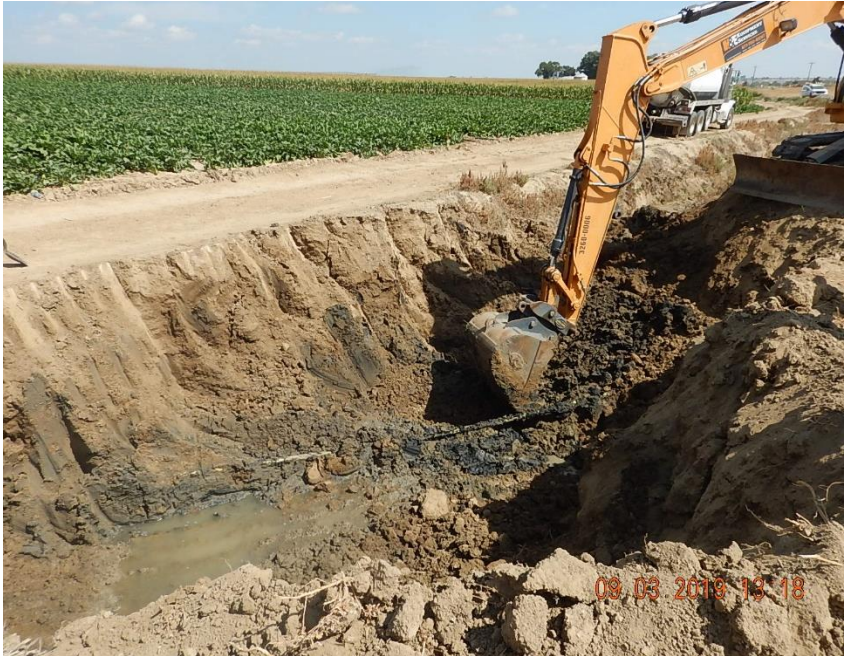
**Excavation at release point; flowline being exposed.
Impacted soils observed.**

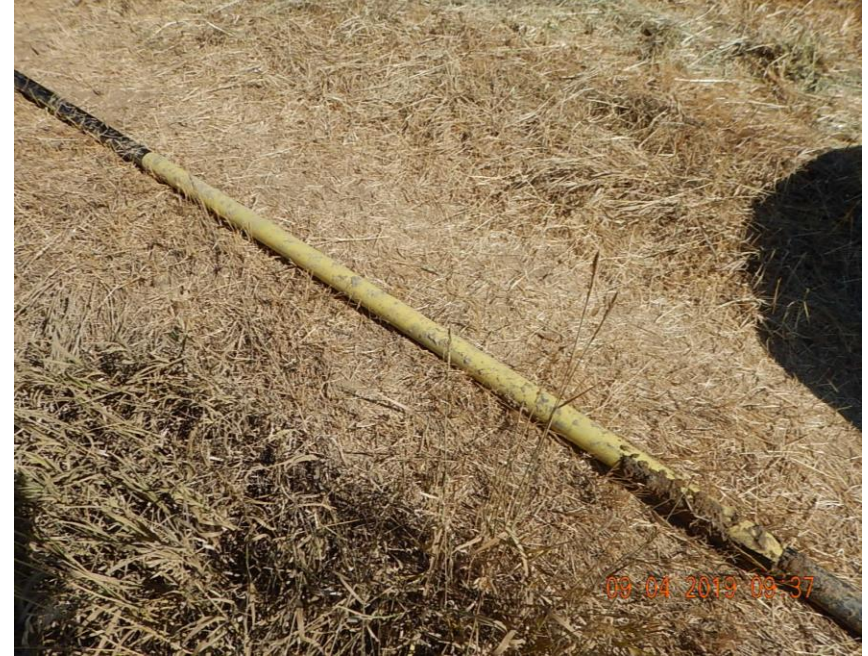
**Section of flowline removed (Yellow Jacket); Coating has
been stripped back to expose corrosion hole.**

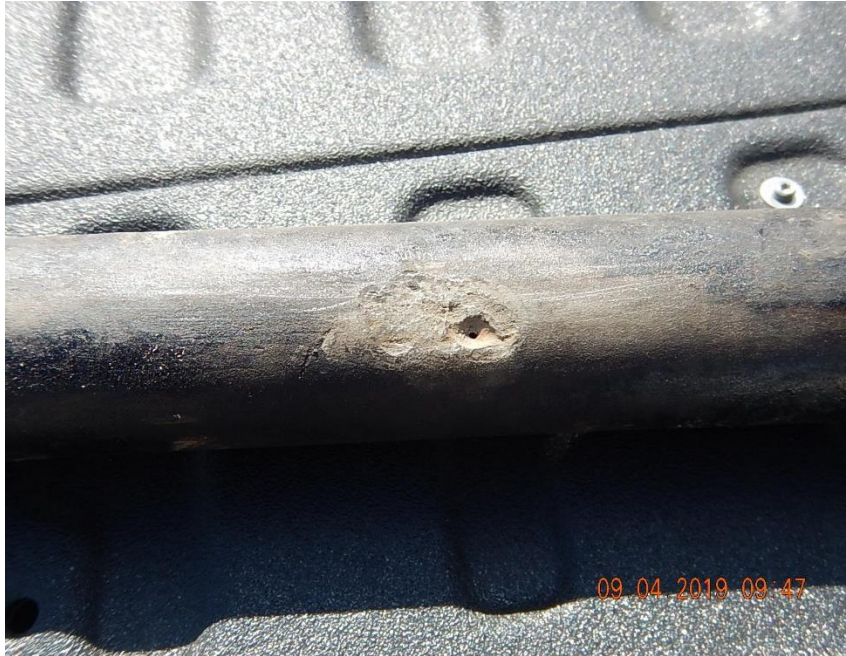
**Failure point identified; External corrosion hole found.
Coating has been removed.**

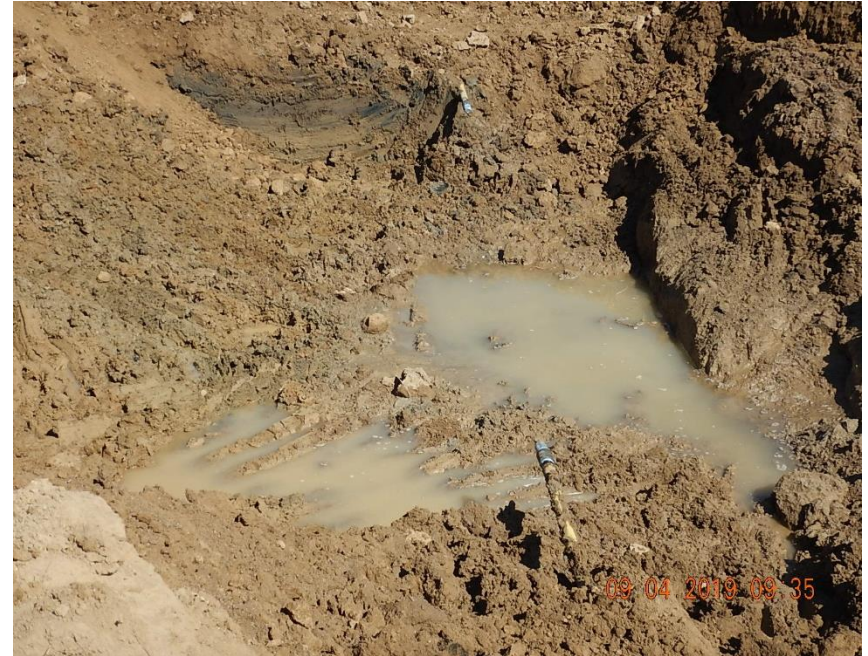
Cut ends of flowline in excavation threaded and bull plugged. Flowline is scheduled to be removed/ replaced.
