Inspection Photos
Location Name: Eagle Hill 1-32
Location ID: 466705

COLORADO
Oil & Gas Conservation
Commission
Department of Natural Resources

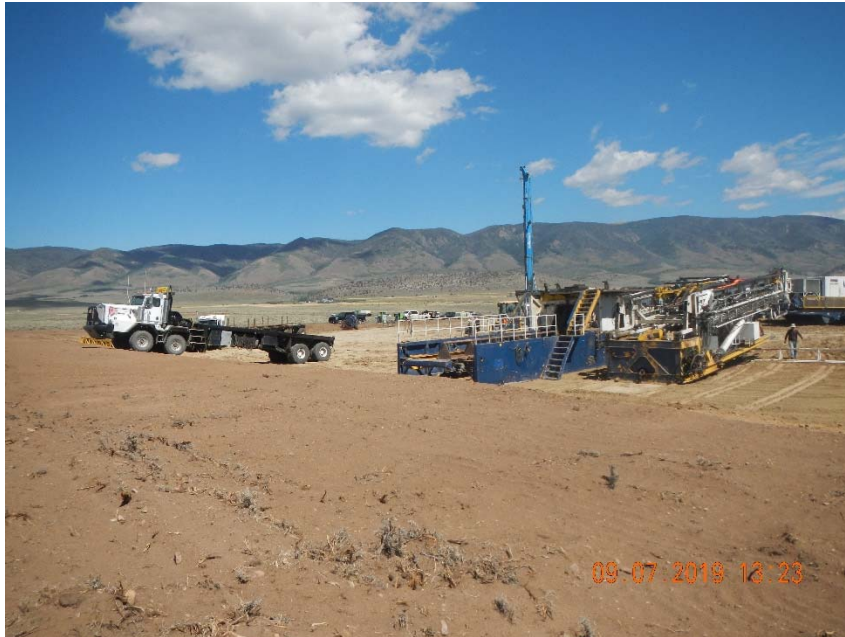
Photo 1. Overview of location with conductor rig and main rig on location. Photo facing east.

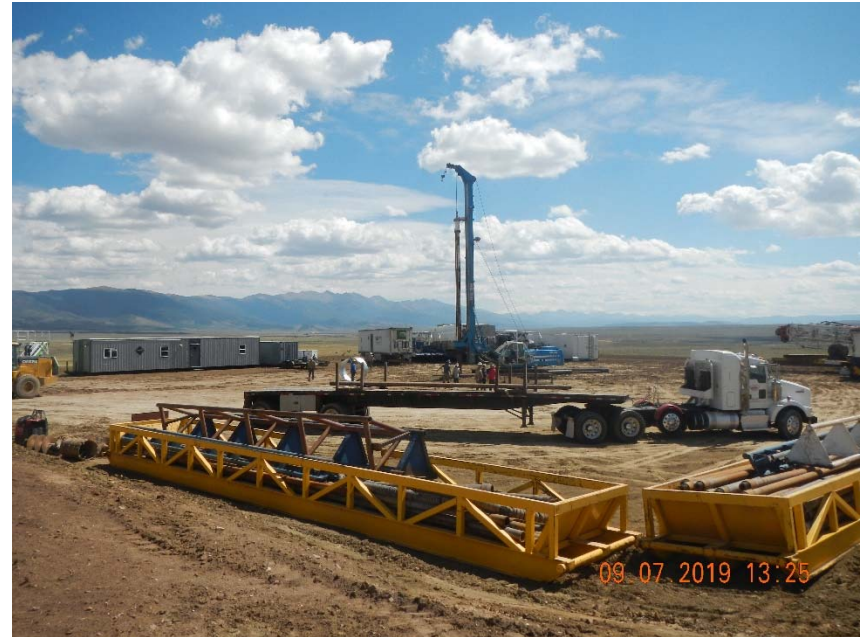
Photo 2. Overview of location facing southeast.

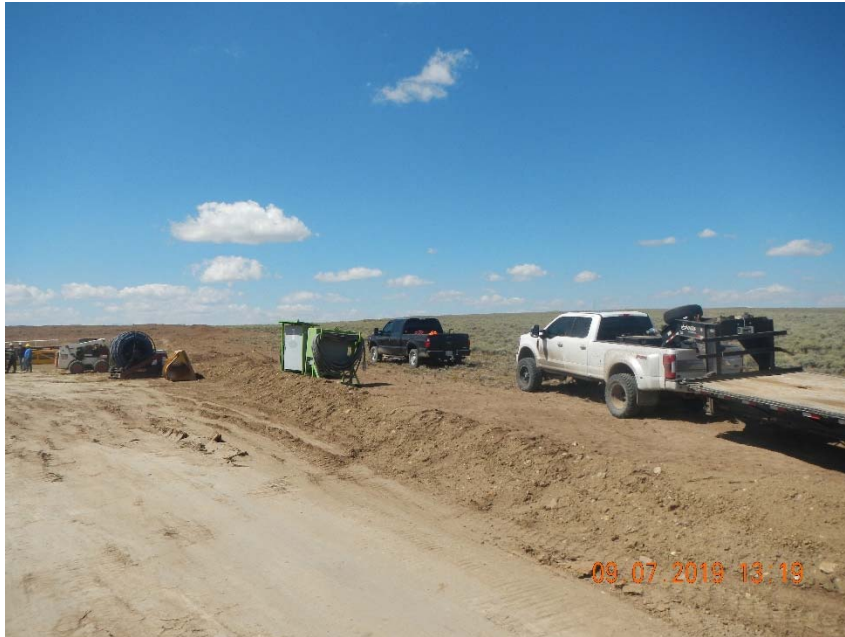
Photo 3. Surface disturbance increase, trucks driving/parking on side of location.

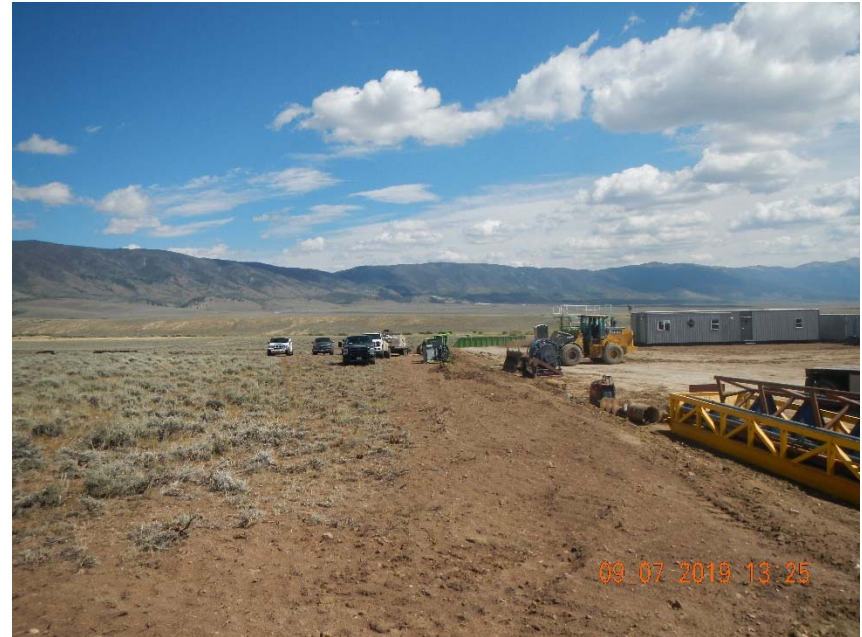
Photo 4. Surface disturbance increase, vehicles parked on side of location.

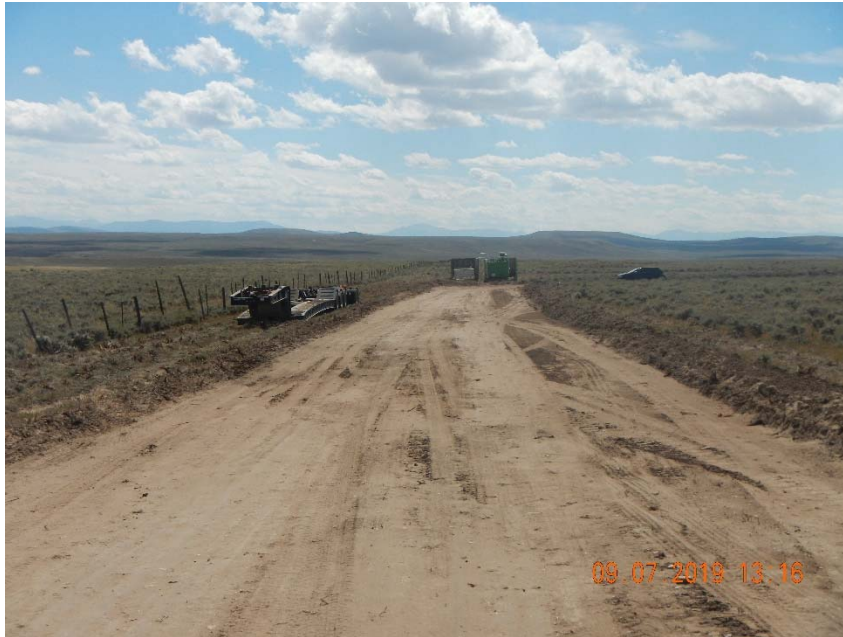
Photo 5. Surface disturbance increase, trucks driving/parking on side of access road. Gravel added to access road, no stormwater controls on perimeter of road.

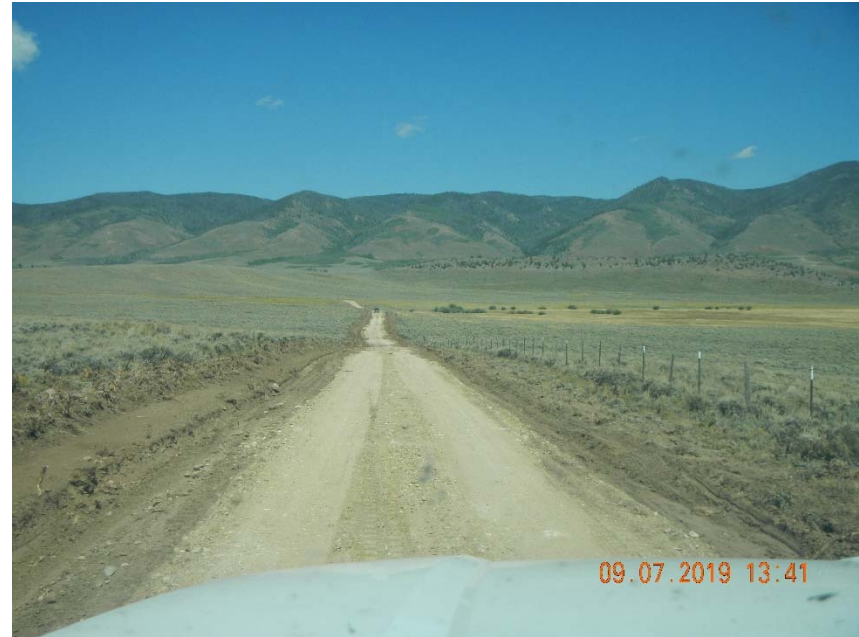
Photo 6. Gravel added to access road, no stormwater controls on perimeter of road.

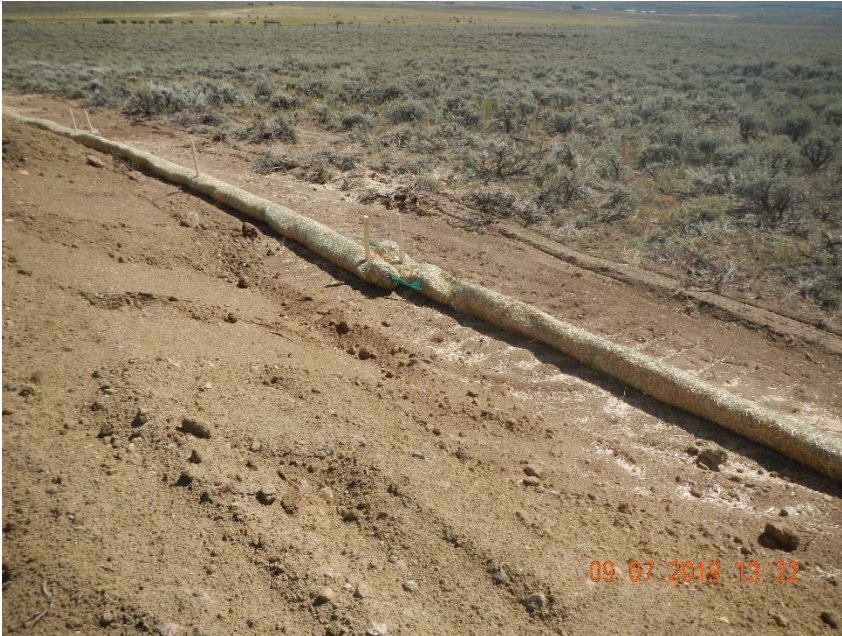
**Photo 7. Wattles installed on some of location perimeter.
Wattles not trenched.**

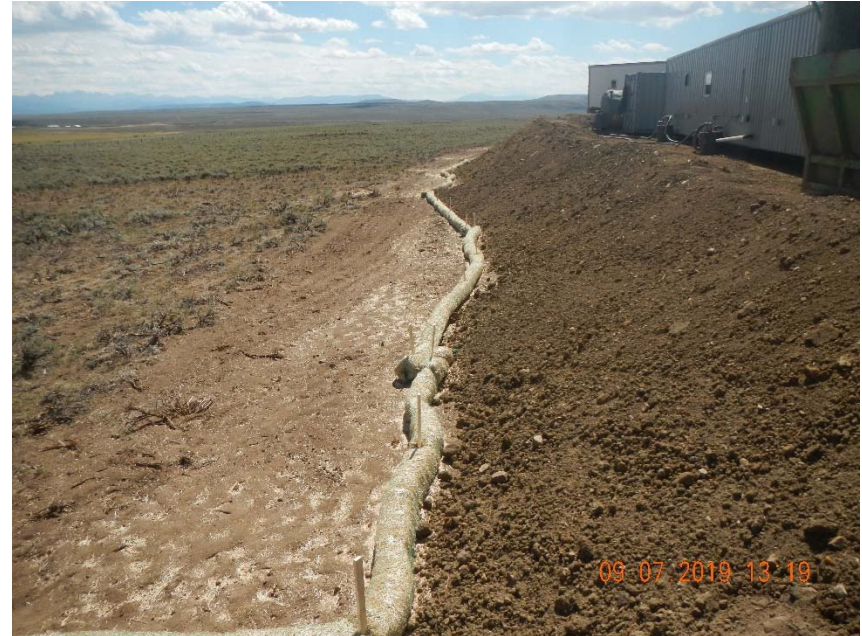
**Photo 8. Wattles installed on some of location perimeter.
Wattles not trenched.**

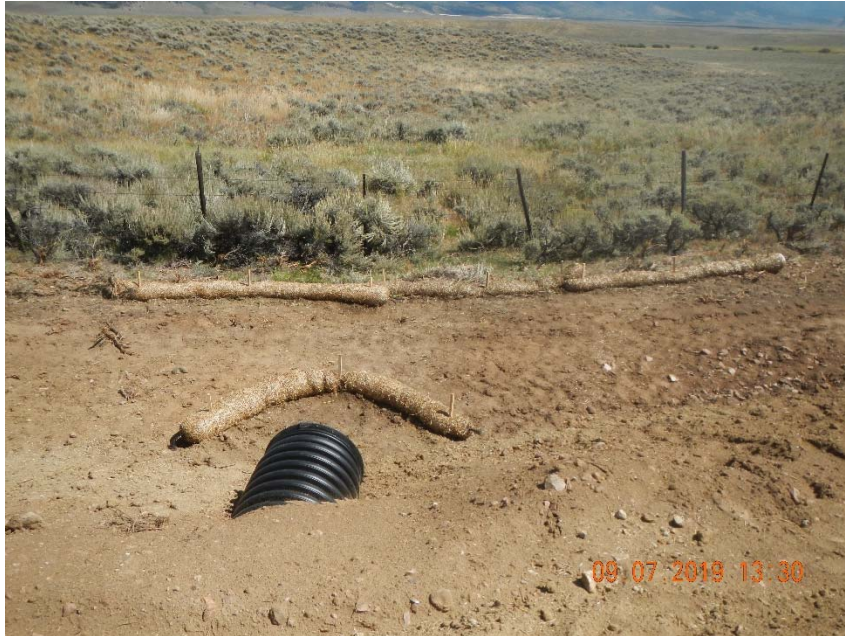
Photo 9. Wattles installed on east side of drainage crossing. Wattles not trenched. No other controls observed.

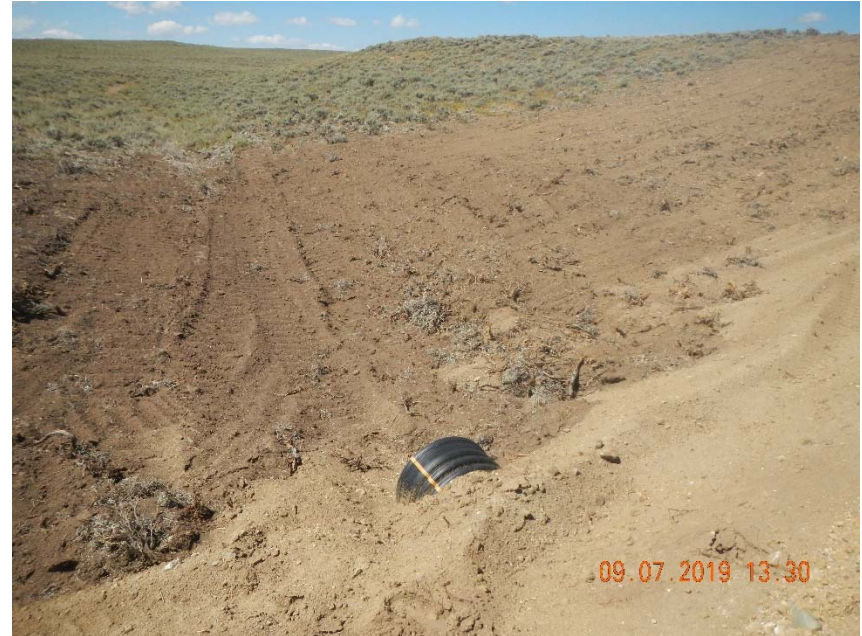
Photo 10. No stormwater controls observed on west, uphill, side of drainage crossing.
