Inspection Photos
Operator: Hilcorp Energy
Location/API #: 067-08128
Date: 8-29-2019

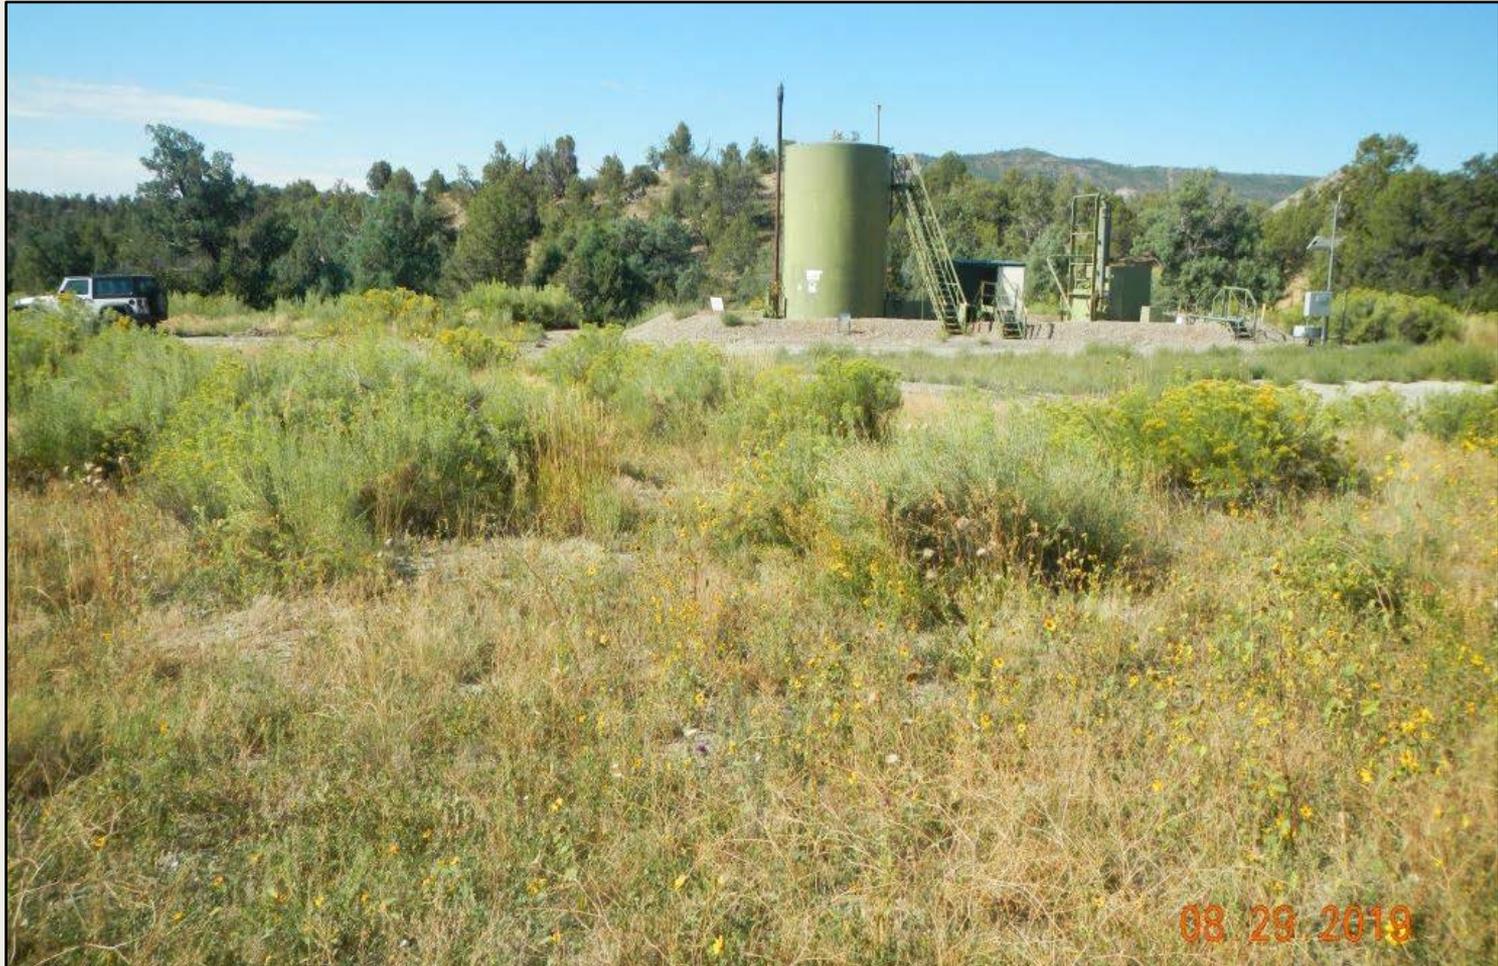
Photo 1. View of the project area from the northeastern corner facing center.

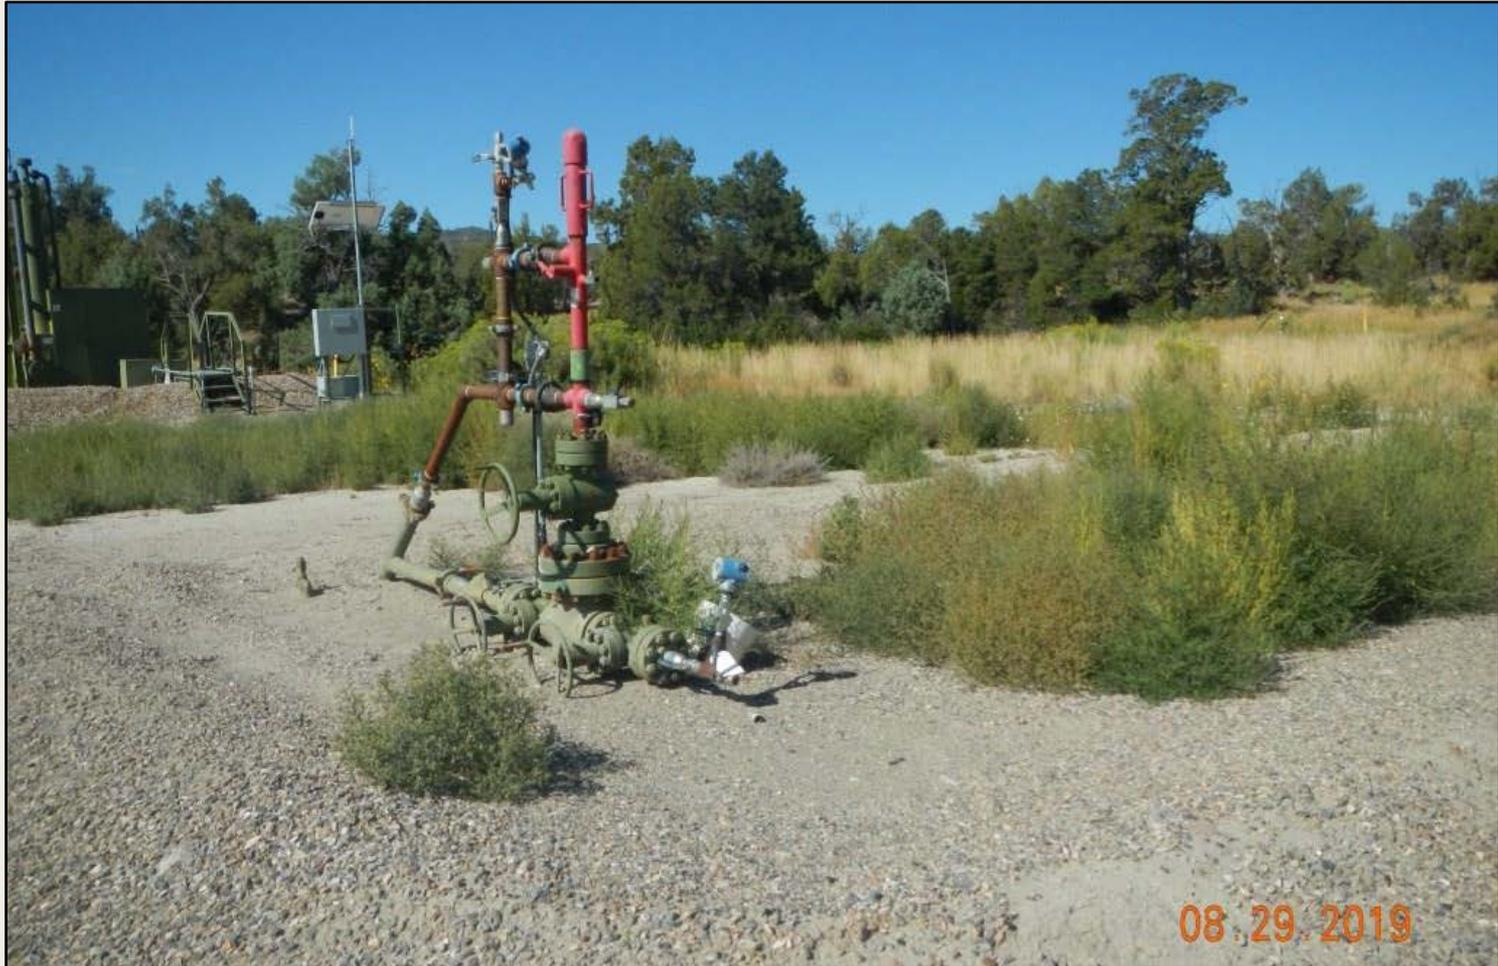
Photo 2. View of kochia weeds around wellhead.

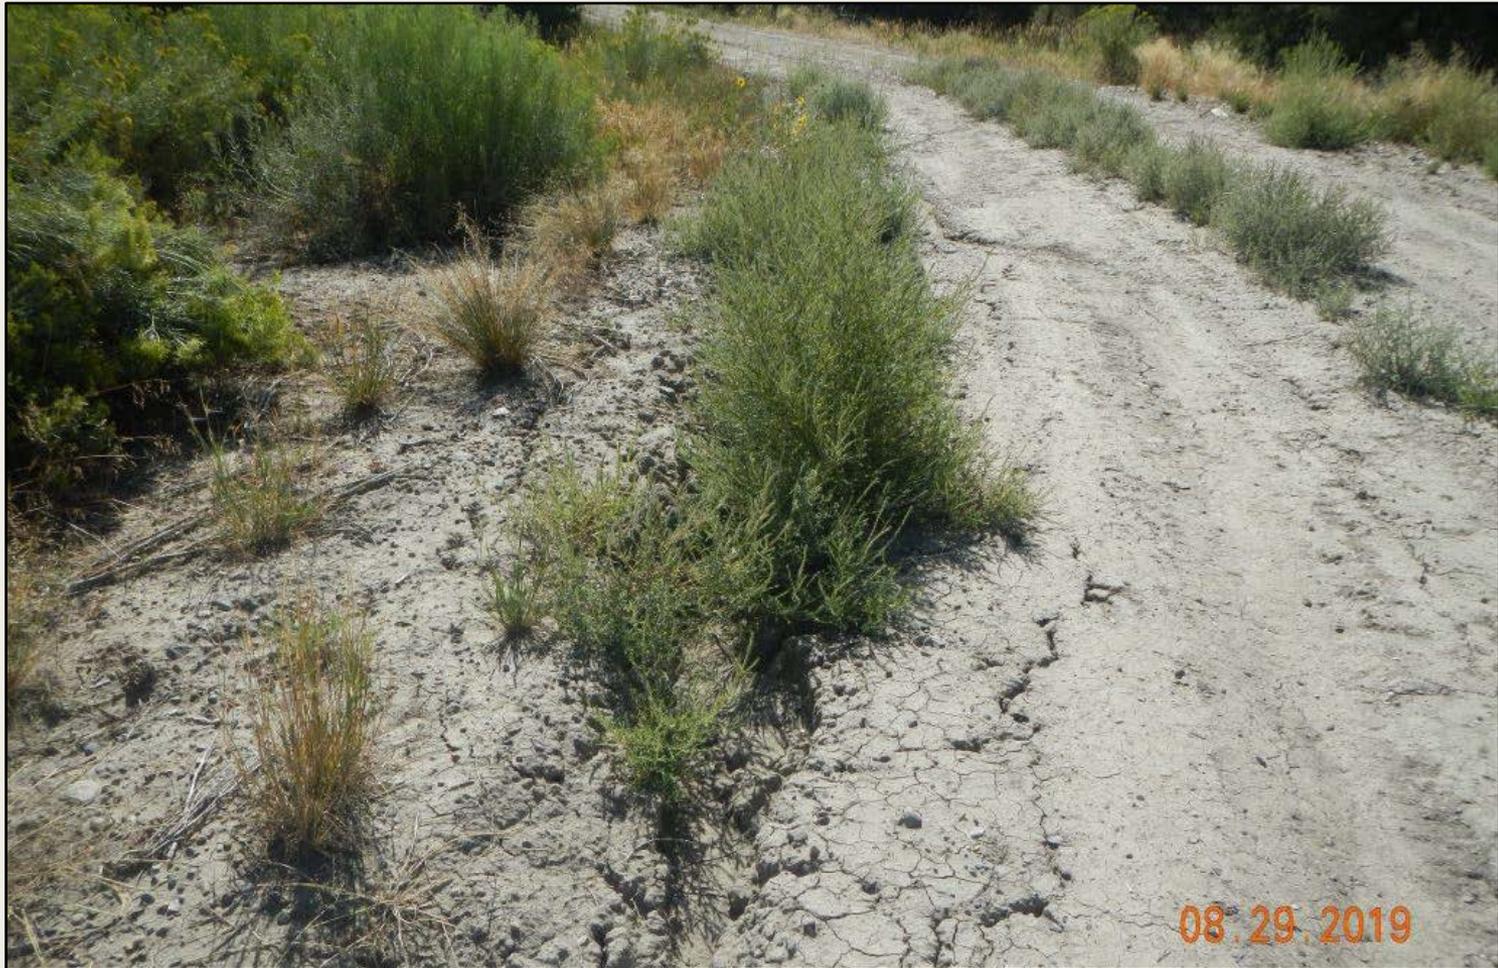
Photo 3. View of erosional channeling at the well pad entrance facing eastward.

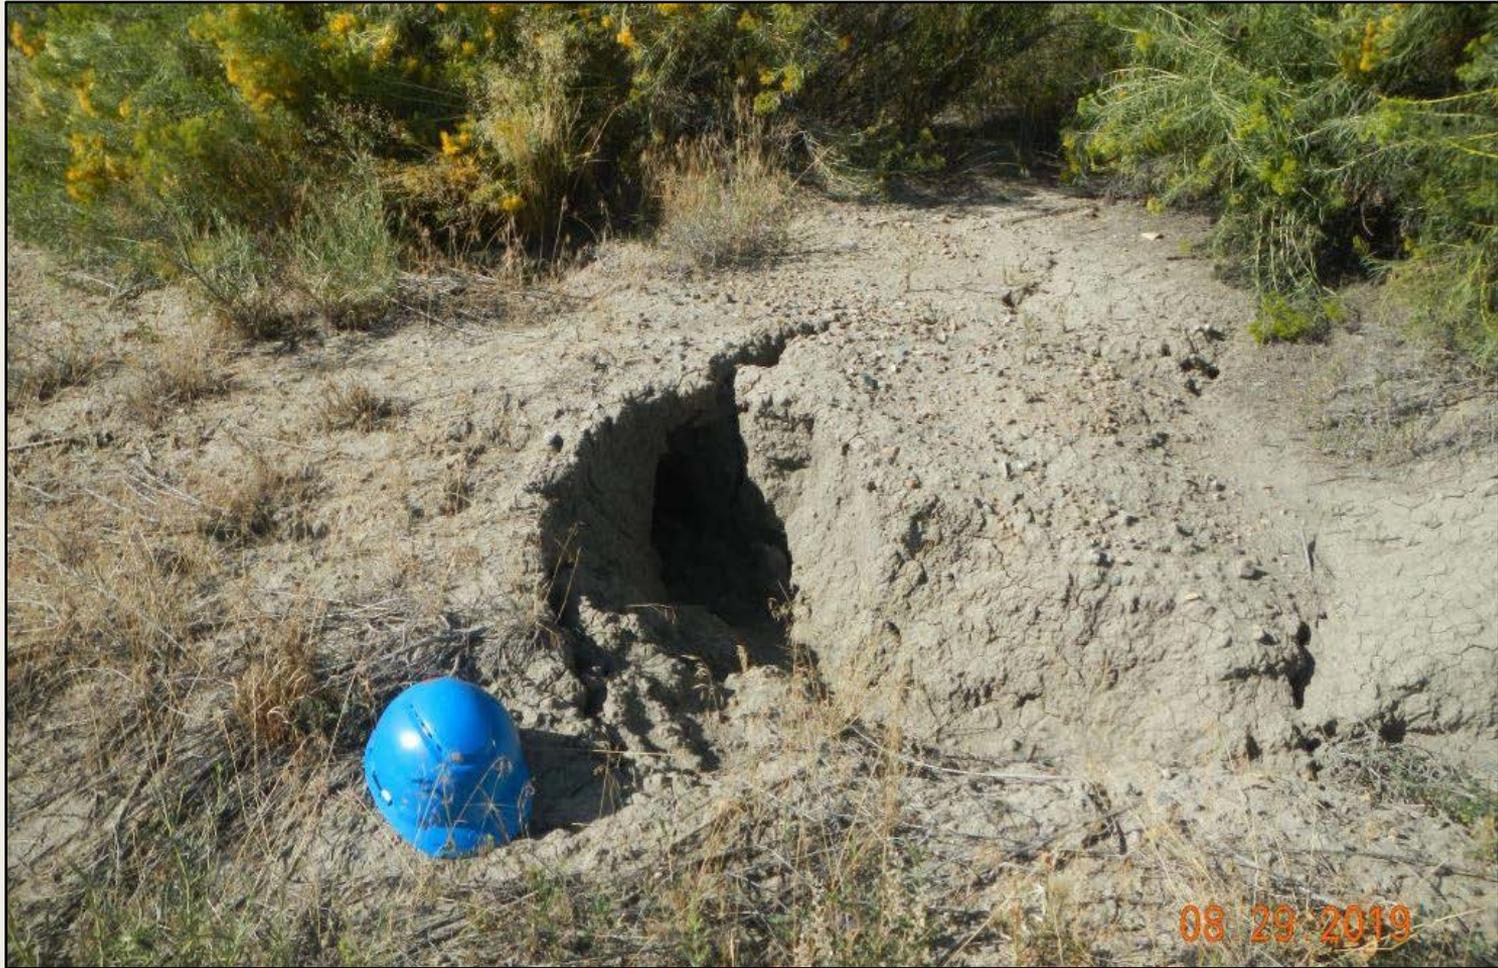
Photo 4. View of erosional tunnel within the southeastern fill slope.

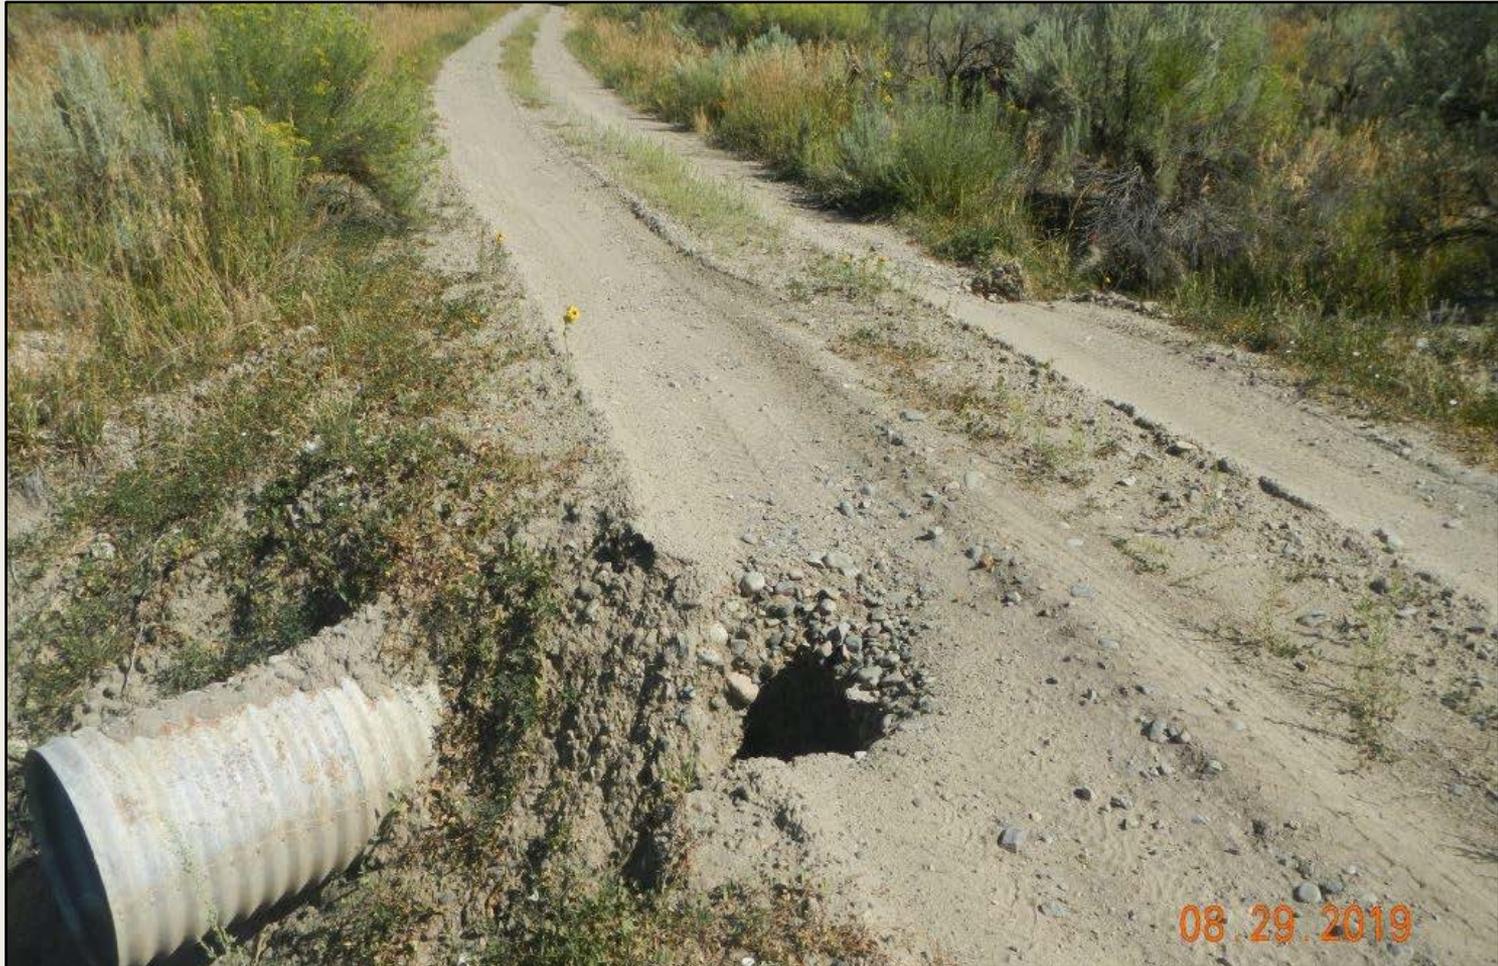
Photo 5. View of erosional downcutting along both sides of culvert along shared access road. This is compromising the integrity of the access road and needs to be repaired.

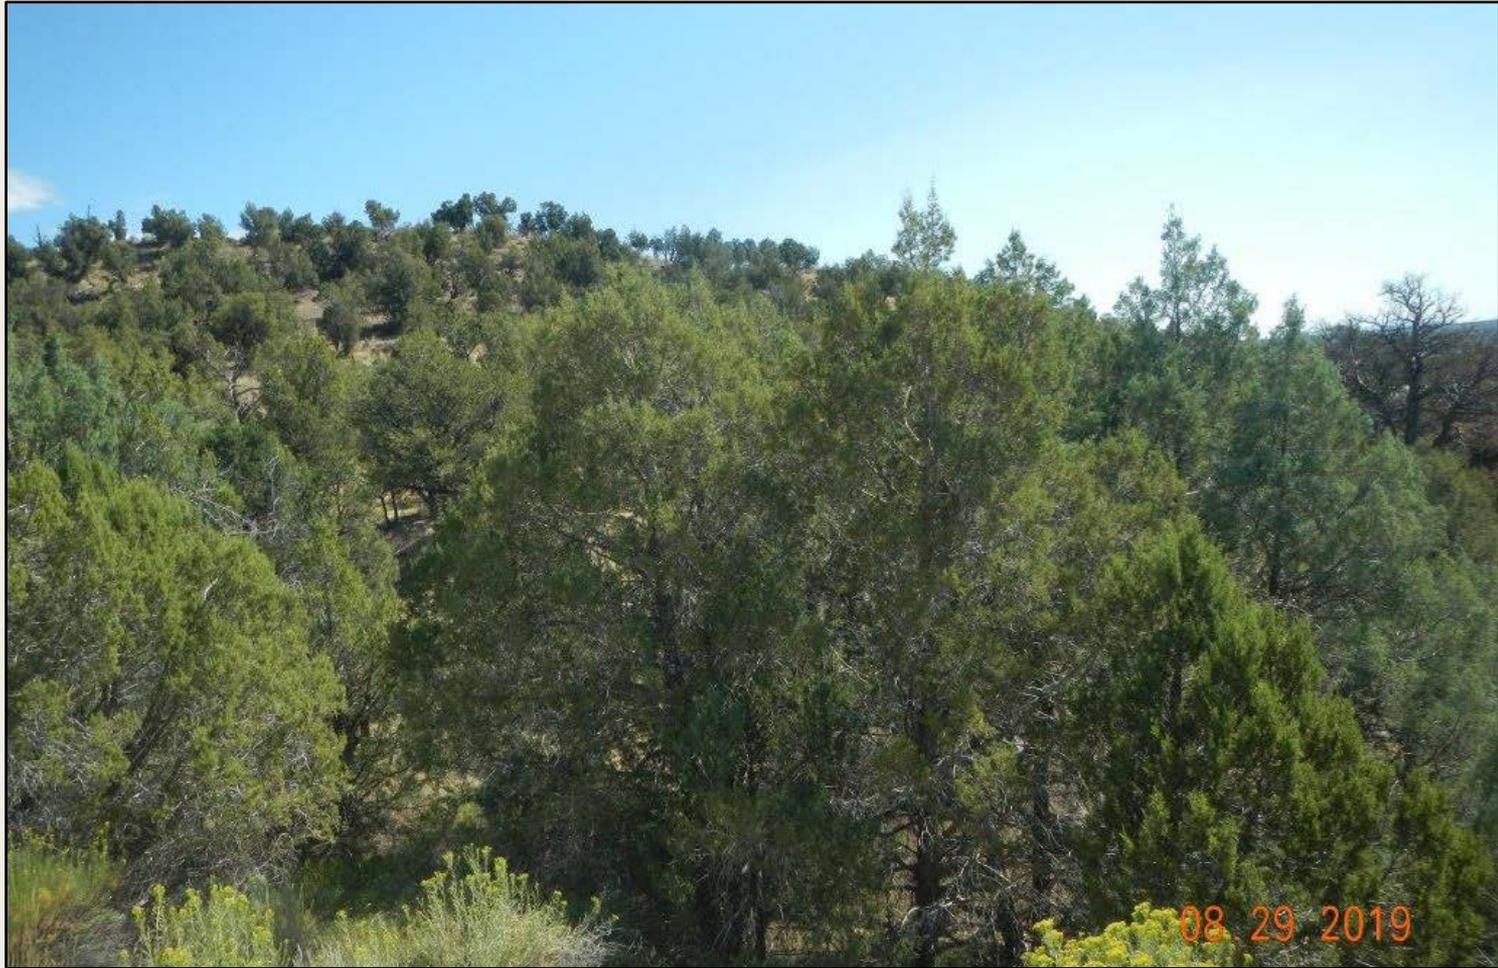
Photo 6. View of reference area facing eastward. Vegetation is comprised of pinyon juniper woodland.
