Inspection Photos
Operator: Vernon E Faulconer
Location/API #: 067-06289
Date: 8-29-2019

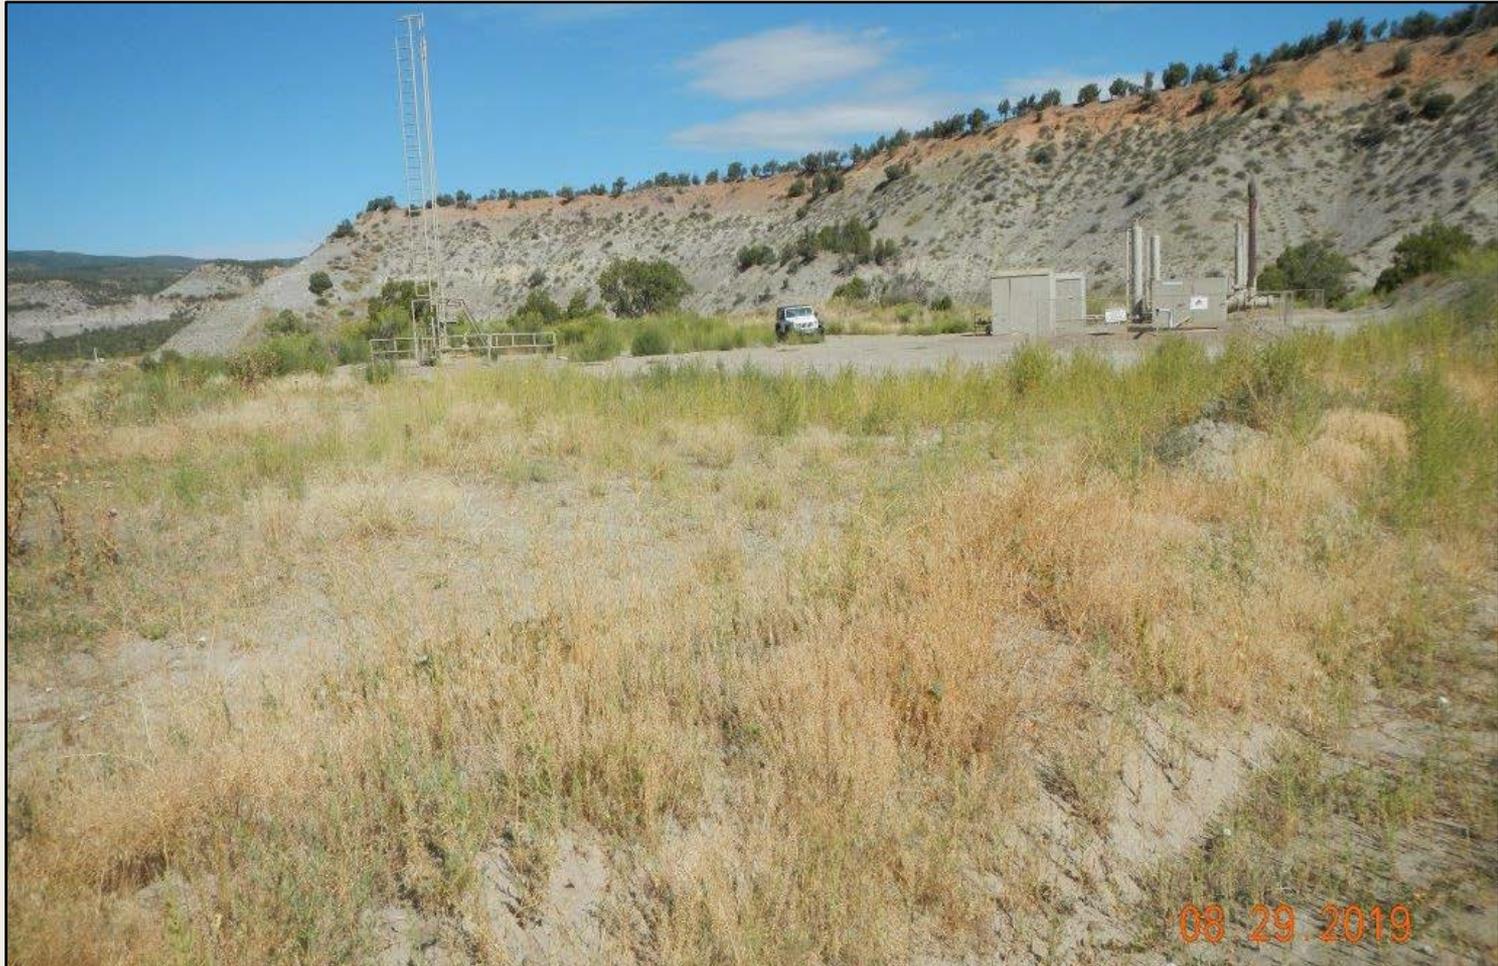
Photo 1. View of the project area from the southwestern corner facing center.

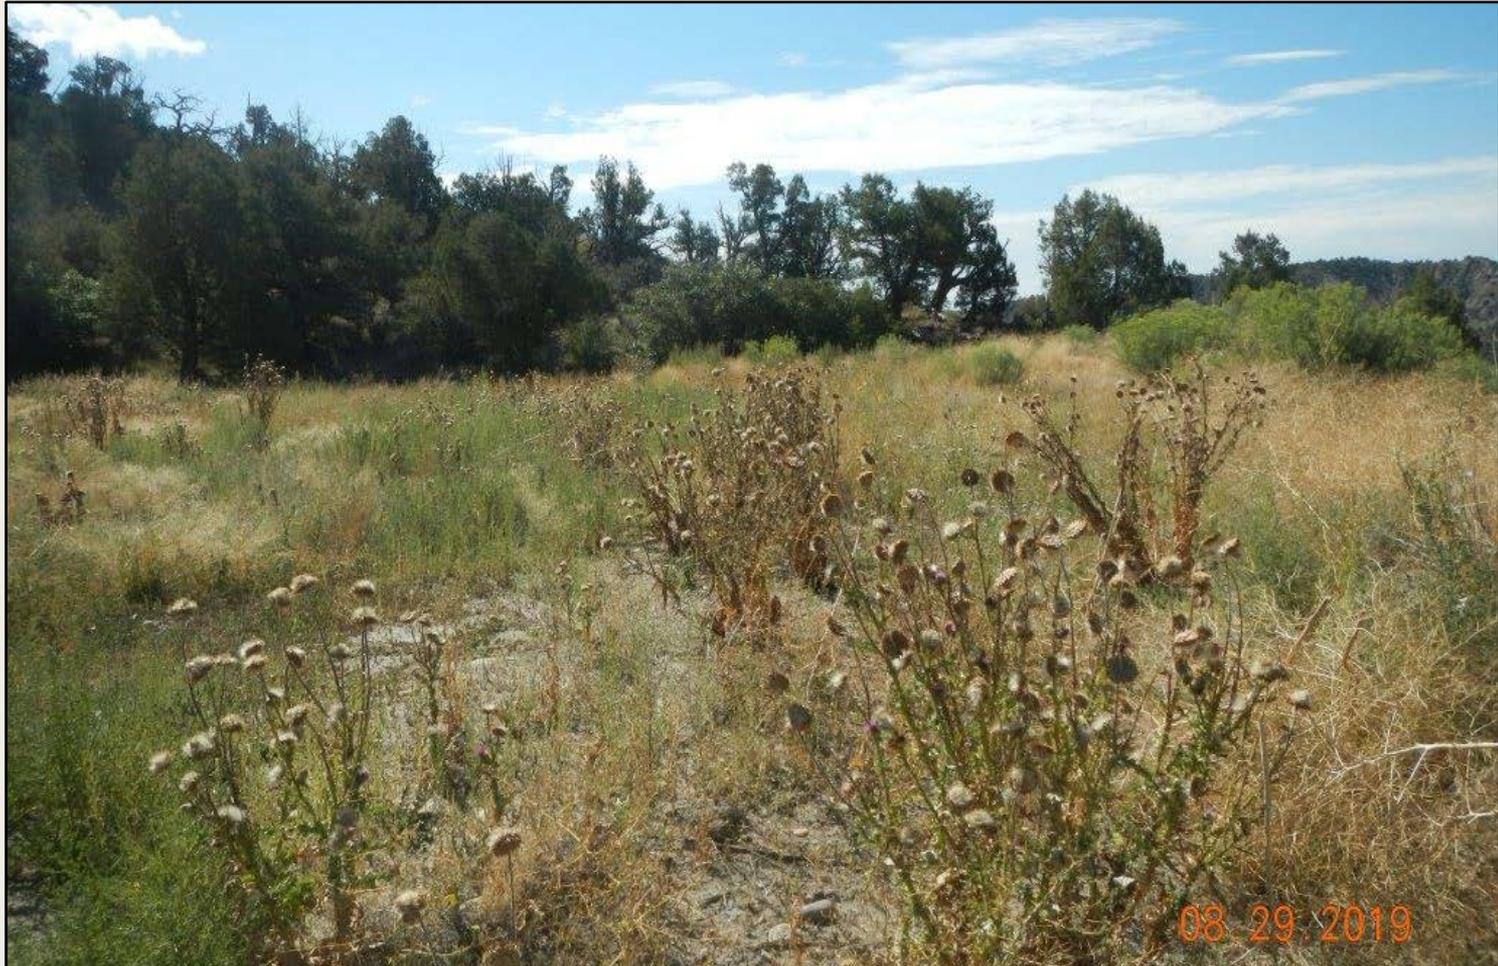
Photo 2. View of musk thistle infestation within the southwestern project area.

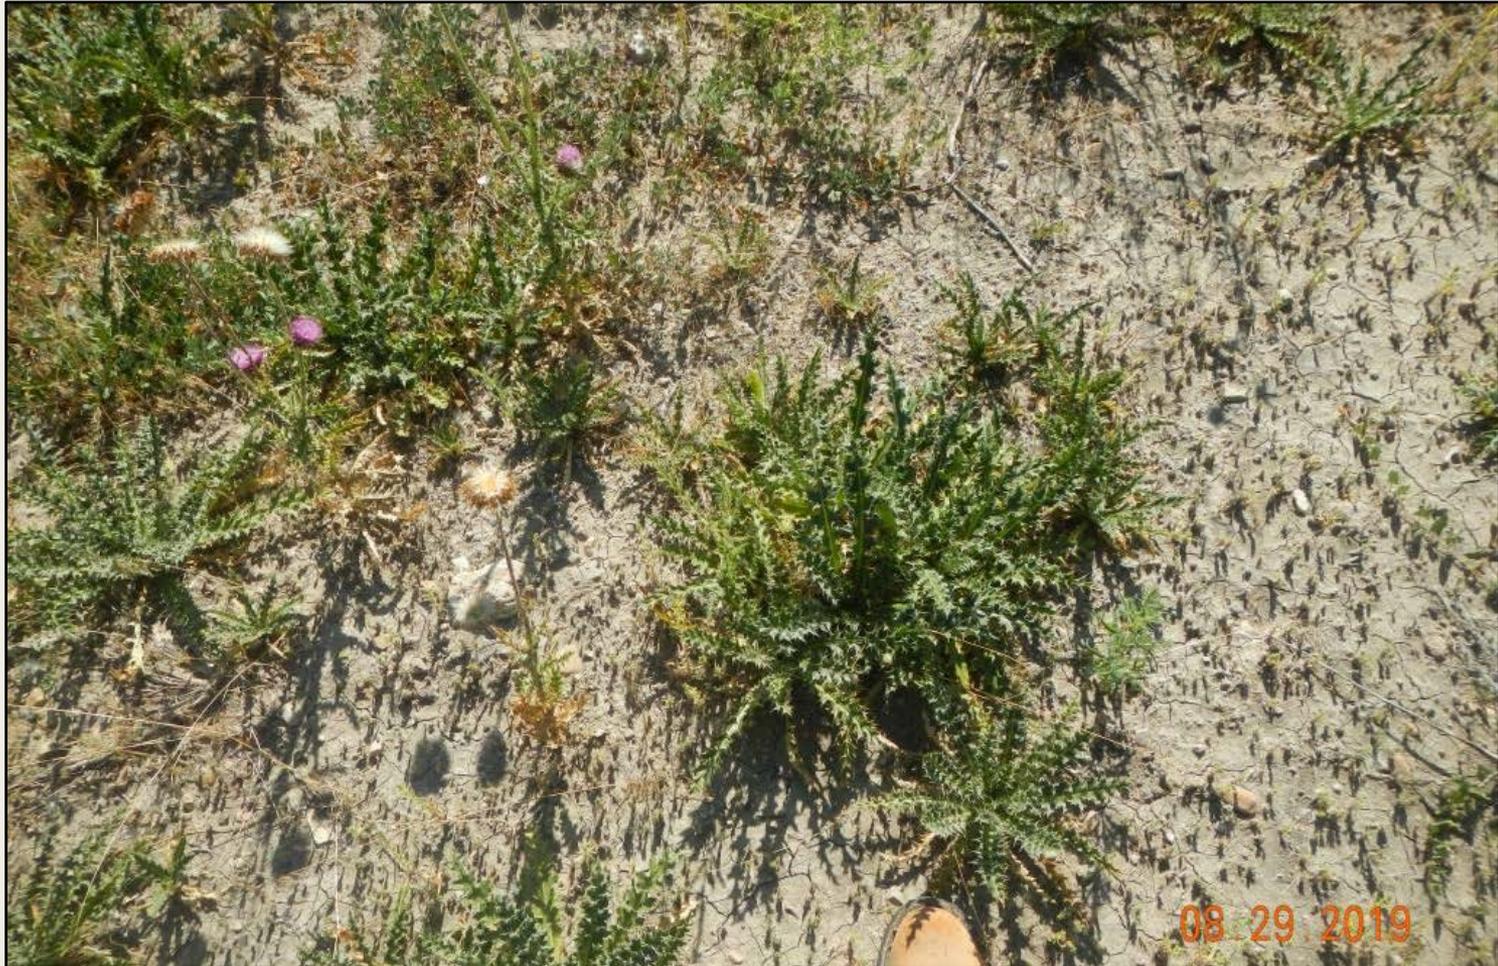
Photo 3. View of dense musk thistle rosettes within the southwestern project area.

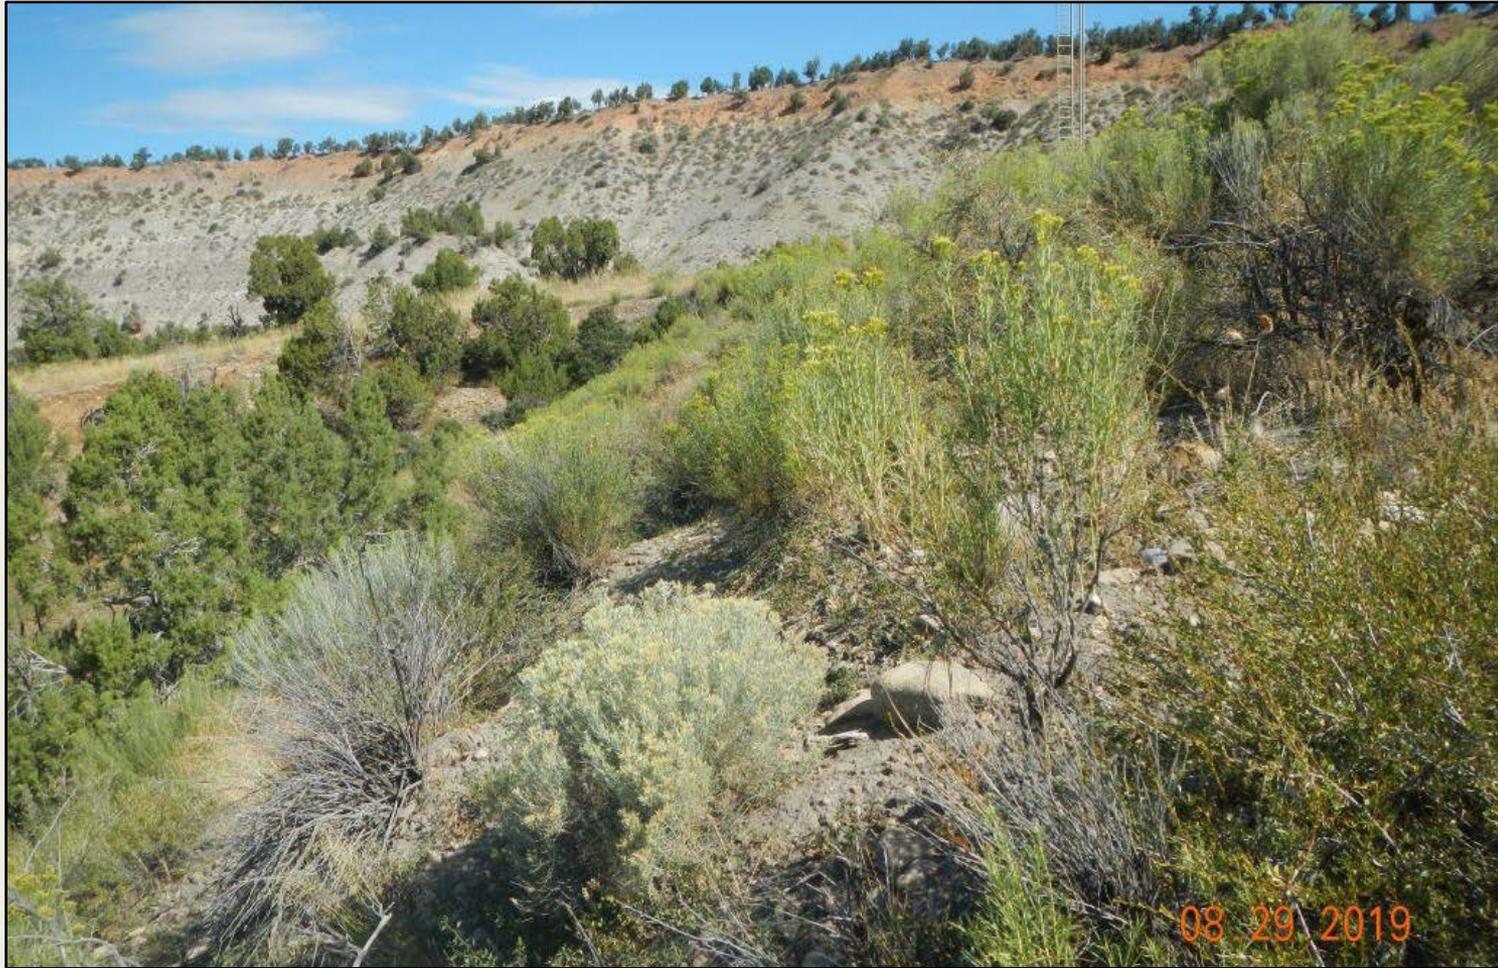
Photo 4. View of the southern fill slope from the southeastern edge facing northwestward.

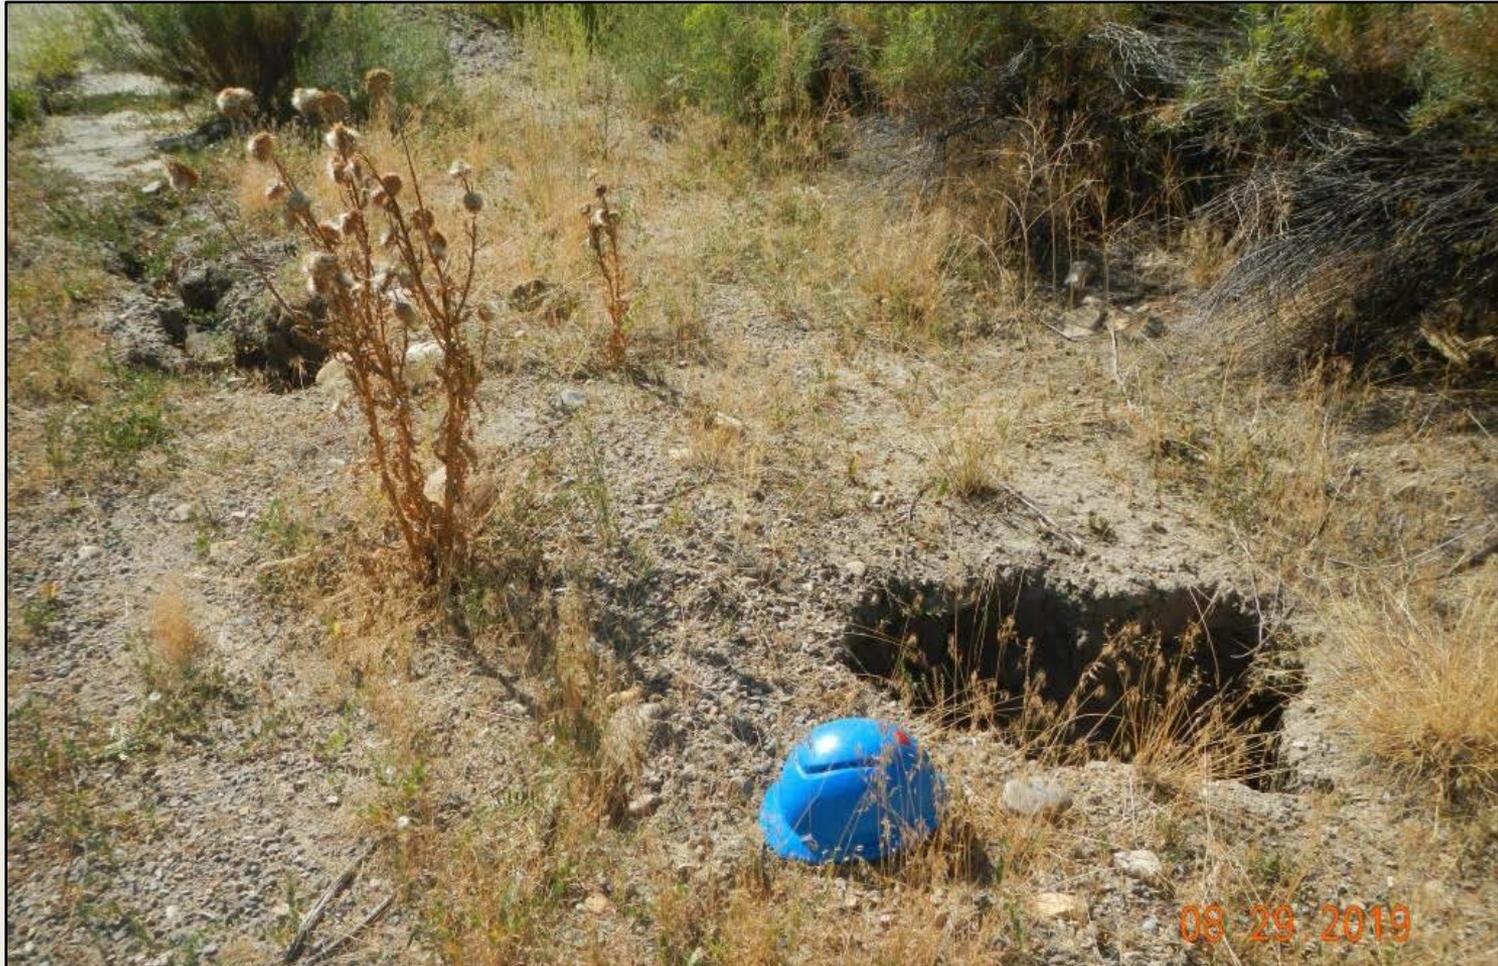
Photo 5. View of erosional tunnels within the northwestern fill slope, near the well pad entrance.

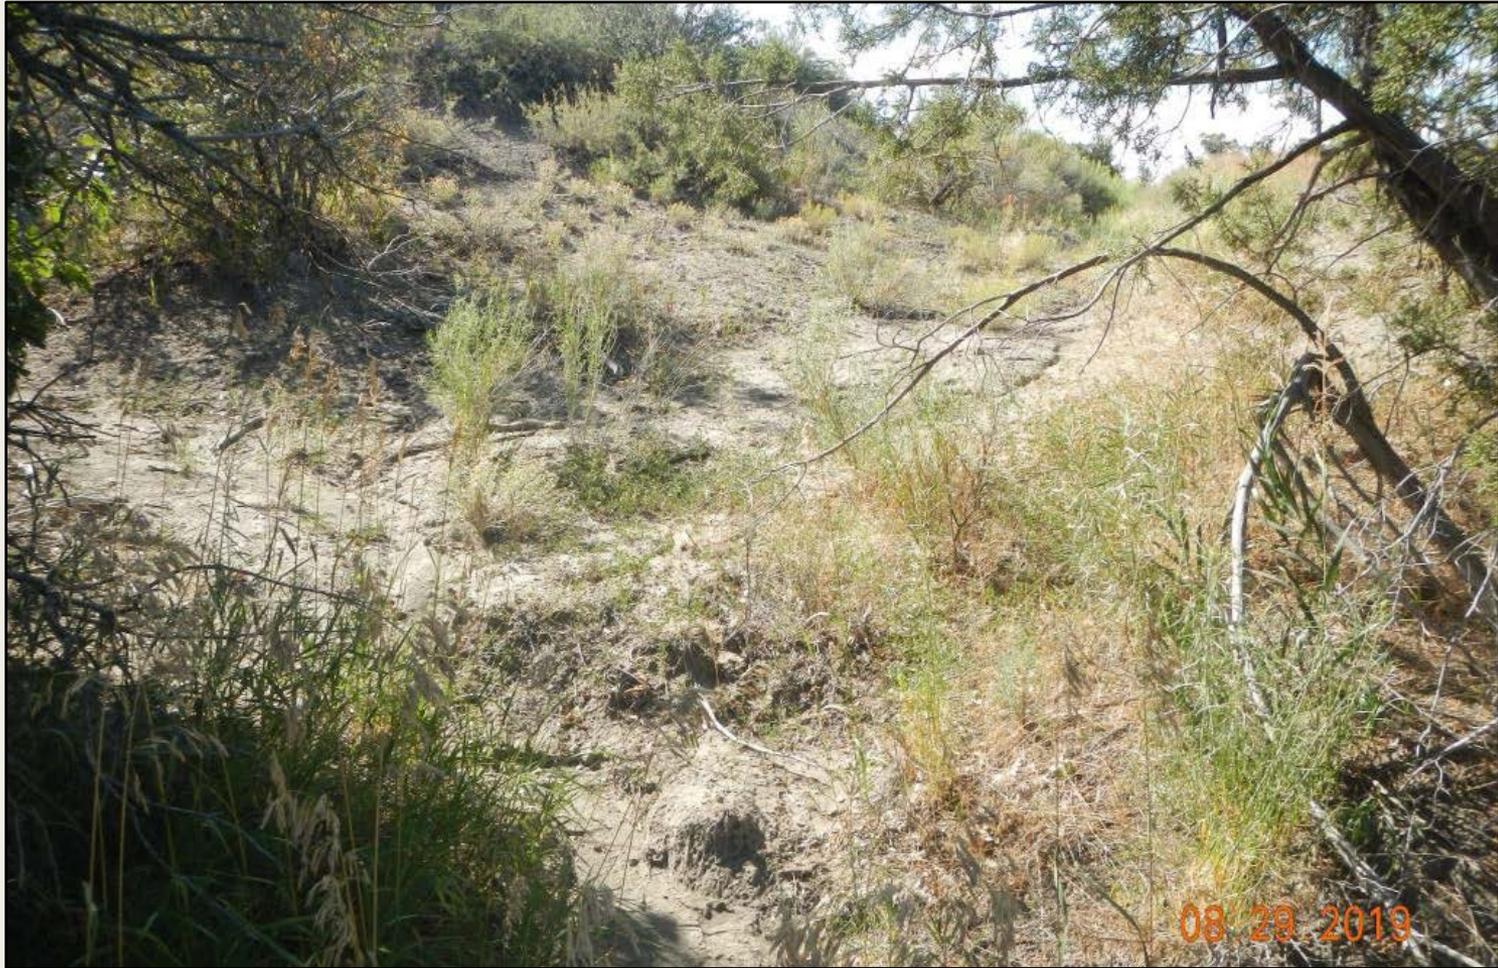
Photo 6. View of area in the northeastern project area that diverted stormwater flows off of the well pad. Evidence sedimentation, and erosional channeling observed.

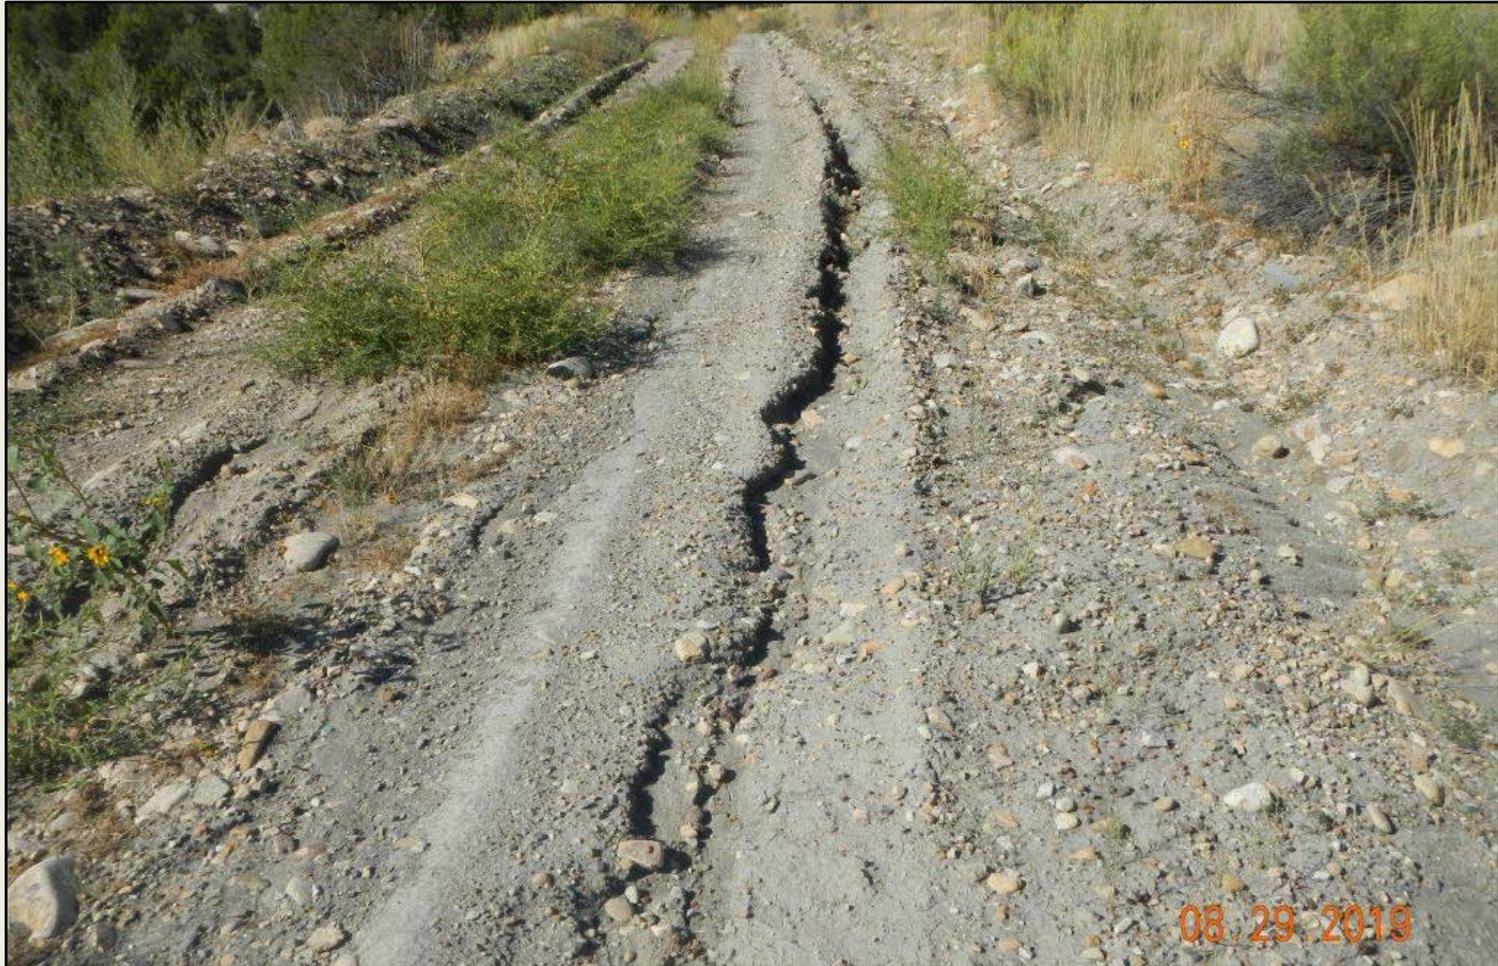
Photo 7. View of erosional channeling and sedimentation on the access road.

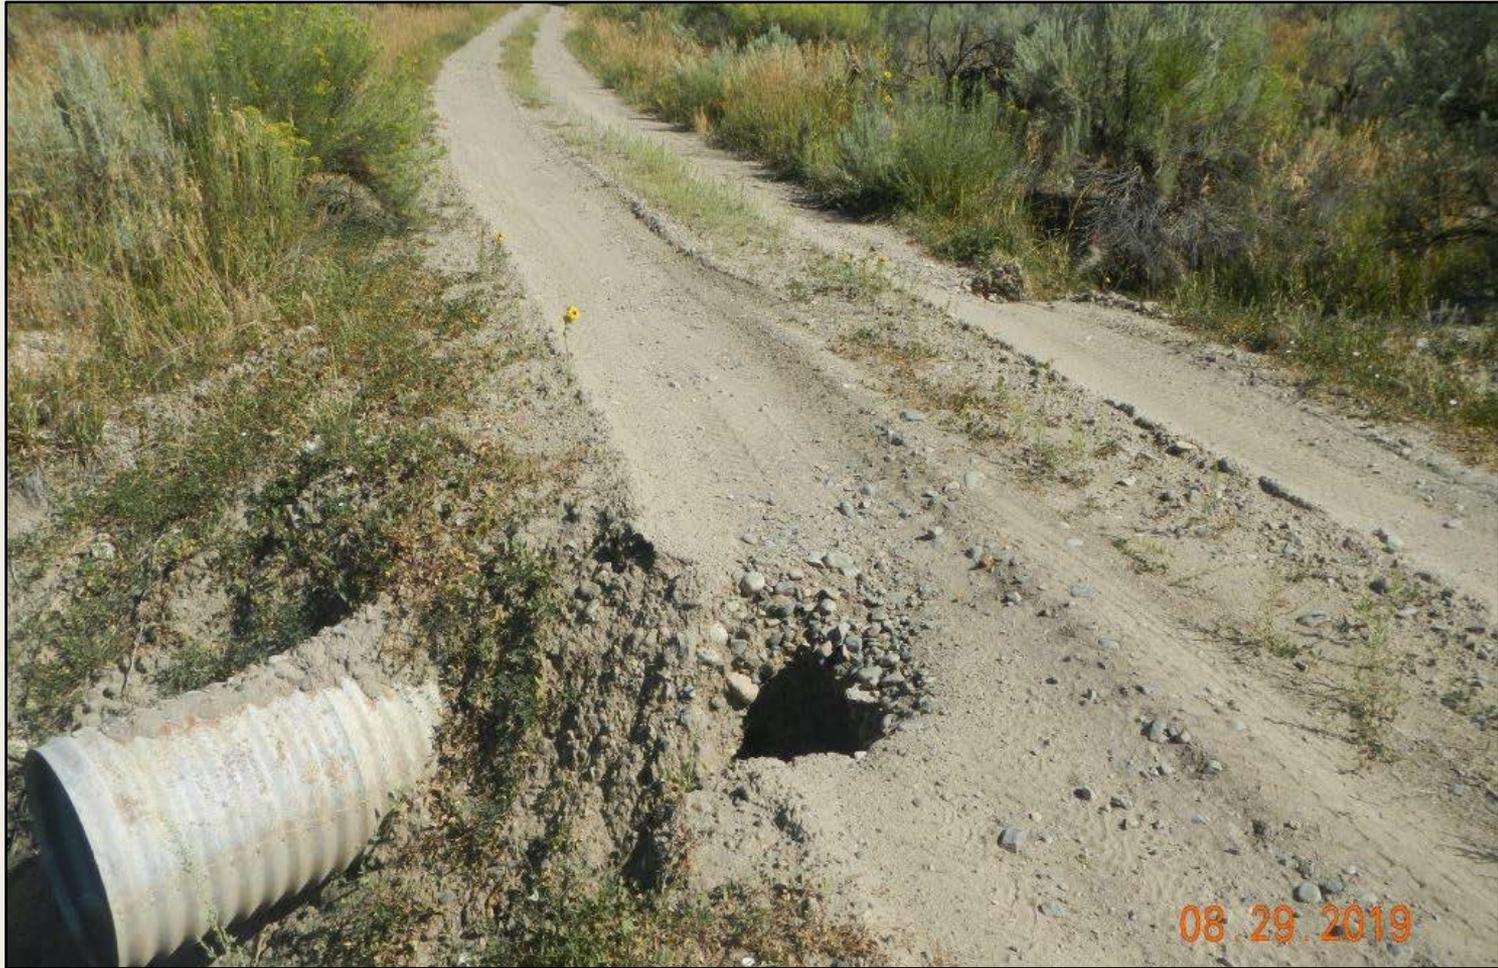
Photo 8. View of erosional downcutting along both sides of culvert along access road. This is compromising the integrity of the access road and needs to be repaired.
