Inspection Photos
Location Name: Hladky O'Gorman #3
Location ID: 332971

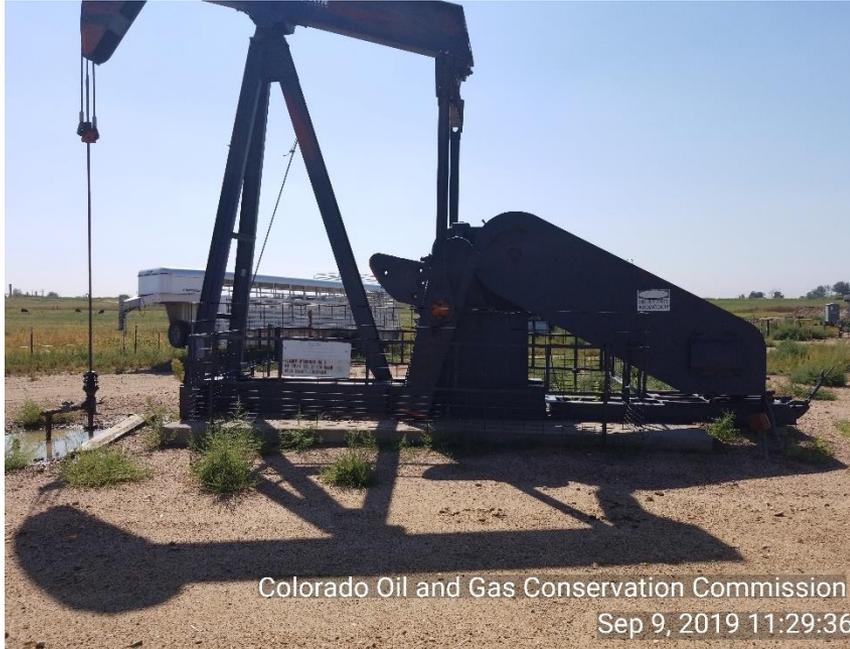
Photo 1 WH sign faded not legible. Well head can visible see and hear what appears to be gas leaking in and around packing.

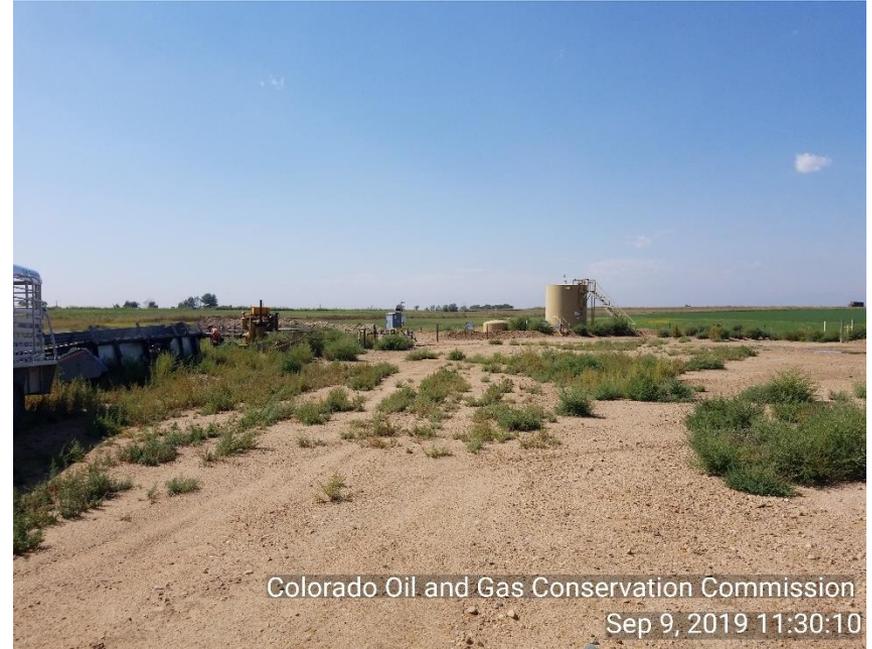
Photo 2 location pic **WEEDS**.

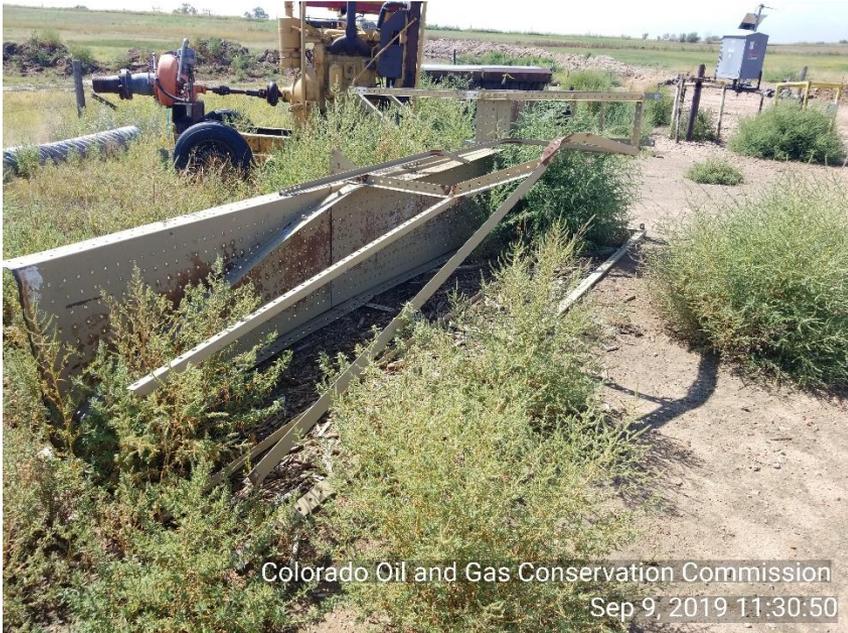
Photo 3 Unused equipment: storage tank stairs. **WEEDS.**

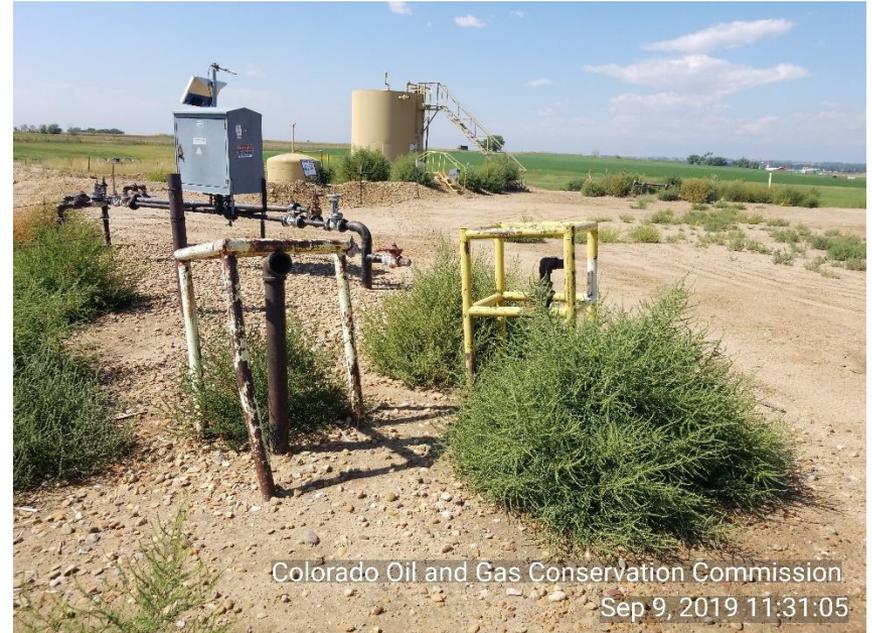
Photo 4 Unused equipment: unmarked not LOTO risers. **WEEDS.**

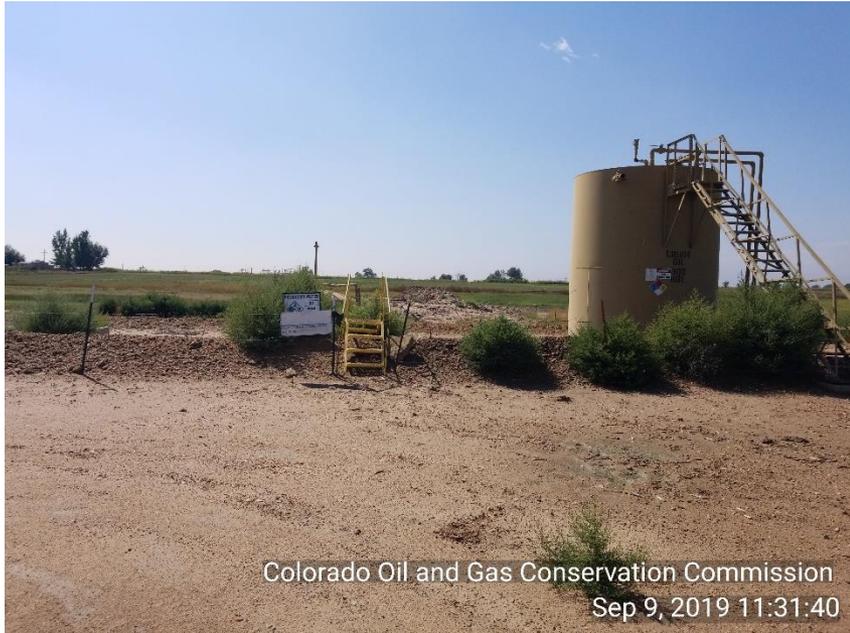
Photo 5 TNK BTRY. BTRY sign faded not legible. **WEEDS.**

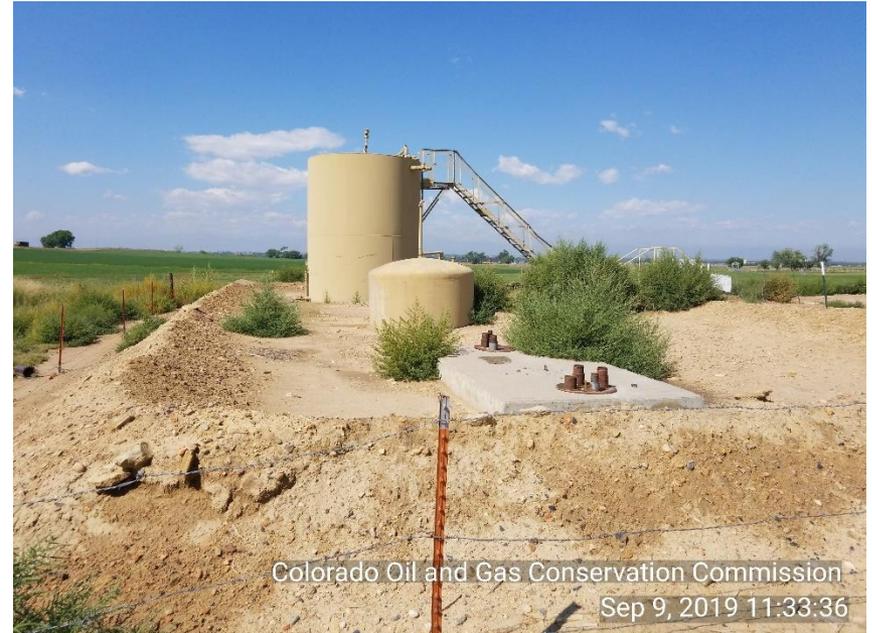
Photo 4 TNK BTRY **WEEDS.**

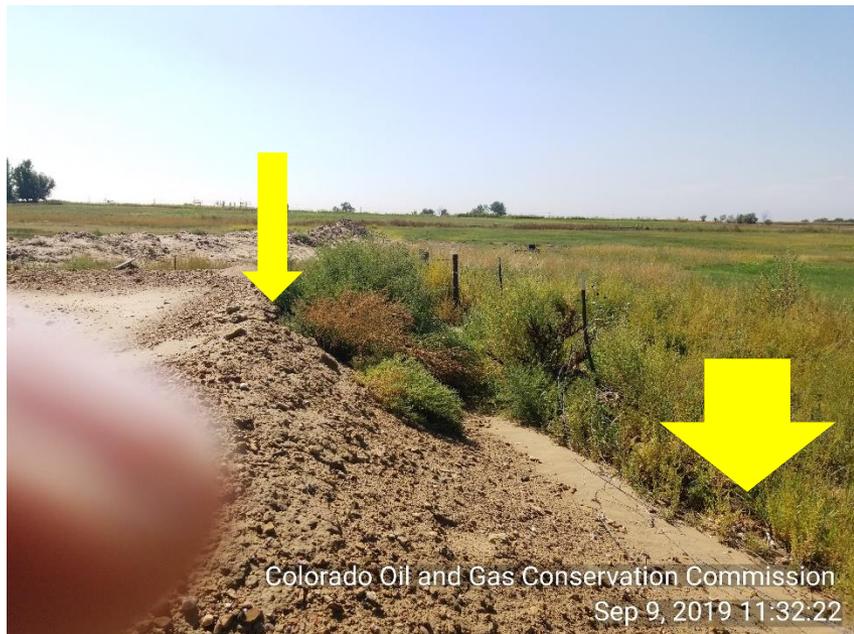
Photo 6 TNK BTRY secondary containment BMP in disrepair sediment being carried of BPM and into field. **WEEDS.**

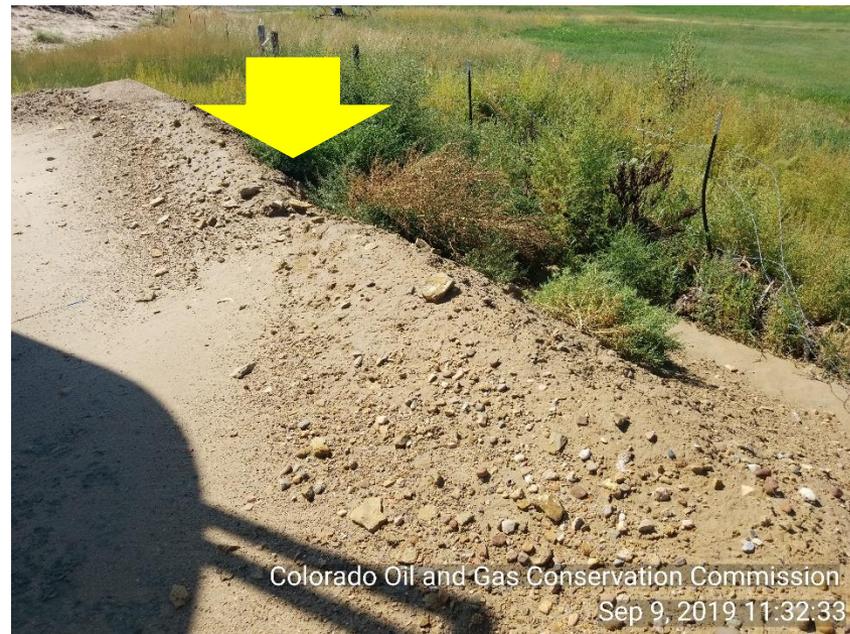
Photo 7 TNK BTRY secondary containment BMP in disrepair sediment being carried of BPM and into field. **WEEDS.**

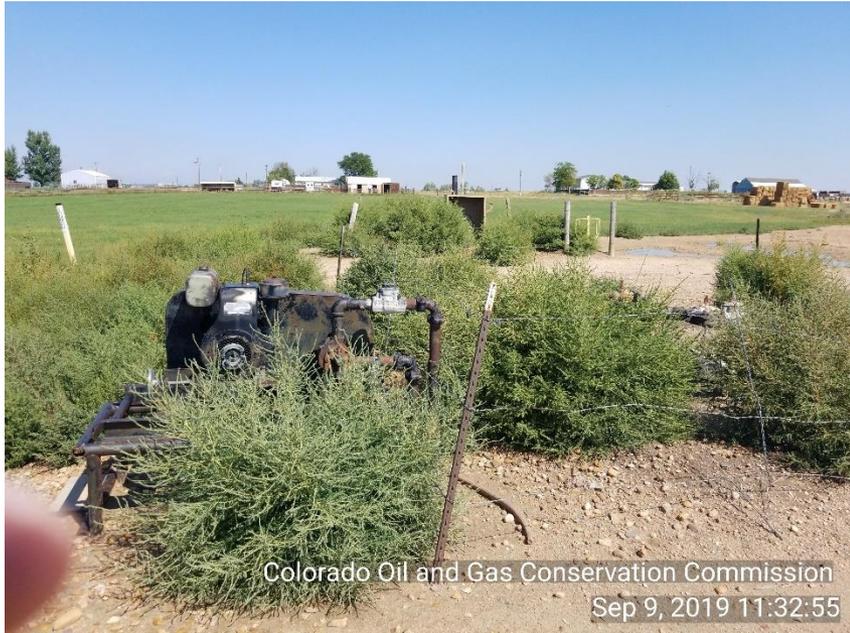
Photo 7 Re-circ pump **WEEDS.**

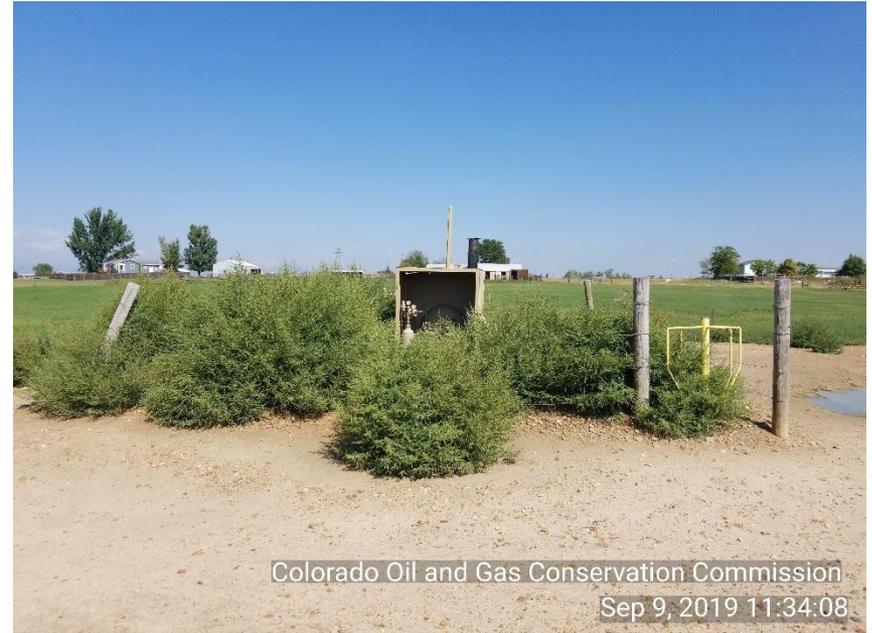
Photo 8 Separator **WEEDS.**

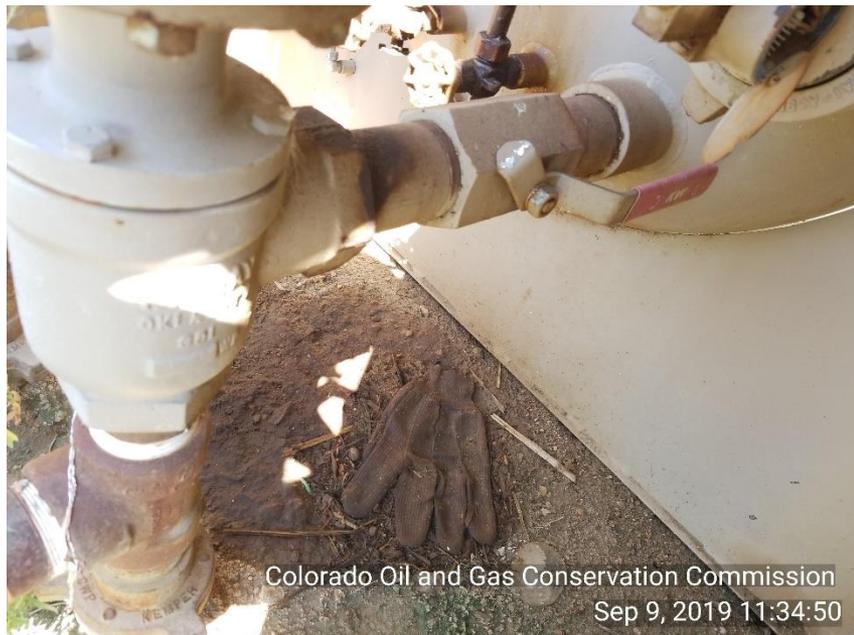
Photo 9 Mechanical issue and stained soil inside separator.

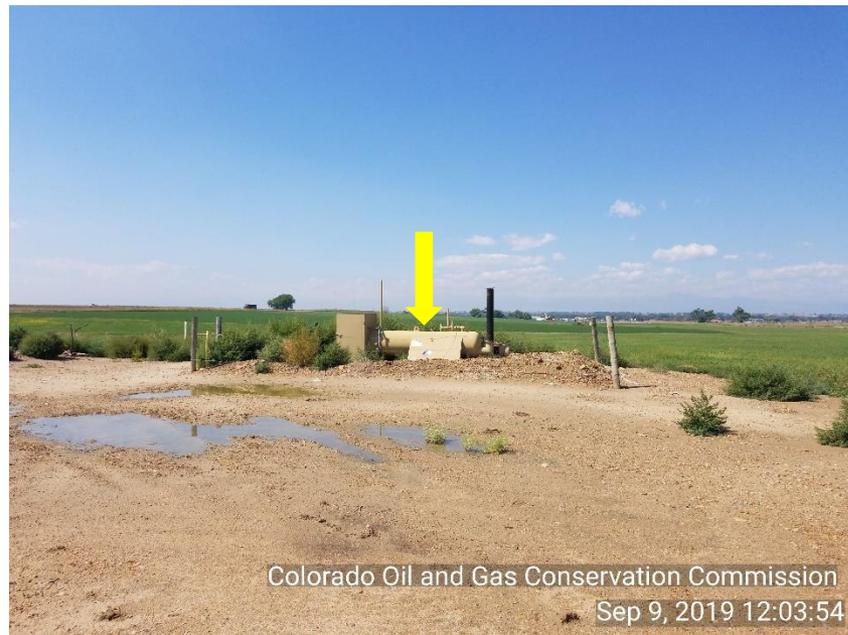
Photo 10 Trash: Separator door laying on ground next to separator. **WEEDS.**

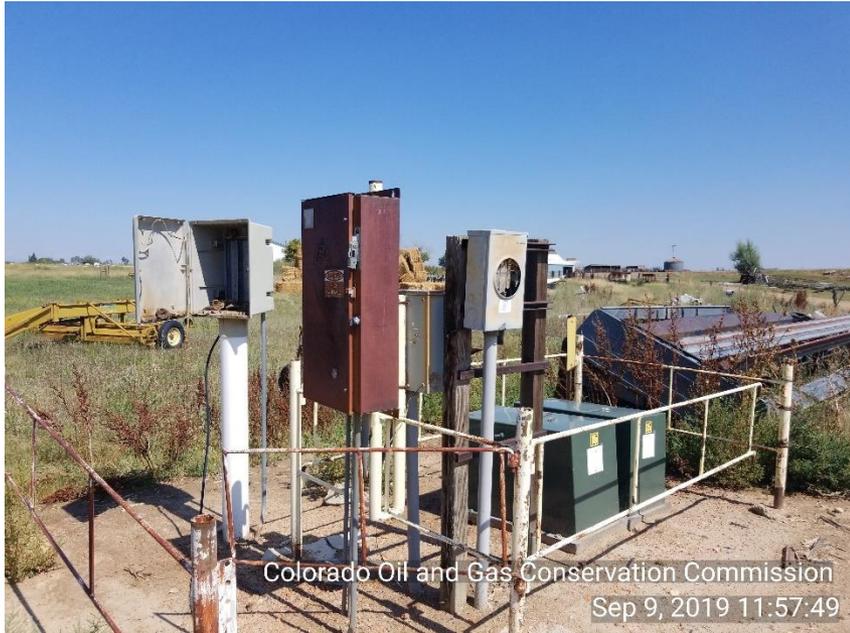
Photo 11 Unused equipment: Electric panel Meter has been pulled.

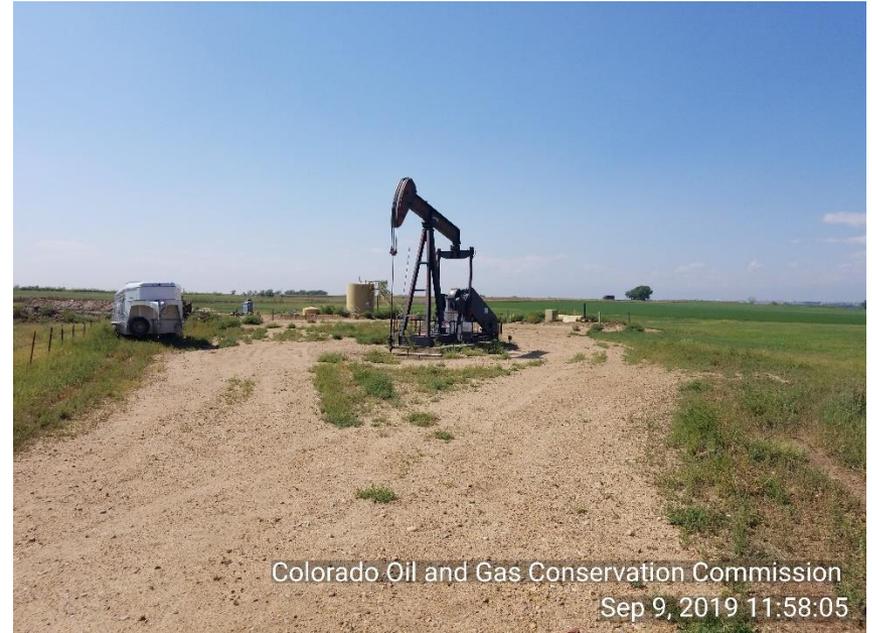
Photo 12 Unused equipment: PU is not inoperable electric meter has been pulled PU cannot run **WEEDS.**
