Inspection Photos
Location Name: William Lansdown #1
Location ID: 317613

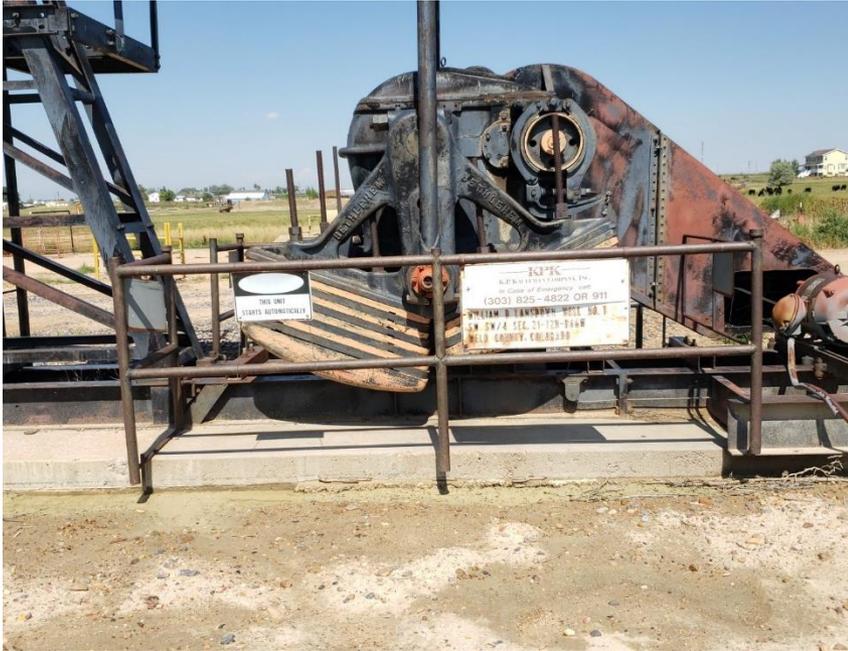
Photo #1 WH sign

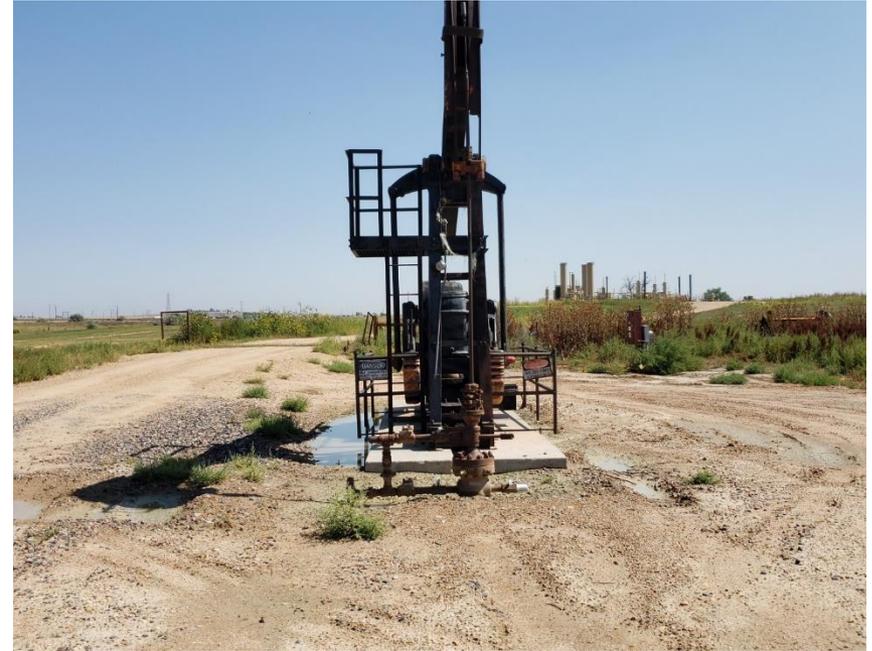
Photo #2 WH PJ

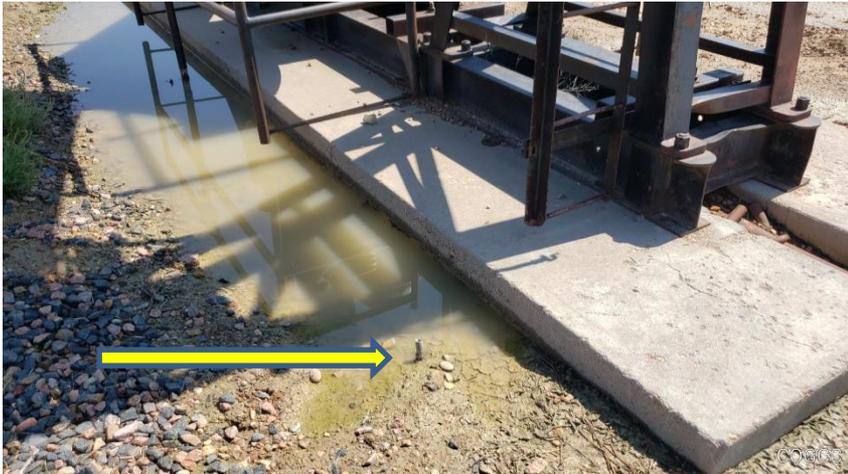
Photo #3 Electric panel removed conduit and wire Exposed at ground level

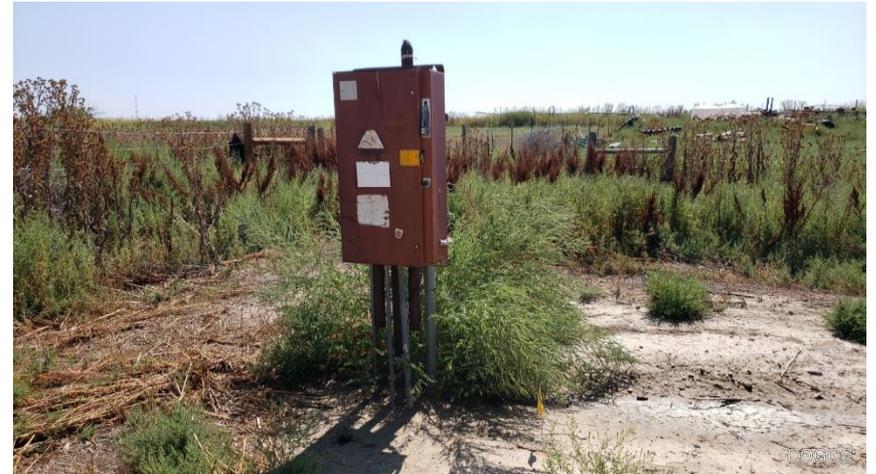
Photo #4 weeds growing around Control panel

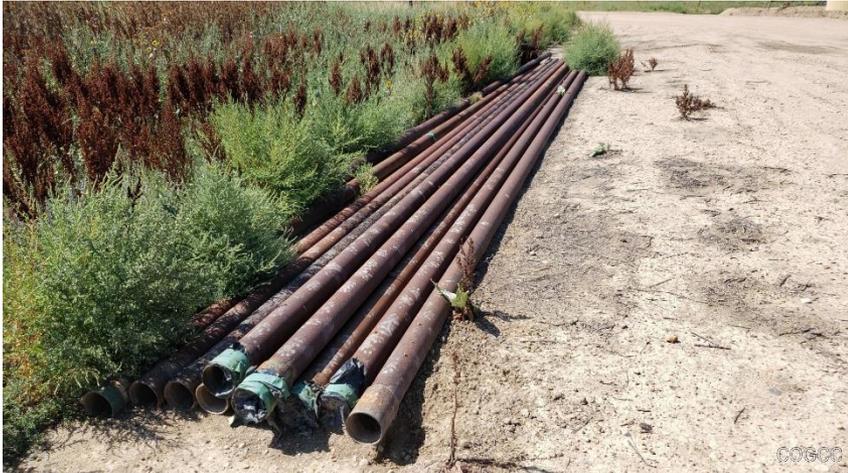
Photo #5 Unused casing along fence

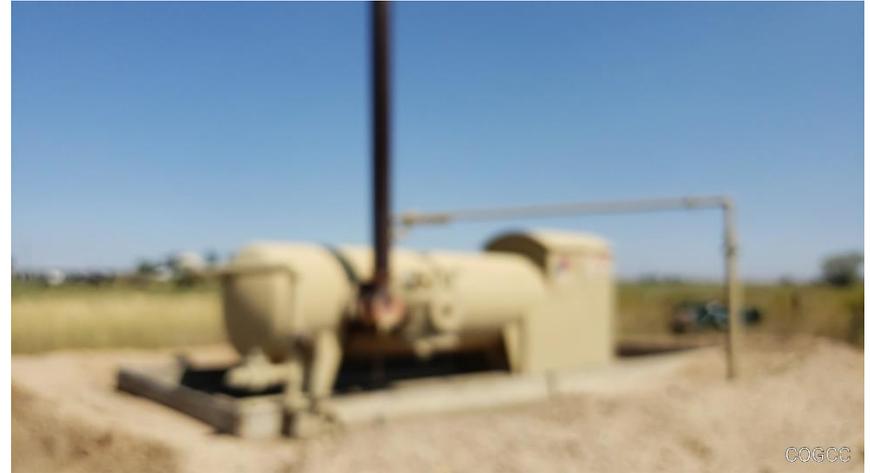
Photo #6 Hoz separator

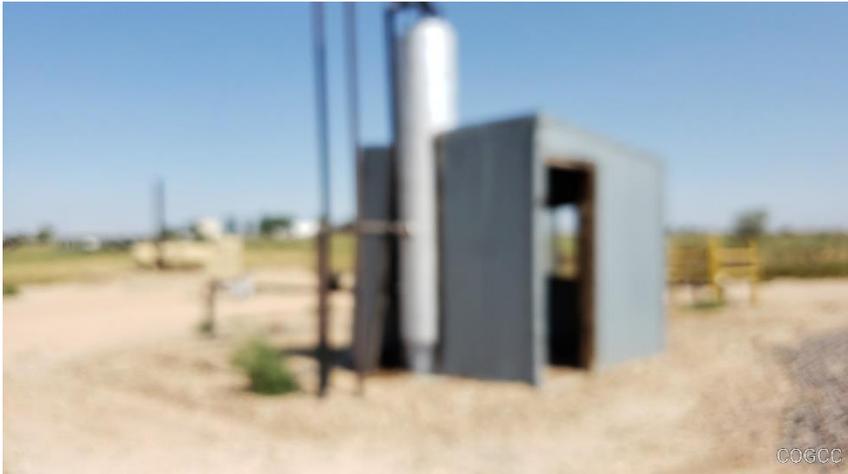
Photo #7 Vert. Sep. building

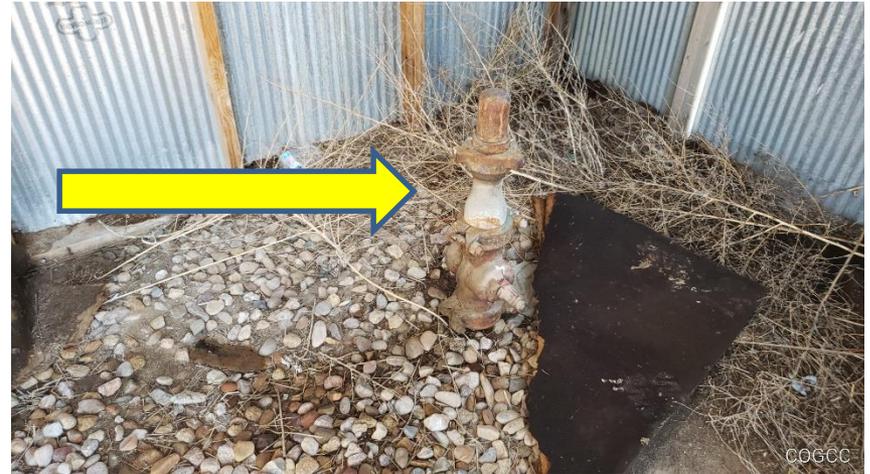
Photo #8 unmarked no LOTO on riser in Vert. Sep. building

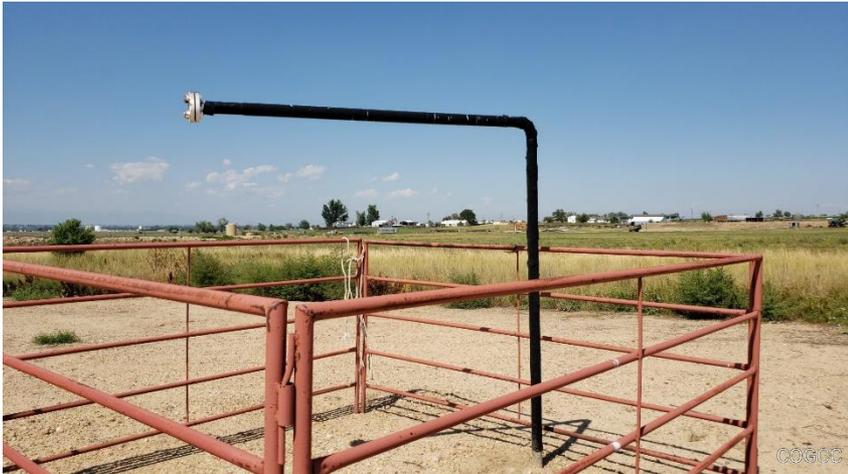
Photo #9 unused riser no LOTO

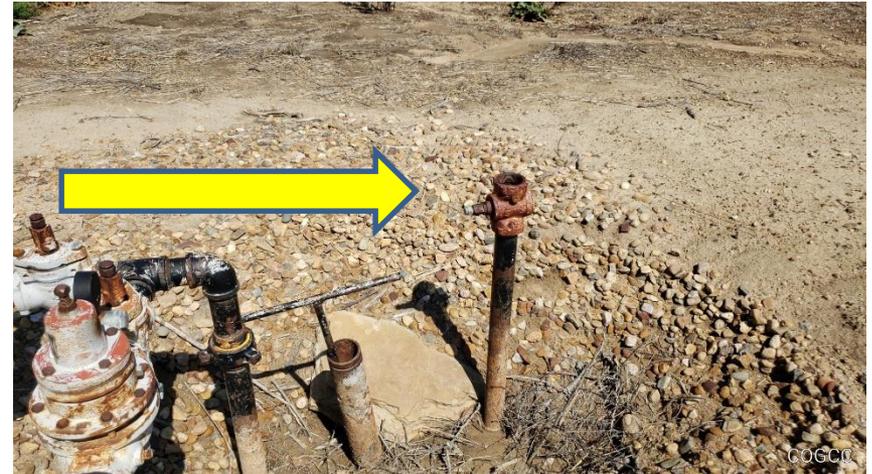
Photo #10 unused riser no LOTO

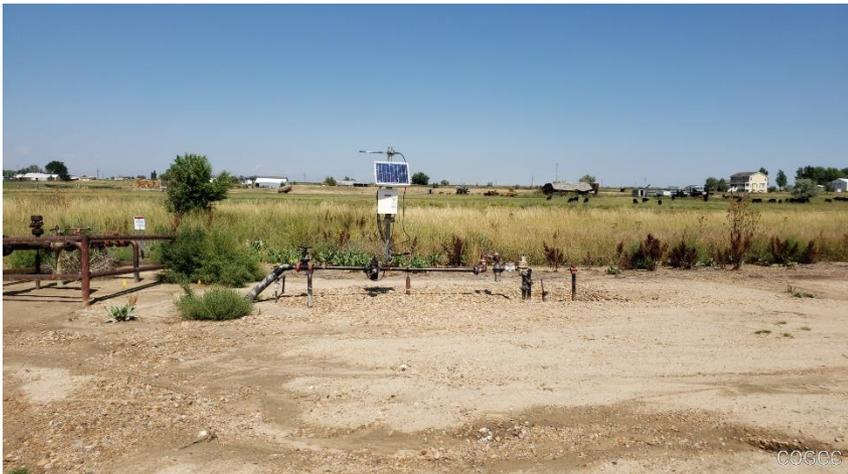
Photo #11 Gas meter run

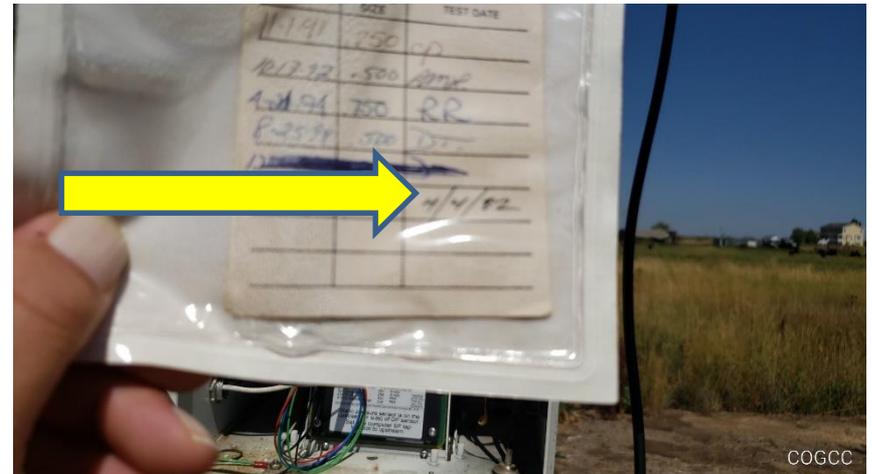
Photo #12 Gas meter appears to have been last calibrated on 4/4/2012

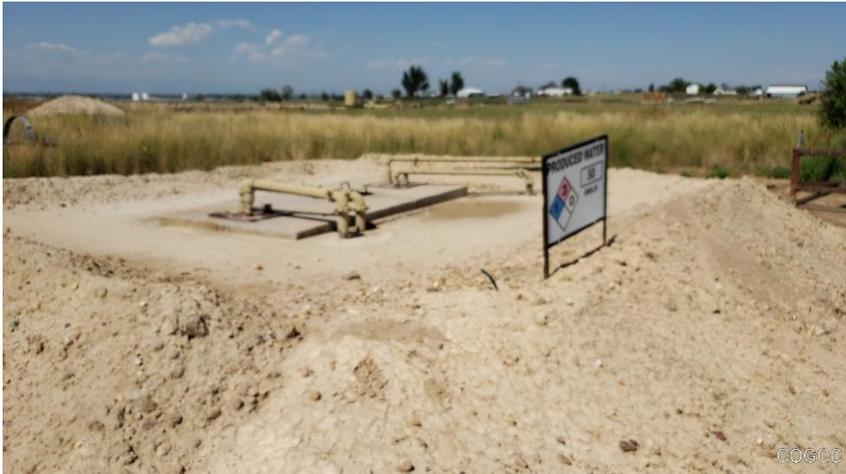
Photo #13 Prod. water tank berm not adequate and in disrepair.

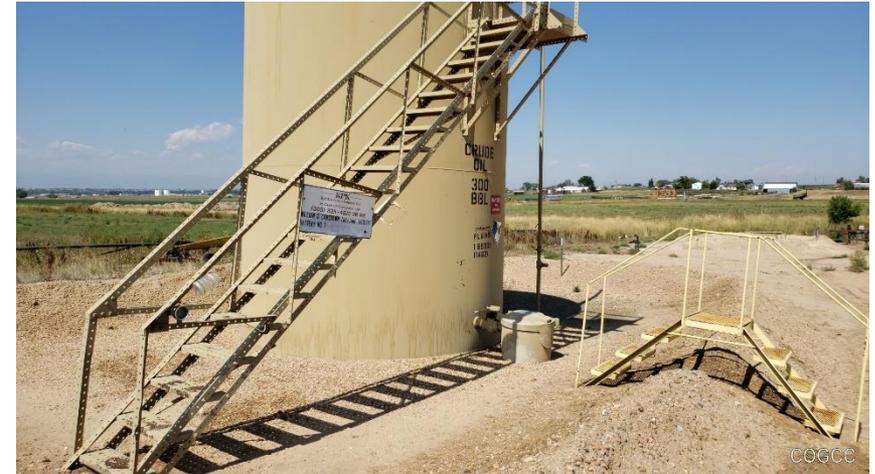
Photo #14 TB

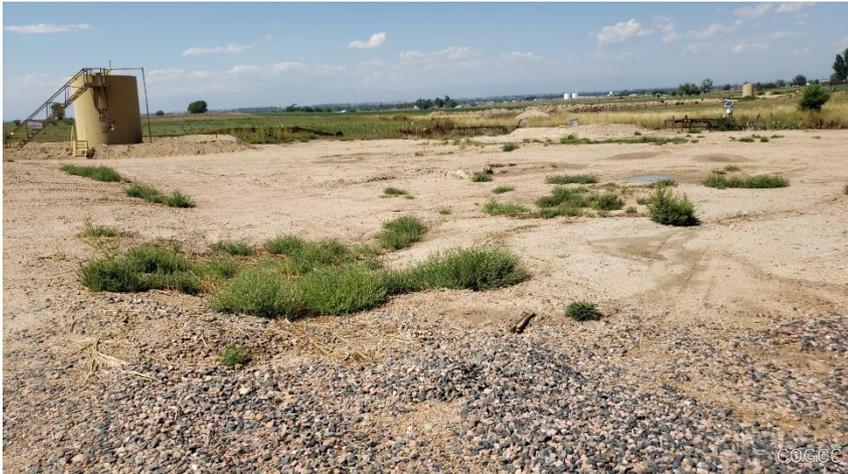
Photo #15 Prod. water tank berm not adequate and in disrepair.
