Inspection Photos

09/09/2019

Operator: FOUNDATION ENERGY
MANAGEMENT LLC # 10112

Location ID: 323461
Weld County, CO

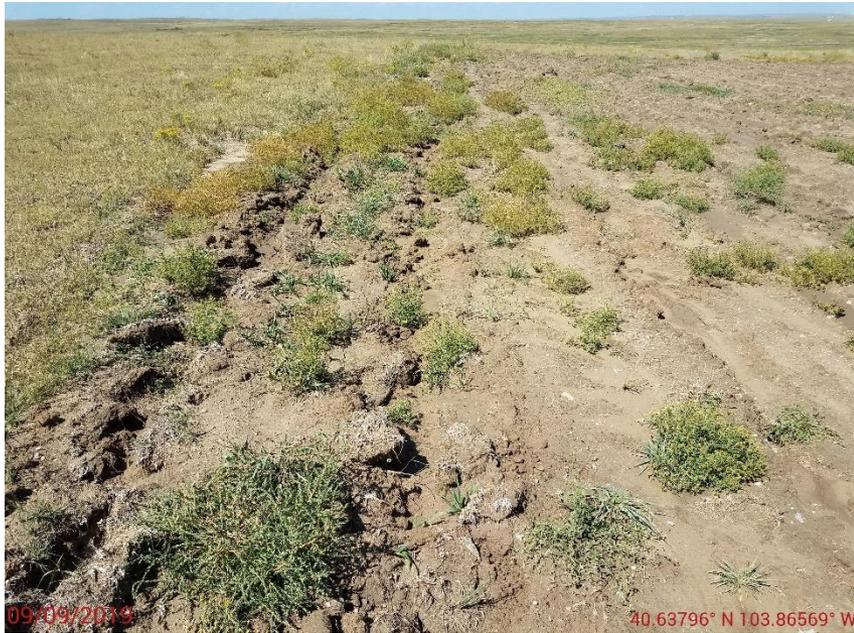
Photo 1: Photo taken from the southeast end of the location, facing west. Photo shows location does not appear to have been cross-ripped in accordance with 1000 series rules; location appears to have been ripped once, in one direction.

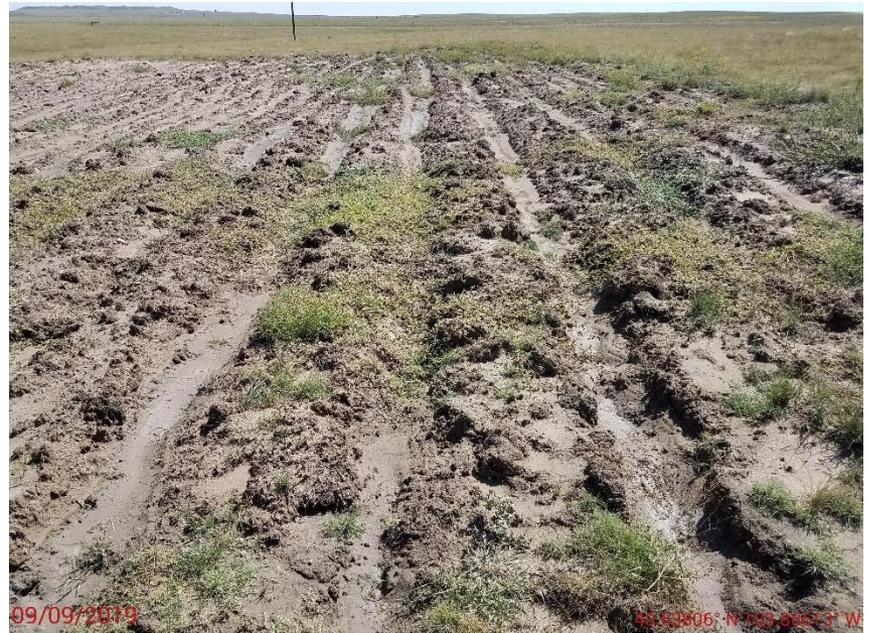
Photo 2: Photo taken from the southwest end of the location, facing east. See comments under photo 1.

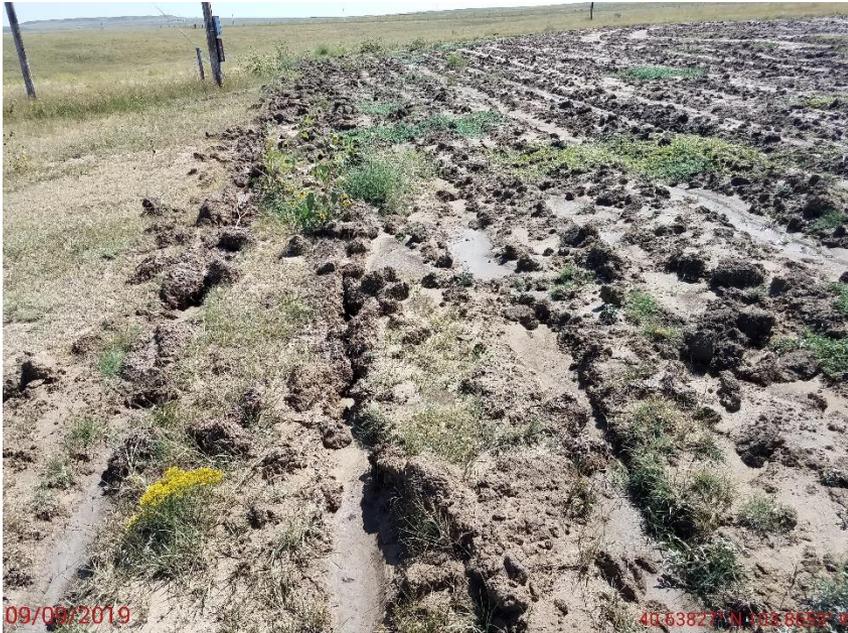
Photo 3: Photo taken from the northwest end of the location, facing east. See comments under photo 1.

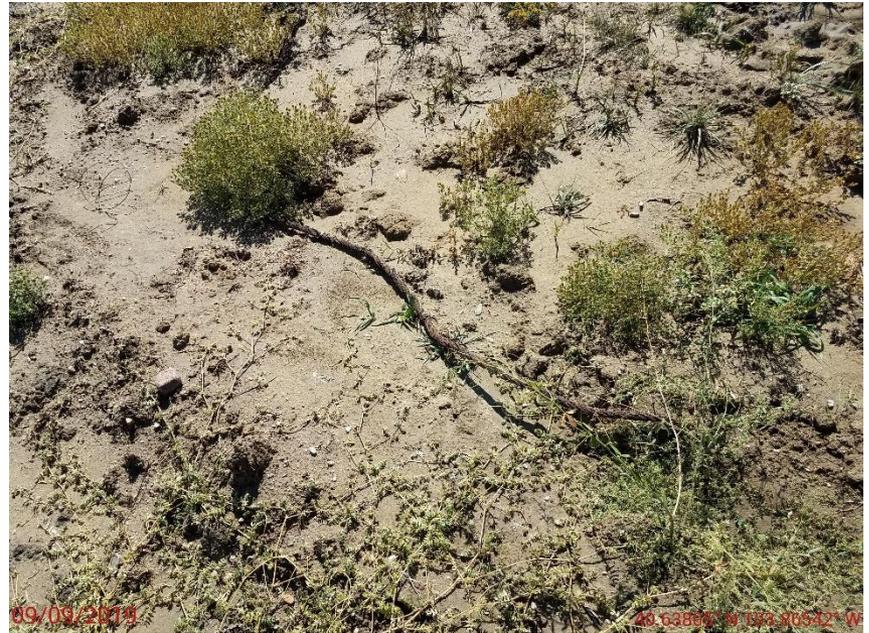
Photo 4: Photo taken from the southeast corner of the location. Photo shows trash debris (cable) remaining on location.

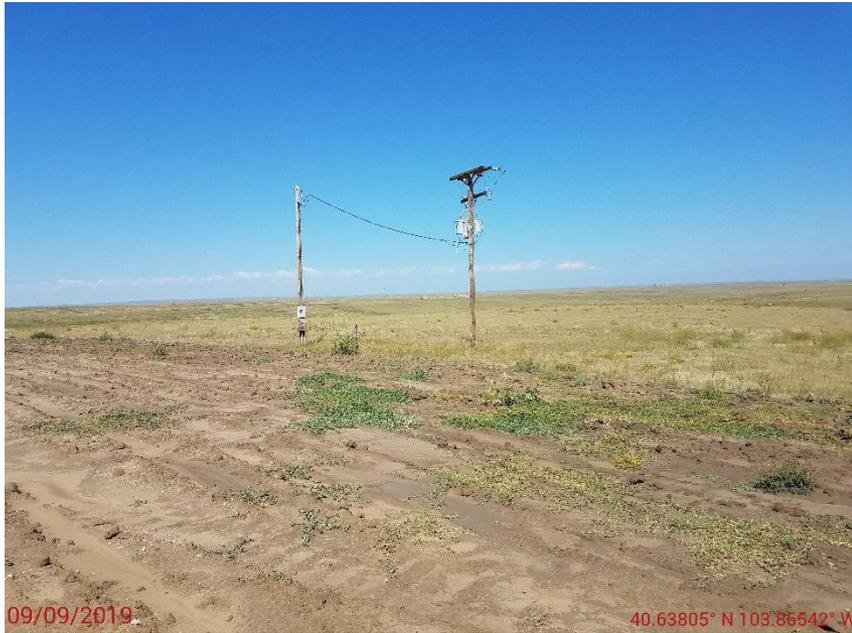
Photo 5: Photo shows utility poles remaining on the north end of the location. Surface equipment has not been removed.

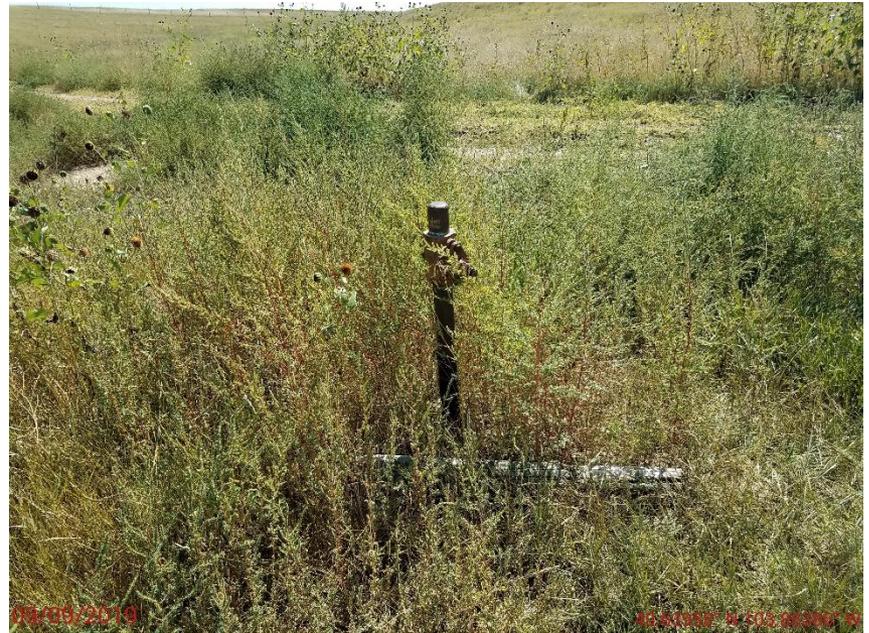
Photo 6: Photo taken from the access road at $\sim 40.639486^\circ$ / -103.864066° . Photo shows a riser remaining along access road; Surface equipment has not been removed.

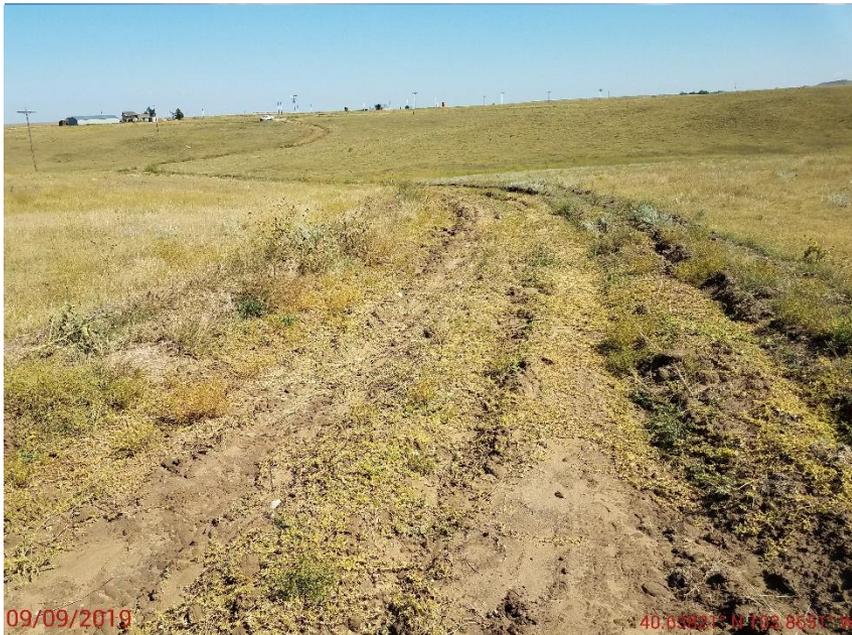
Photo 7: Photo taken from the access road on the east end of the location. Photo shows *Tribulus terrestris* has established over a majority of the access road.

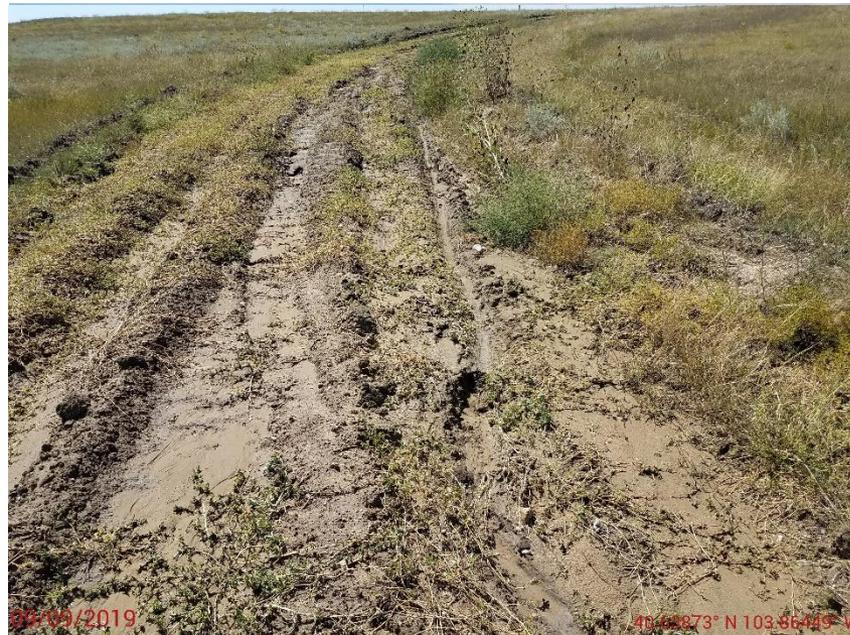
Photo 8: Photo taken from the access road. Photo shows erosion degradation observed on access road. Operator has not installed BMPs on location or access road.

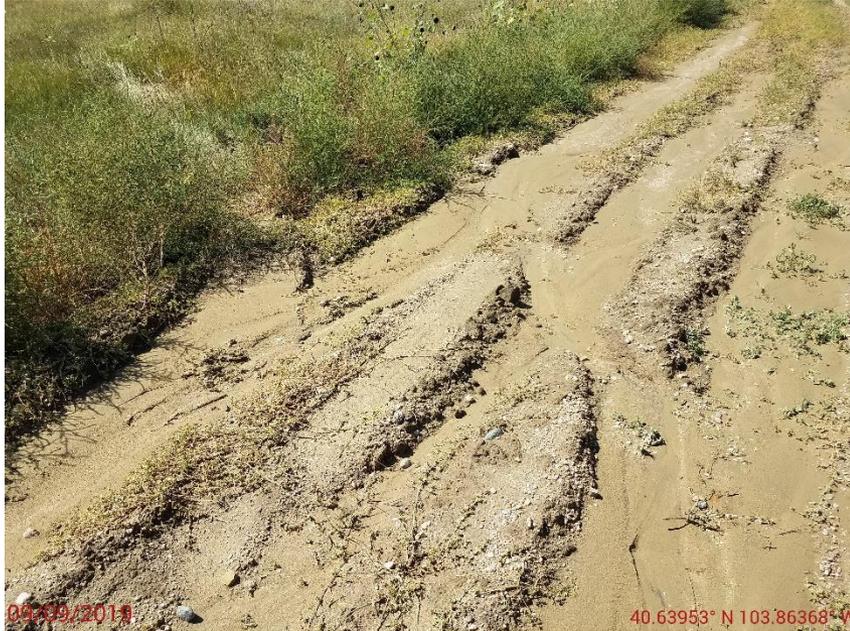
Photo 9: Additional photo of stormwater erosion degradation observed on access road.

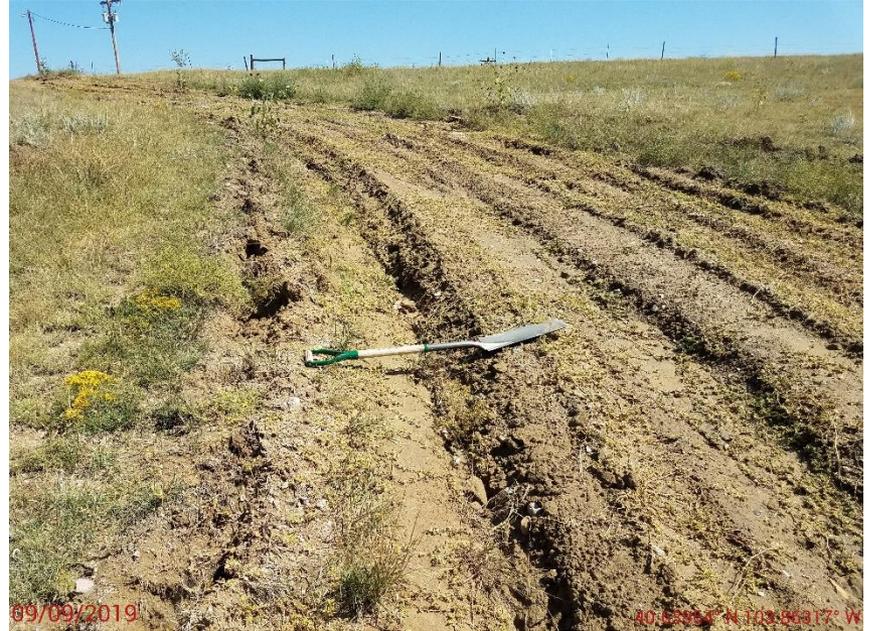
Photo 10: Additional photo of stormwater erosion degradation observed on access road. Areas of gully erosion forming. Shovel for reference.

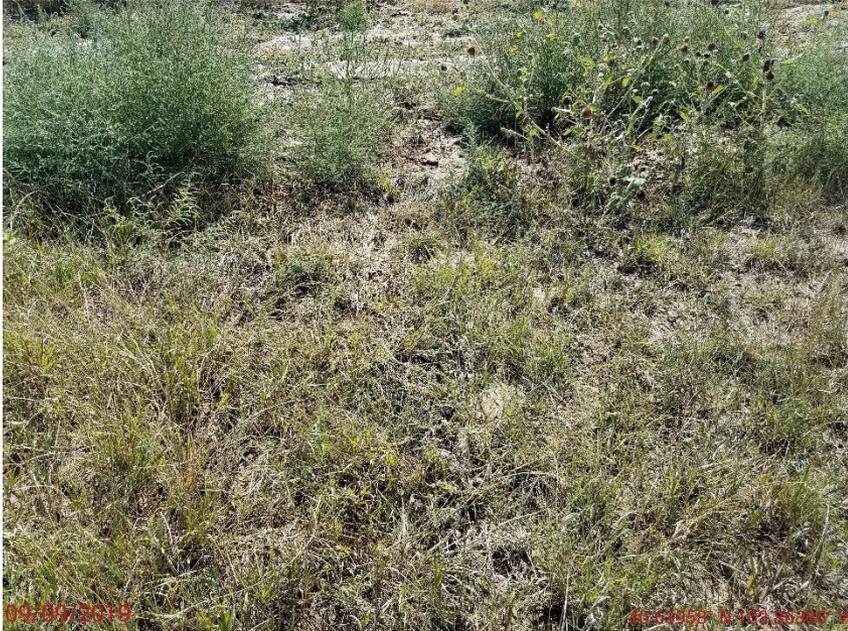
Photo 11: Photo taken from the access road. Photo shows area where stormwater runoff and sediment transport from the disturbance areas are evident.

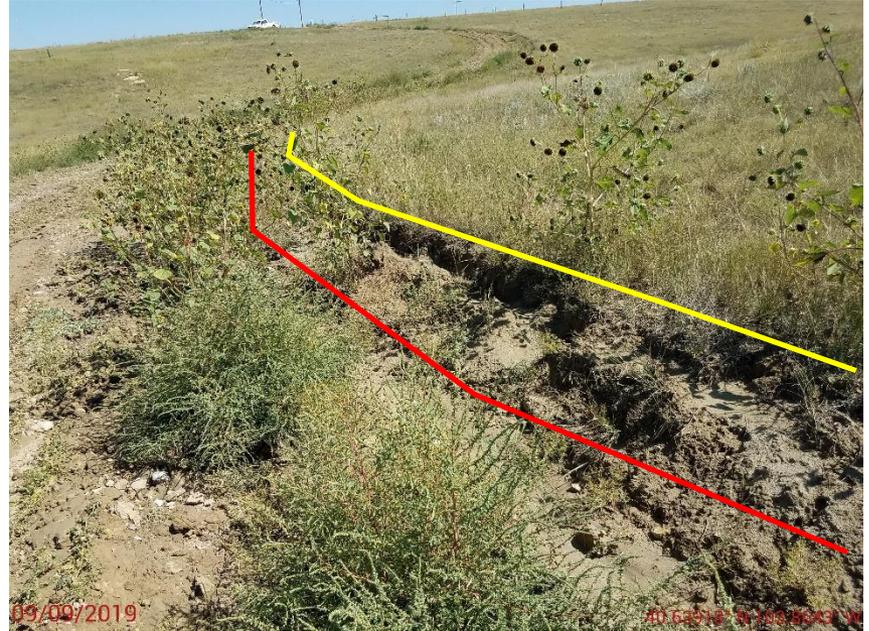
Photo 12: Photo taken from the access road, facing north. Photo shows access road (red) has not been recontoured or graded to that of the adjacent lands (yellow).

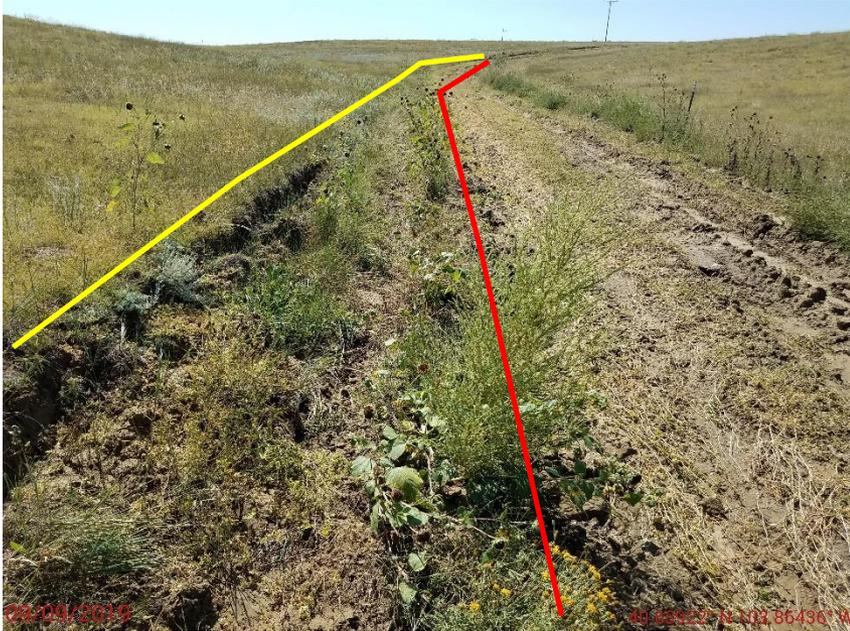
Photo 13: Photo taken from the access road, facing south. Photo shows access road (red) has not been recontoured or graded to that of the adjacent lands (yellow).

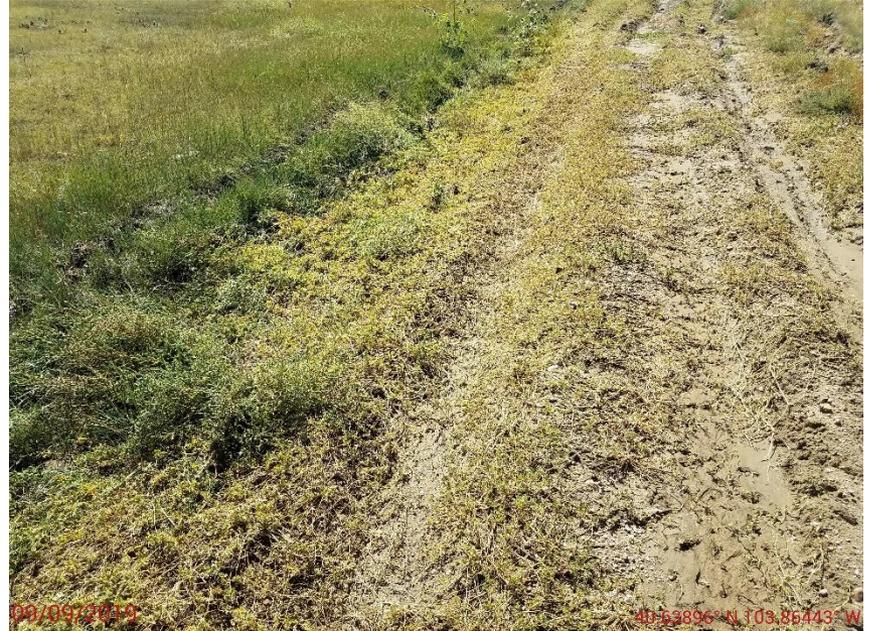
Photo 14: Photo taken from the access road. Photo shows *Tribulus terrestris* has established over a majority of the access road.

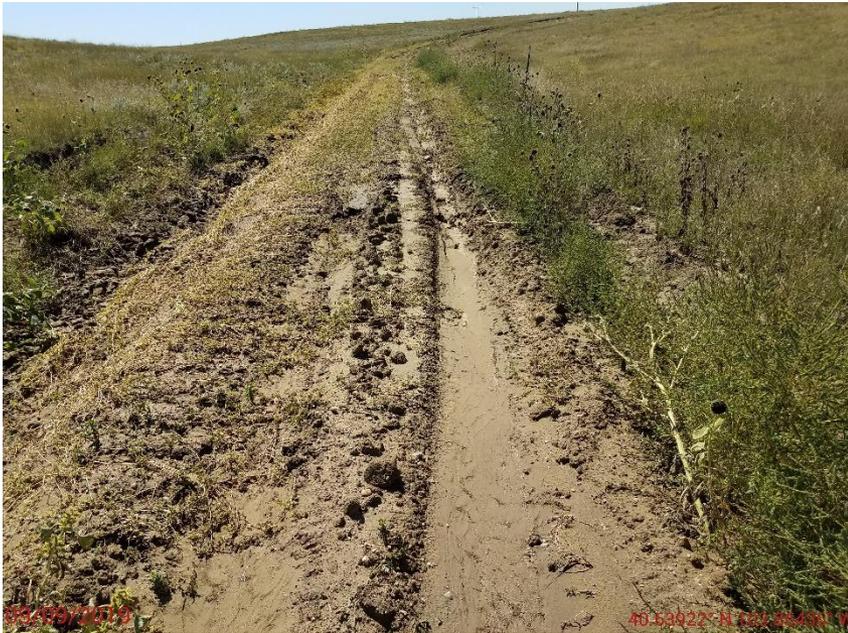
Photo 15: Additional photo of stormwater erosion degradation observed on access road. Areas of gully erosion forming. Photo also shows access road has not been recontoured or graded to that of the adjacent lands.

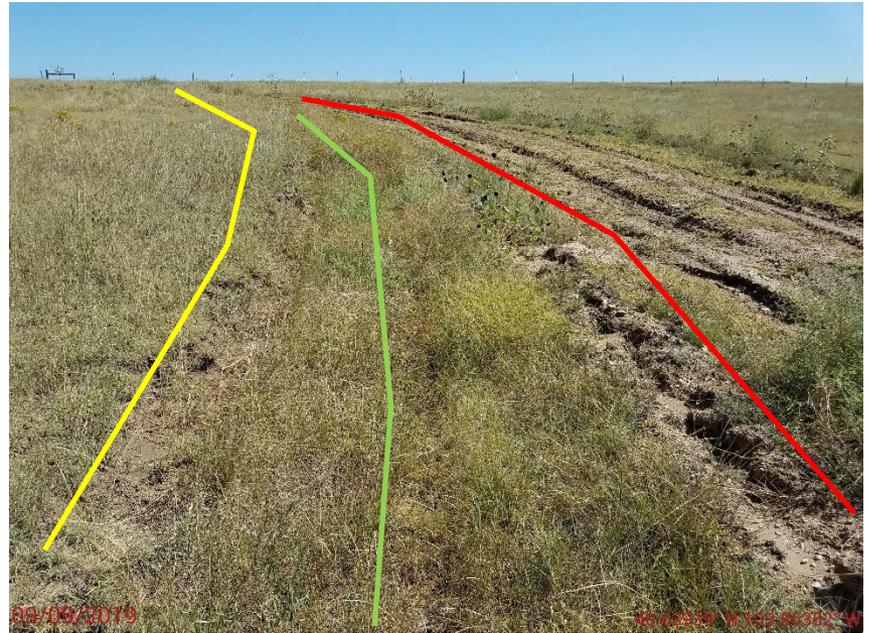
Photo 16: Photo taken from the access road, facing east. Photo shows access road (red) has not been recontoured or graded to that of the adjacent lands (yellow). Ditch (green) evident.

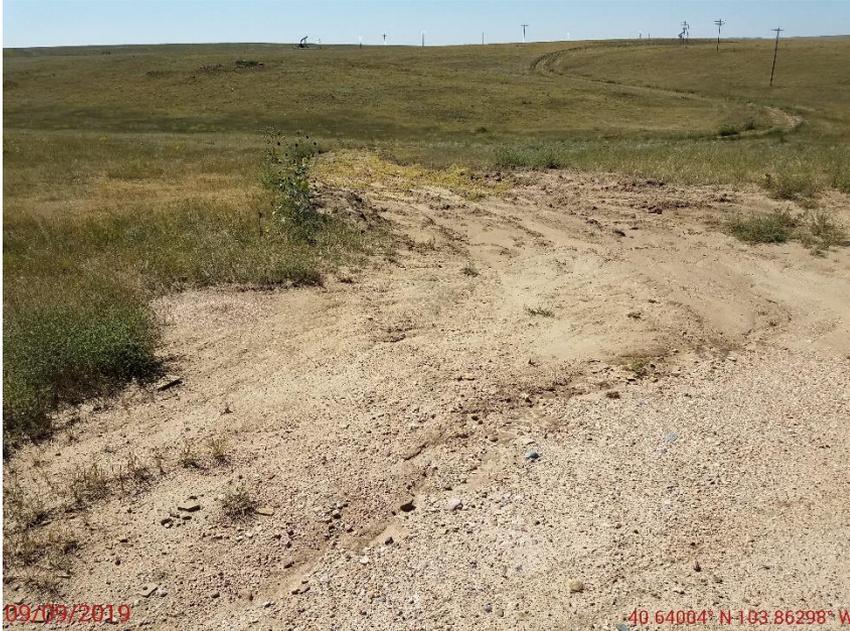
Photo 17: Photo taken from where access road intersects with main road, facing south. Photo shows erosion degradation observed on access road. Operator has not installed BMPs on location or access road.

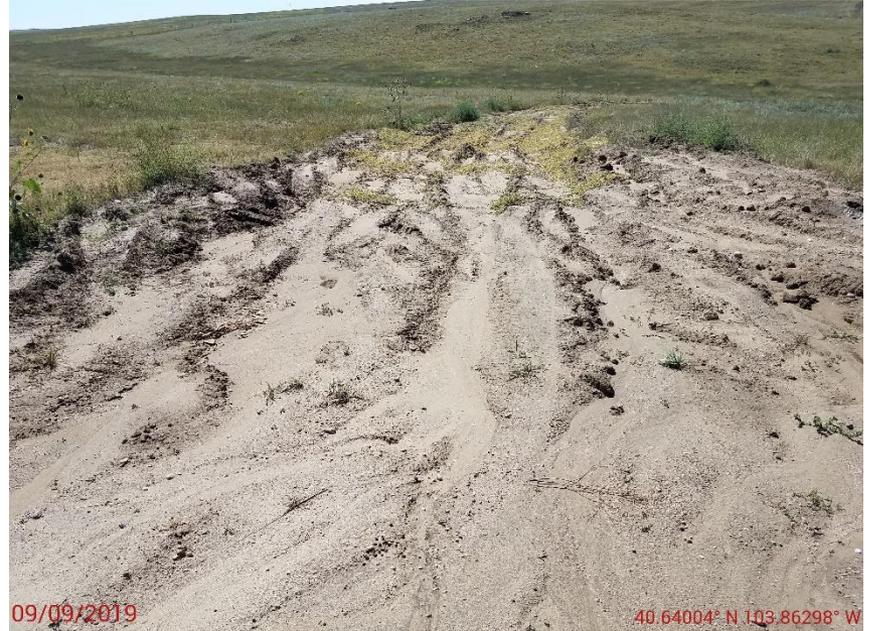
Photo 18: Photo taken from where access road intersects with main road, facing south. Photo shows erosion degradation observed on access road. Operator has not installed BMPs on location or access road.
