Inspection Photos
Operator: Benson Montin Greer
Location/API #: 067-06175
Date: 8-29-2019

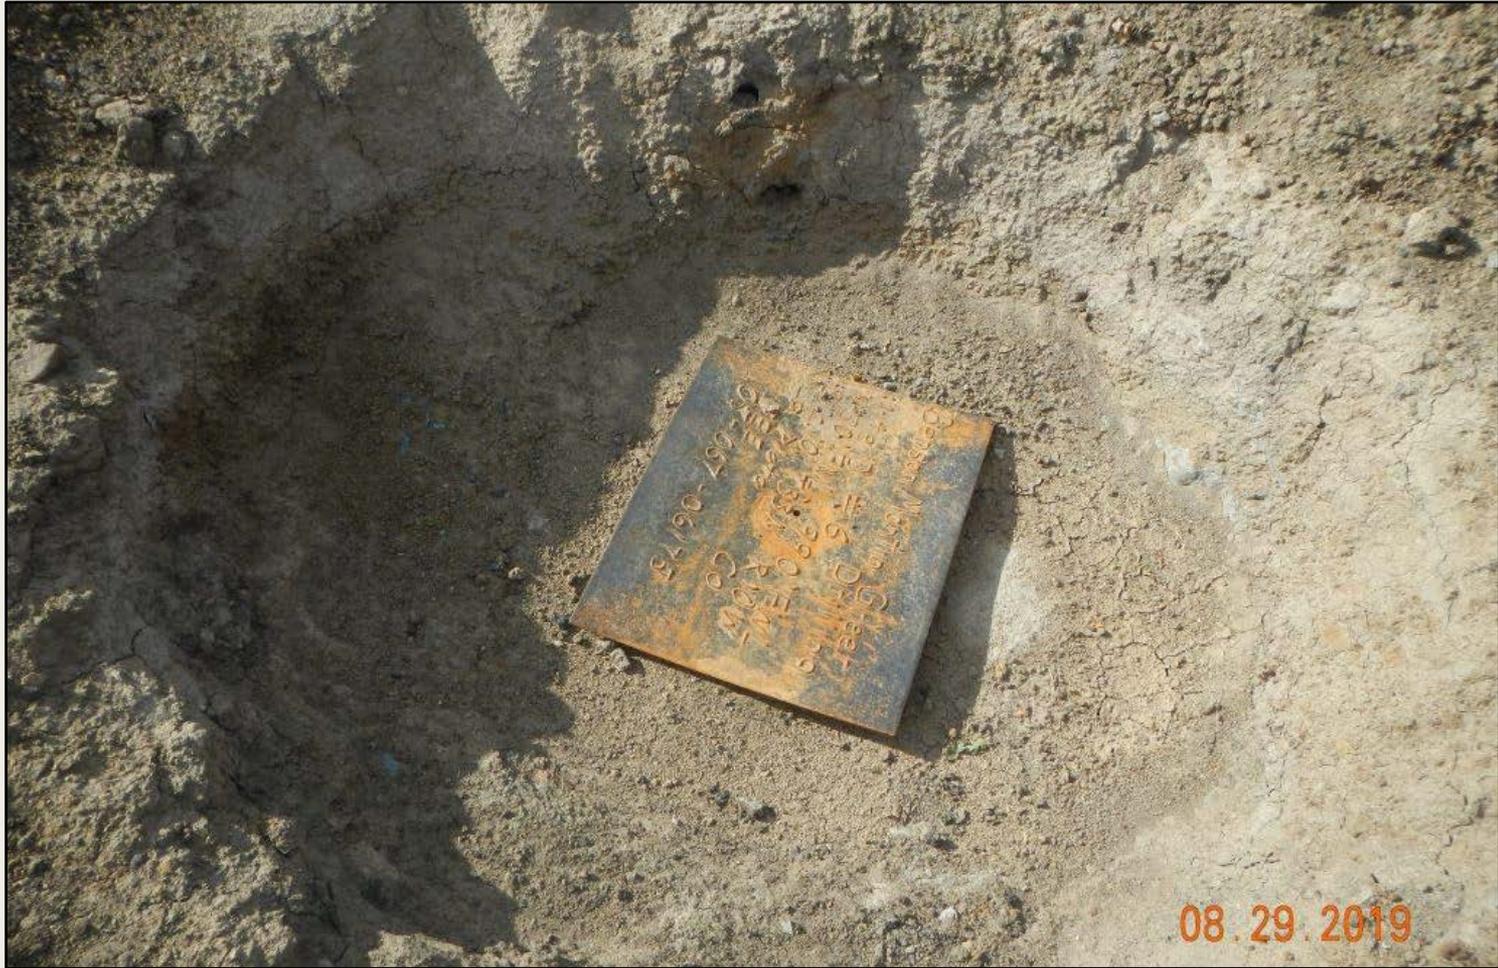
Photo 1. View of the plugged well marker.

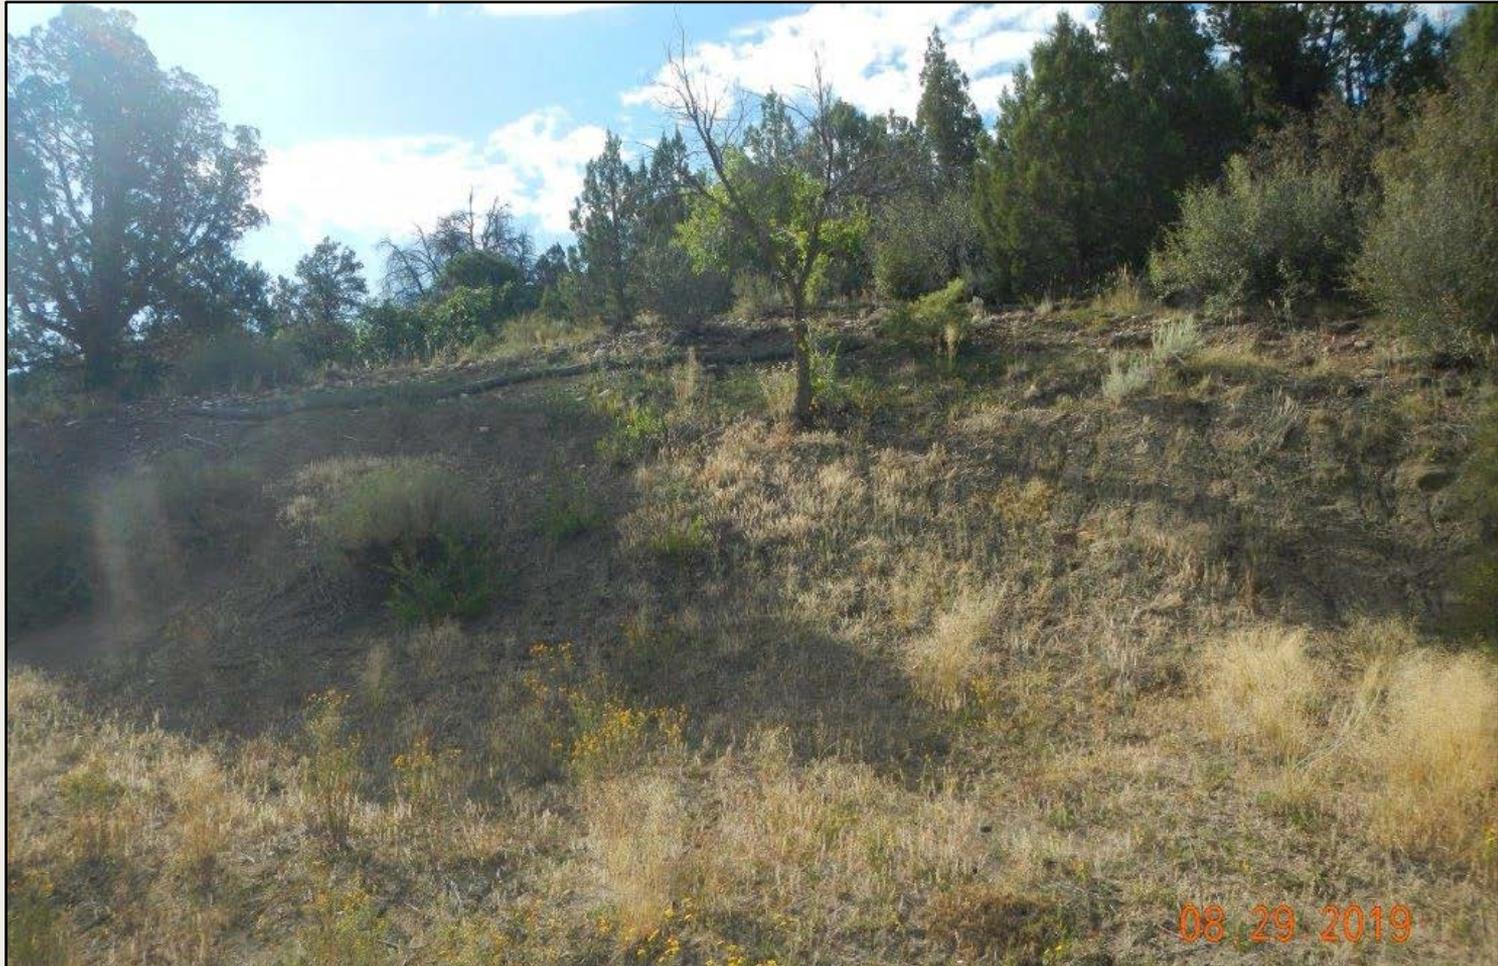
Photo 2. View of southern cut-slope, largely comprised of annual weeds such as cheatgrass (*Bromus tectorum*) and alyssum (*Allysum simplex*) This slope is not stabilized as annual weeds, bare soils, and rilling observed.

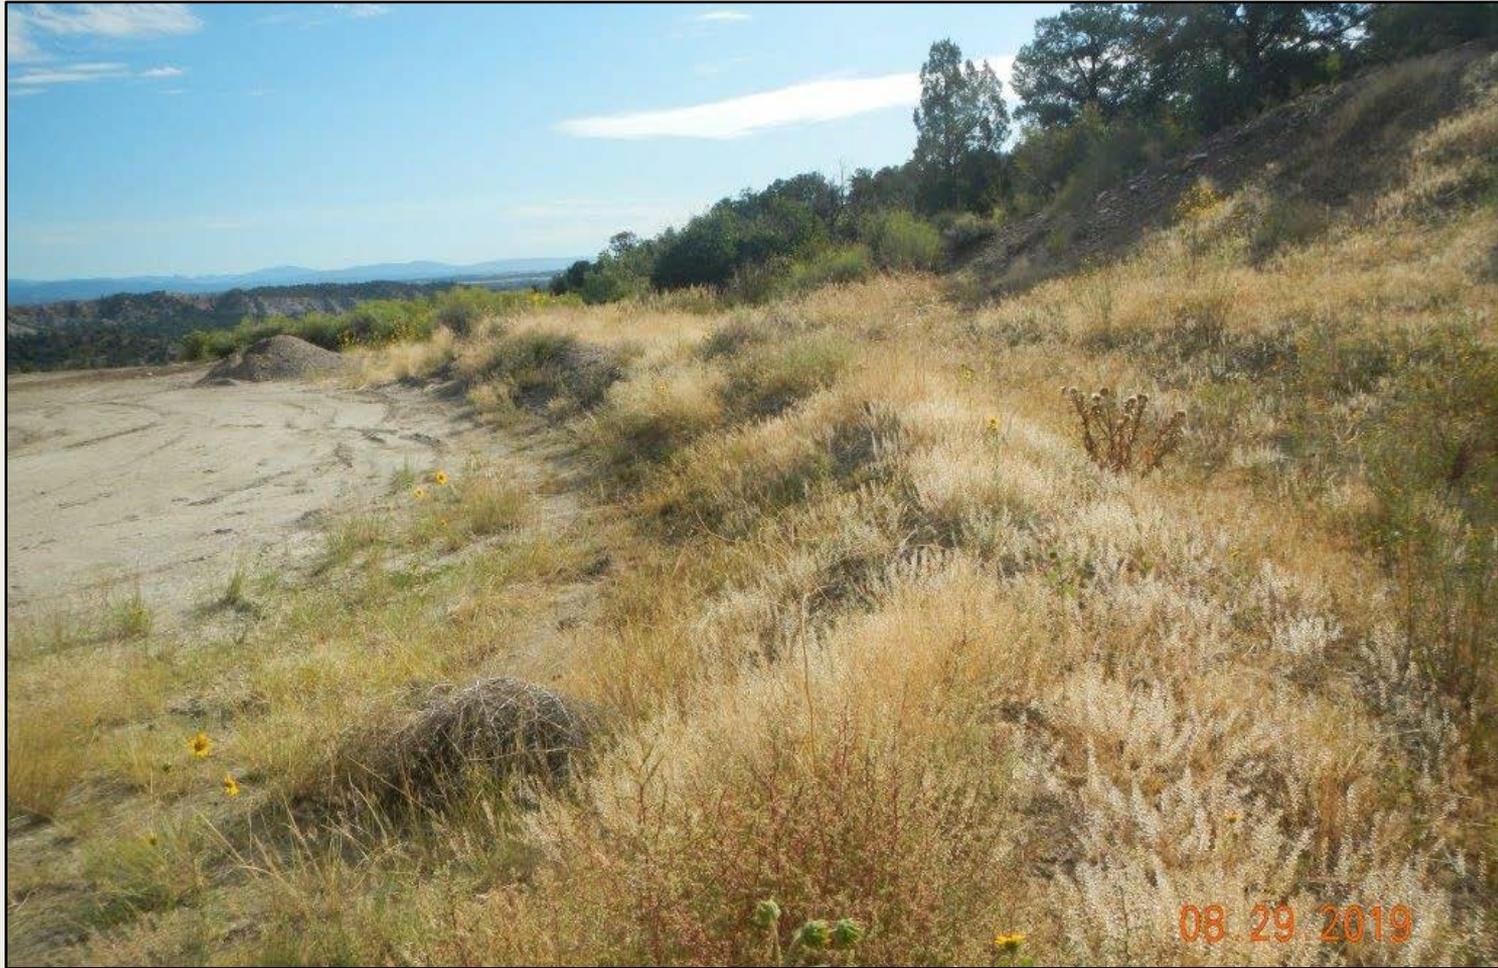
Photo 3. View of the southern berm and diversion, largely comprised of annual weeds such as cheatgrass, Russian thistle, and alyssum.

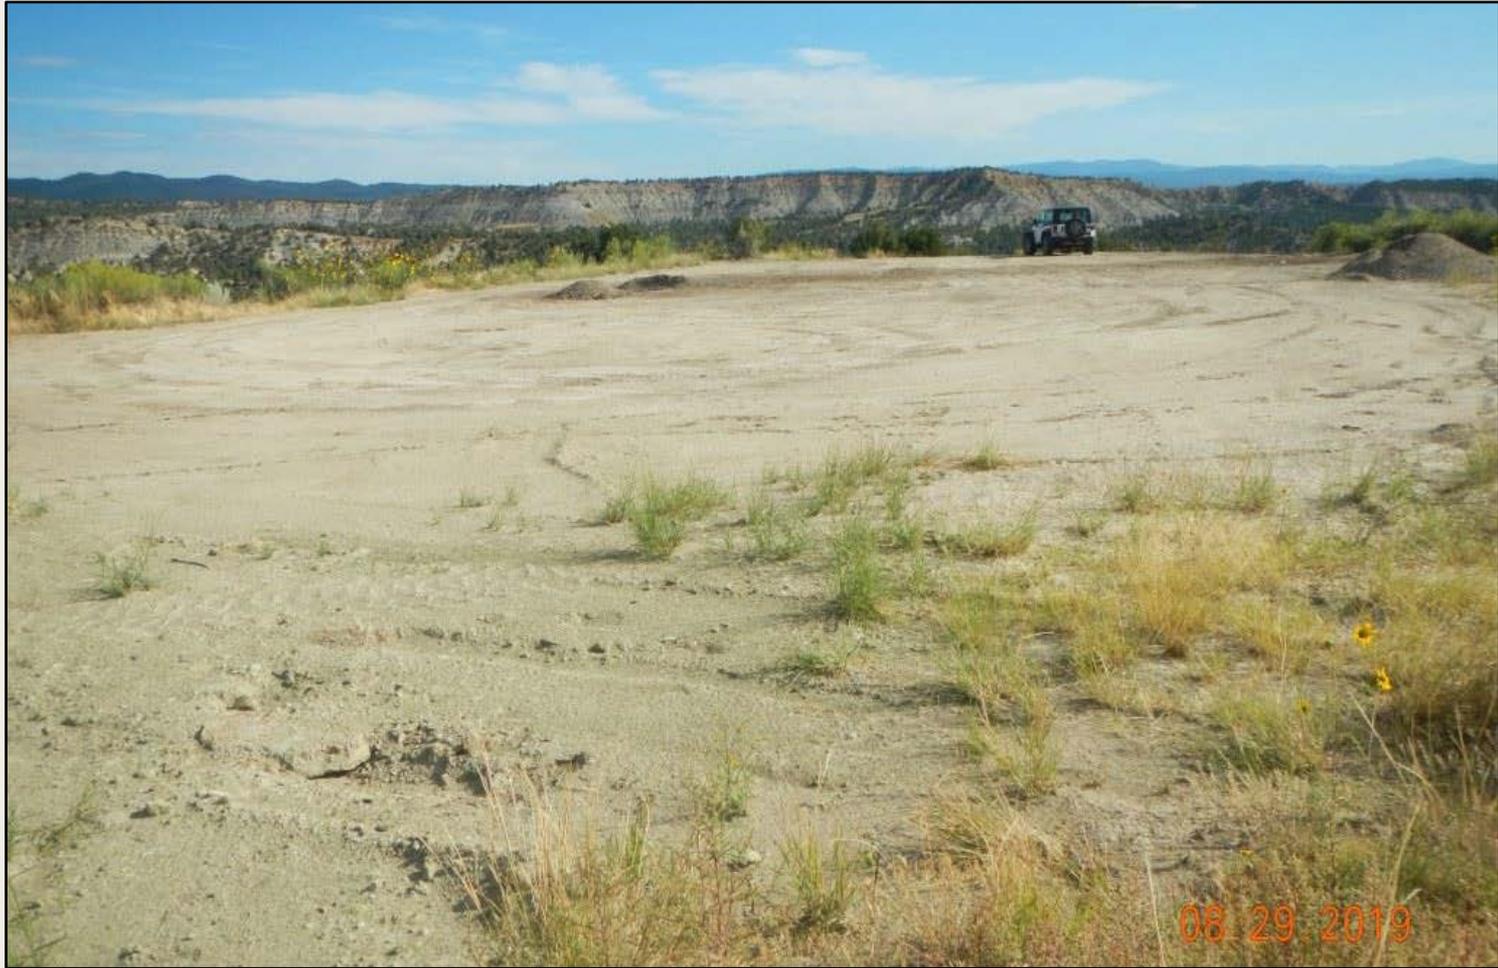
Photo 4. View of the well pad area from the southwestern edge facing center.

Sediment deposition down slope appears to be ongoing erosion

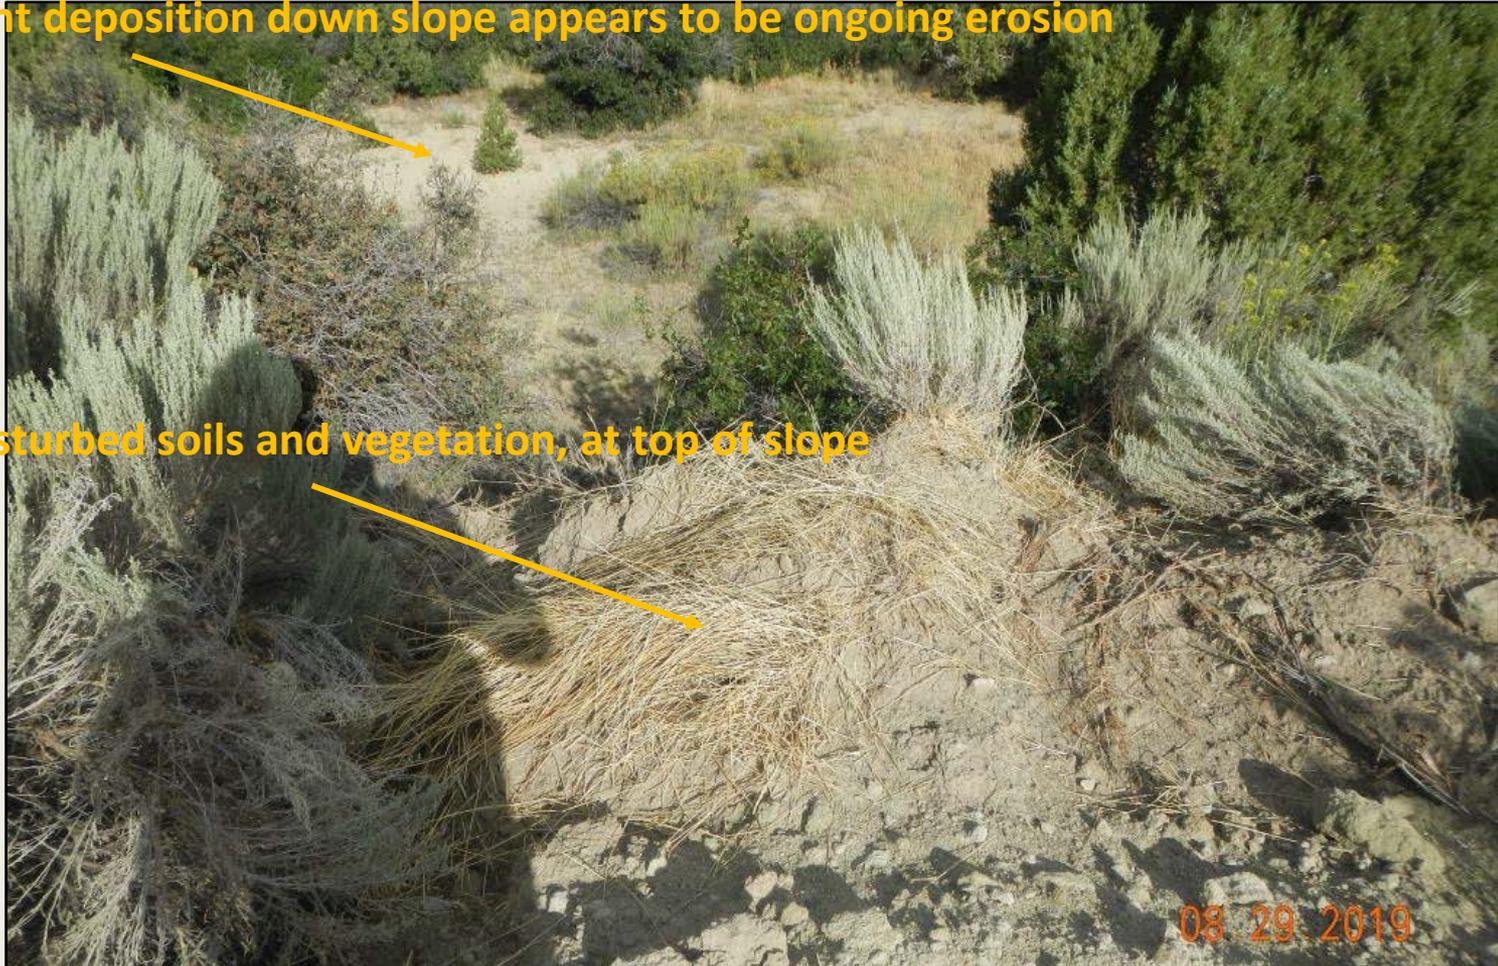
Loose disturbed soils and vegetation, at top of slope

Photo 5. View of area in the western project area that is disturbed, and evidence of ongoing erosion on fill slope as well as sedimentation observed.

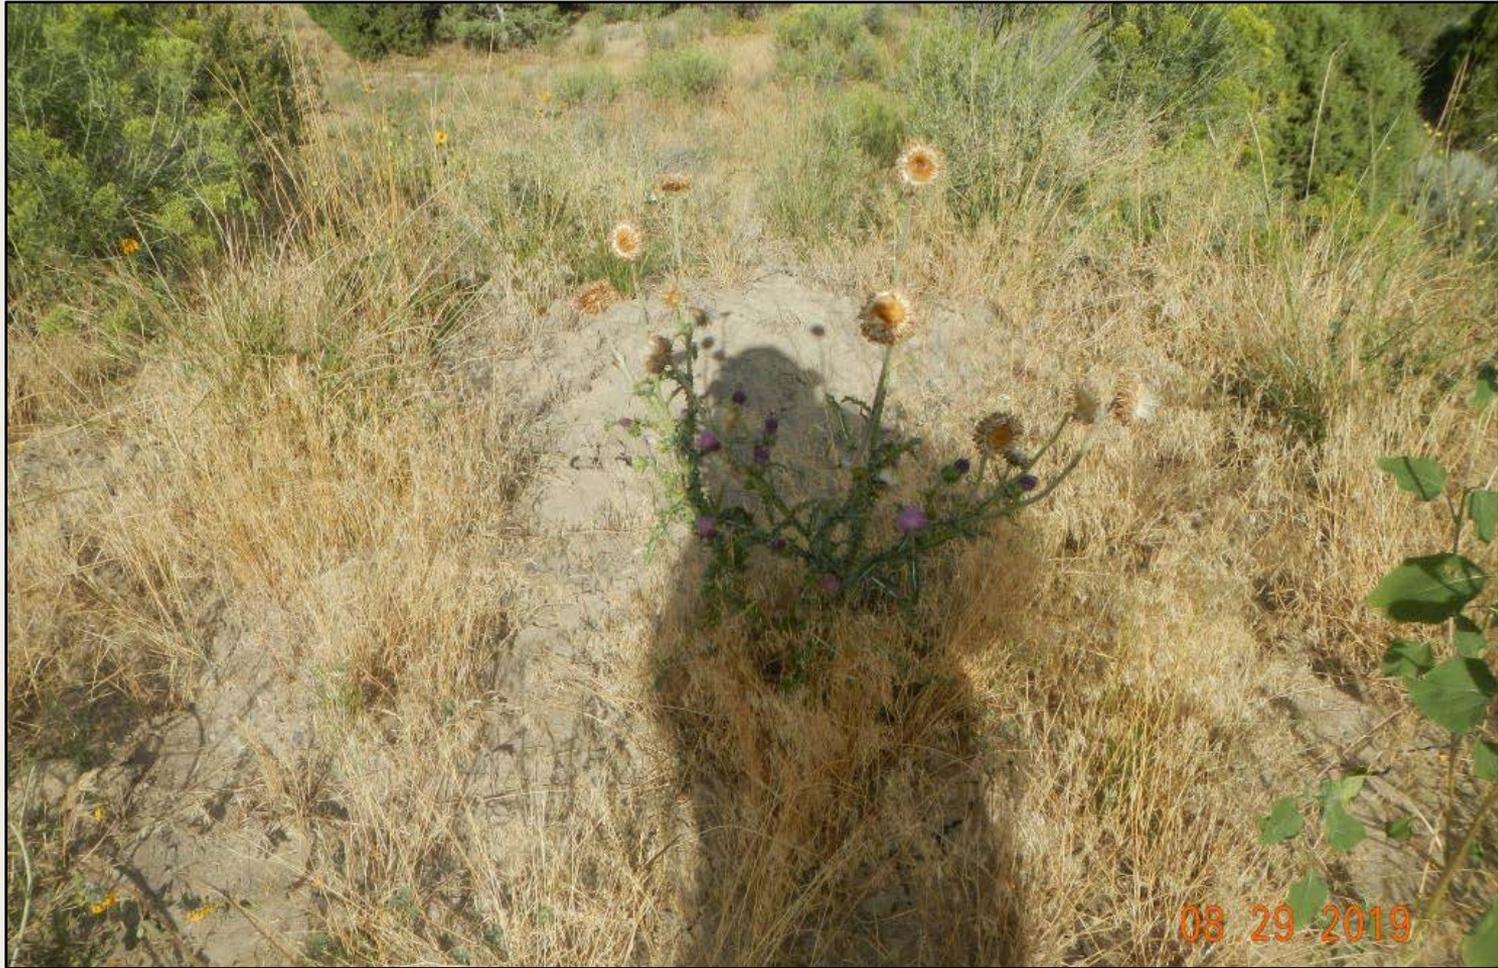
Photo 6. View of musk thistle (*Carduus nutans*) within the project area.

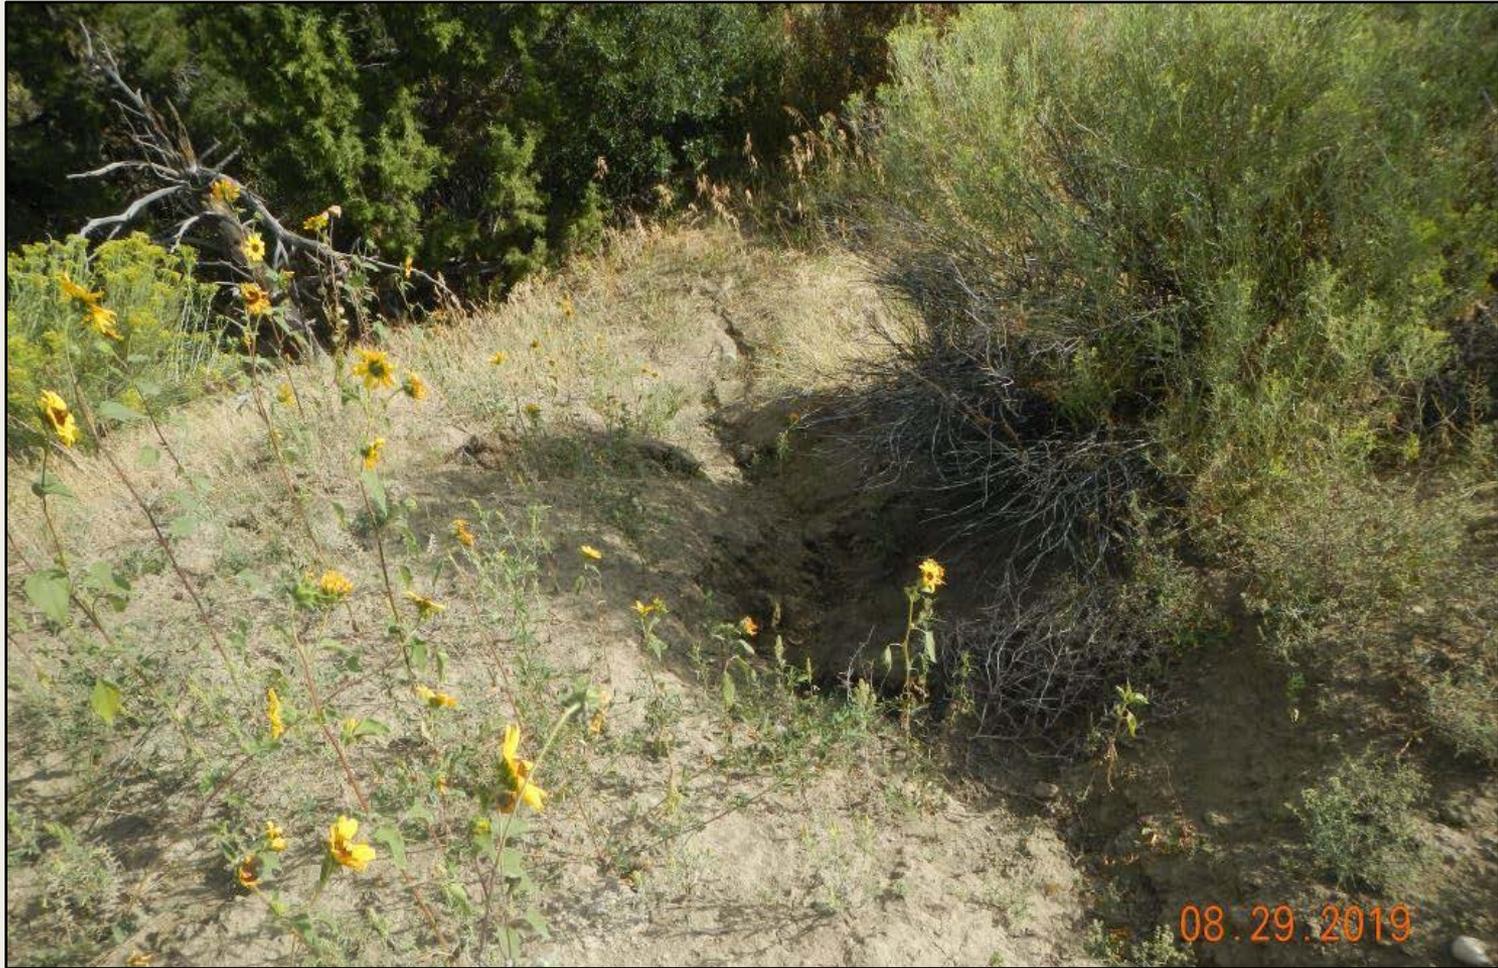
Photo 7. View of erosional channel approximately 18 inches wide and deep within the northern portion of the project area.

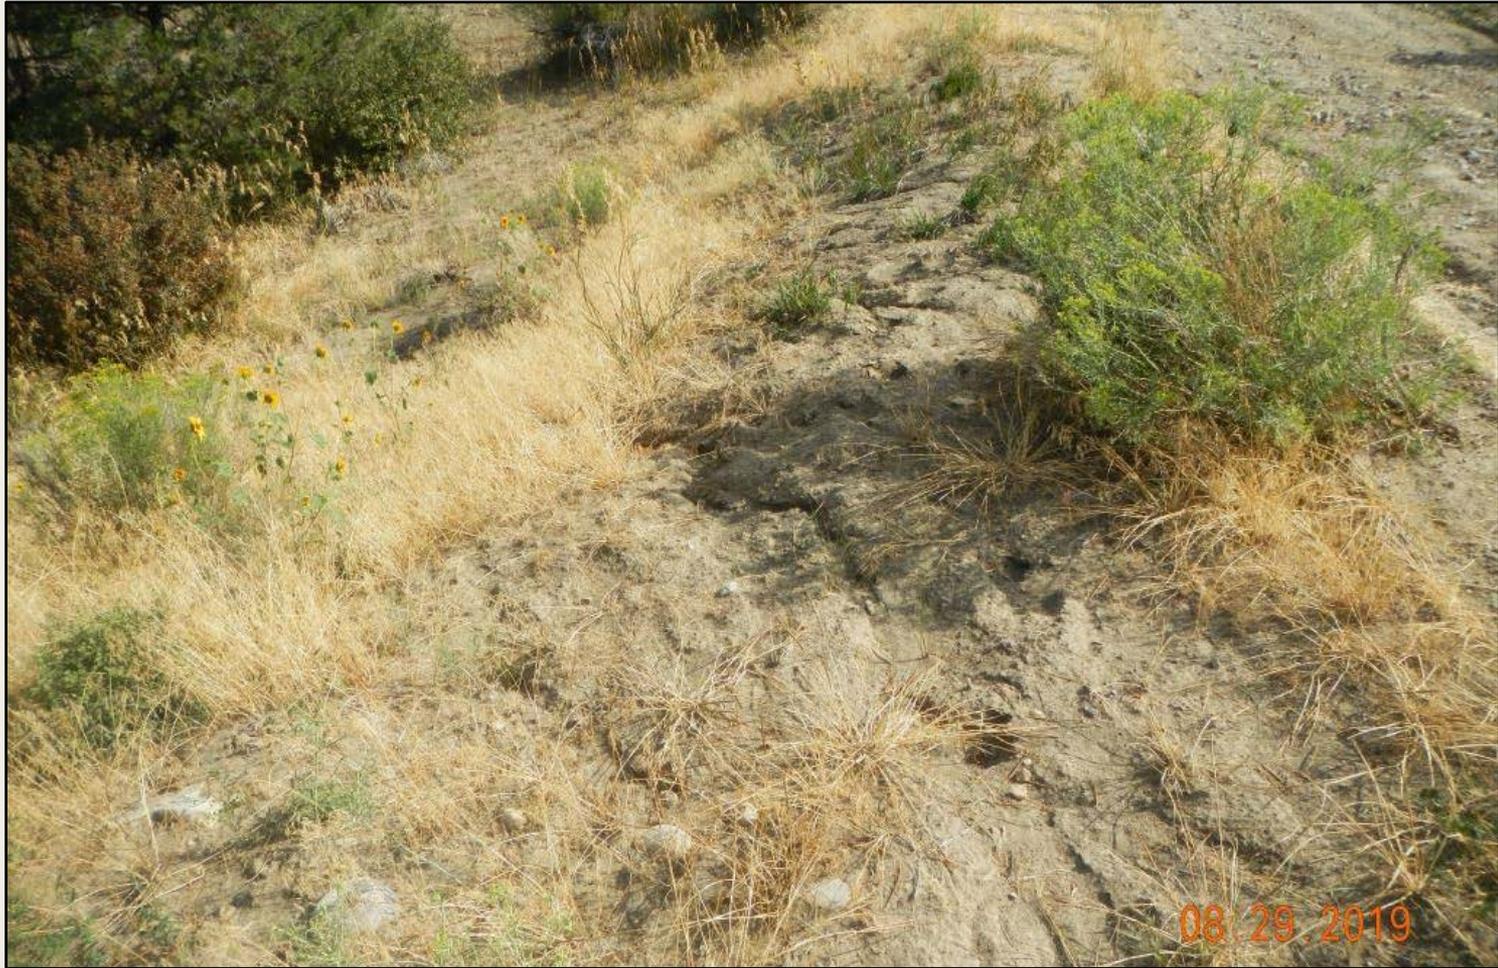
Photo 8. View of erosional channeling along the access road near the well pad entrance, facing down-slope.

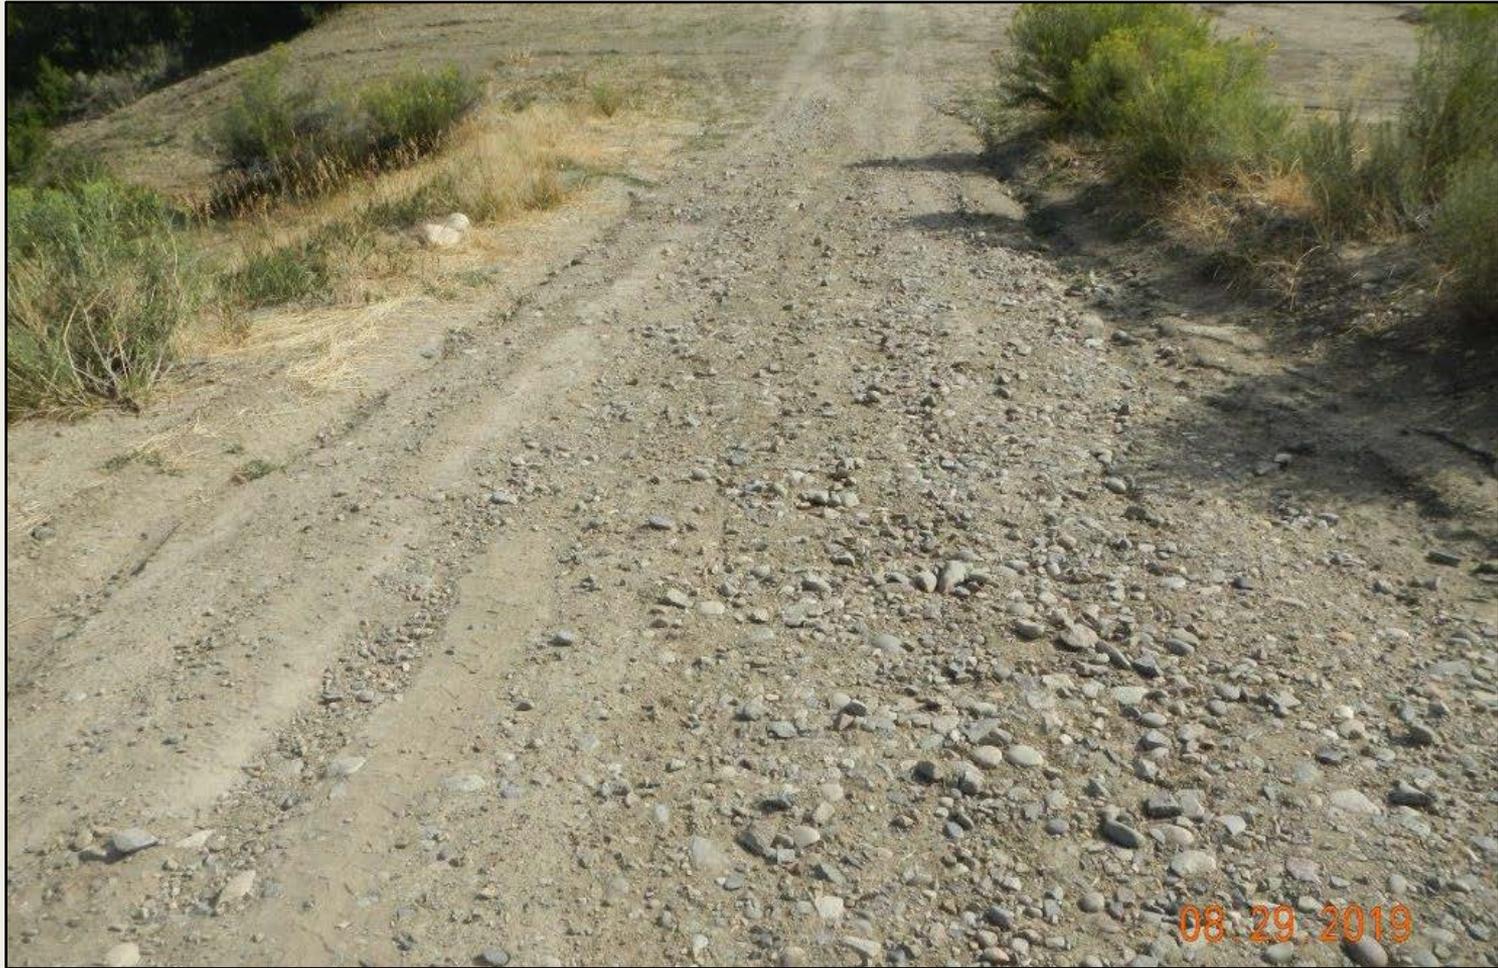
Photo 9. View of current and developing erosional channeling along the access road near the well pad entrance.

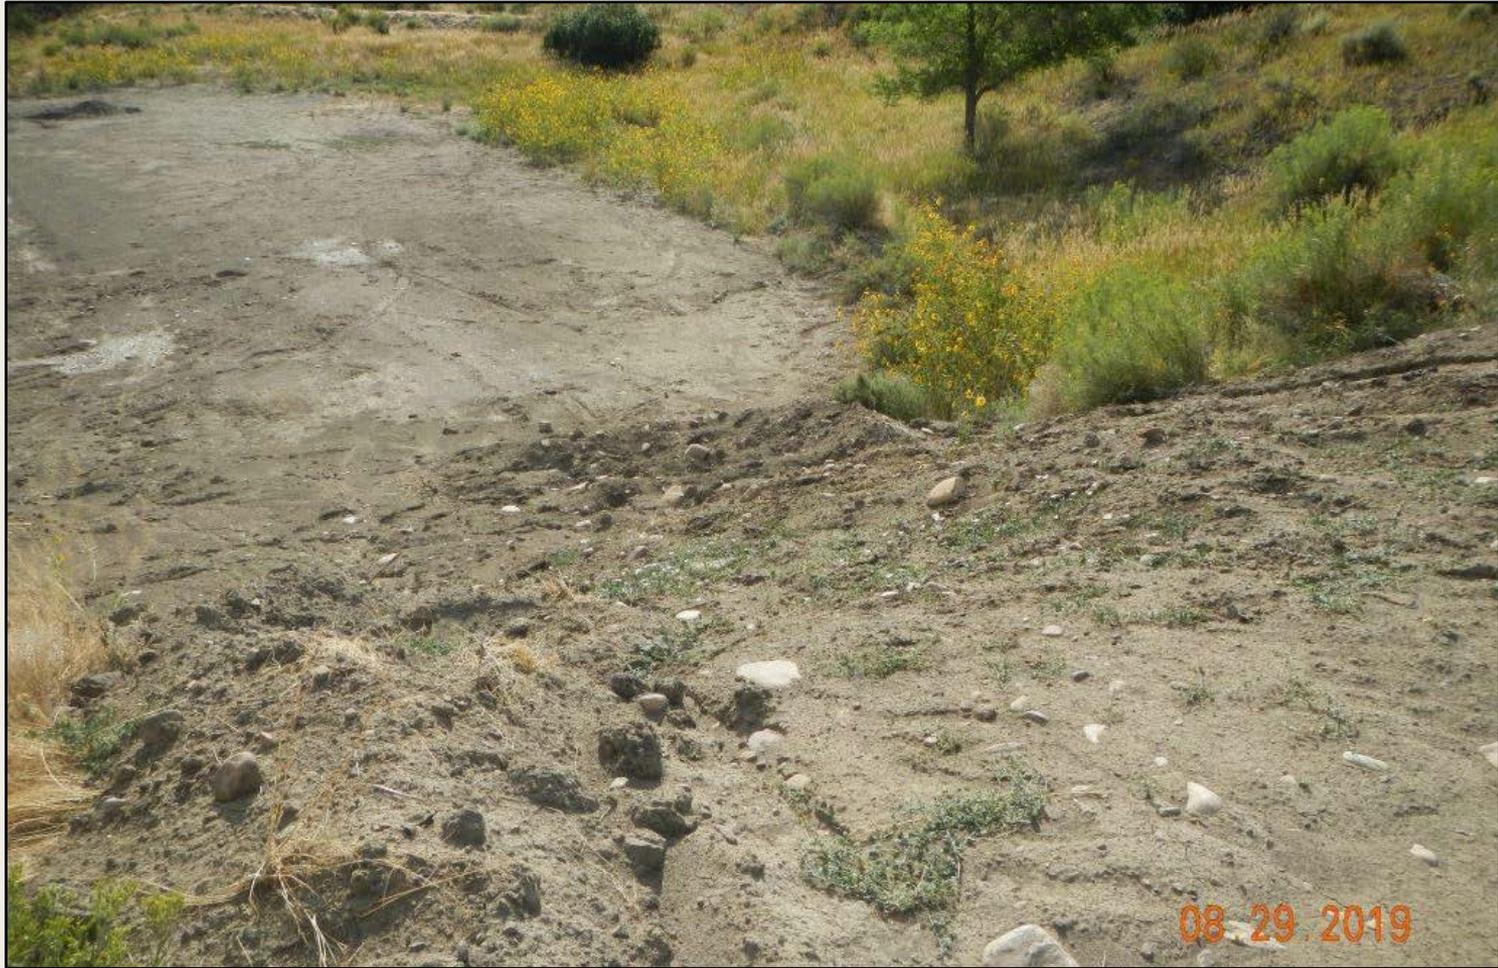
Photo 10. View of disturbed soils, unprotected within the northeastern project area, facing downslope. Rilling observed.

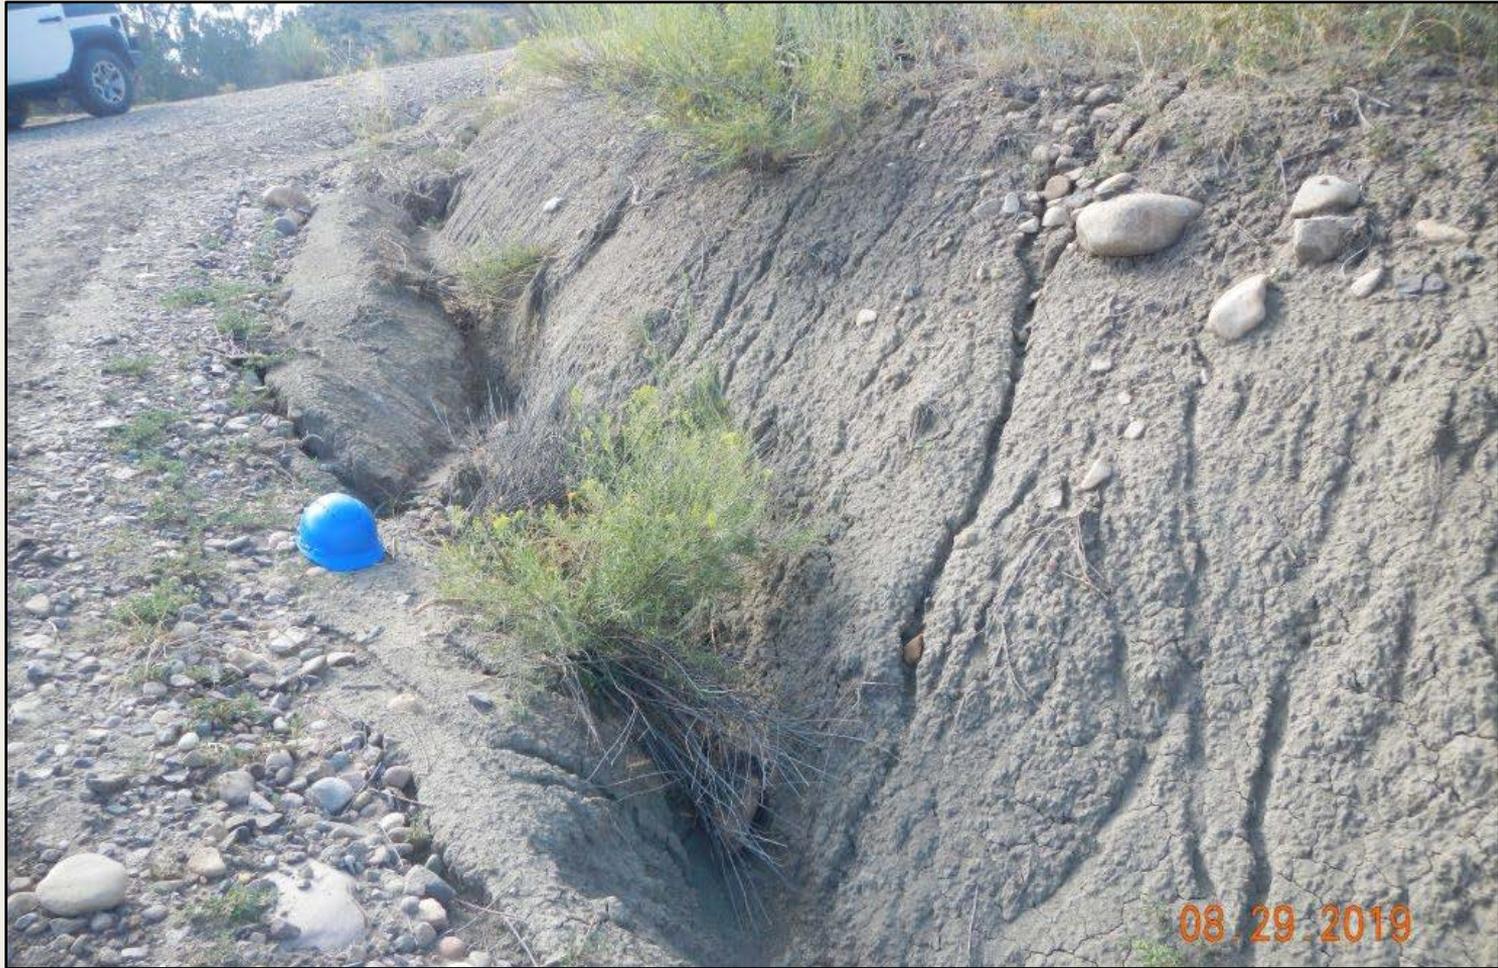
Photo 11. View of erosional channeling and rilling along the edge of the access road.

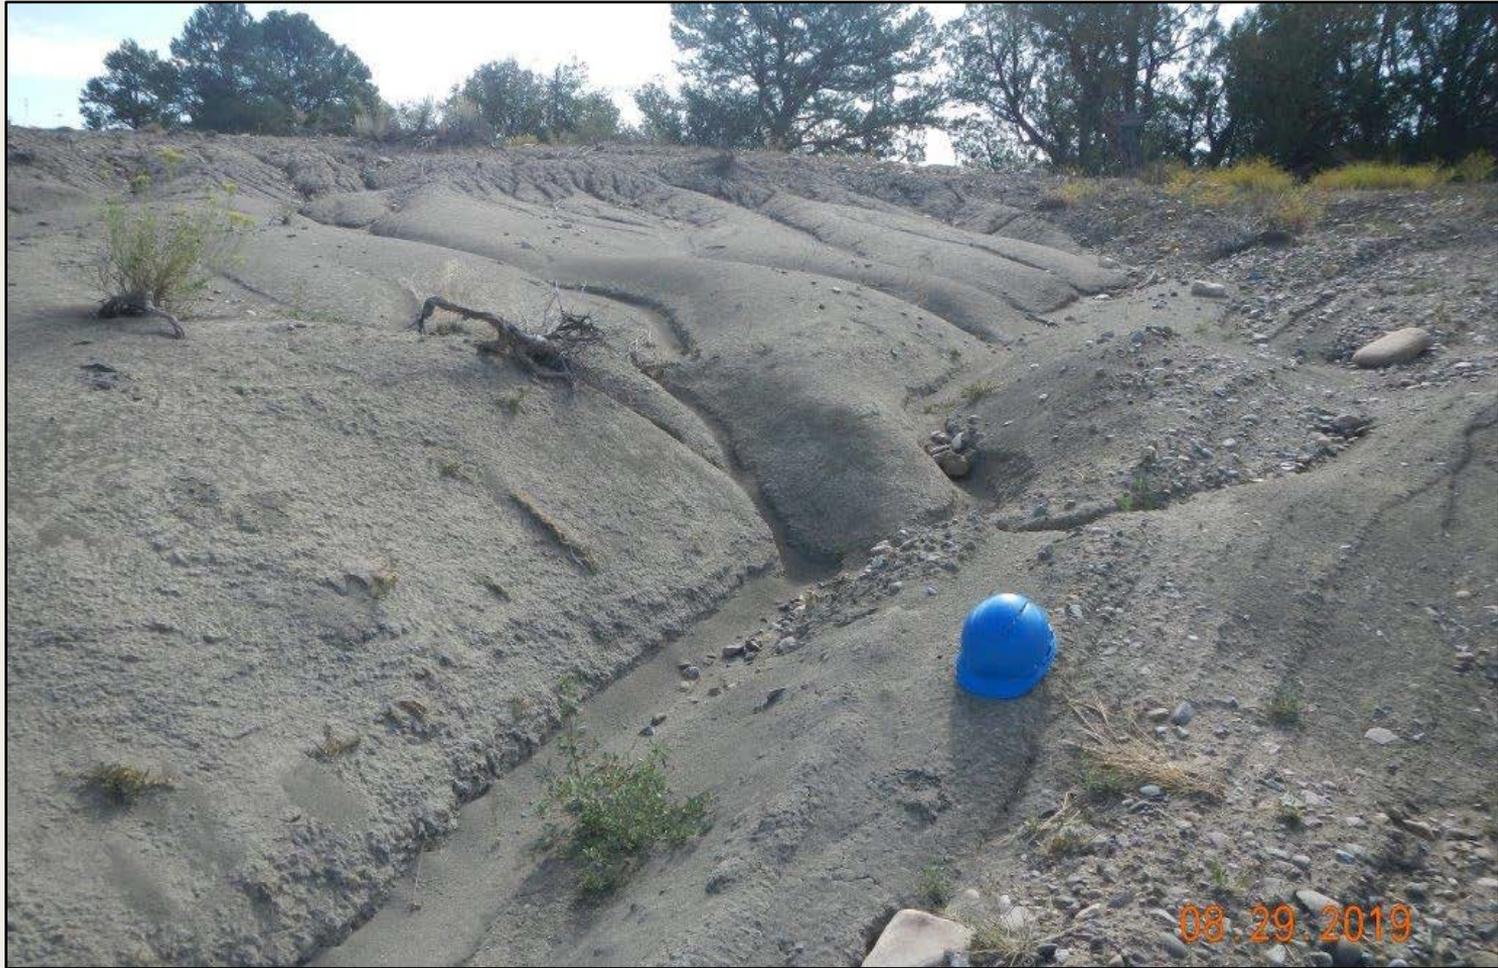
Photo 12. View of area of significant erosional channeling, scouring, and destabilized cut-slope along the access road.

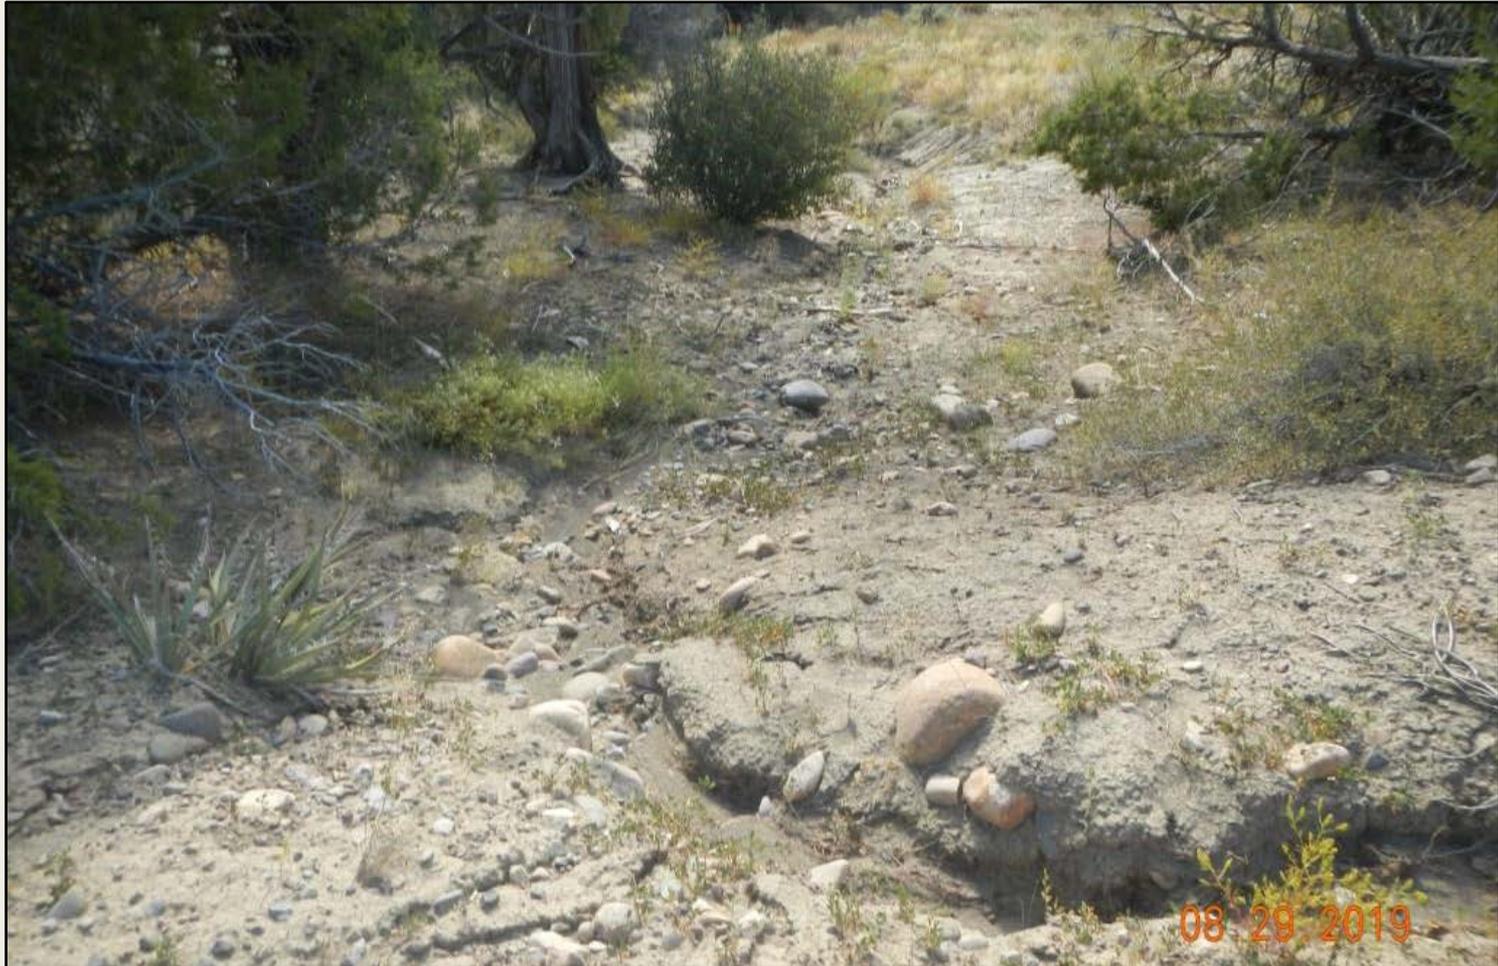
Photo 13. View of area where roadside stormwater flows are diverted without erosion or sediment controls, and erosion is occurring within a channel that is approximately 1 foot wide and deep, scouring and channeling continues downstream.

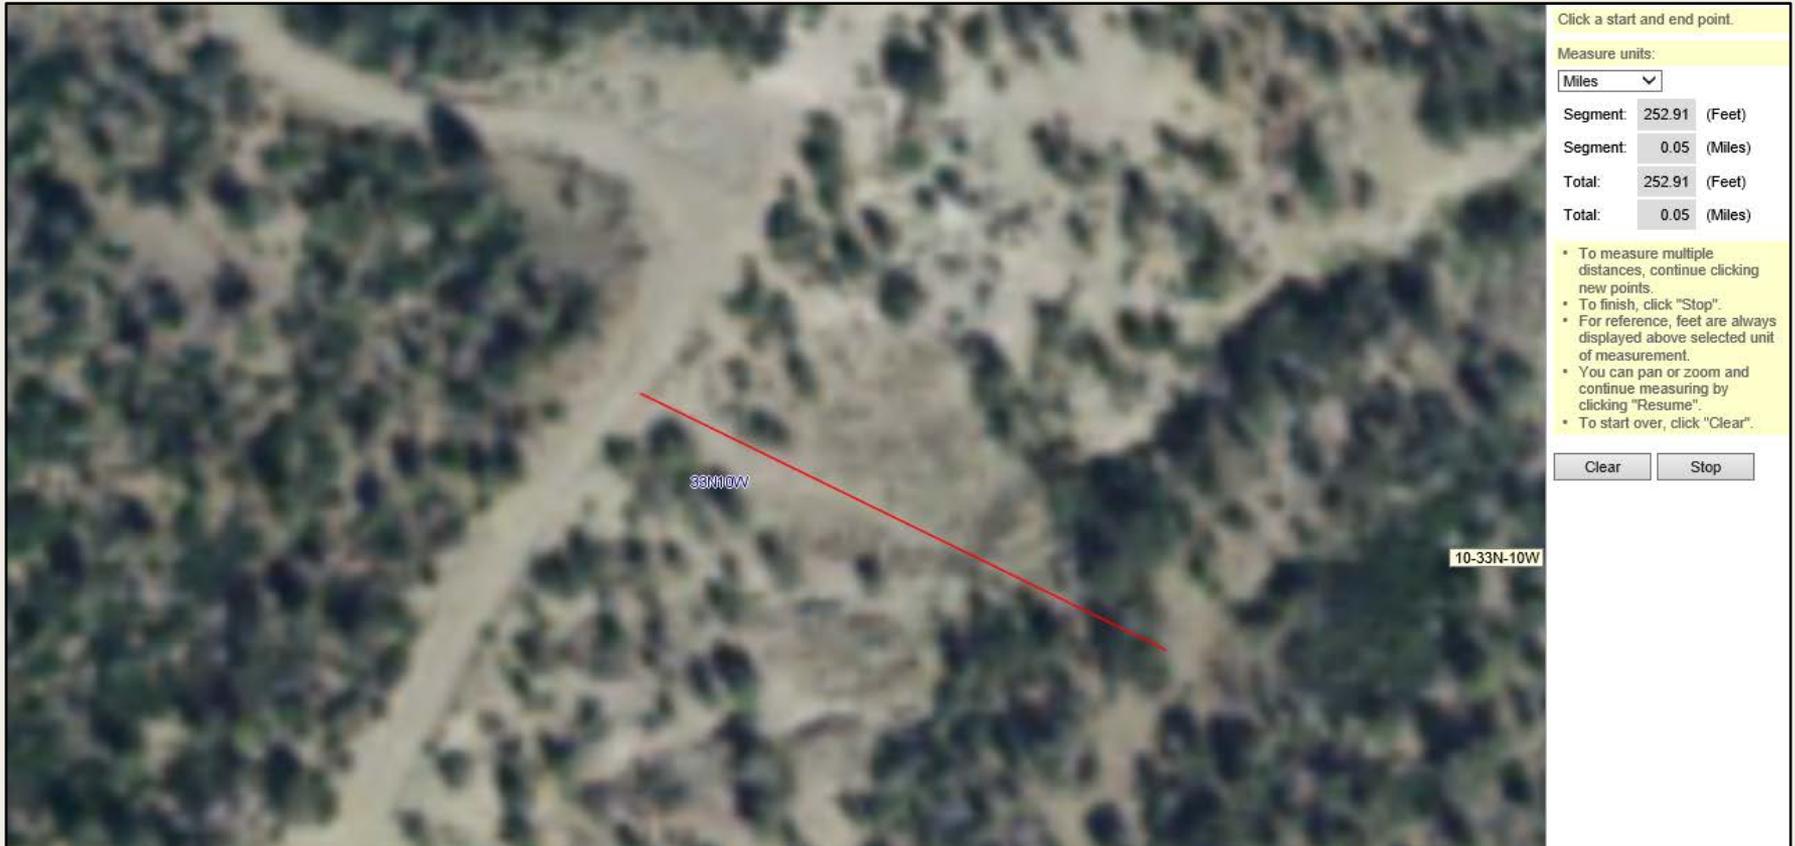
2017 aerial photograph. Red line follows example of one of the erosional channels off of the access road, measuring approximately 250 feet long.

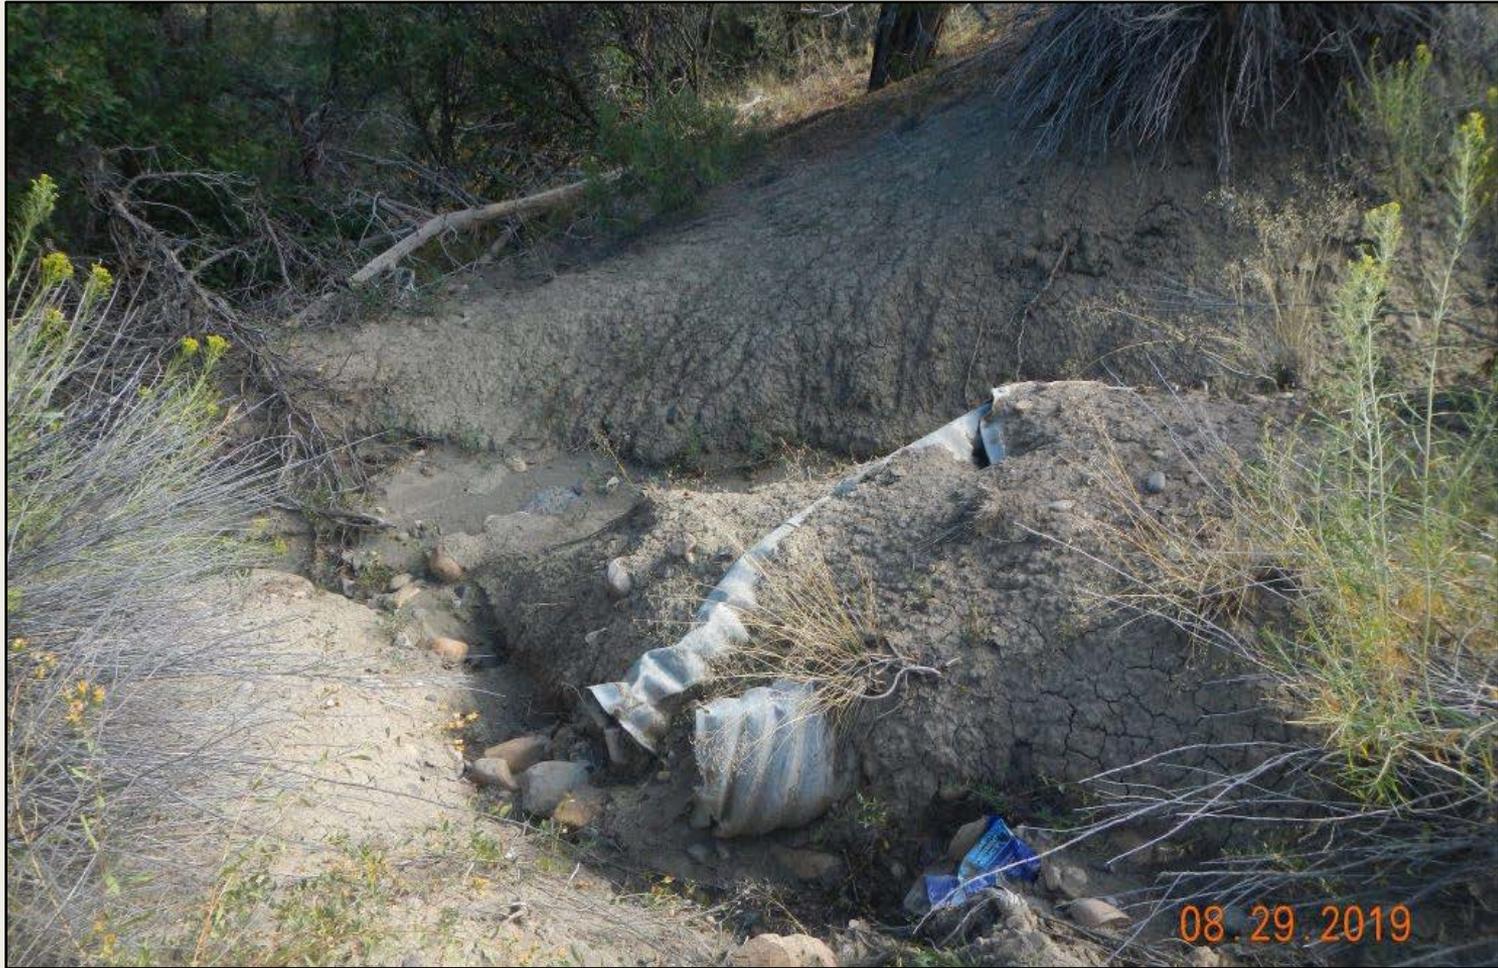
Photo 14. View of area along the access road where a blocked culvert has resulted in significant headcut erosion up to approximately 4 feet wide and deep. Culvert in photo is debris and no longer in place.
