Inspection Photos  
Operator: Benson Montin Greer  
Location/API #: 067-06117  
Date: 8-29-2019

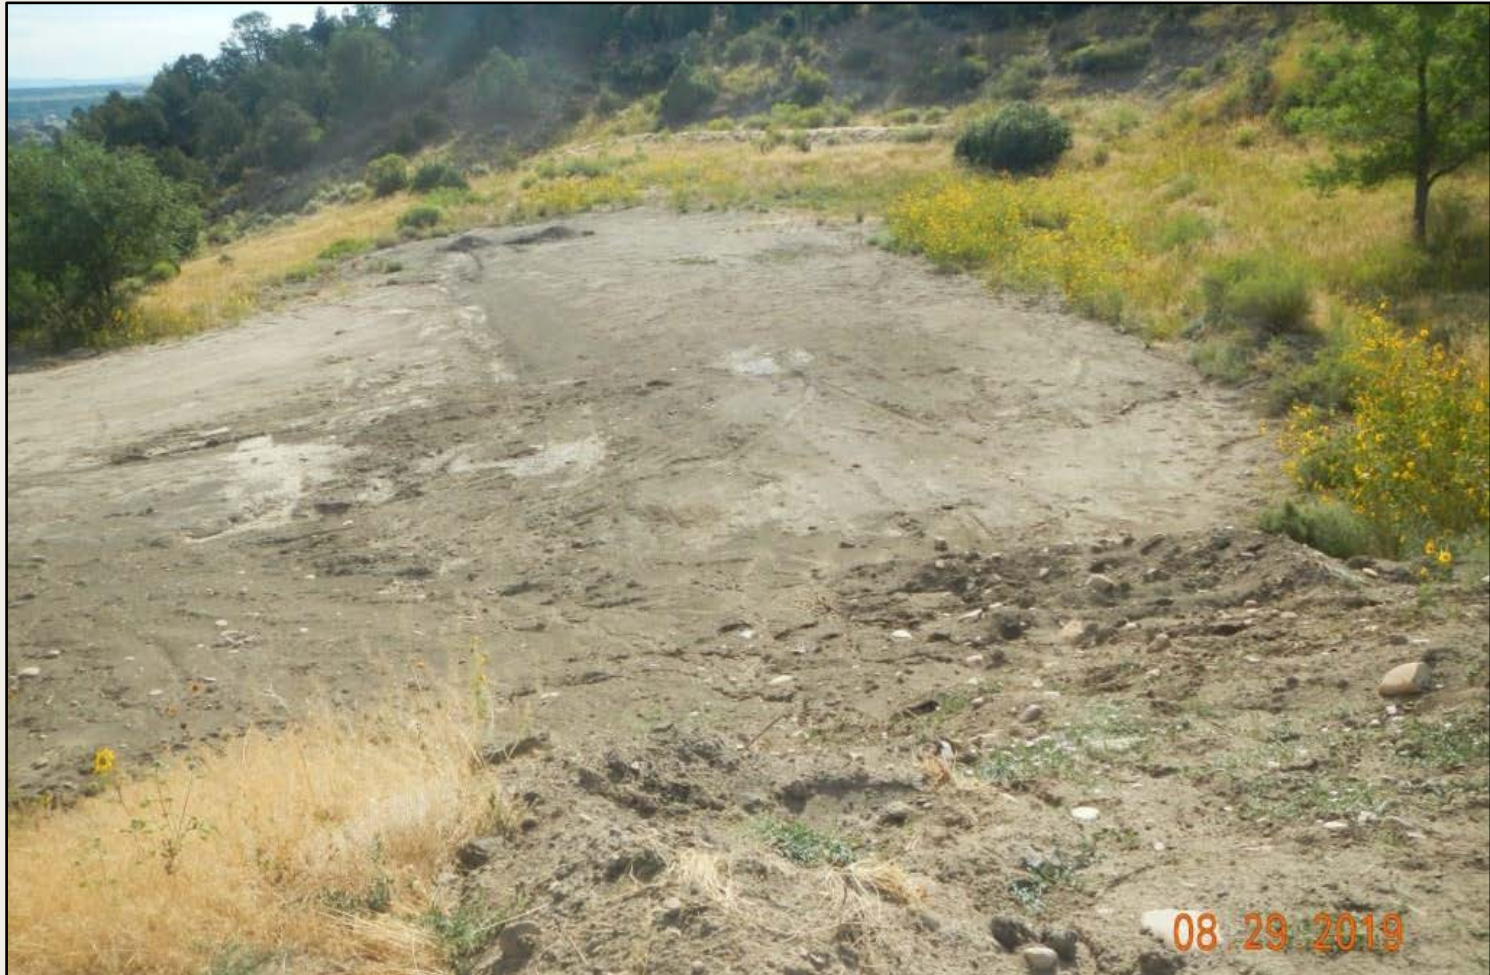
Photo 1. View of the project area from the western edge facing center. Plugged well in background where mounds of soil are present.

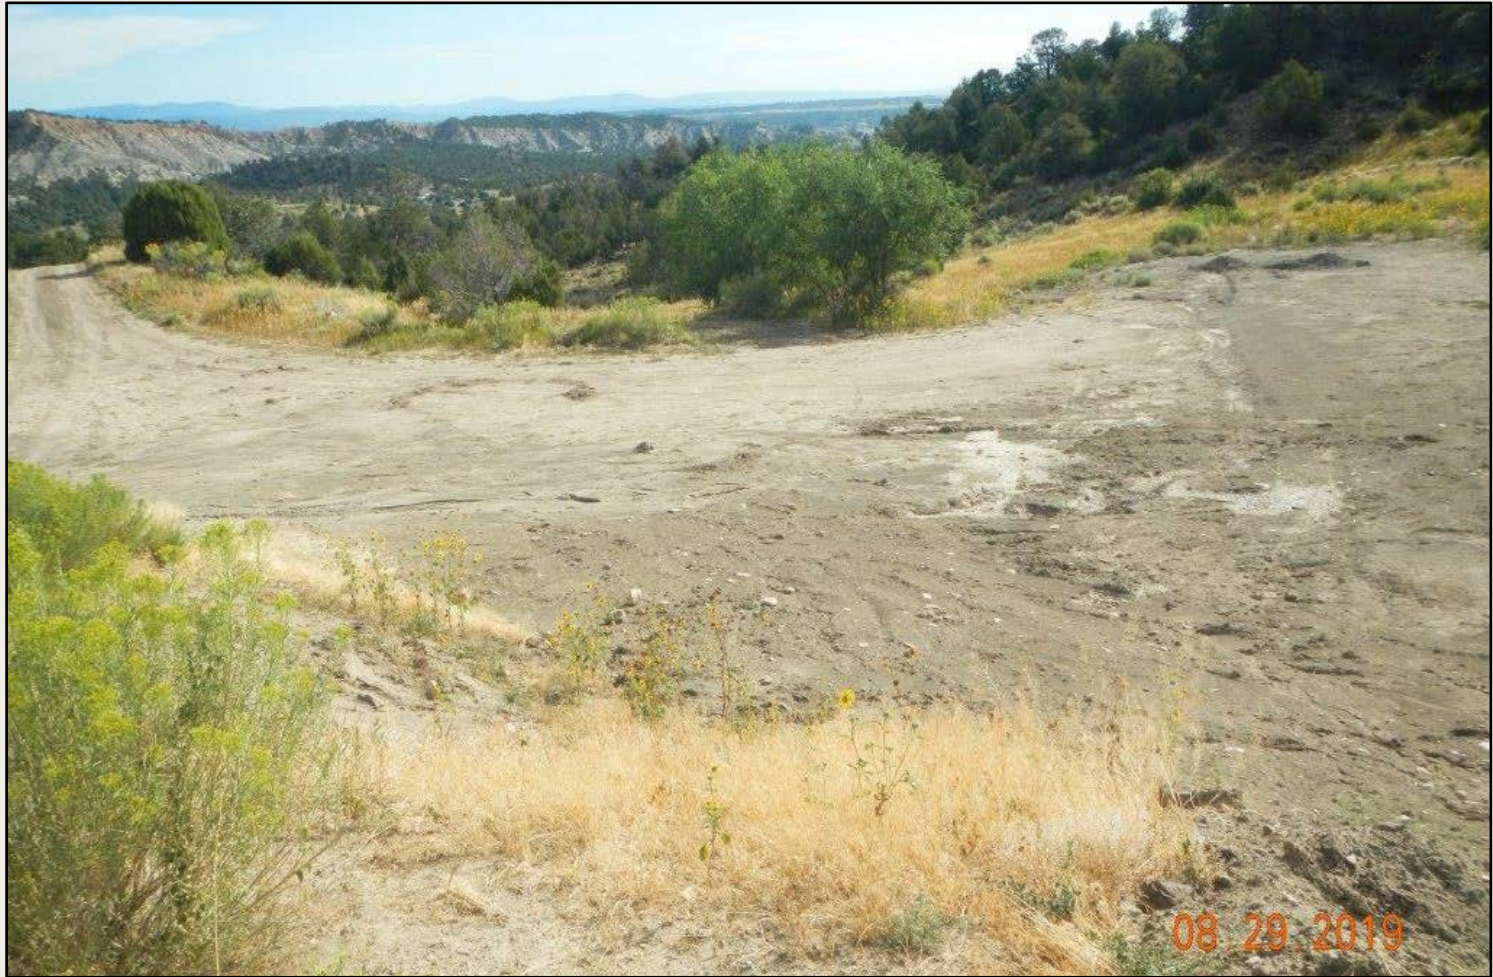
Photo 2. View of the northwestern project area from the western edge facing northward. Flow pattern toward the northwest observed (See photos 3 and 4)

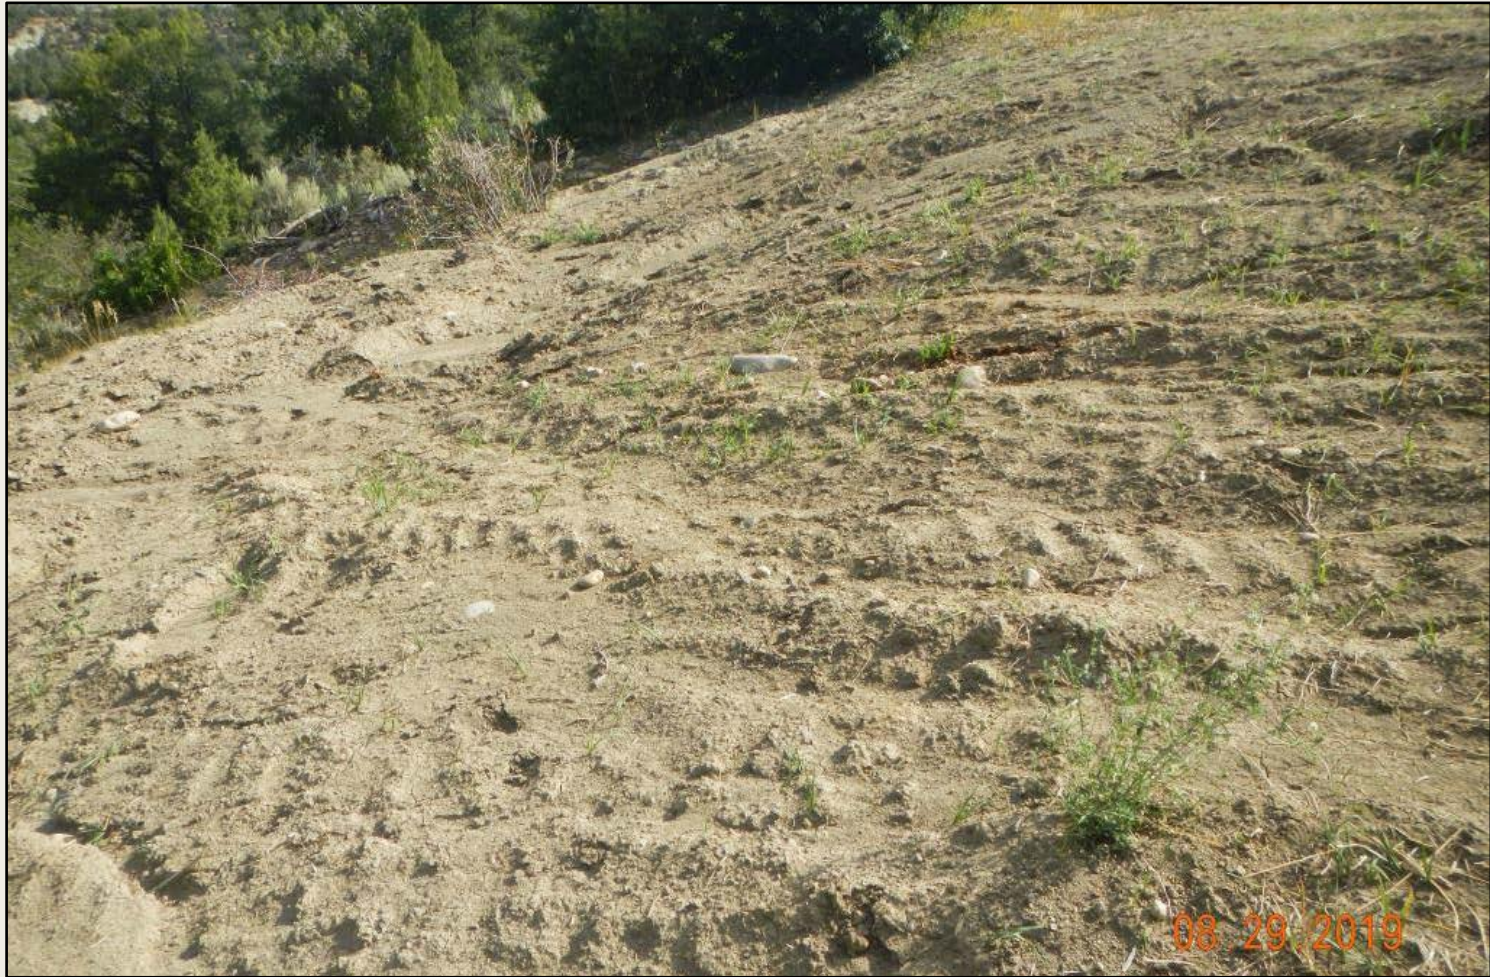
Photo 3. View of area northwest of photo two, along the flowline disturbance, where soils are disturbed and are not stabilized.

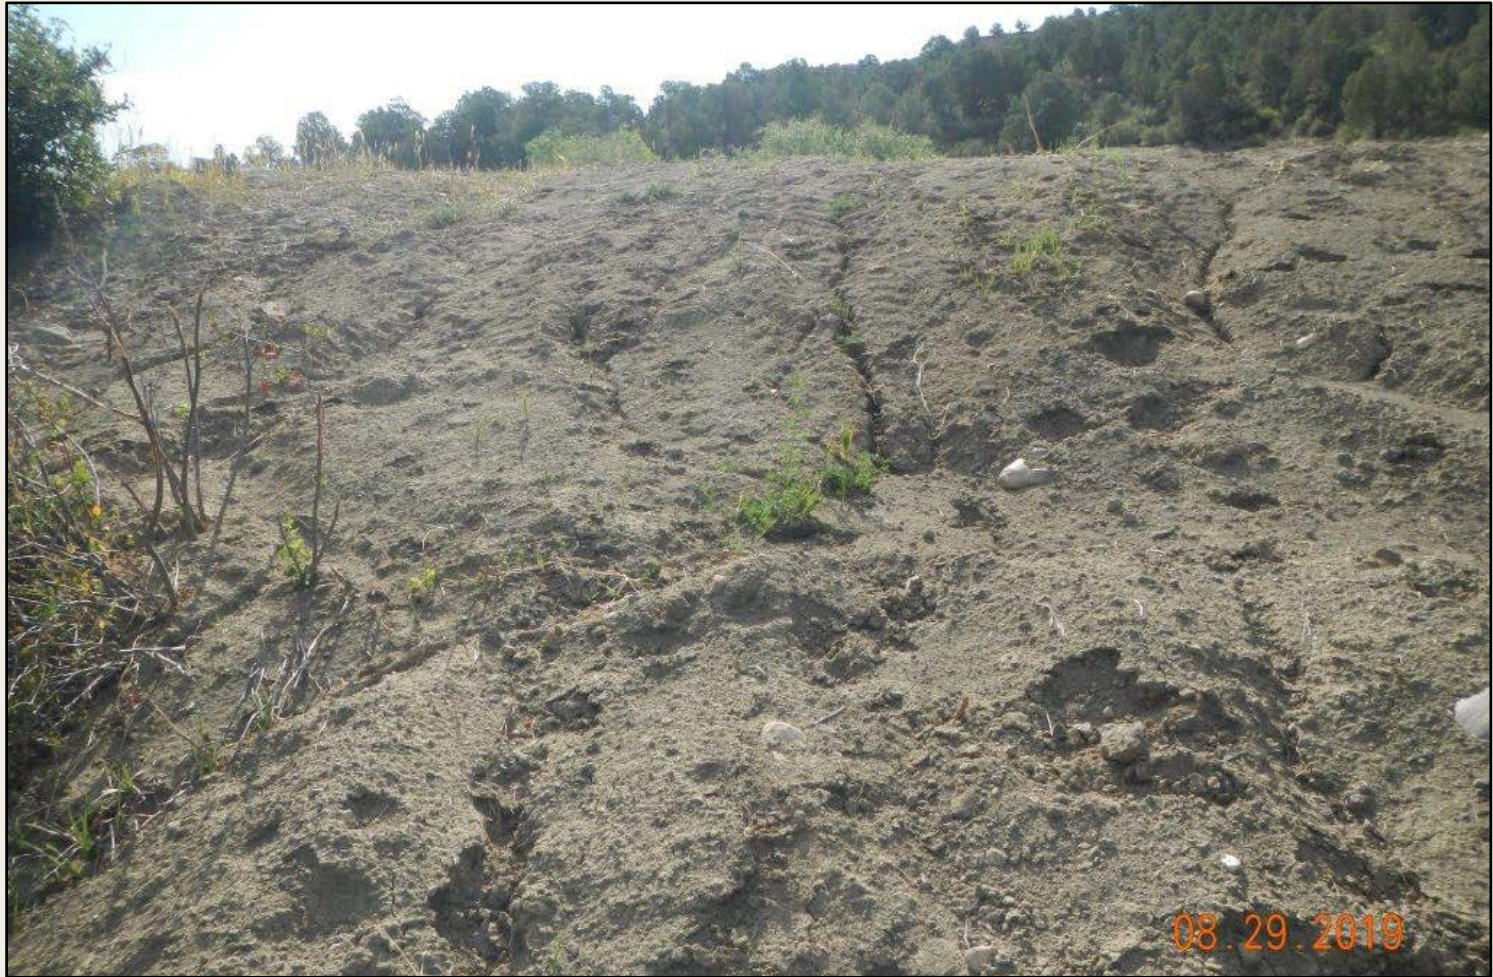
Photo 4. View of disturbed soils northwest of well pad and along flowline with bare soils on slope that are eroding.

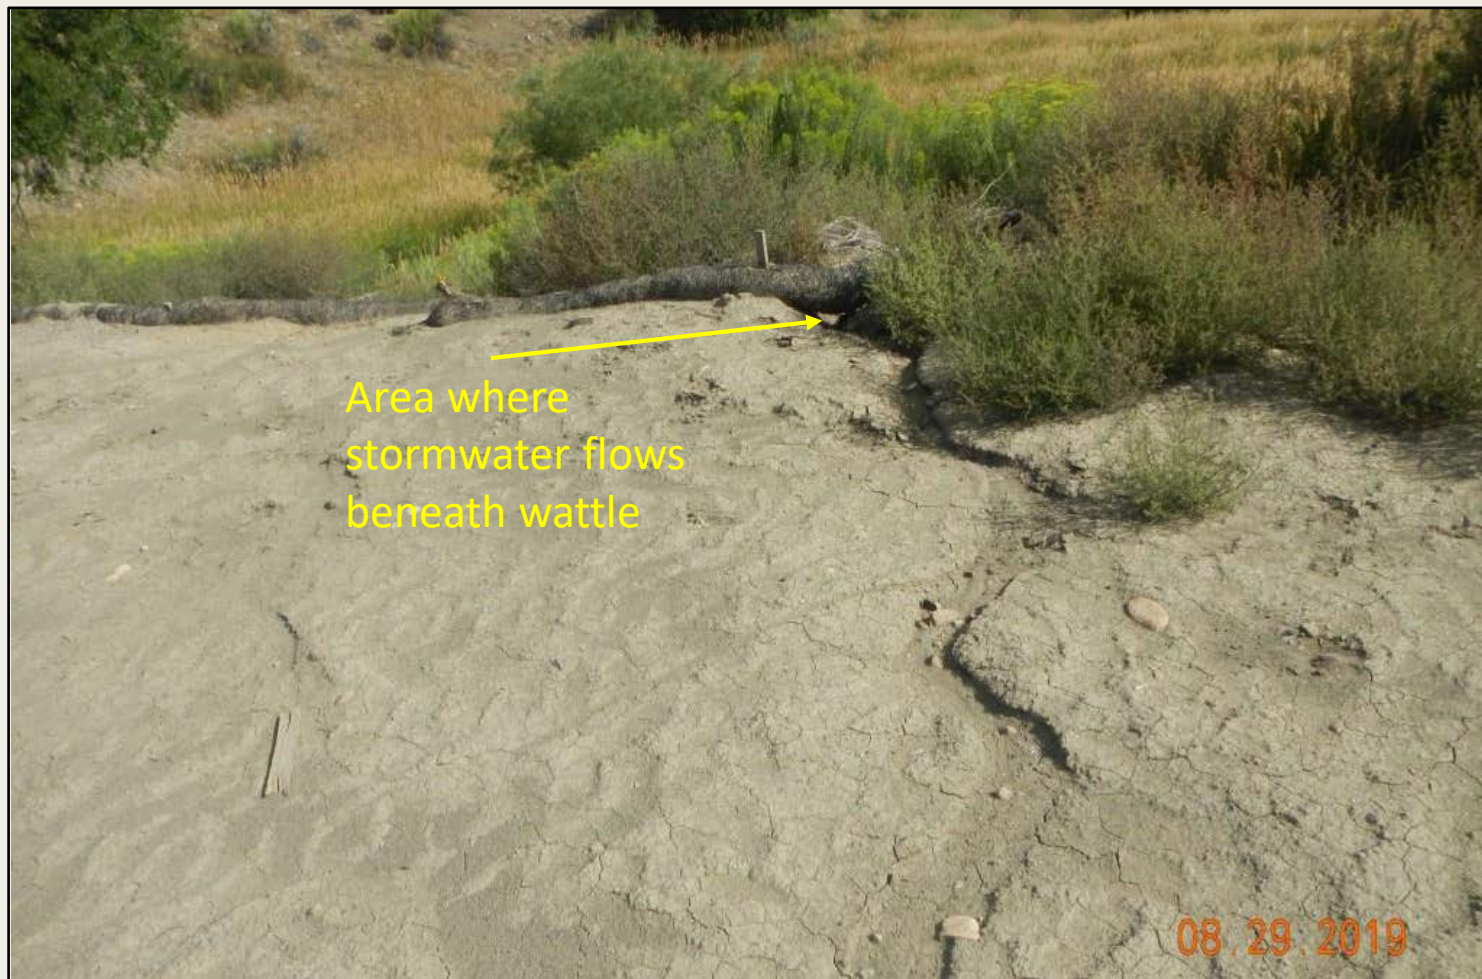
Photo 5. View of erosional channeling where concentrated stormwater and sediment flows off of the northeastern edge of the well pad. Wattles are failed, and are not adequate stormwater BMPs in this area.

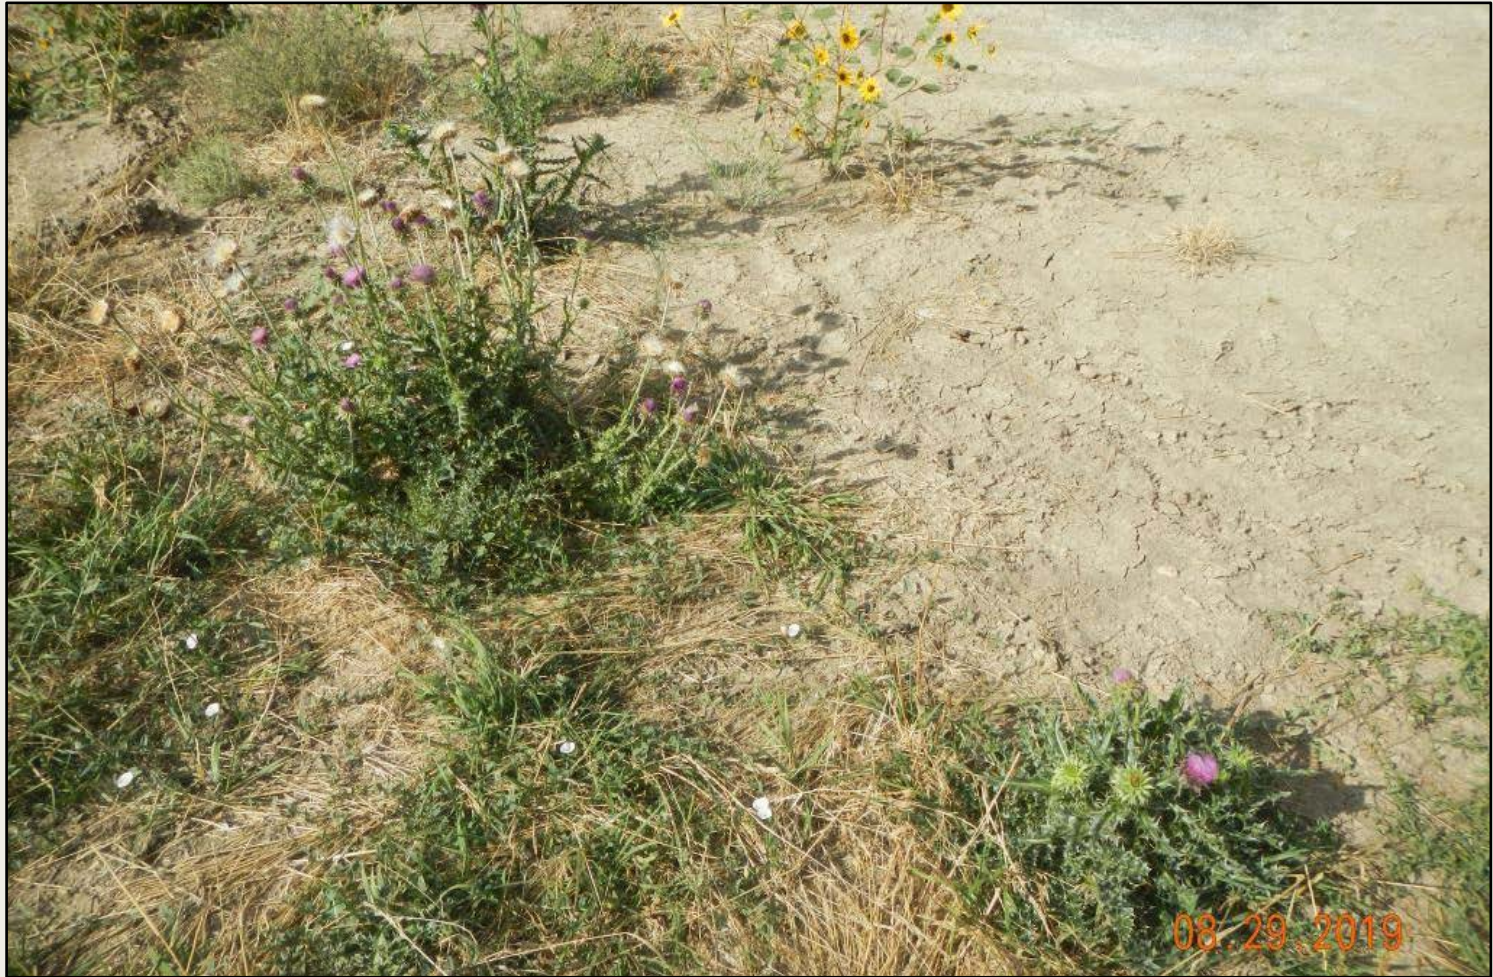
Photo 6. View of musk thistles (*Carduus nutans*) within the project area.

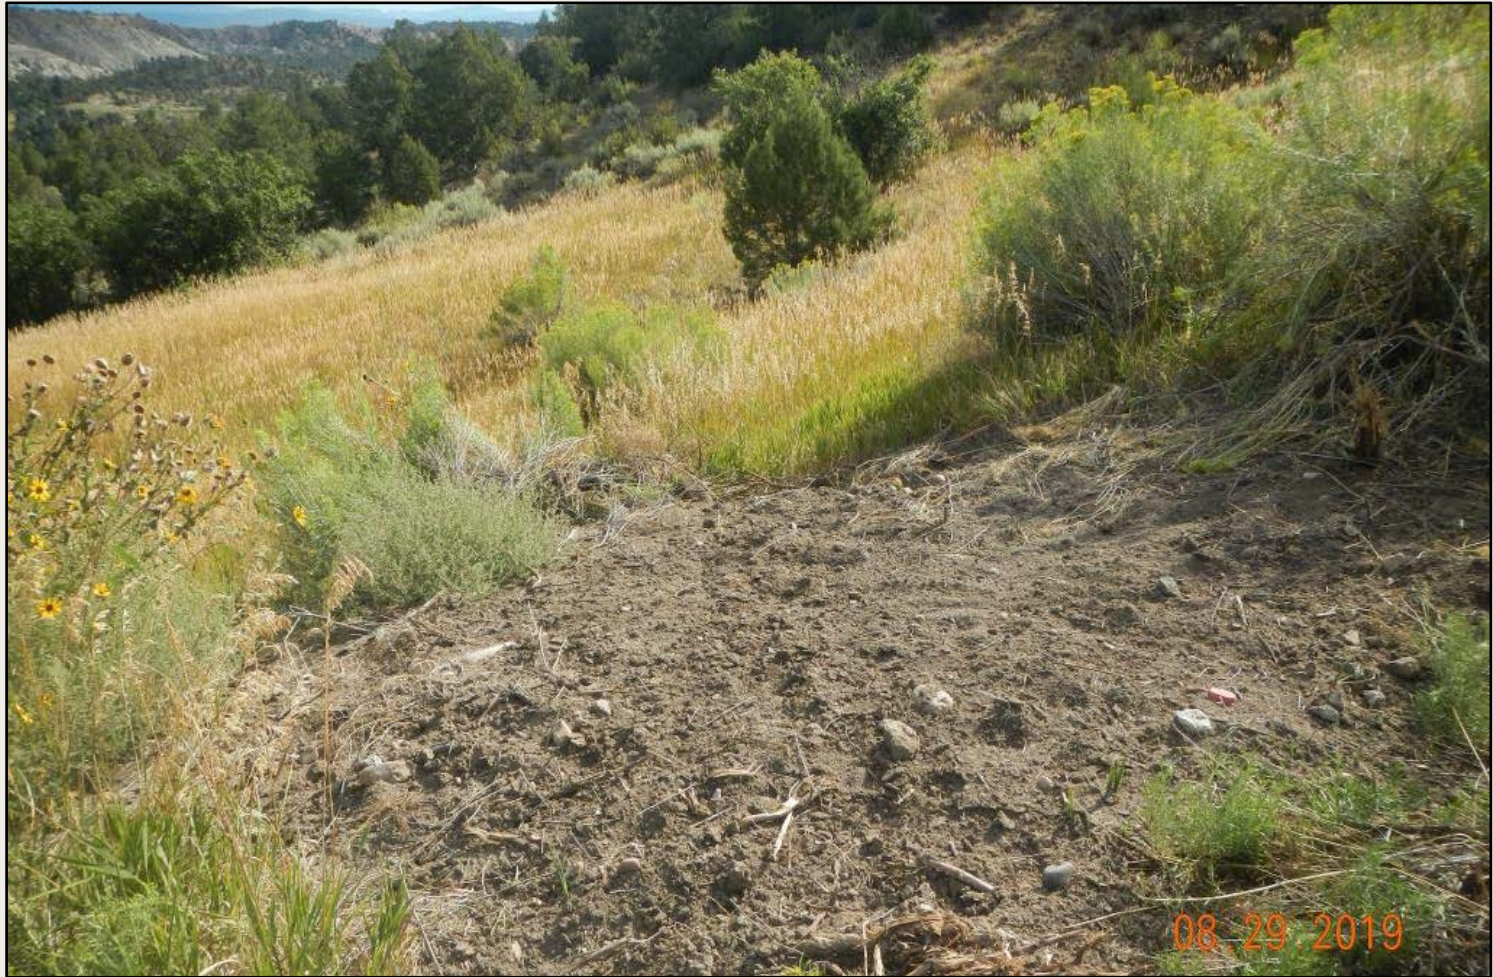
Photo 7. View of soil disturbance and bare soils needing stabilization within the northeastern project area.

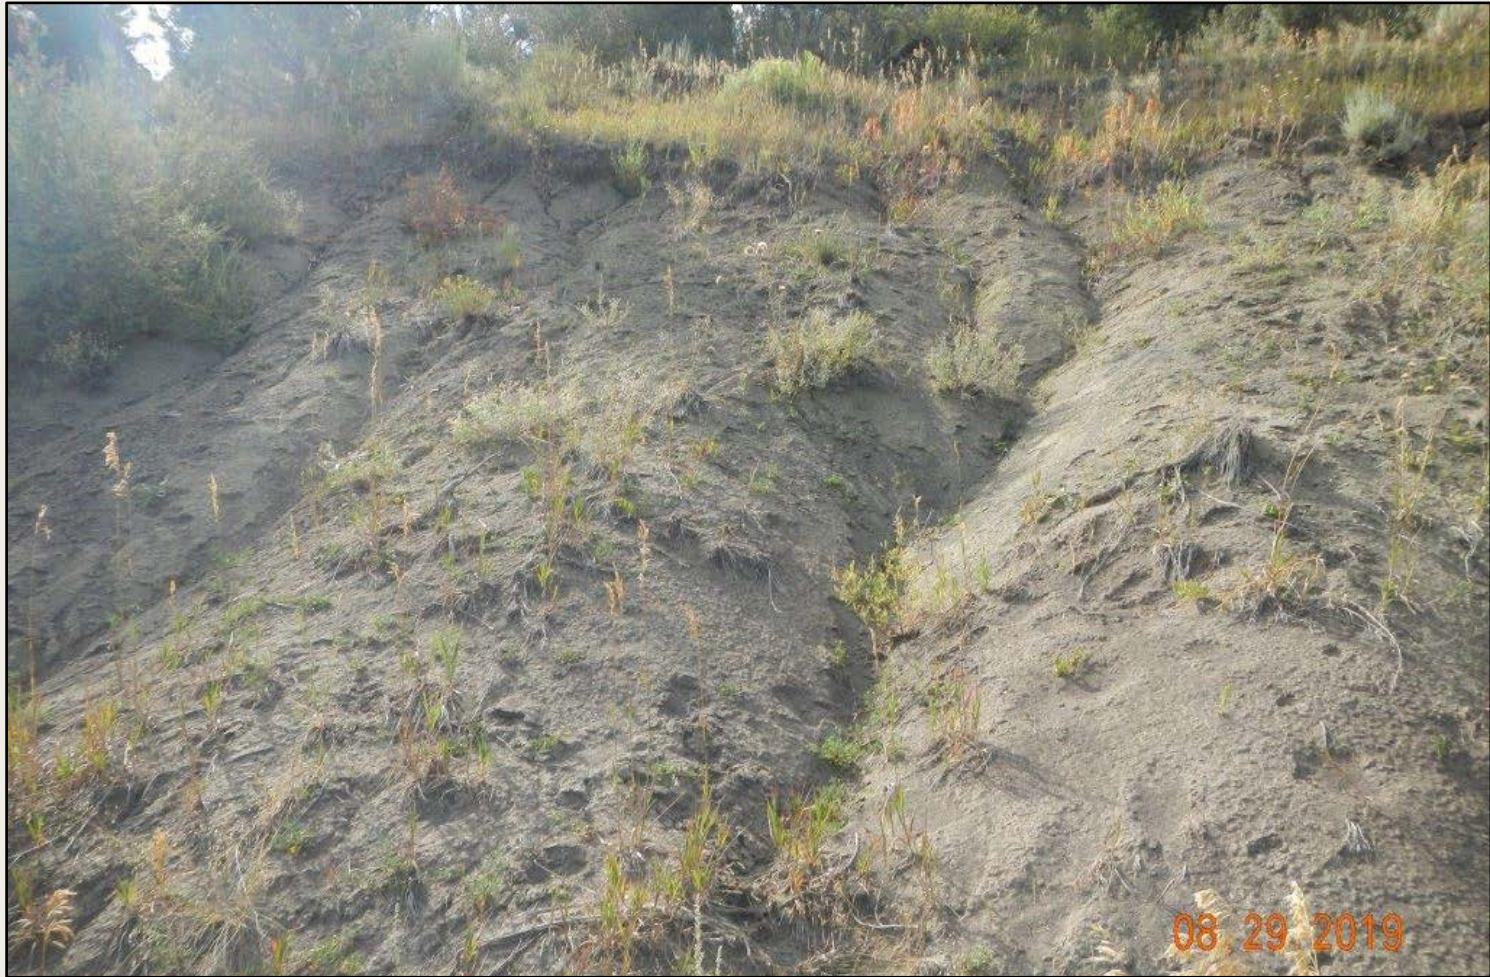
Photo 8. View of erosional rilling and bare soils on the well pad cut-slope. Evidence of erosional undercutting observed at top of slope.

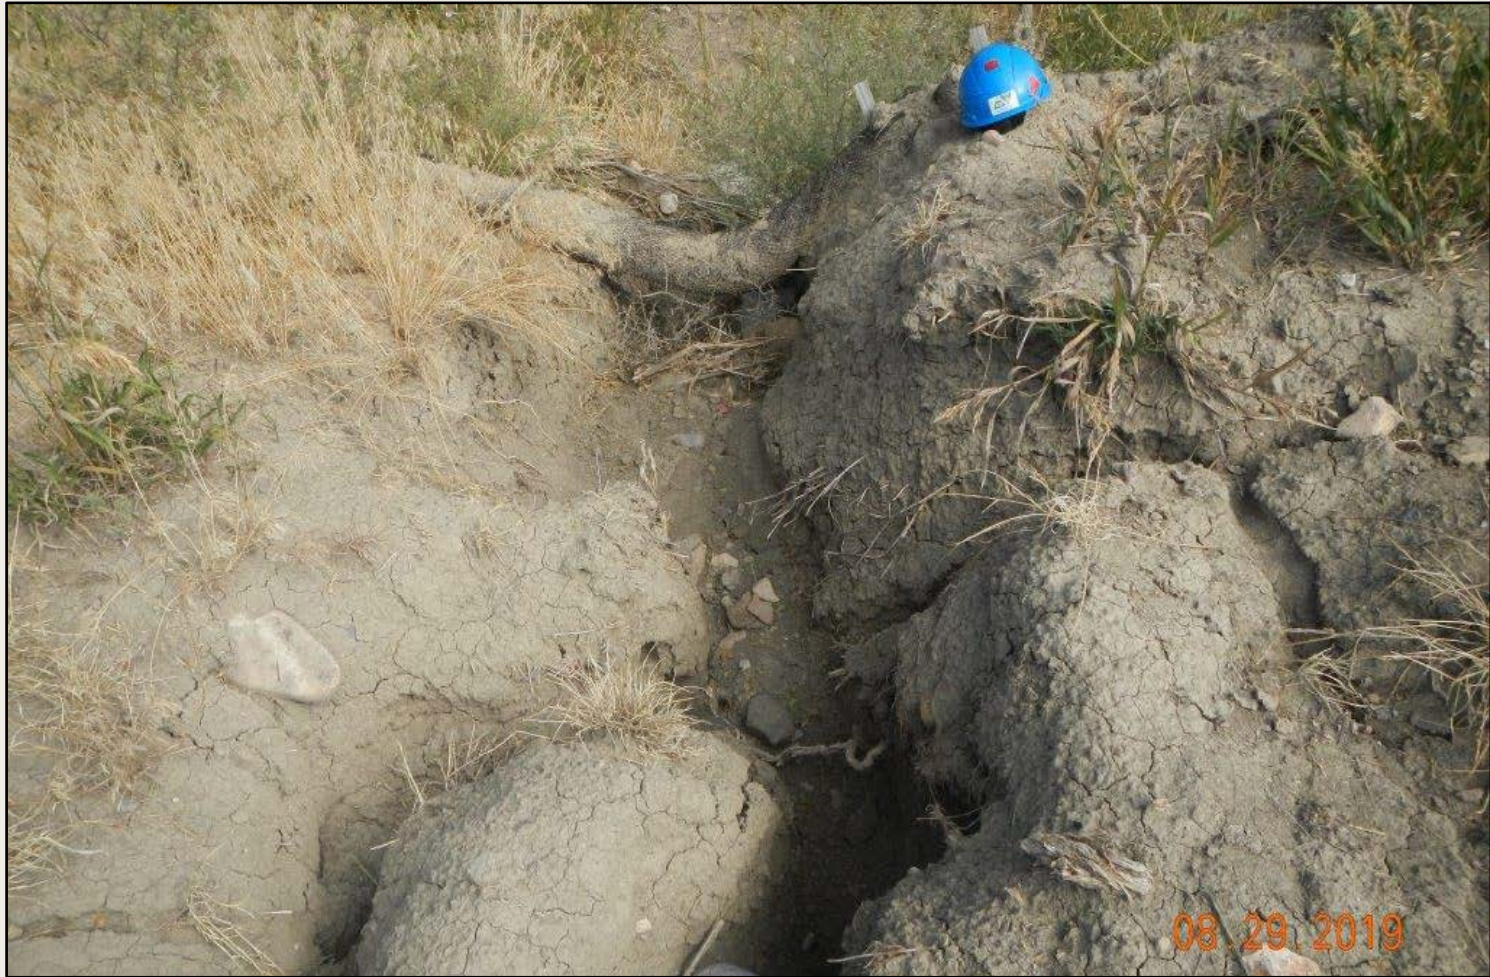
Photo 9. View of erosional channel approximately 3 feet wide and deep within the northern project area. Sediment laden stormwater flows off of the project area in this location.

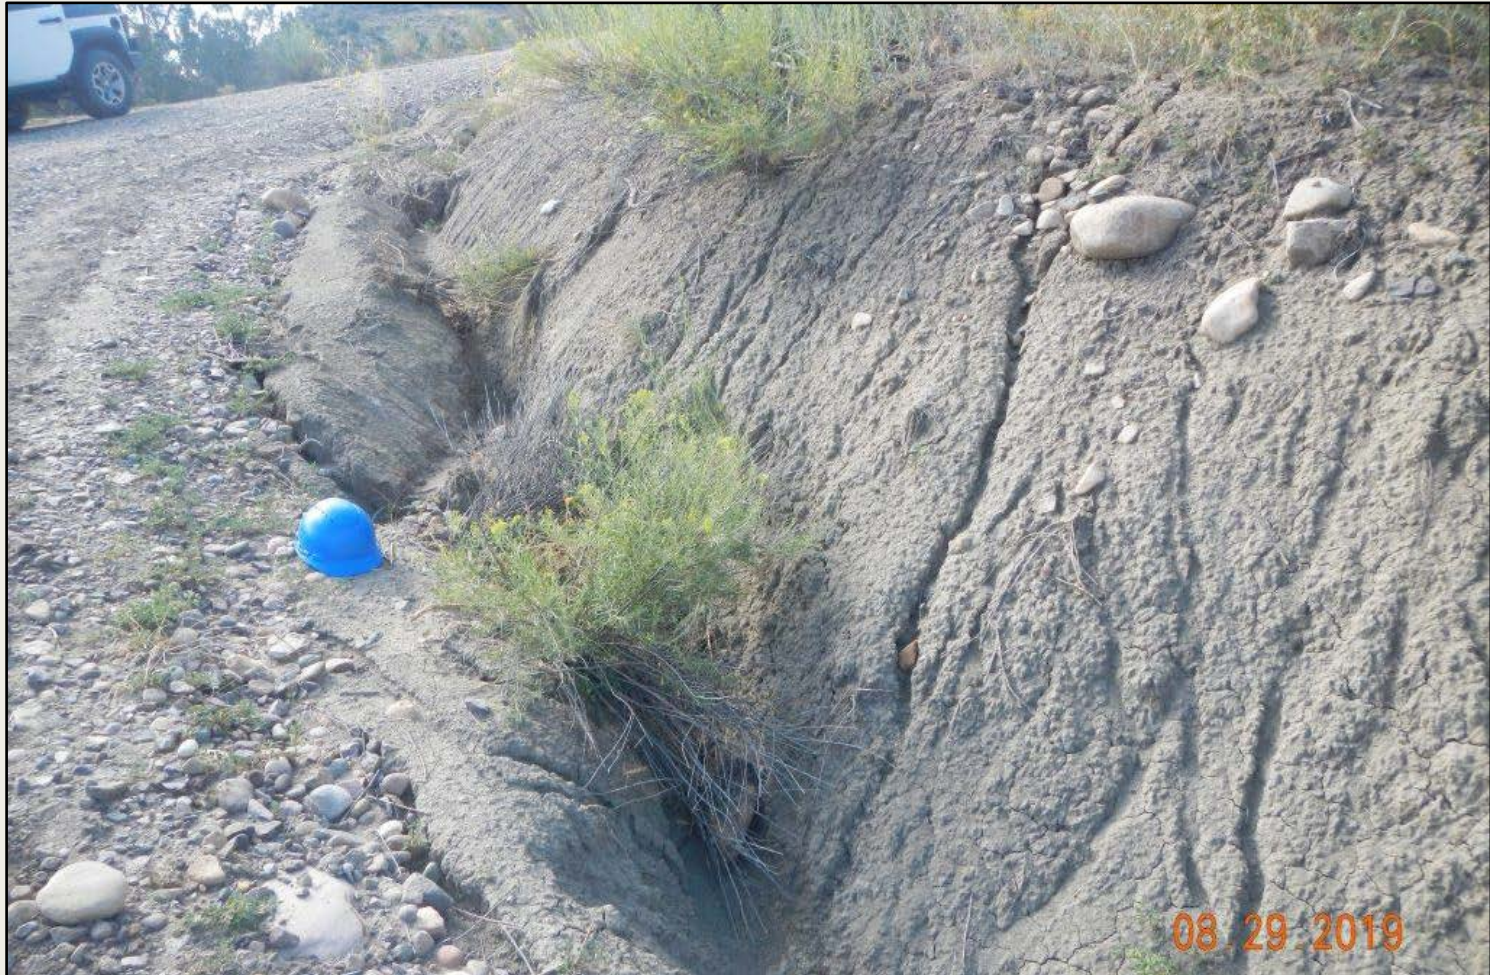
Photo 11. View of erosional channeling and rilling along the edge of the access road.

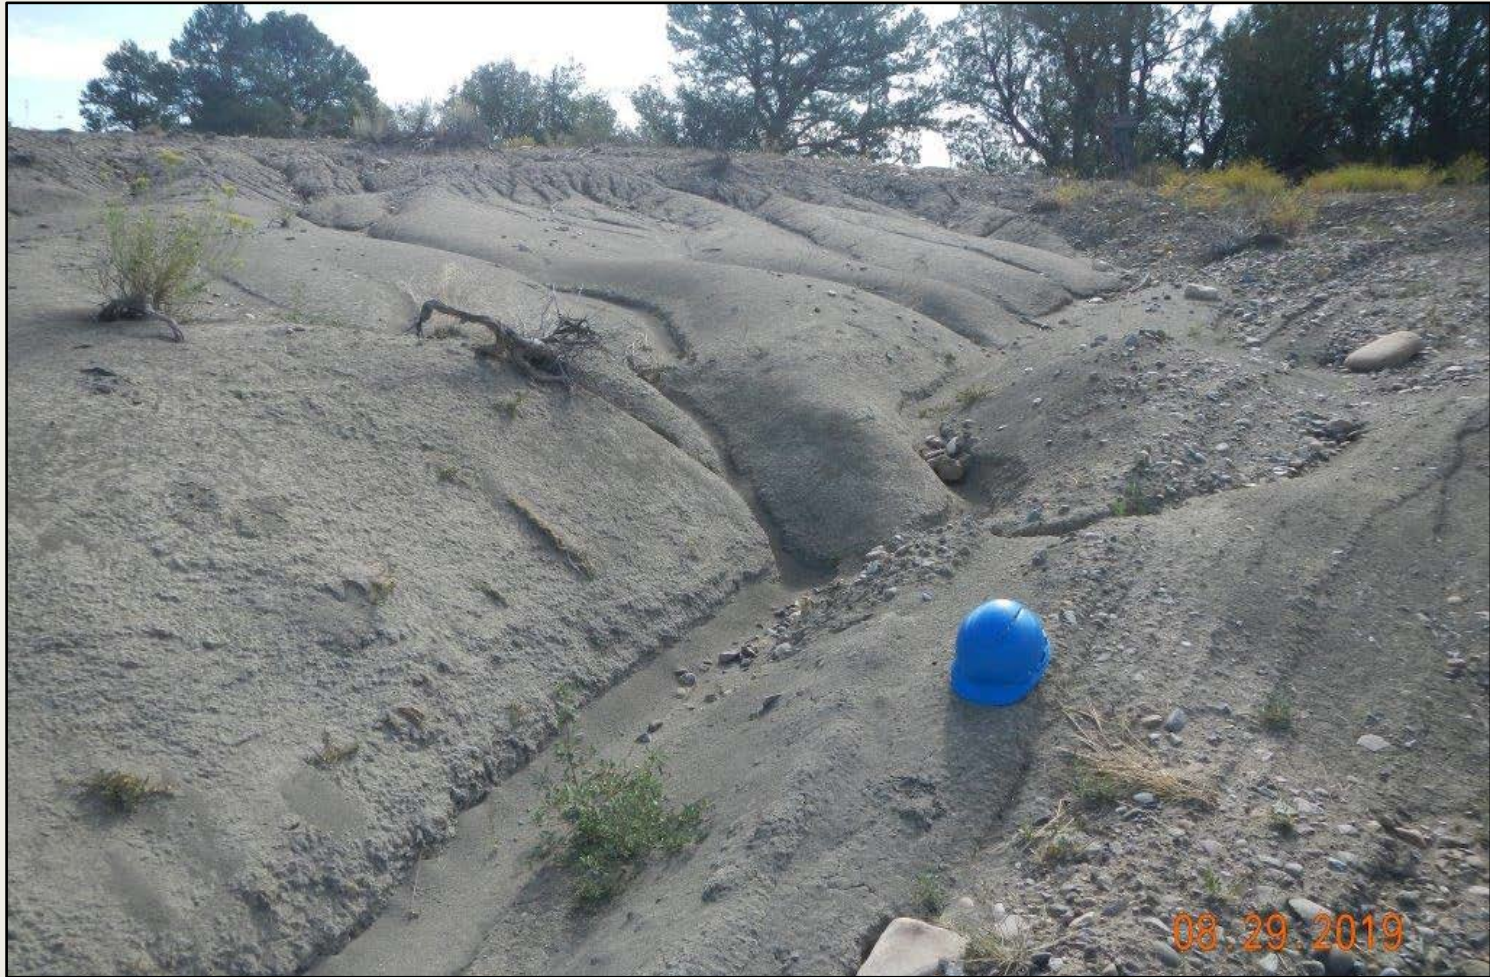
Photo 12. View of area of significant erosional channeling, scouring, and destabilized cut-slope along the access road.

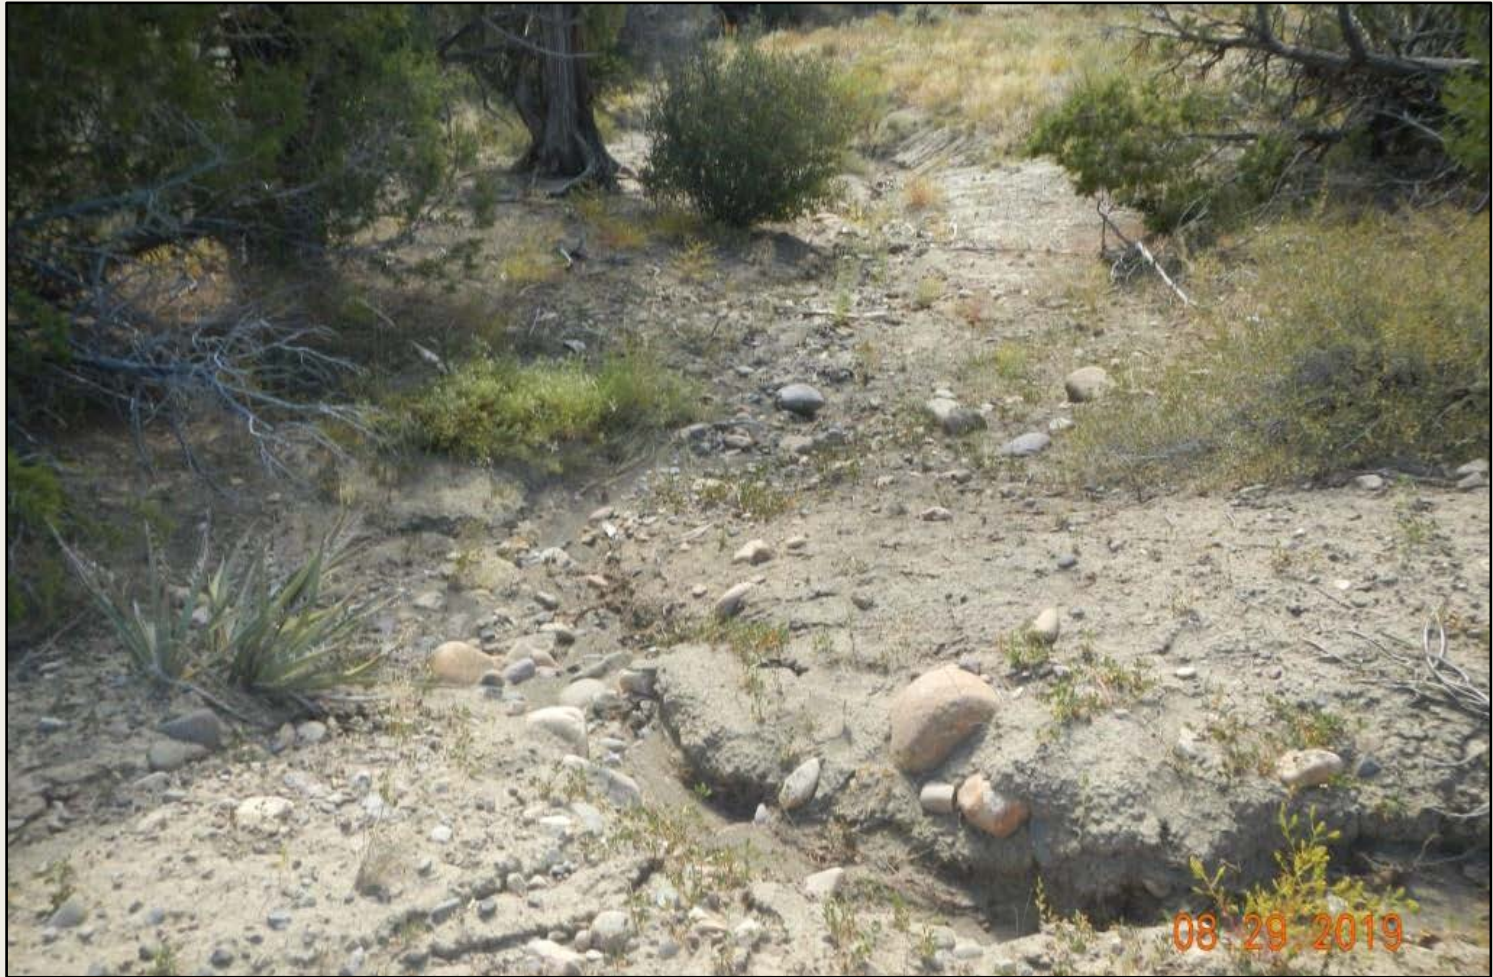
Photo 13. View of area where roadside stormwater flows are diverted without erosion or sediment controls, and erosion is occurring within a channel that is approximately 1 foot wide and deep, scouring and channeling continues downstream.

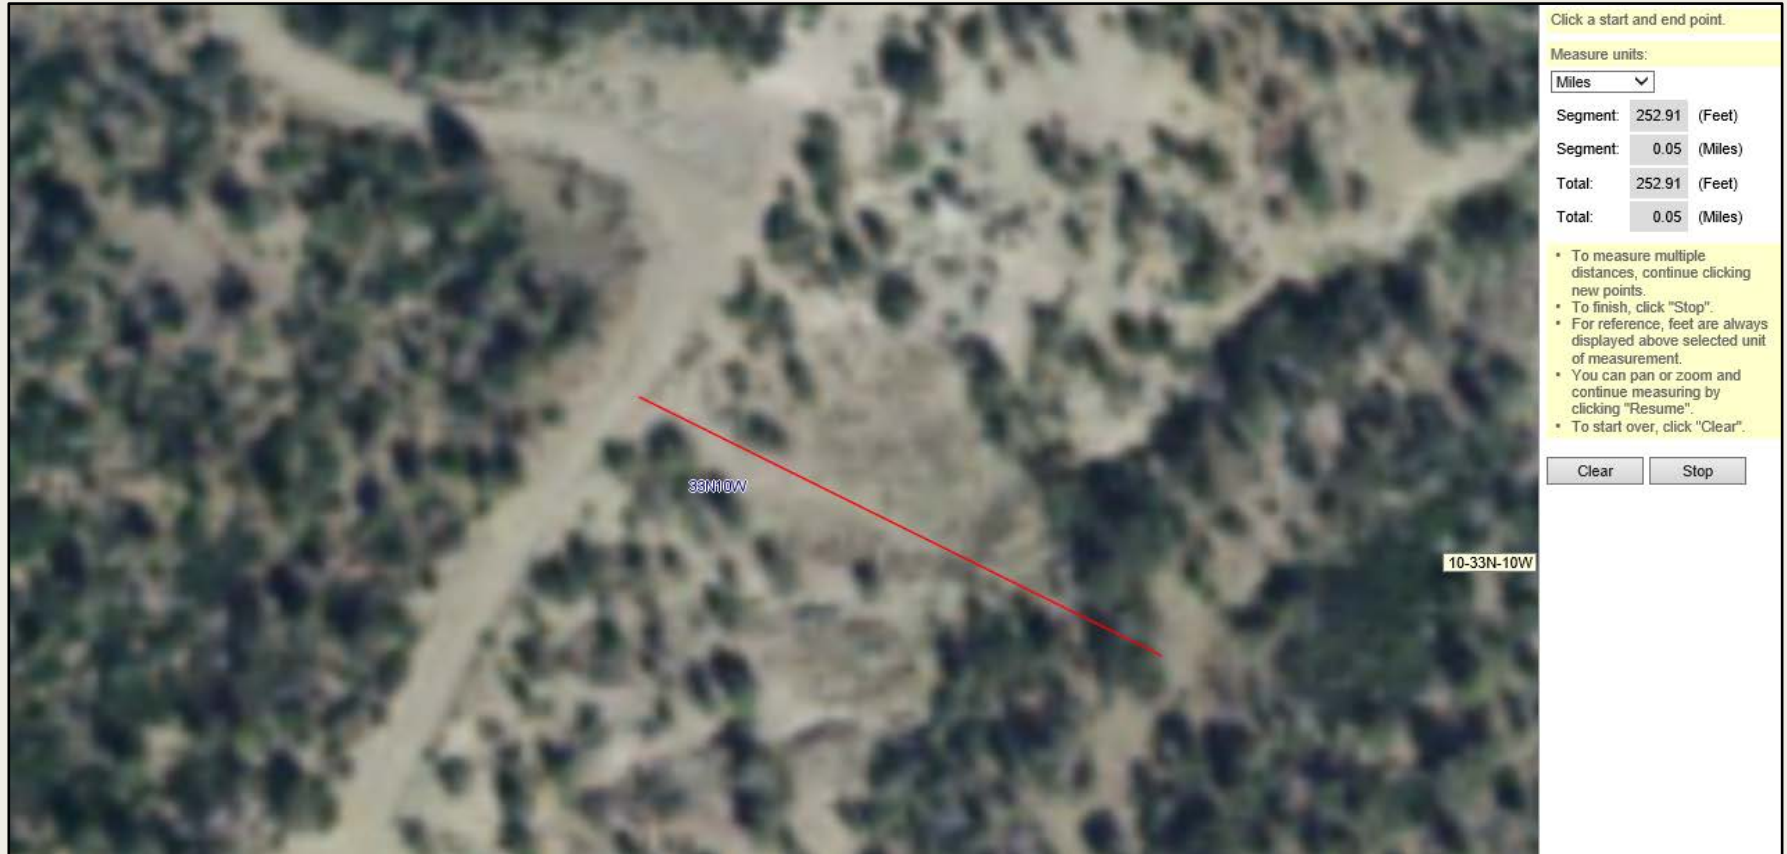
2017 aerial photograph. Red line follows example of one of the erosional channels off of the access road, measuring approximately 250 feet long.

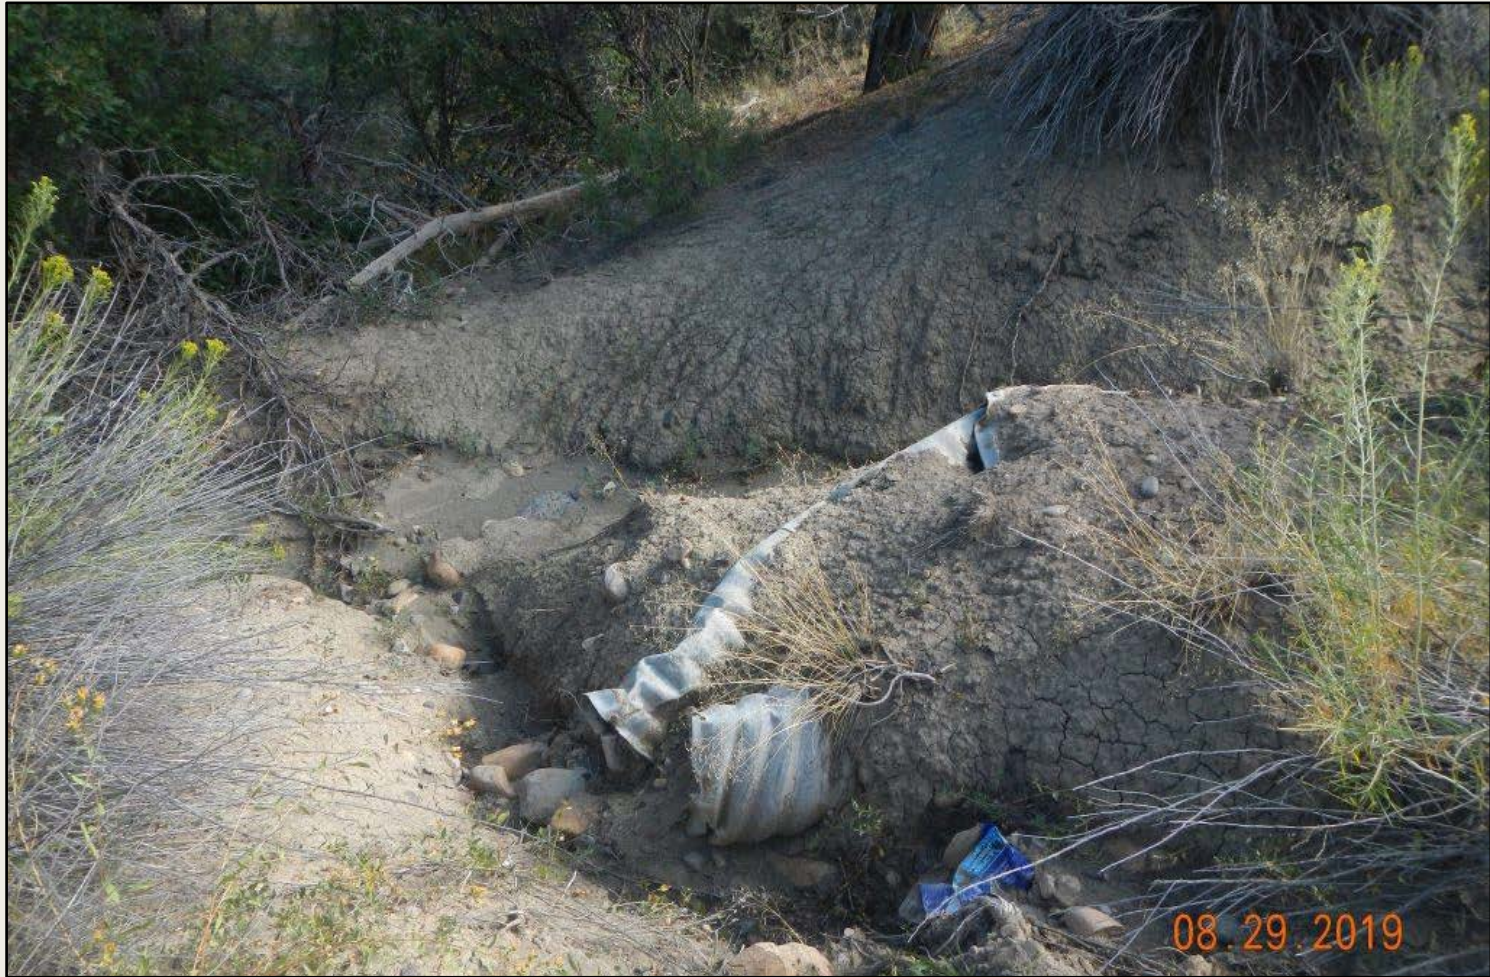
Photo 14. View of area along the access road where a blocked culvert has resulted in significant headcut erosion up to approximately 4 feet wide and deep. Culvert in photo is debris and no longer in place. Sediment laden stormwater flows off of the project area in this location as well as multiple other areas along the access road.
