# Inspection Photos

API: 05-071-09797

Operator: XTO ENERGY

Inspection Date: 9/6/2019

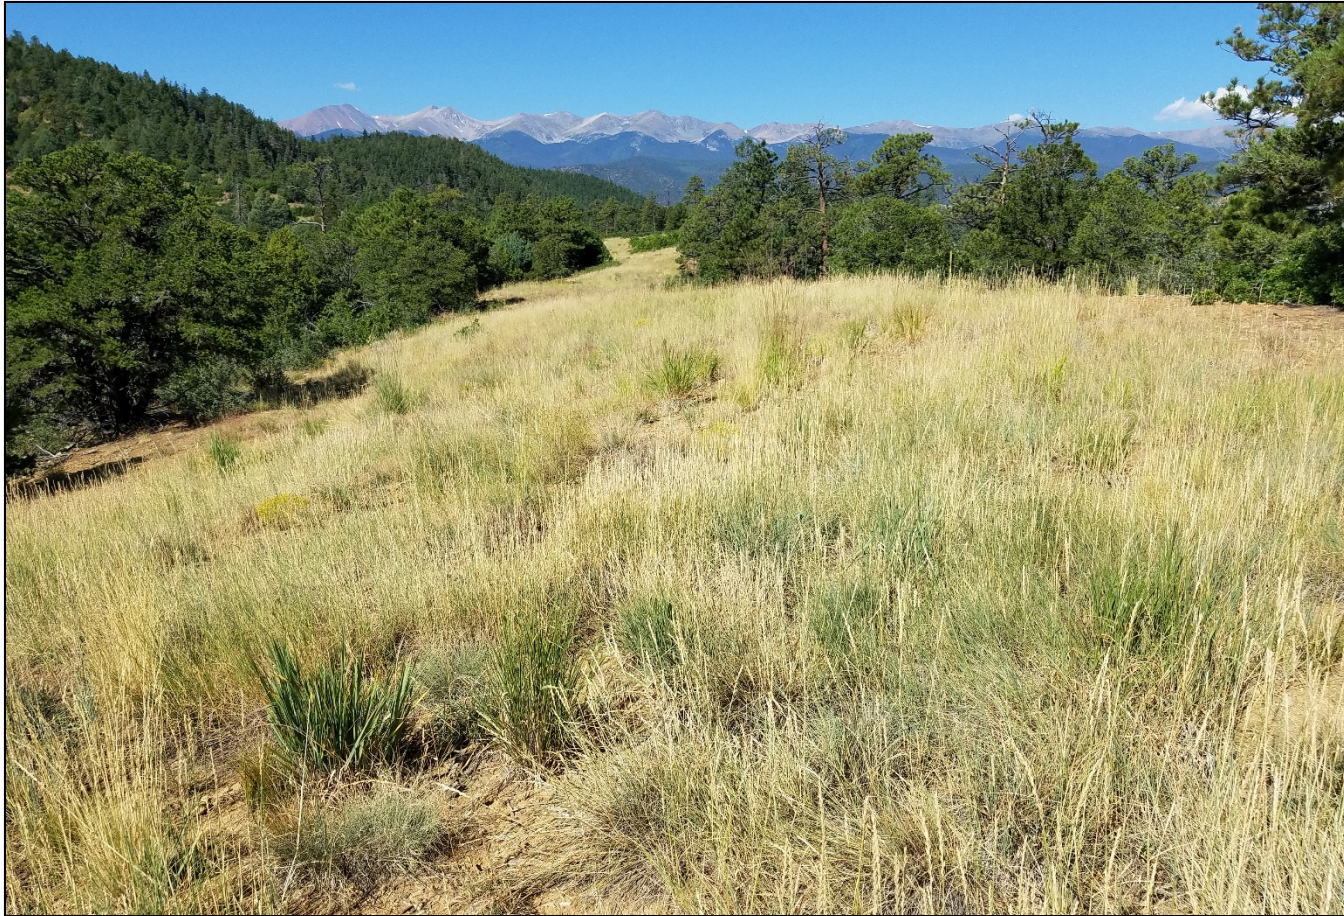
**Photo 1.** Facing west along the reclaimed access road. Perennial vegetation is uniformly established. This photo is near the NEW ELK #27-02 site.

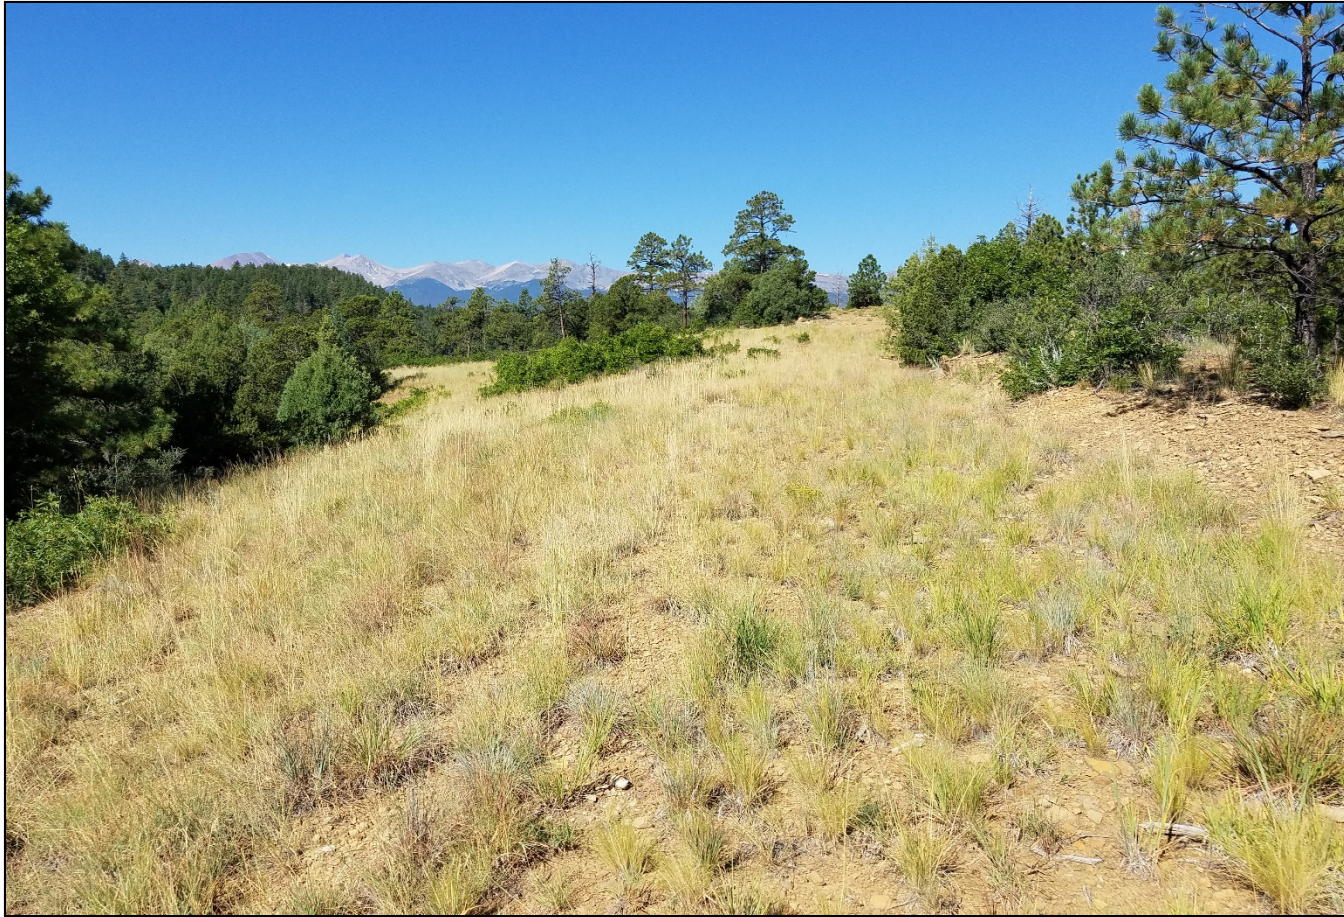
**Photo 2.** Facing west along the reclaimed access road. Perennial vegetation is uniformly established.

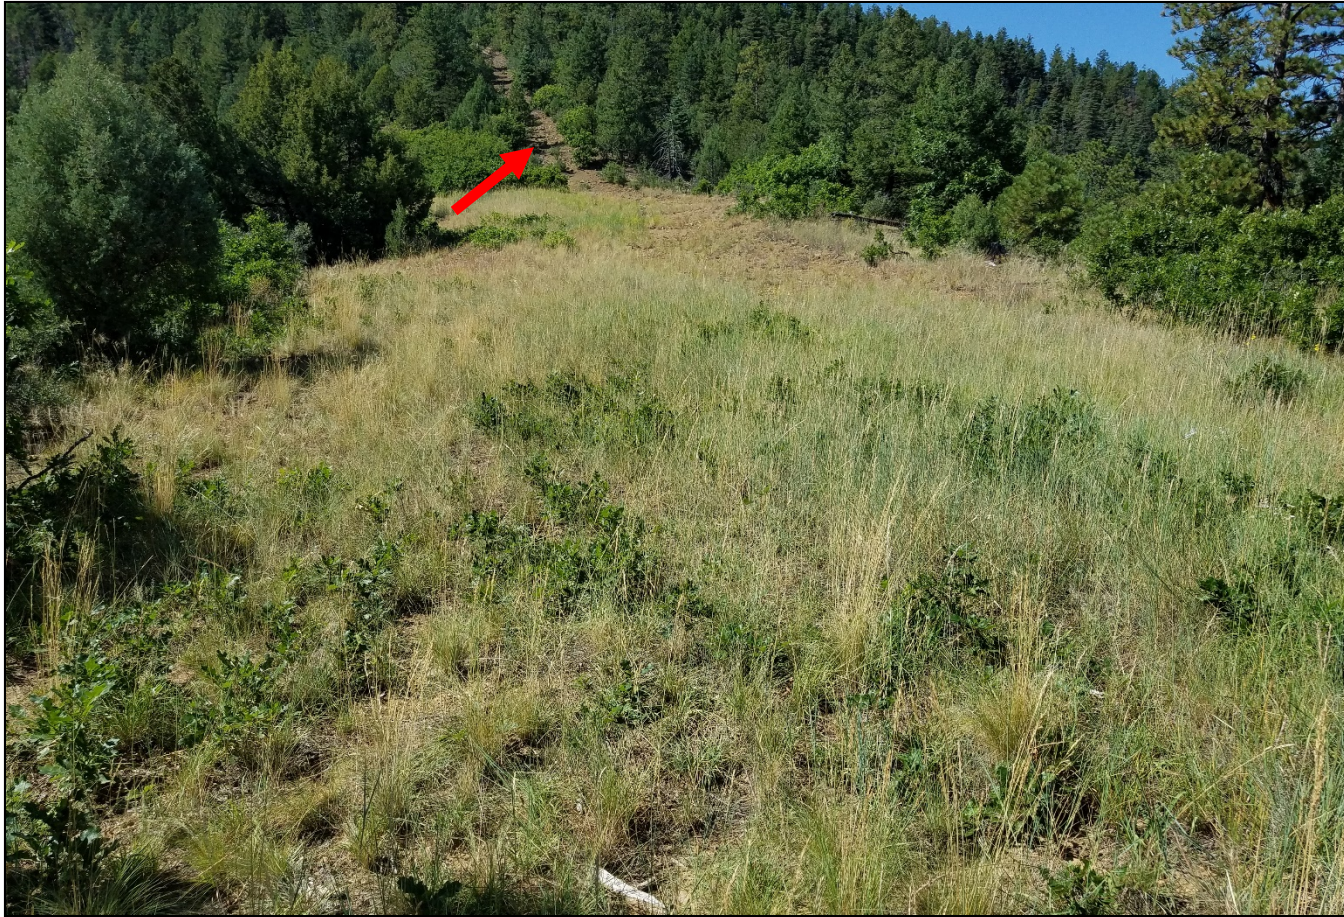
**Photo 3.** Facing southwest along the reclaimed access road. Shrubs (Gambel oak) are reestablishing along the road. Arrow points to preexisting road that continues along the ridge.

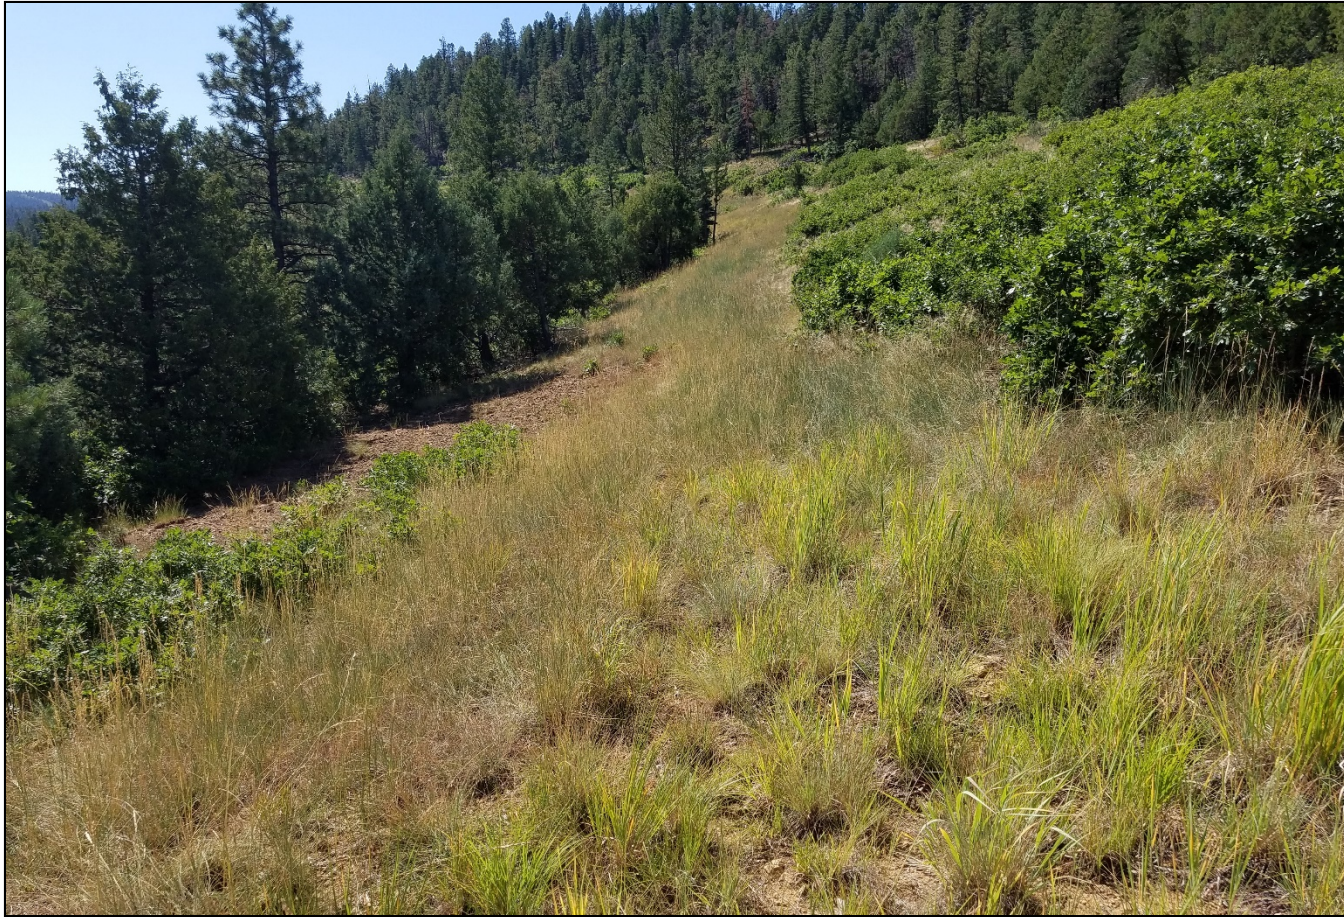
**Photo 4.** Facing south along the reclaimed access road. Perennial vegetation is well established.

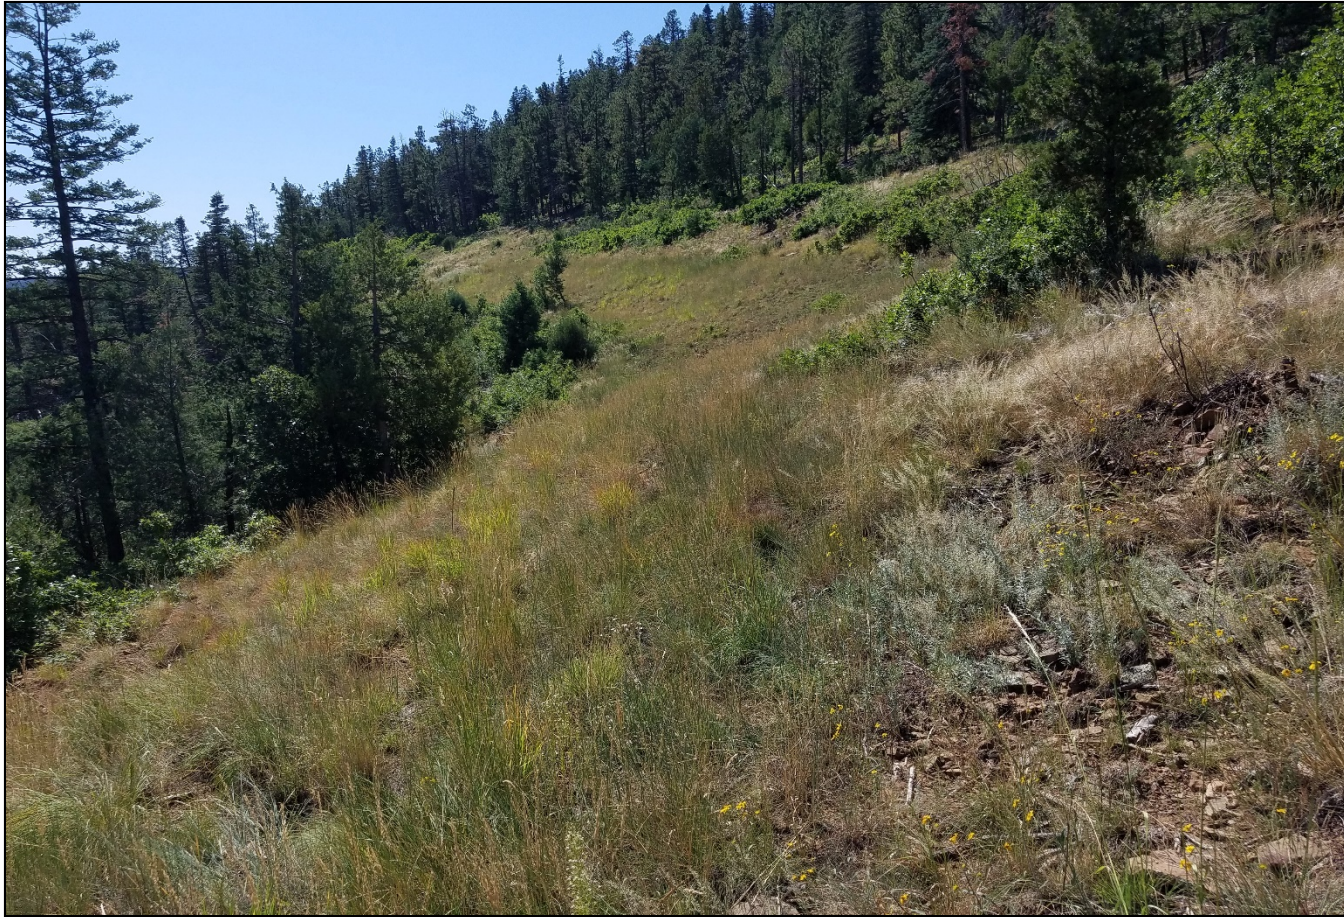
**Photo 5.** Facing south along the reclaimed access road. Perennial vegetation is well established.

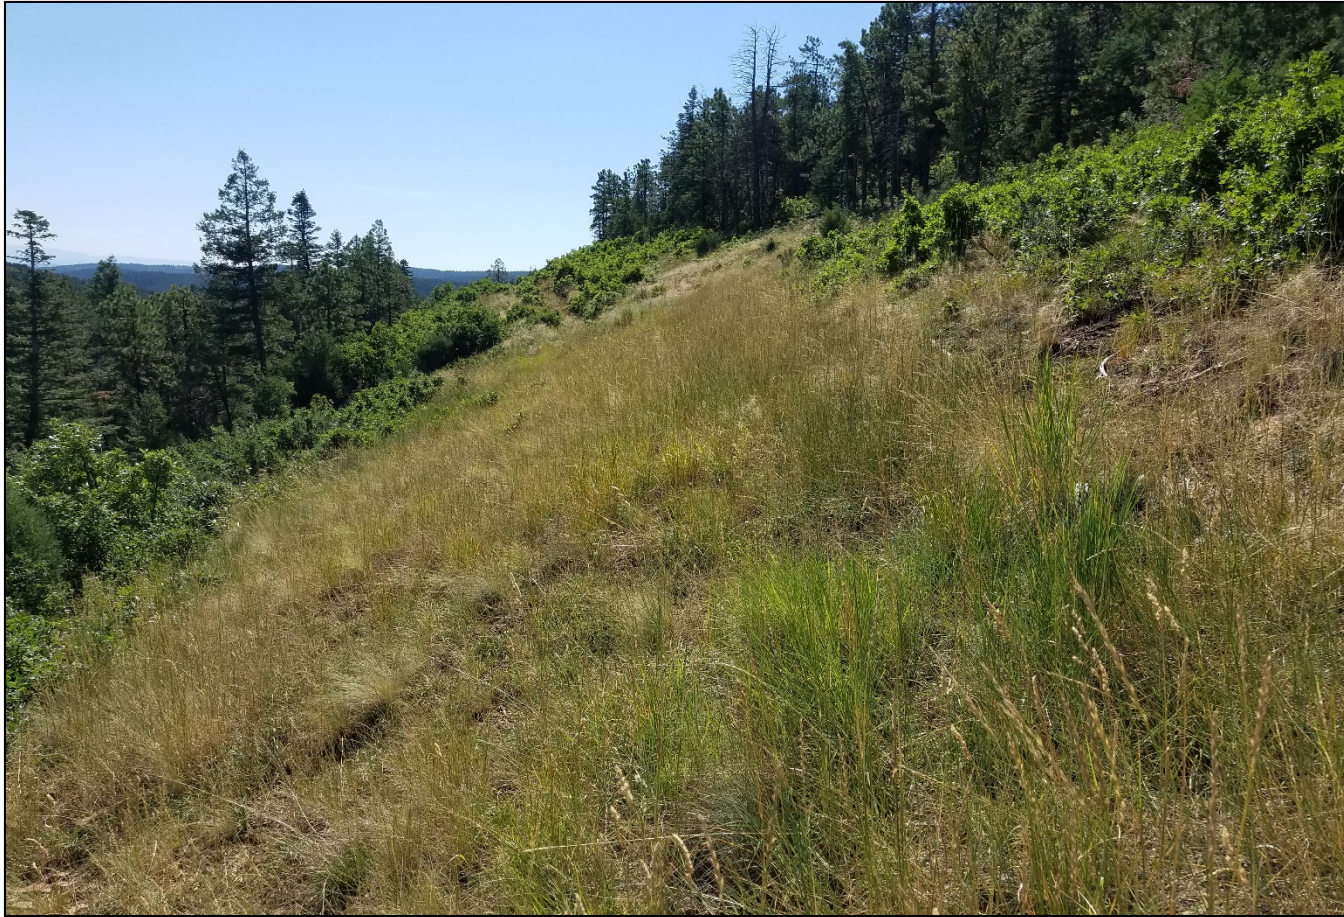
**Photo 6.** Facing southeast at the end of the reclaimed access road. Perennial vegetation is well established. There was no location built at the NEW ELK #27-06 site.
