Inspection Photos

API: 05-071-09790

Operator: XTO ENERGY

Inspection Date: 9/6/2019

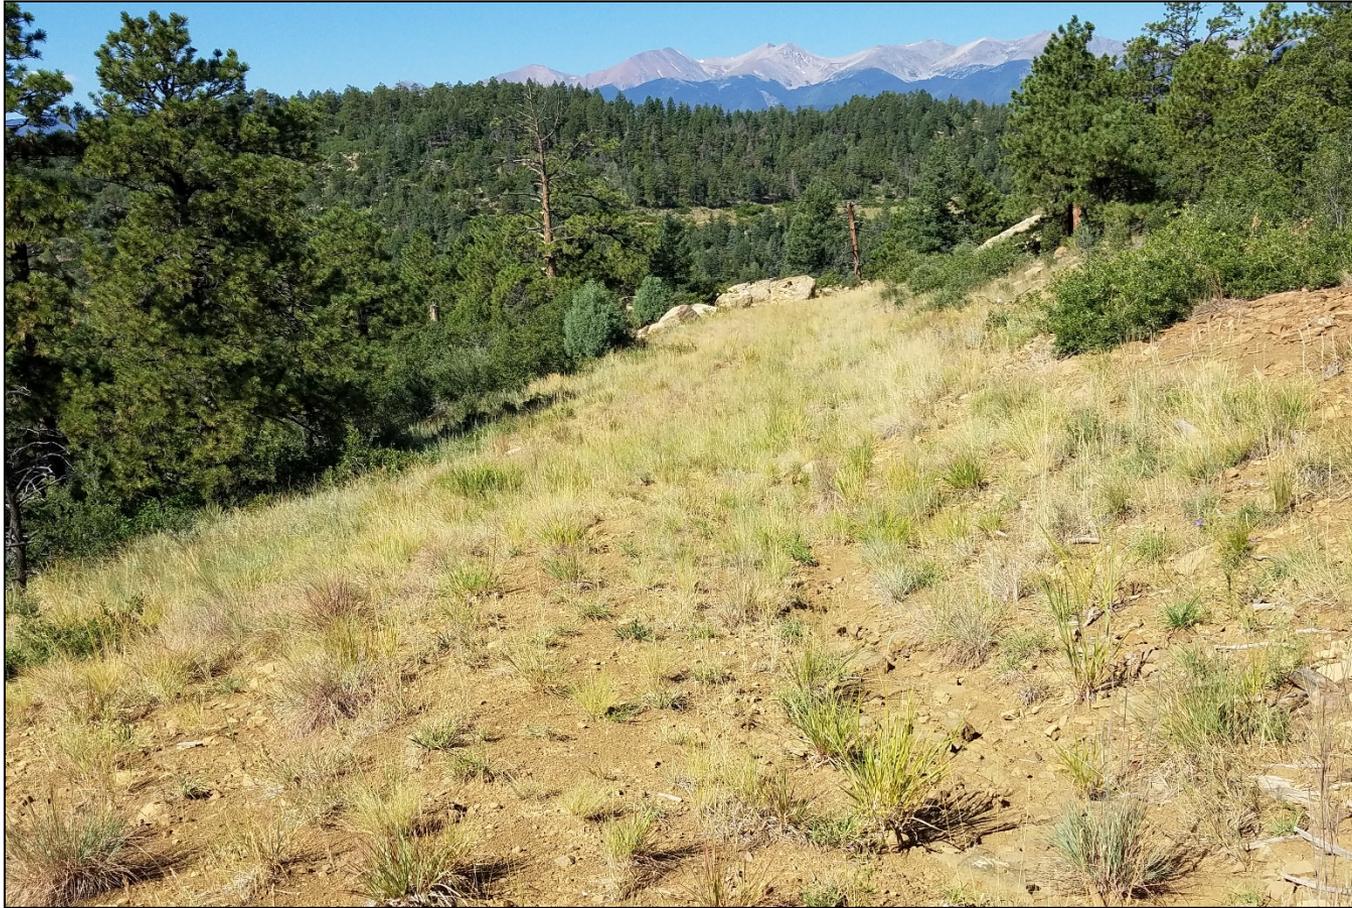
Photo 1. Facing west along the reclaimed access road. Perennial vegetation is uniformly established. This photo is taken near the NEW ELK #27-08 site.

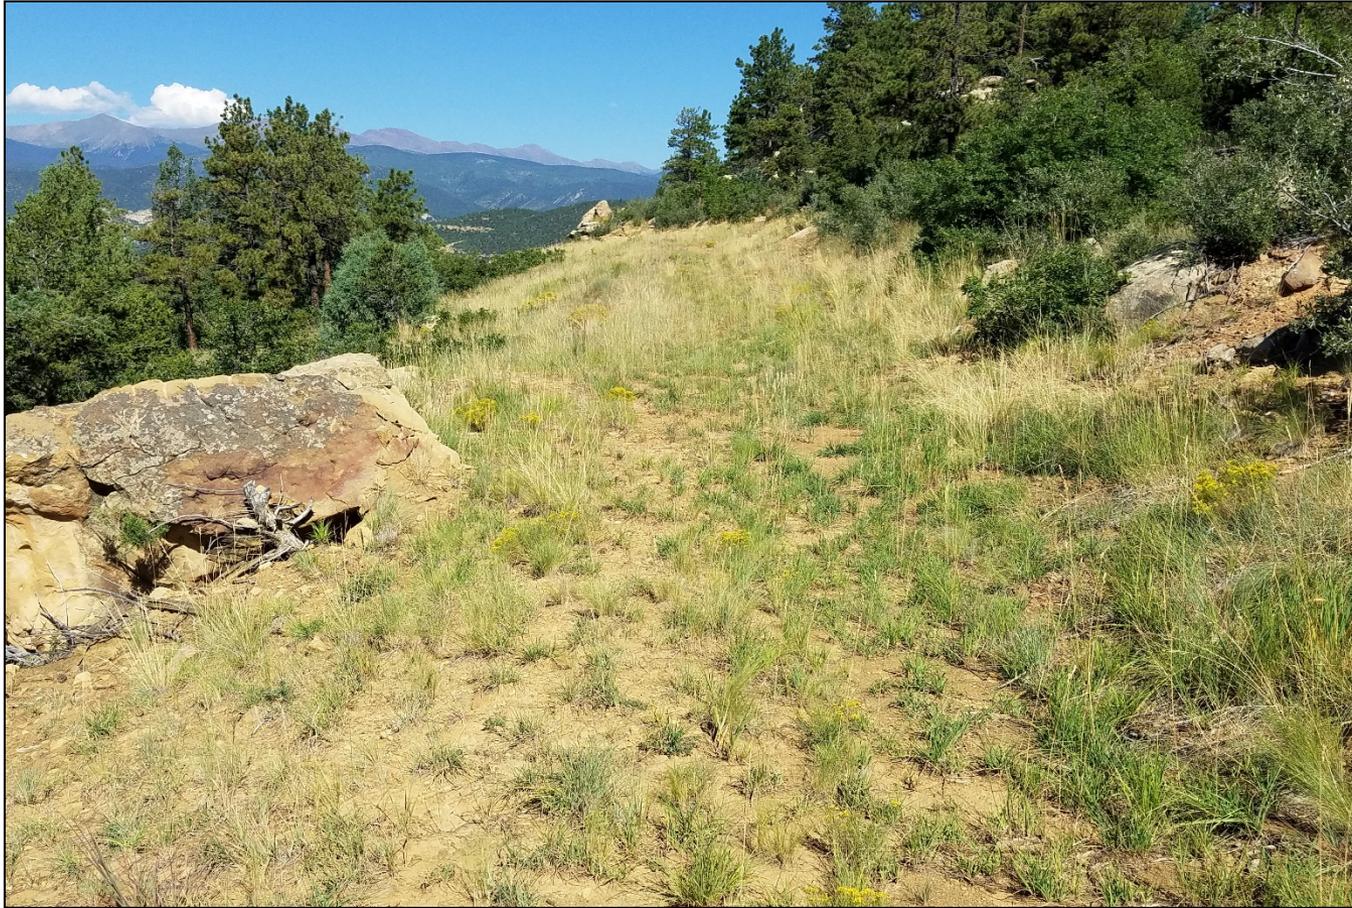
Photo 2. Facing west along the reclaimed access road. Perennial vegetation is uniformly established.

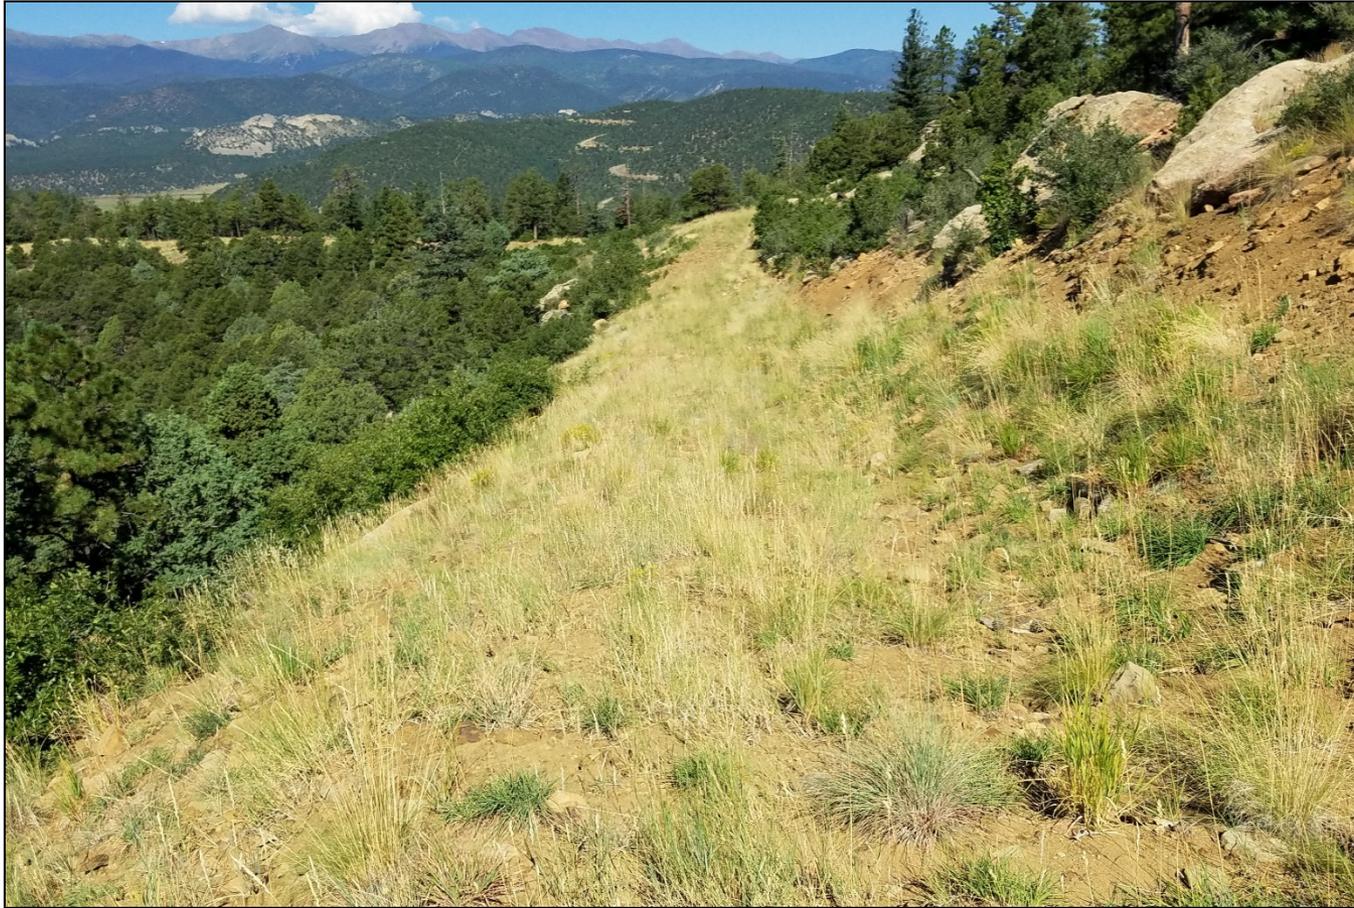
Photo 3. Facing southwest along the reclaimed access road. A preexisting road went through this area which can still be accessed.

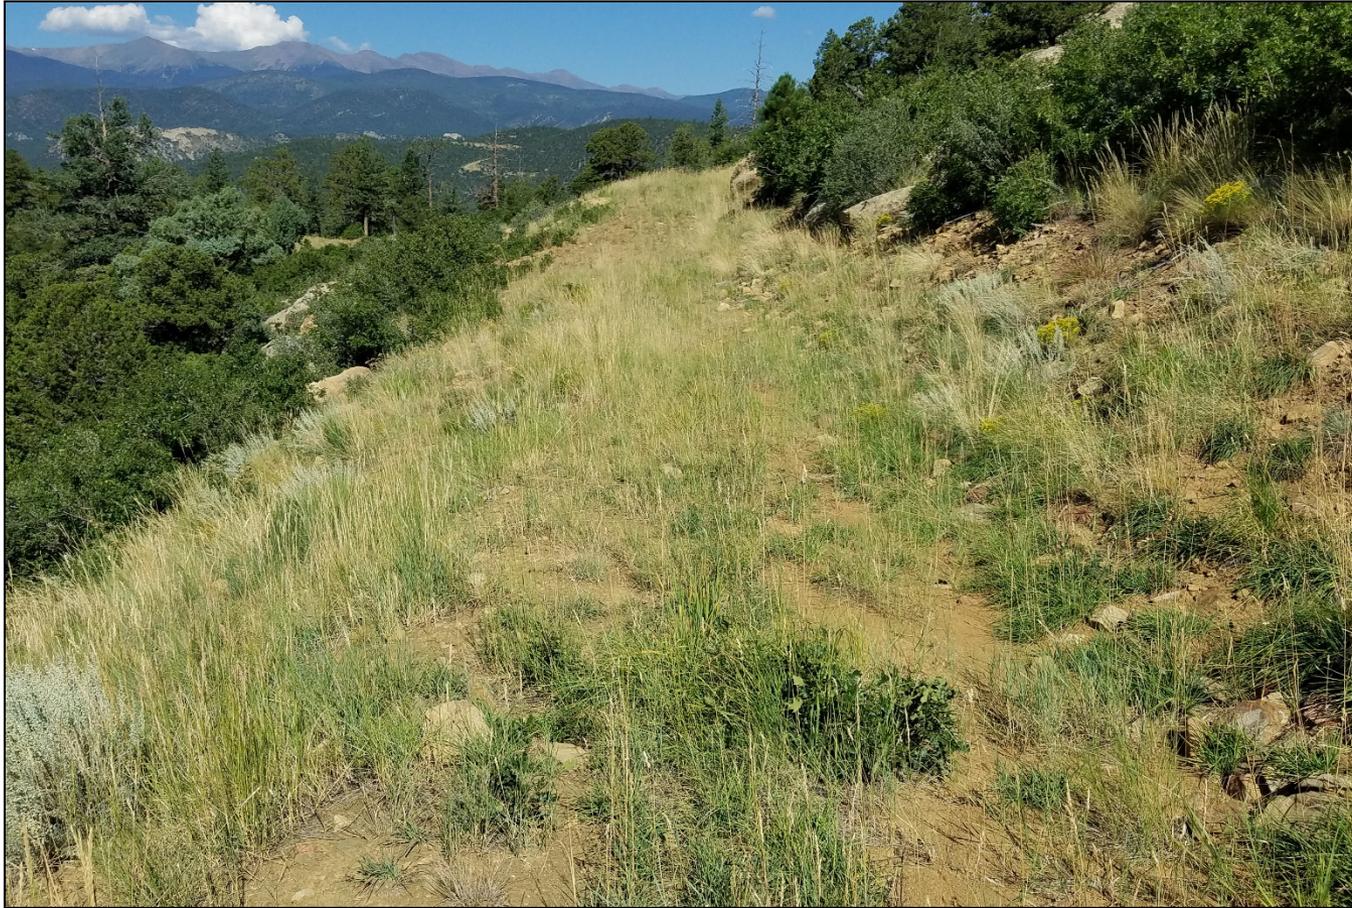
Photo 4. Facing southwest along the reclaimed access road. A preexisting road went through this area which can still be accessed.

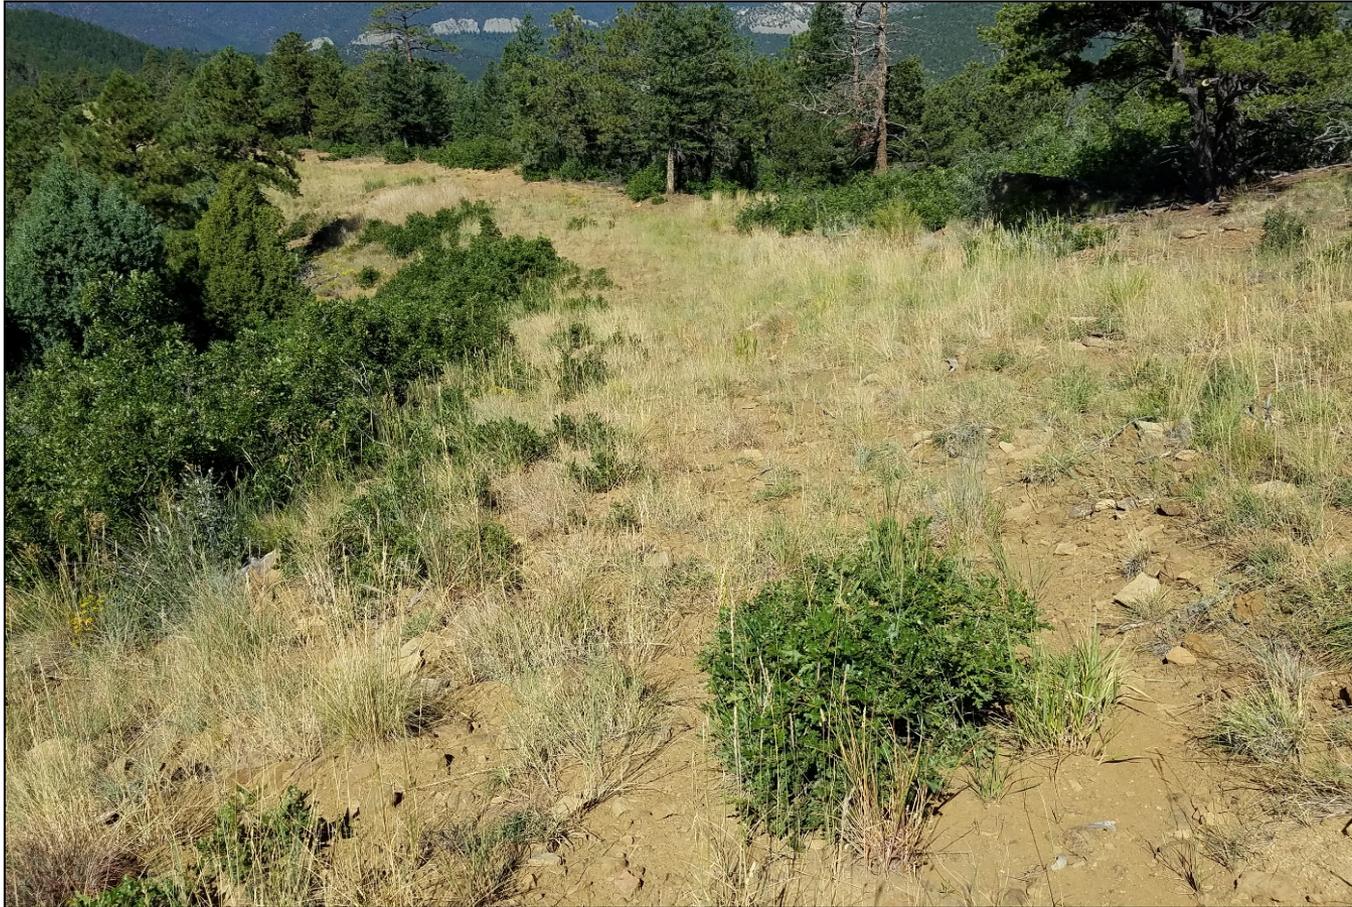
Photo 5. Facing west along the reclaimed access road. There was no location built at the NEW ELK #27-02 site.
