Inspection Photos

API: 05-071-09786

Operator: XTO ENERGY

Inspection Date: 9/6/2019

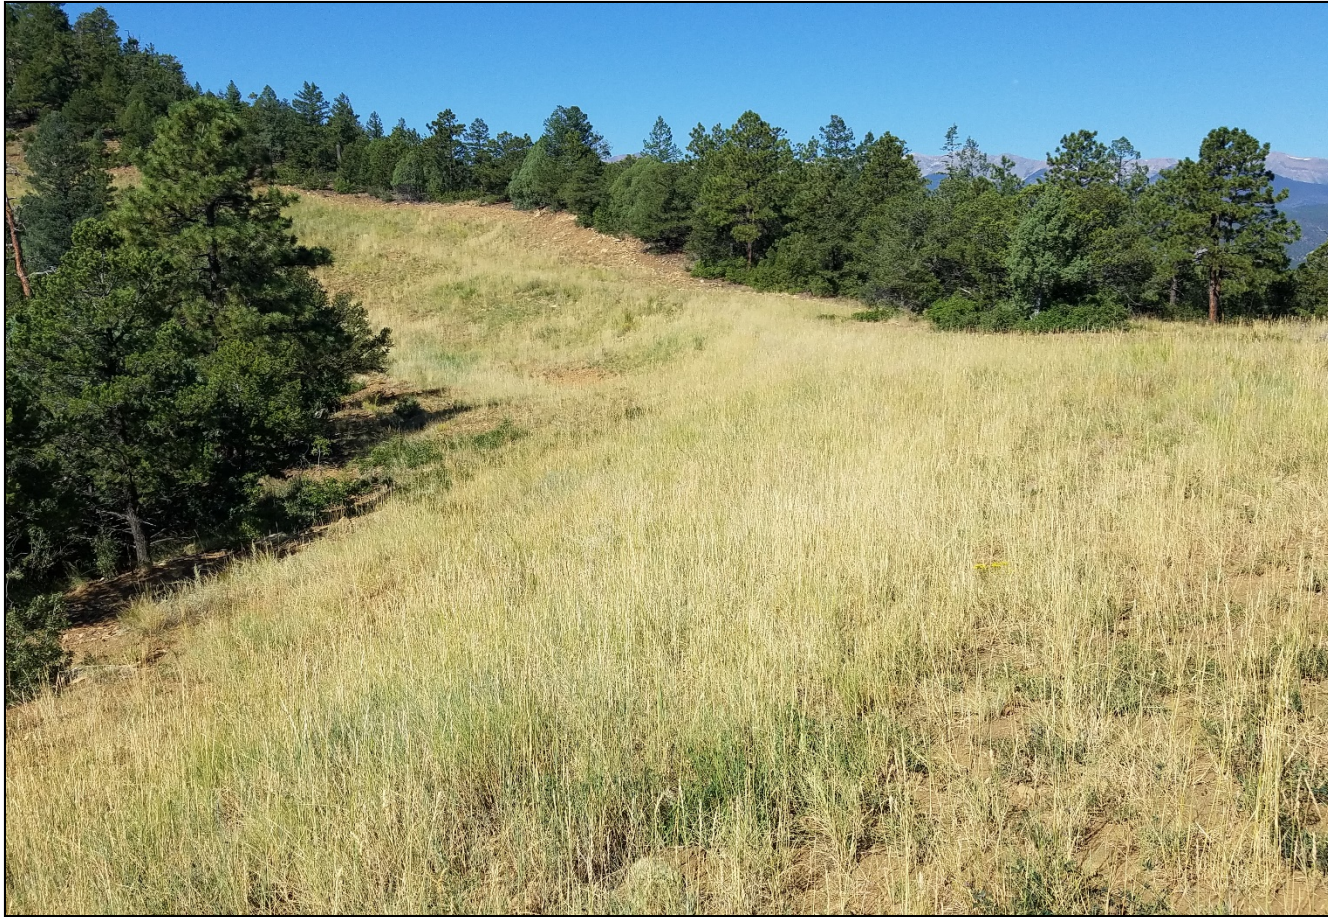
Photo 1. Facing west along the reclaimed access road. Perennial vegetation is uniformly established. This photo is taken near the NEW ELK #26-04 site.

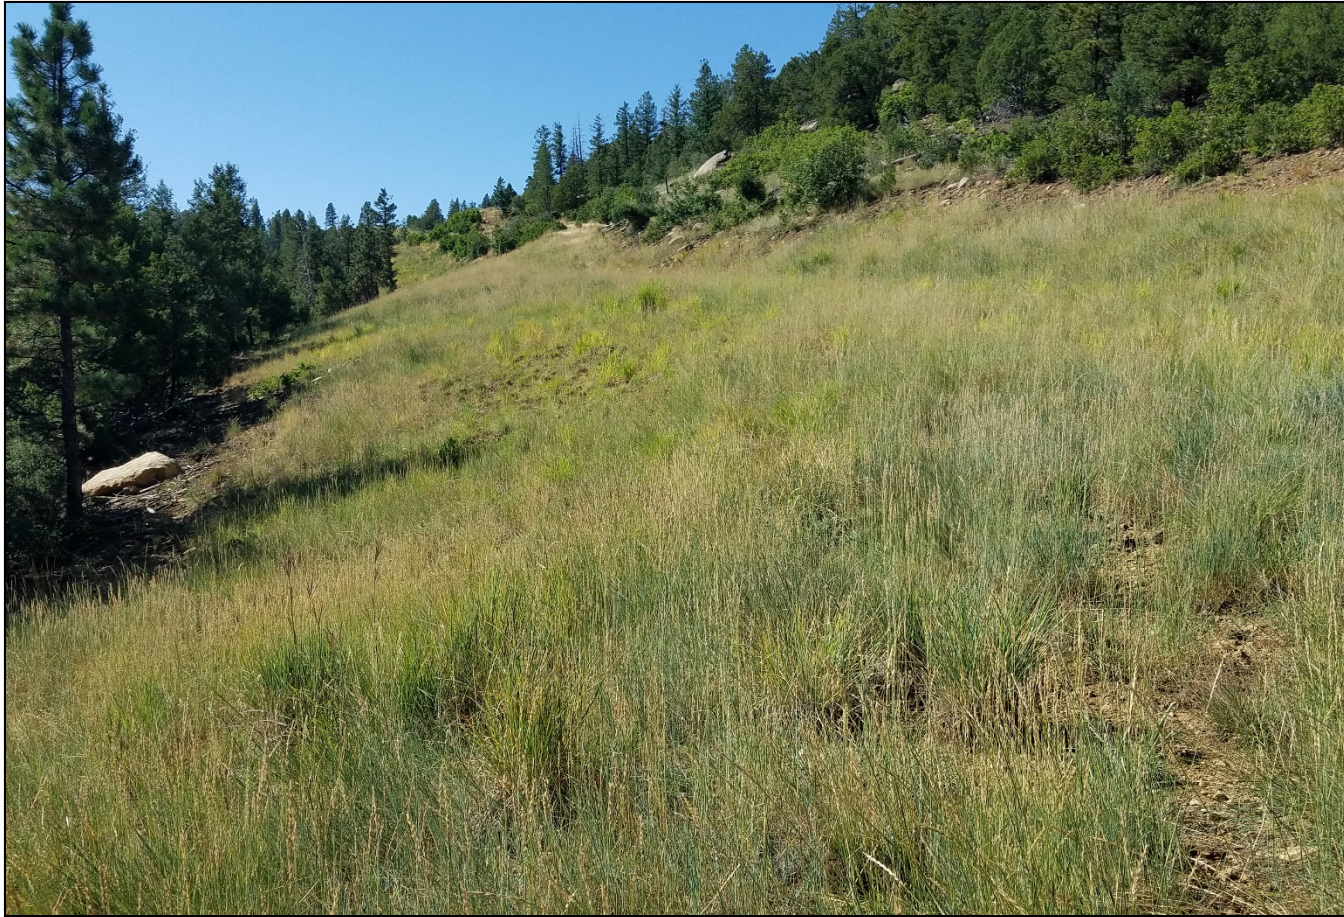
Photo 2. Facing southwest along the reclaimed access road. Perennial vegetation is uniformly established.

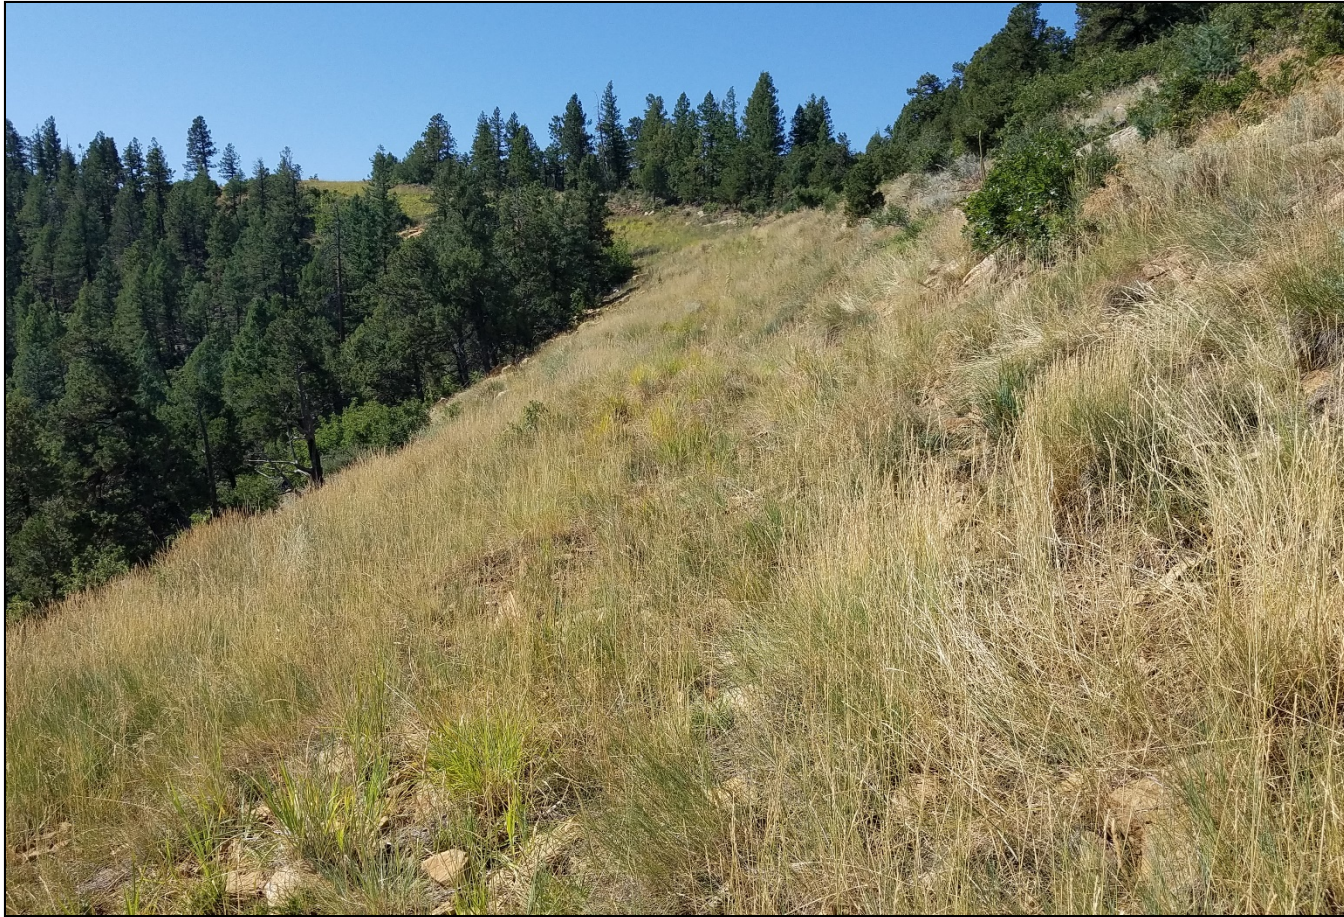
Photo 3. Facing southwest along the reclaimed access road. Perennial vegetation is uniformly established.

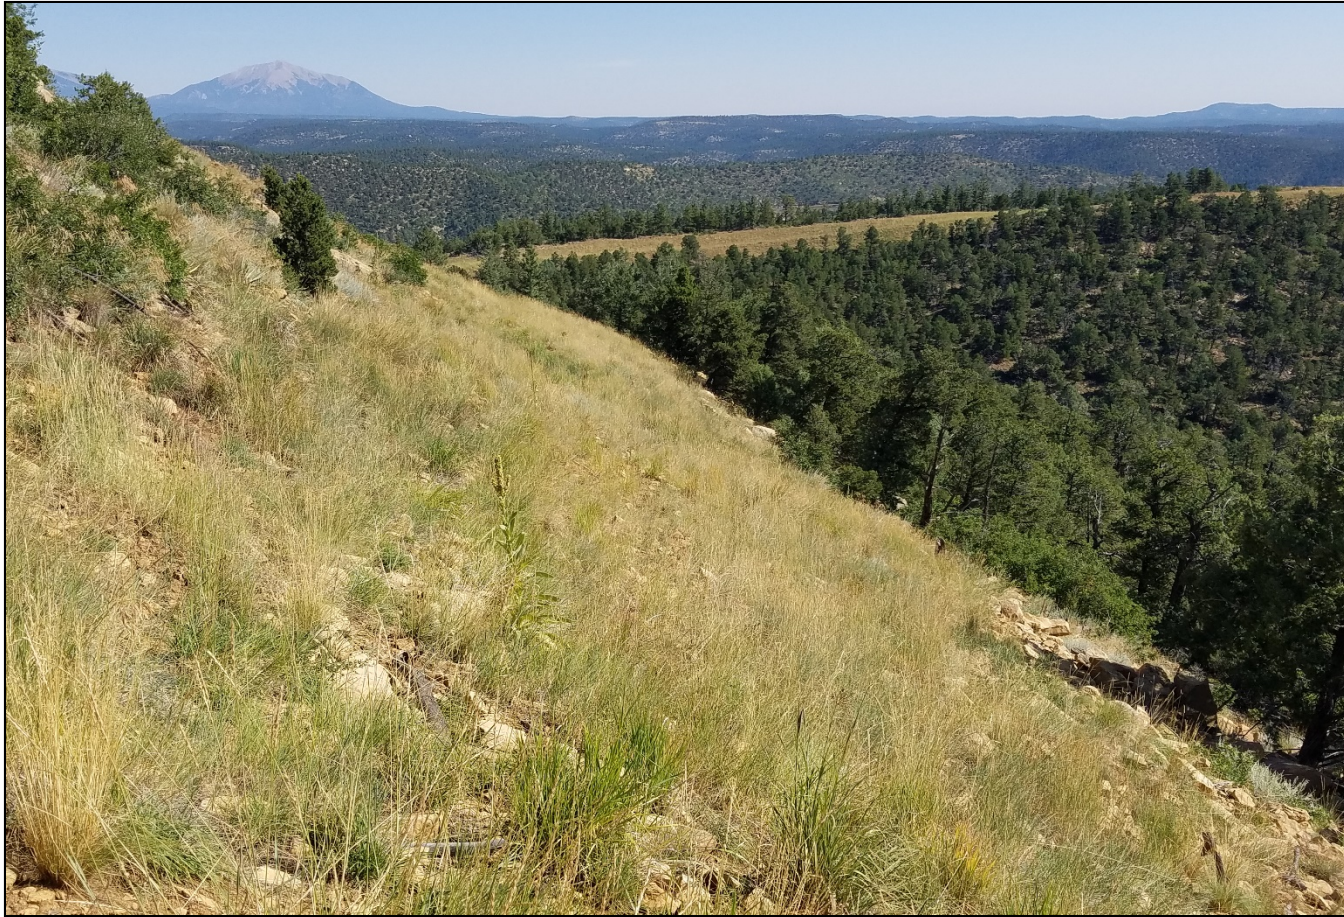
Photo 4. Facing back toward the northeast along the reclaimed access road.

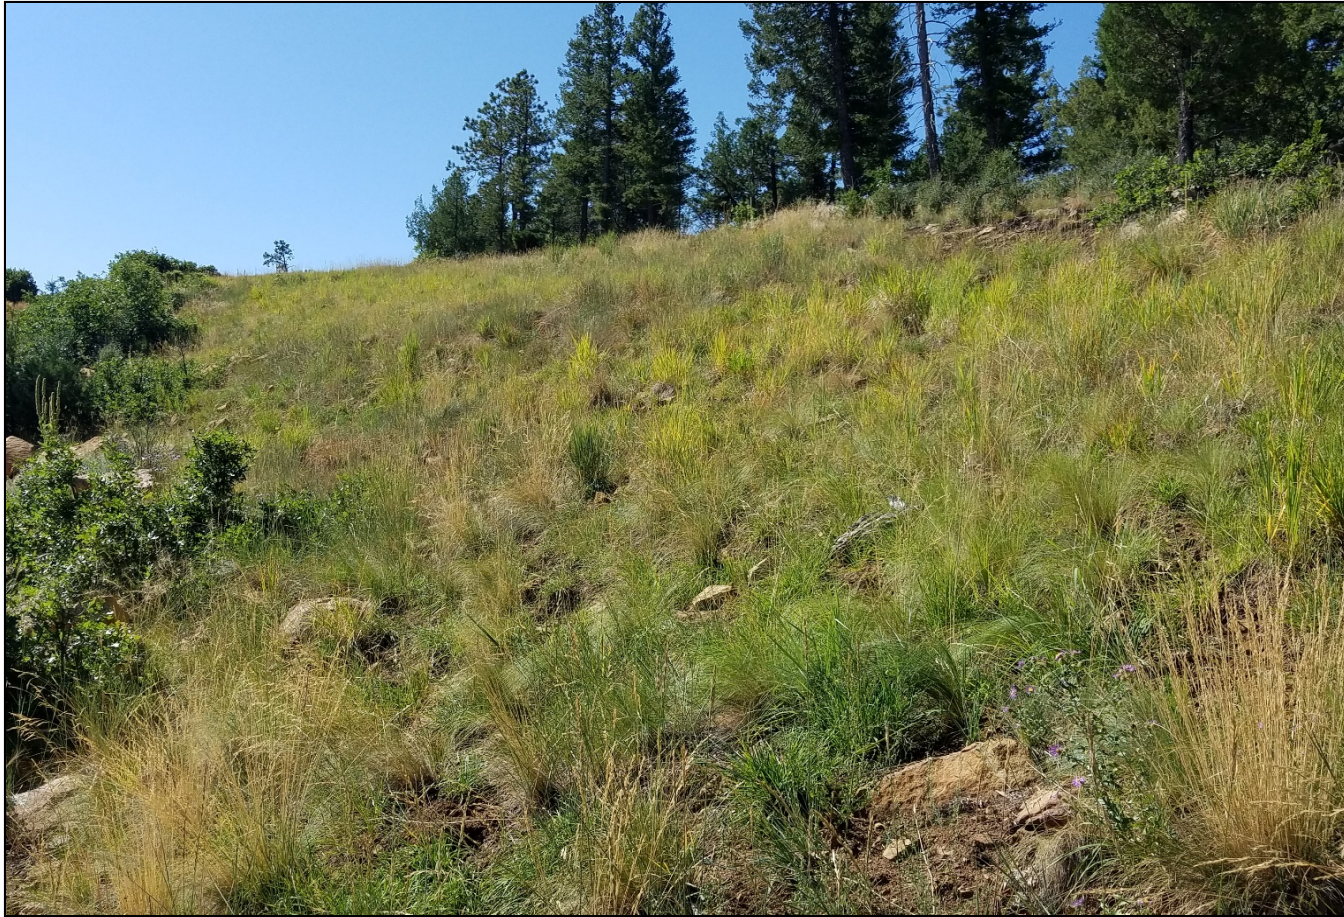
Photo 5. Facing southwest along the reclaimed access road. Perennial vegetation is uniformly established. The site is located at the top of the ridge.

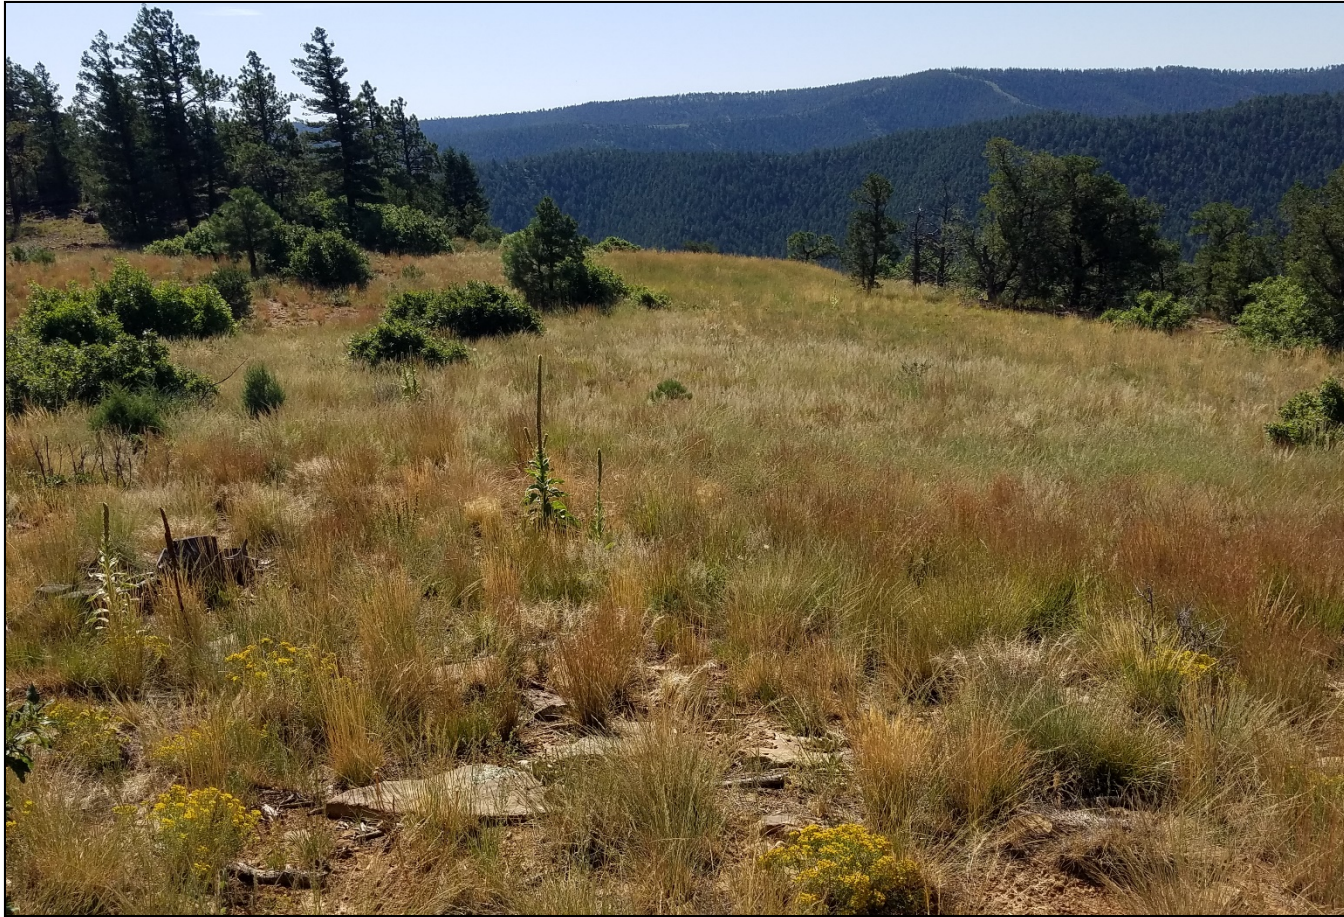
Photo 6. Facing south toward the site. There was no location built at the NEW ELK #27-08 site.
