Inspection Photos

Location Name: MOYER 'A'-612N56W /29NESW

Location #: 317535

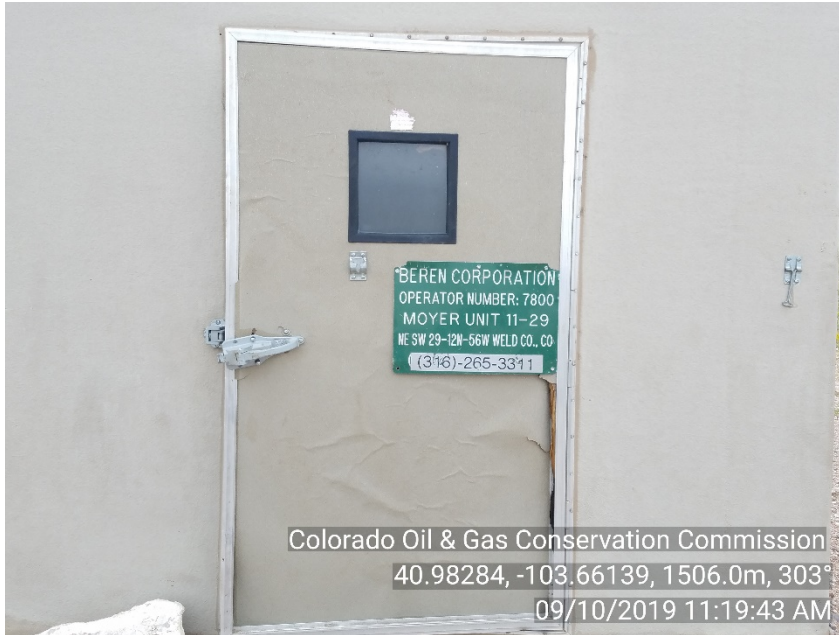
Photo #1

Moyer Unit 11-29 (05-123-07033) UIC - Wellsite

**Active Injection | IJ
Injecting**

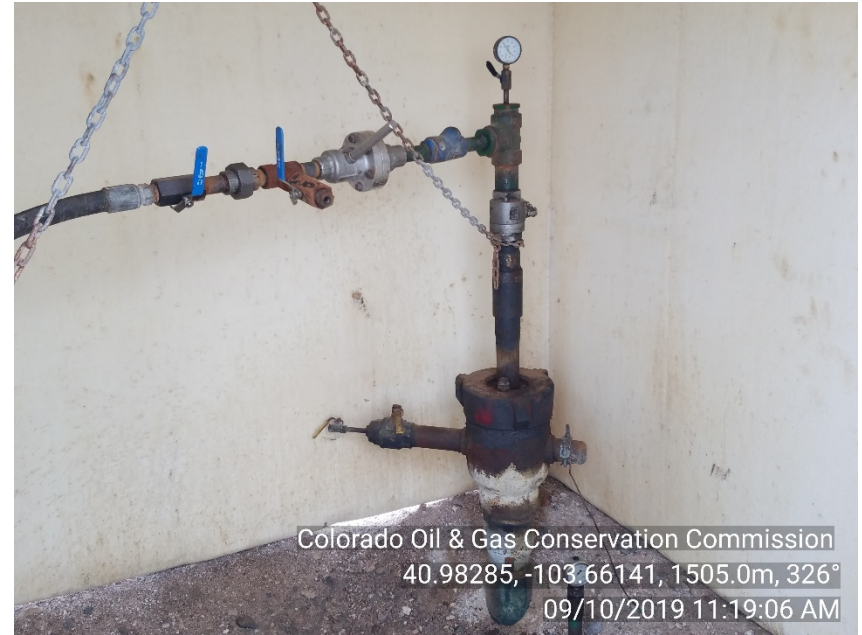
Photo #2

Moyer Unit 11-29 UIC – Wellhead

**Active Injection | IJ
Injecting**

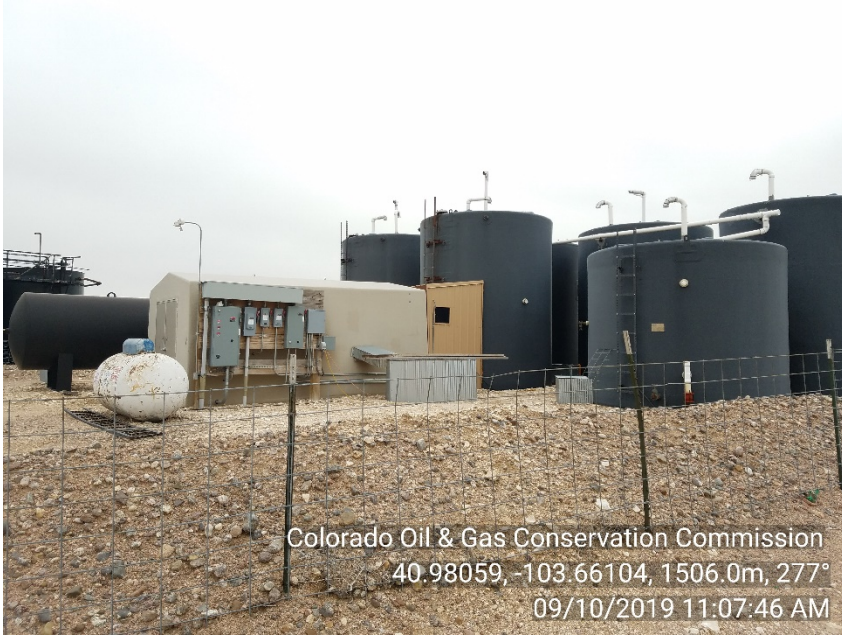
Photo #3

Moyer Unit UIC - Injection Facility

Moyer Unit 11-29, 13-29, 15-29, 3-32, 11-32 (UIC wells)

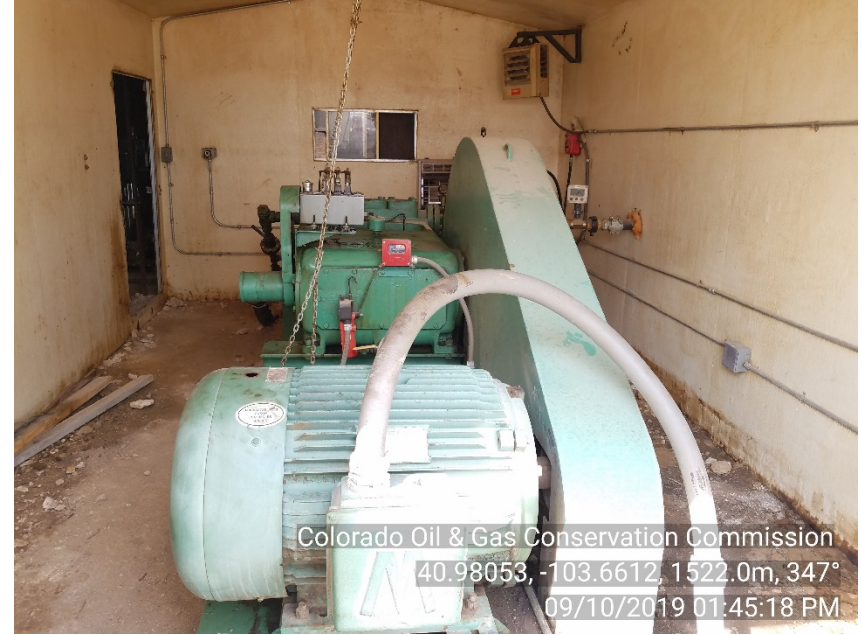
Photo #4

Moyer Unit UIC - Injection Facility

Injection pump
Injecting

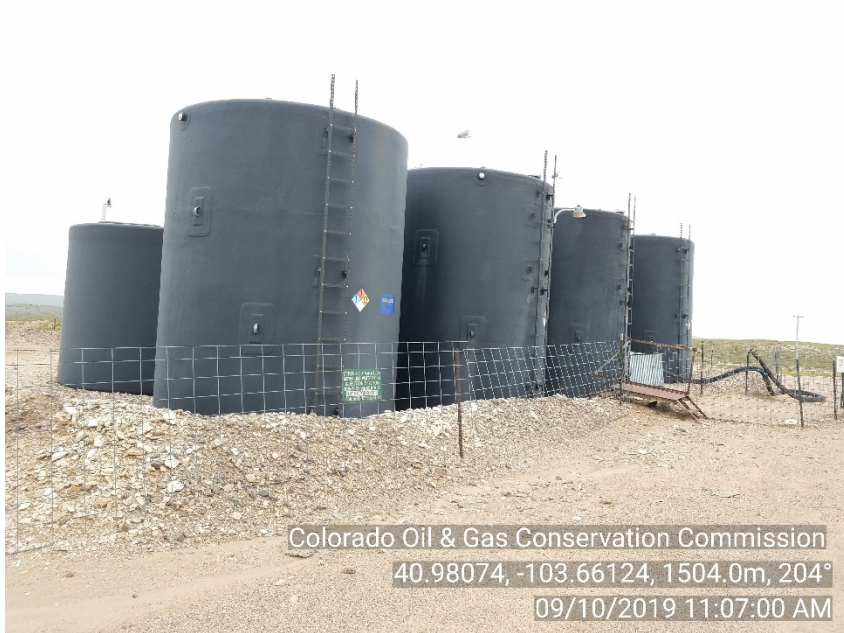
Photo #5

Moyer Unit UIC - Injection Facility

Water Tanks

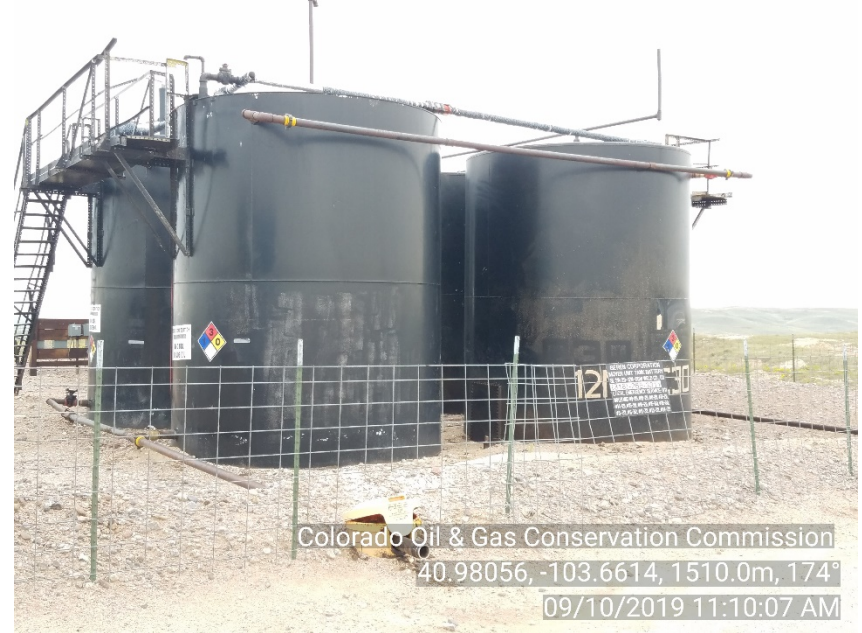
Photo #6

Moyer Unit UIC - Injection Facility

Crude Oil tanks
