Inspection Photos

Location Name: WIDOW WOMAN FEDERAL 42-7

API#: 05-071-07788

INSP. #: 6951013

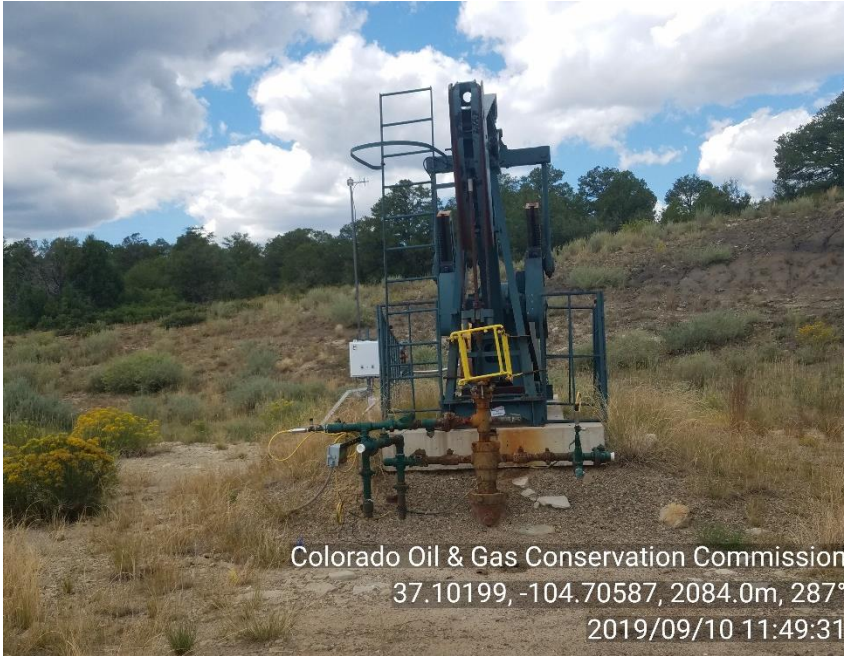
PHOTO 1: WELLHEAD

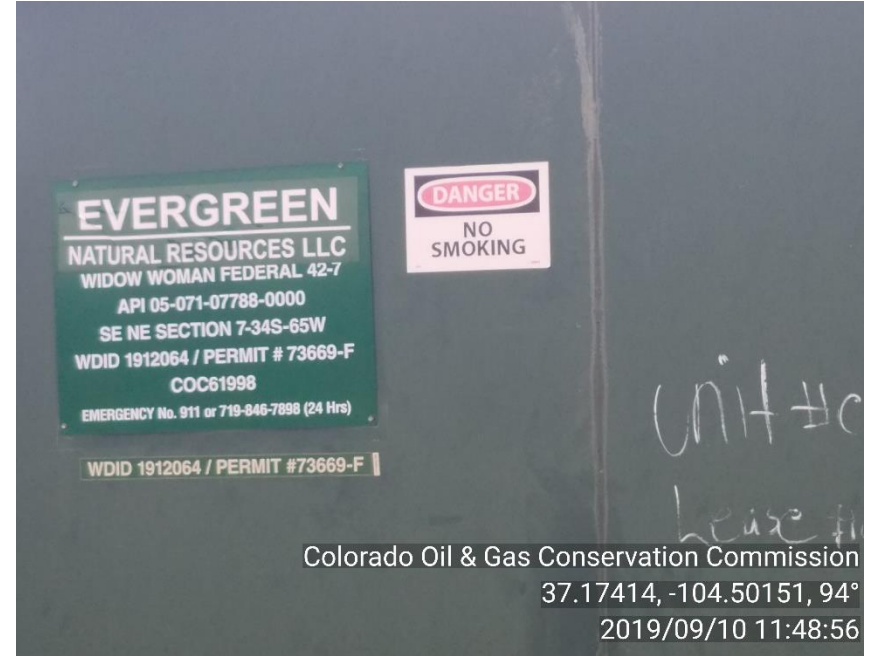
PHOTO 2: WELL SIGN

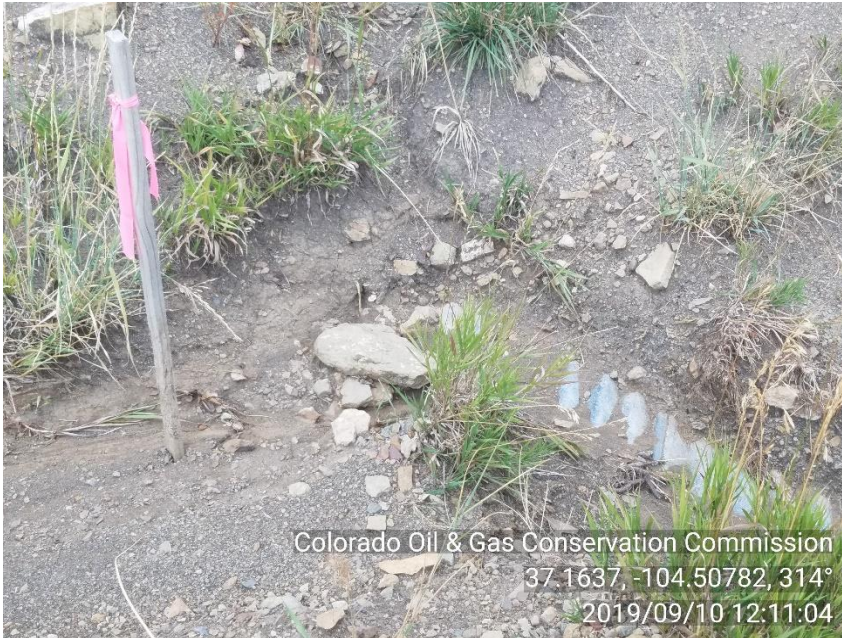
PHOTO 3: CULVERT ON ROW NORTH OF LOCATION IS PLUGGED. CLEAN CULVERT AND PROPERLY MAINTAIN BMP'S, COMPLY WITH RULE 1002.f. CA DATE 11-10-19

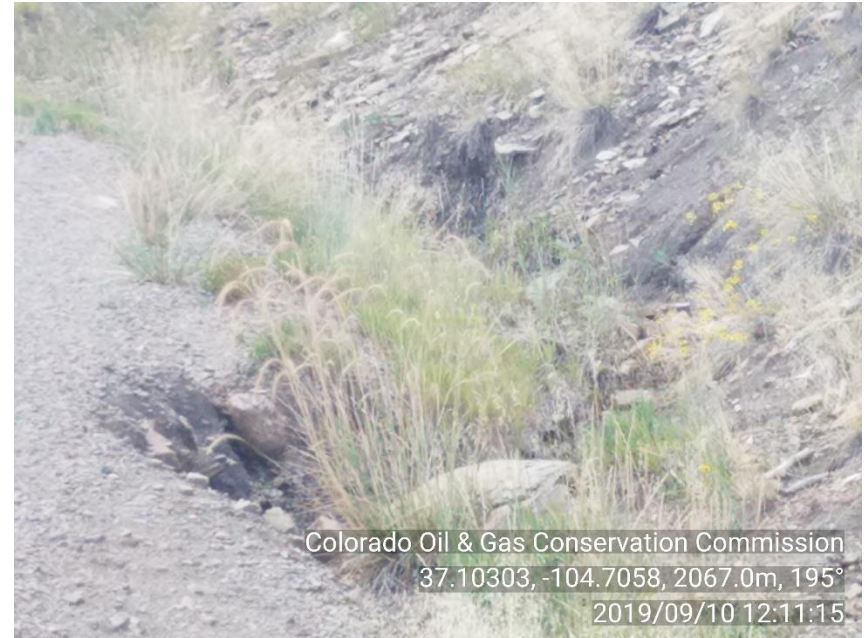
PHOTO 4: EROSION IN BMP DITCH NORTH OF LOCATION. REPAIR EROSION IN DITCH, ADD ADDITIONAL BMP'S TO SLOW STORM WATER FLOW AND PREVENT FURTHER EROSION. COMPLY WITH RULE 1002.f. CA DATE 11-10-19

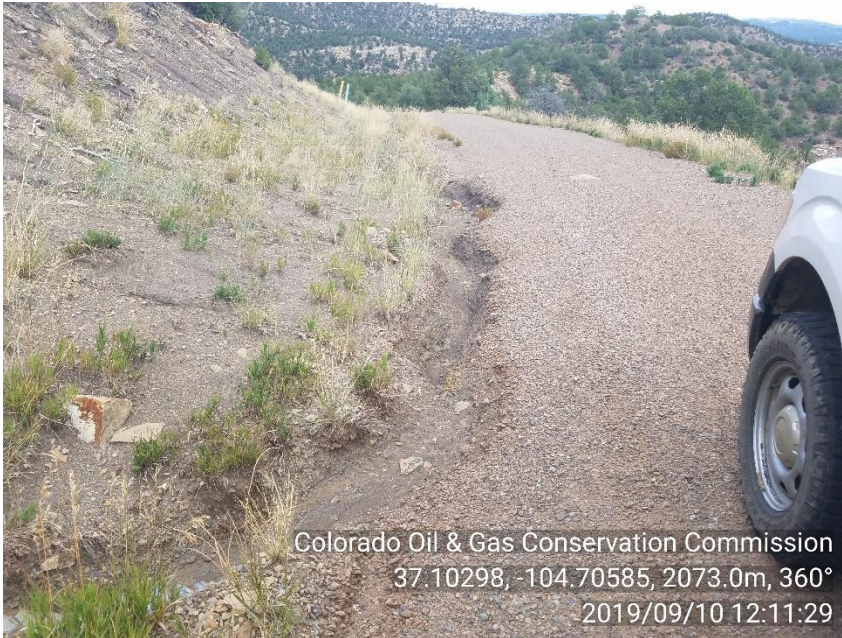
PHOTO 5: EROSION IN BMP DITCH NORTH OF LOCATION. SEDIMENT FROM UP GRADE OF DITCH HAS FILLED DITCH CAUSING EROSION TO EXTEND INTO DRIVING PATH ON ROW. REPAIR EROSION IN DITCH, ADD ADDITIONAL BMP'S TO SLOW STORM WATER FLOW AND PREVENT FURTHER EROSION. COMPLY WITH RULE 1002.f. CA DATE 11-10-19

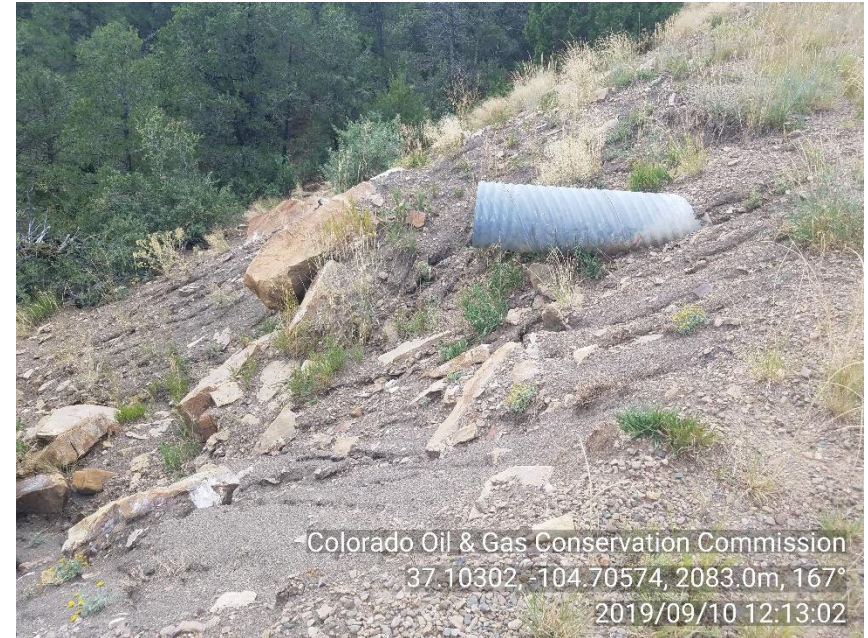
PHOTO 6: CULVERT ON DOWN GRADE SIDE OF ROW APPEARS TO BE TOO SHORT CAUSING FILL FROM ROW TO ERODE. REPAIR EROSION, INSTALL PROPER BMP'S TO PREVENT EROSION AND SEDIMENT FROM ROW TO MIGRATE PAST THE ORIGINAL ROW DISTURBANCE AREA, COMPLY WITH RULE 1002.f. CA DATE 11-10-19.

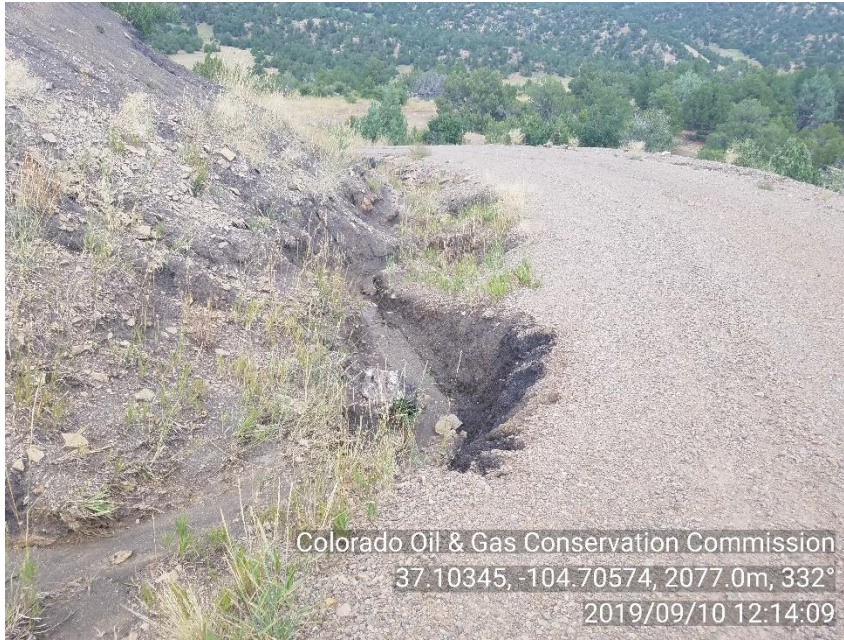
**PHOTO 7: EROSION IN BMP DITCH NORTH OF LOCATION.
REPAIR EROSION IN DITCH, ADD ADDITIONAL BMP'S TO
SLOW STORM WATER FLOW AND PREVENT FURTHER
EROSION. COMPLY WITH RULE 1002.f. CA DATE 11-10-19**

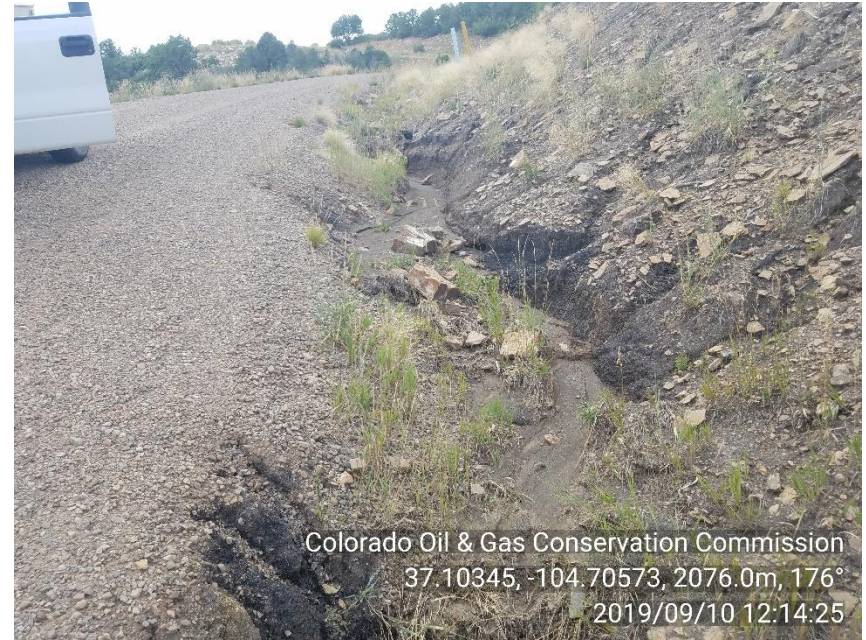
**PHOTO 8: EROSION IN BMP DITCH NORTH OF LOCATION.
REPAIR EROSION IN DITCH, ADD ADDITIONAL BMP'S TO
SLOW STORM WATER FLOW AND PREVENT FURTHER
EROSION. COMPLY WITH RULE 1002.f. CA DATE 11-10-19**

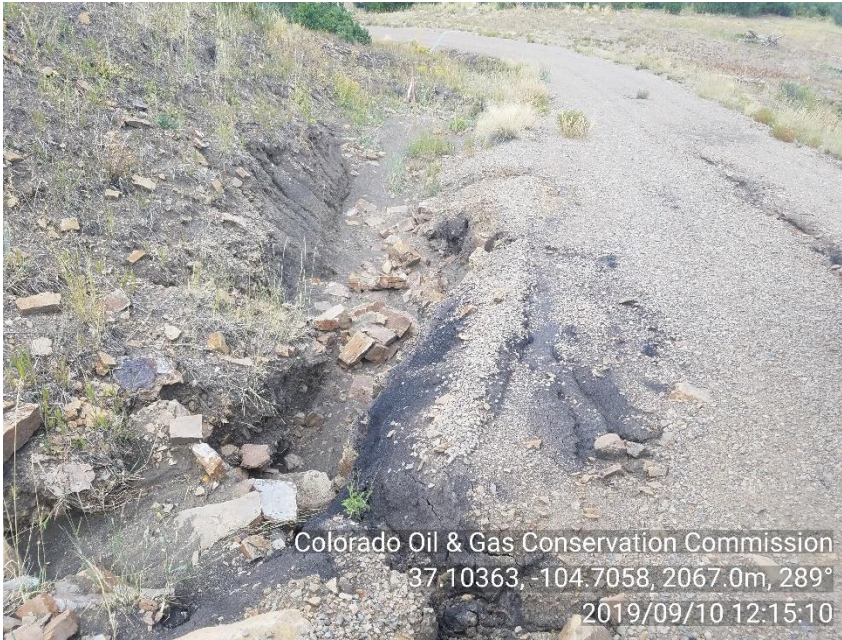
**PHOTO 9: EROSION IN BMP DITCH NORTH OF LOCATION.
REPAIR EROSION IN DITCH, ADD ADDITIONAL BMP'S TO
SLOW STORM WATER FLOW AND PREVENT FURTHER
EROSION. COMPLY WITH RULE 1002.f. CA DATE 11-10-19**

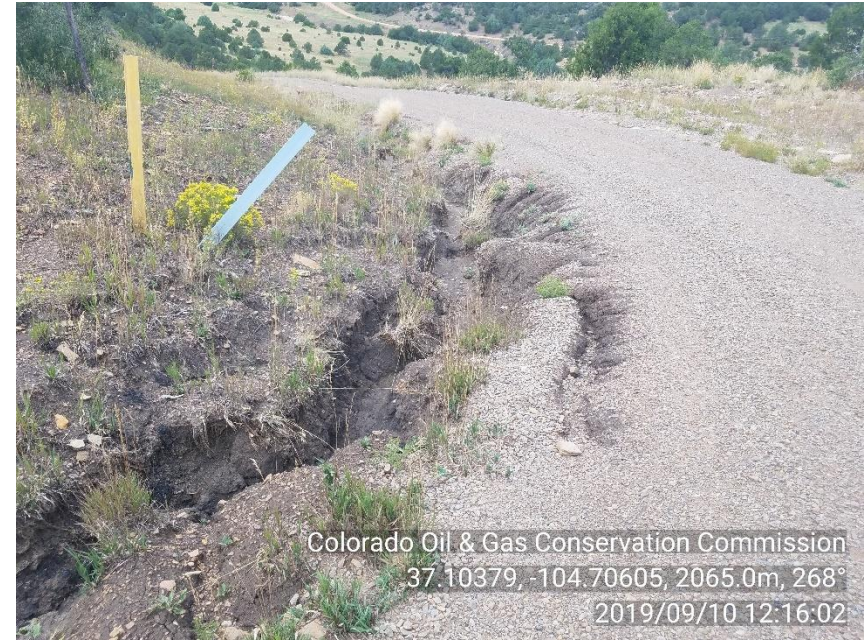
**PHOTO 8: EROSION IN BMP DITCH NORTH OF LOCATION.
REPAIR EROSION IN DITCH, ADD ADDITIONAL BMP'S TO
SLOW STORM WATER FLOW AND PREVENT FURTHER
EROSION. COMPLY WITH RULE 1002.f. CA DATE 11-10-19**

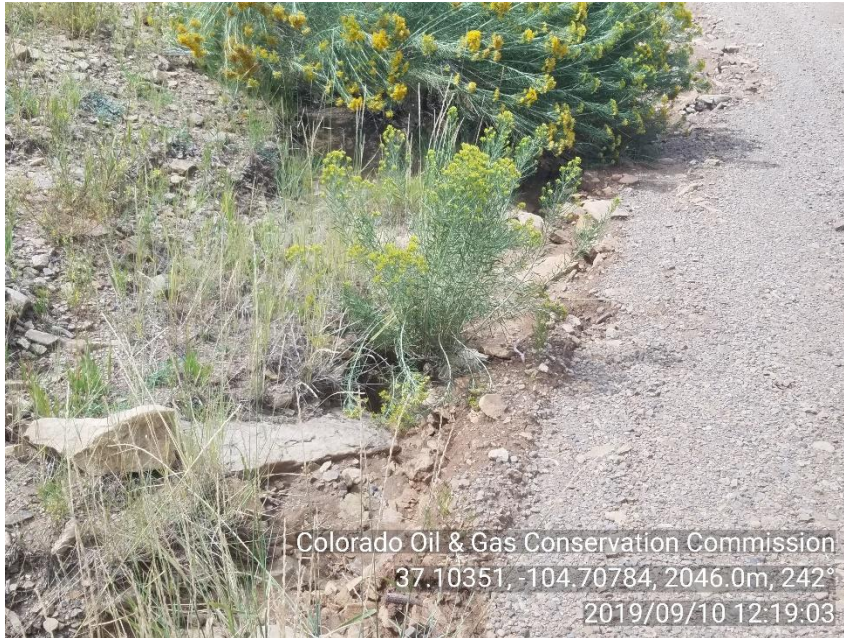
PHOTO 11: VEGETATION IN BM' DITCH IS CAUSING STORWATER TO BYPASS THE CULVERT THAT IS RIGHT BEHIND THE VEGETATION IN PHOTO AND ERODE ROW DRIVE PATH. REMOVE VETETATION AND REPAIR EROSION IN DITCH, ADD ADDITIONAL BMP'S TO SLOW STORM WATER FLOW AND PREVENT FURTHER EROSION. COMPLY WITH RULE 1002.f. CA DATE 11-10-19
