FRAM OPERATING LLC – 10310

Location ID # 334481

API # 05-077-09325 Seminole 32-2-I

Inspection Date : 9/9/2019

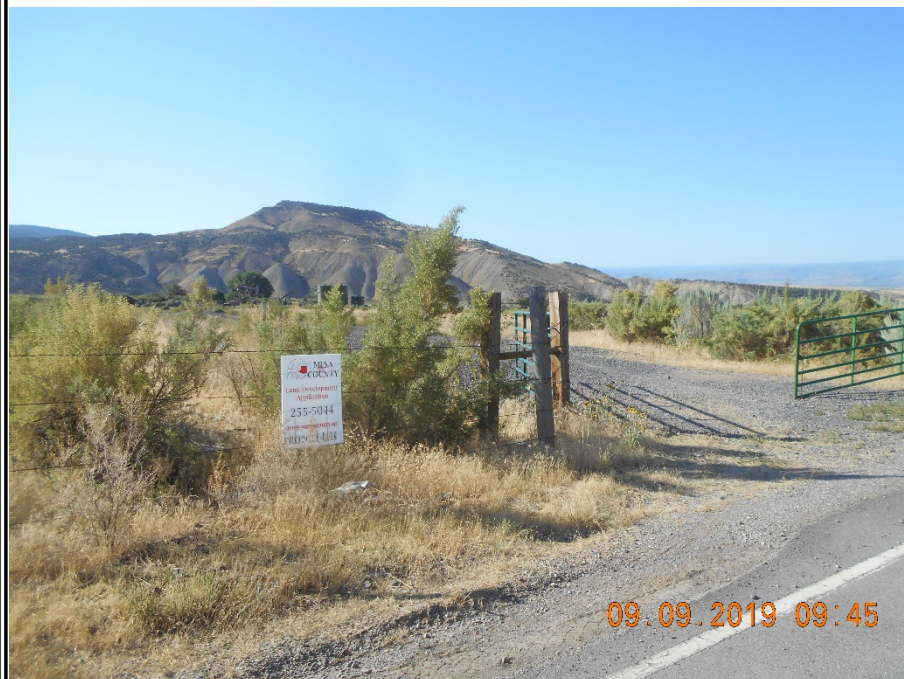
Entrance gate to location off Forest Service Rd 70 (FS.70).

Lock removed, gate open.

Mesa County Land Development Application sign on fence.

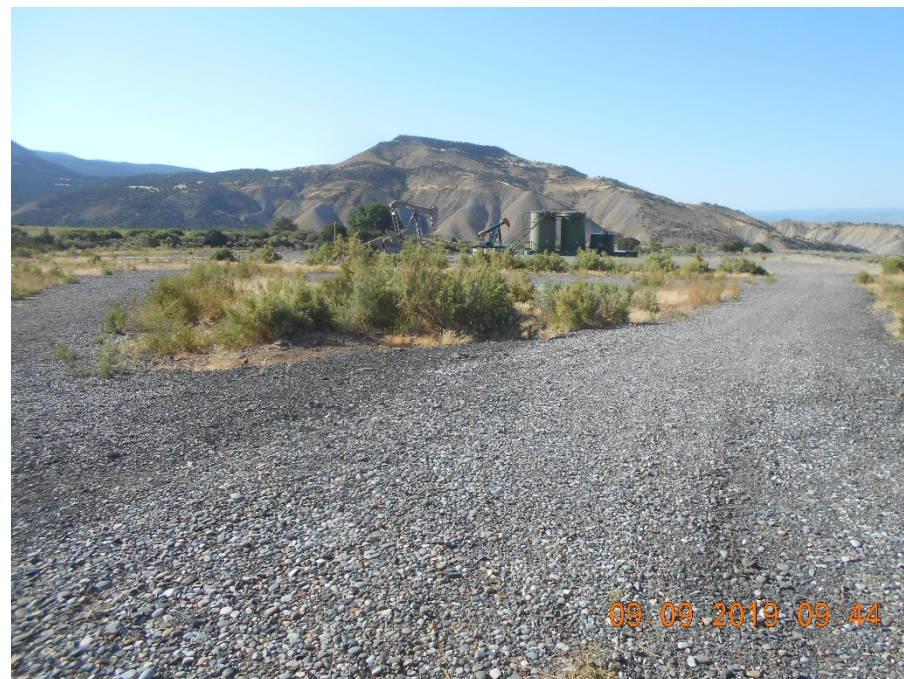
Overview of location from N entrance of pad looking S

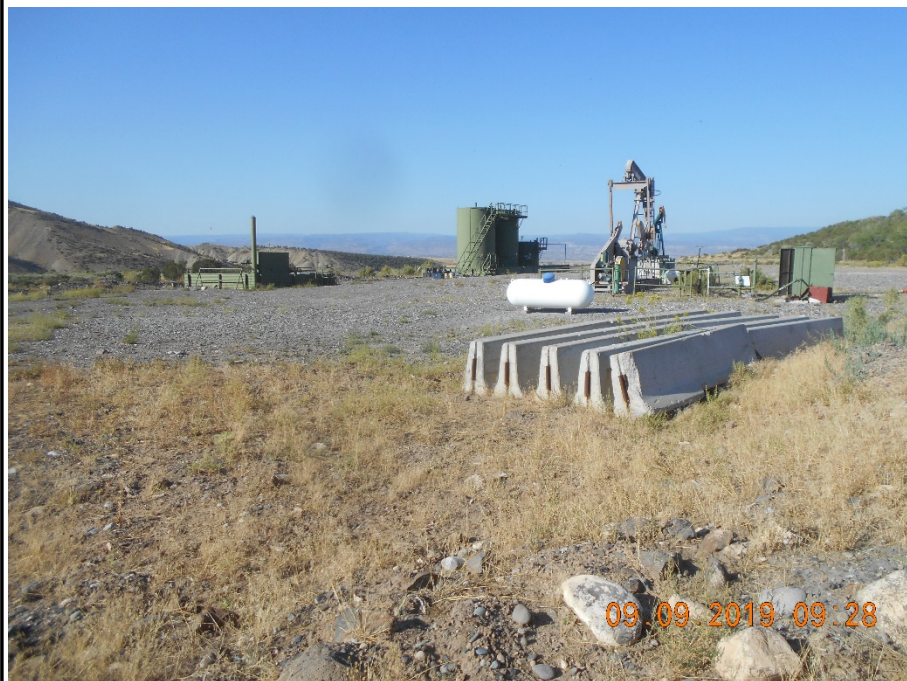
NE corner of location looking SW

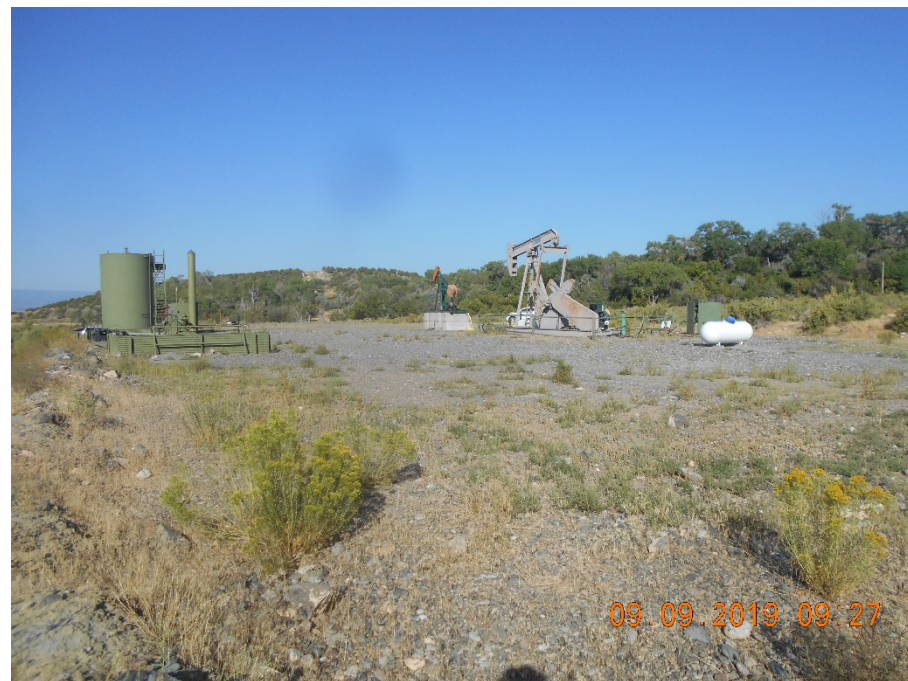
SE corner of location looking NW

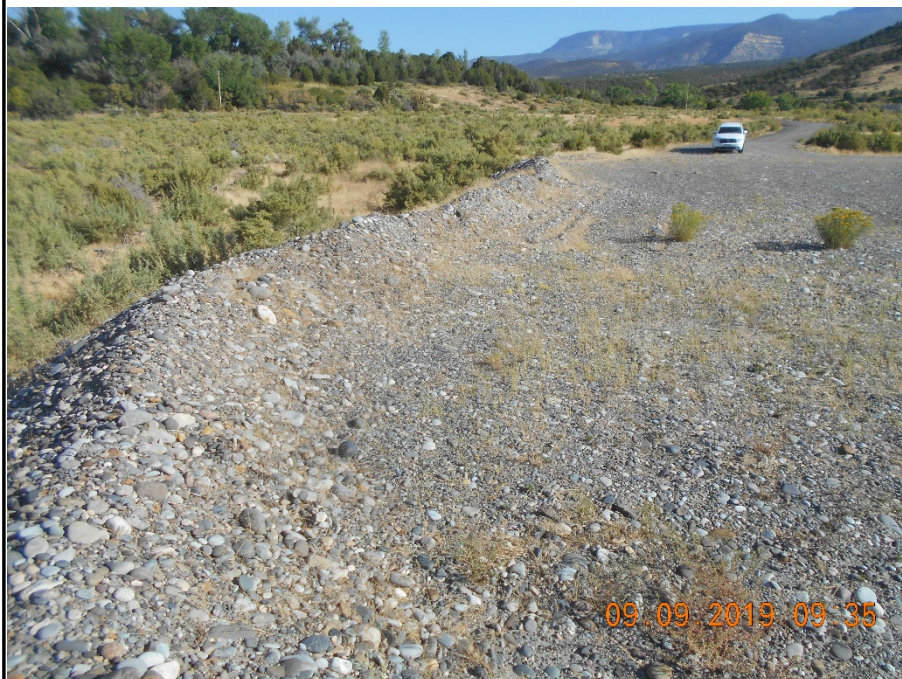
SW corner of location looking N

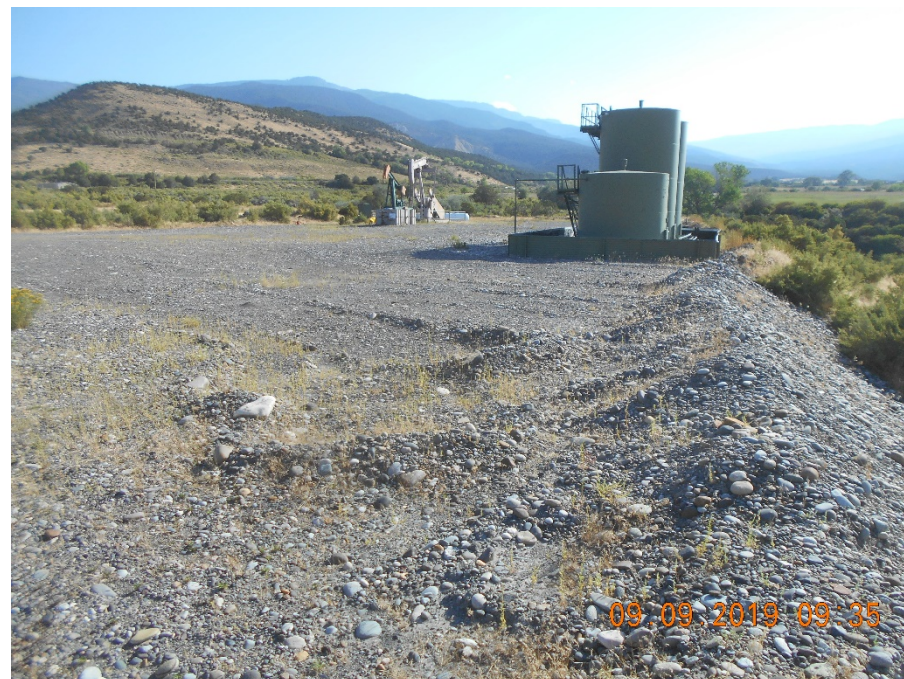
SW corner of location looking NE

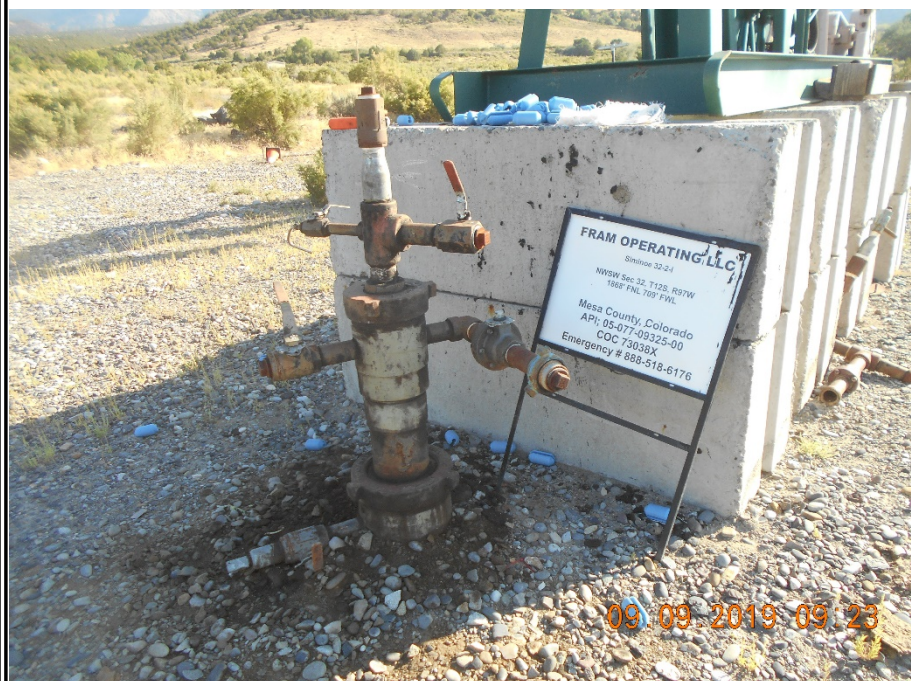
05-077-09325 Seminoe 32-2-I

**Wellhead with sign and pump jack. Well Temporarily abandoned.
Stained soil around wellhead.**

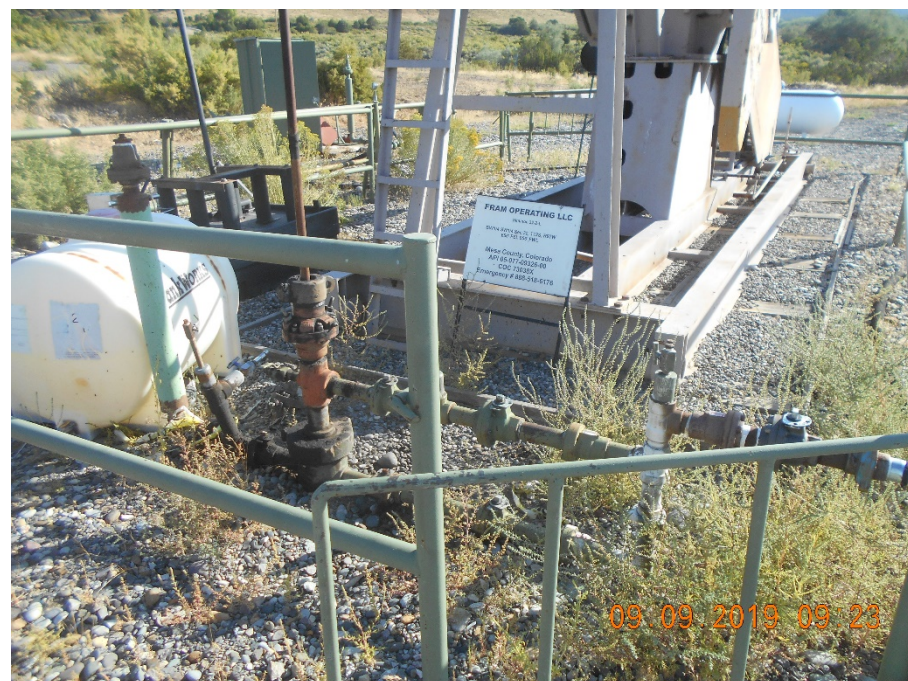
05-077-09326 Seminoe 32-2-L

Wellhead with sign and pump jack. Stained soil around wellhead.

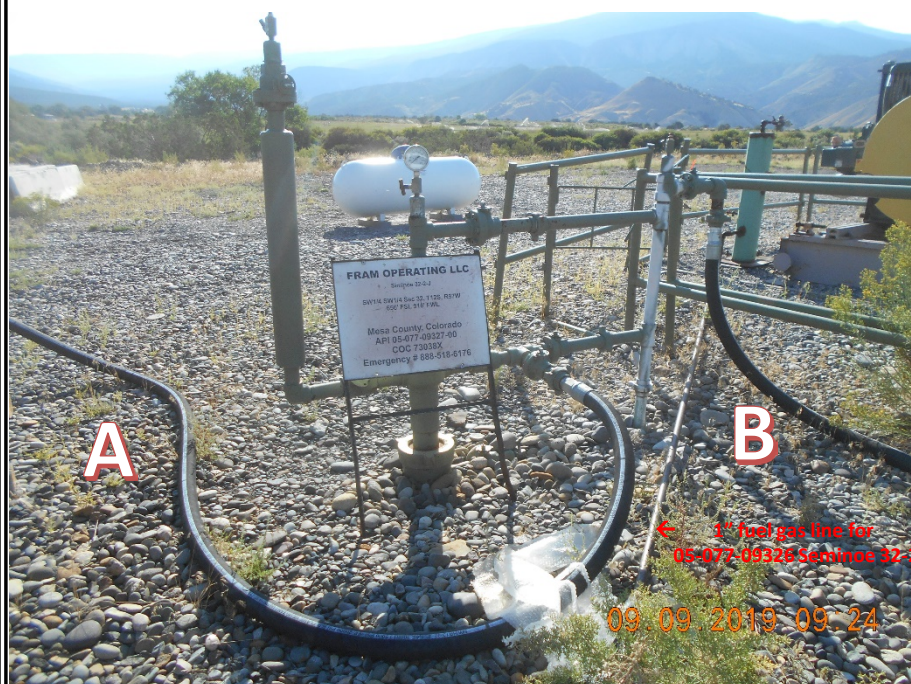
05-077-09327 Seminole 32-2-J. Wellhead with sign.
2" hose connected to wellhead flowing to meter. (A)
2" hose from meter to production riser at wellhead. (B)

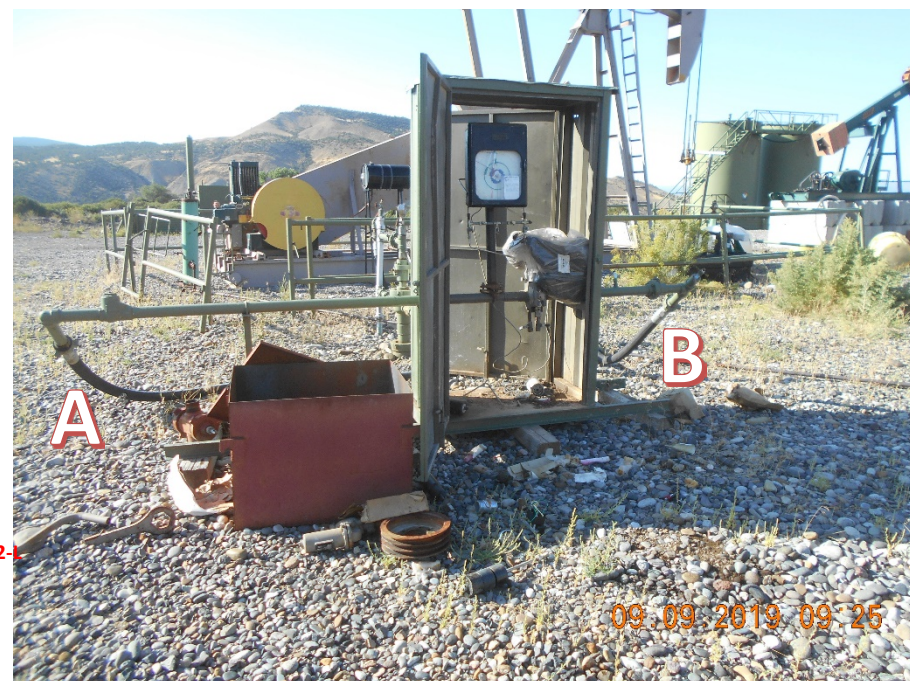
Meter housing with sides open. Looking S.
2" hose connected to wellhead flowing to meter. (A)
2" hose from meter to production riser at wellhead. (B)
Parts, pipe and fittings scattered around .

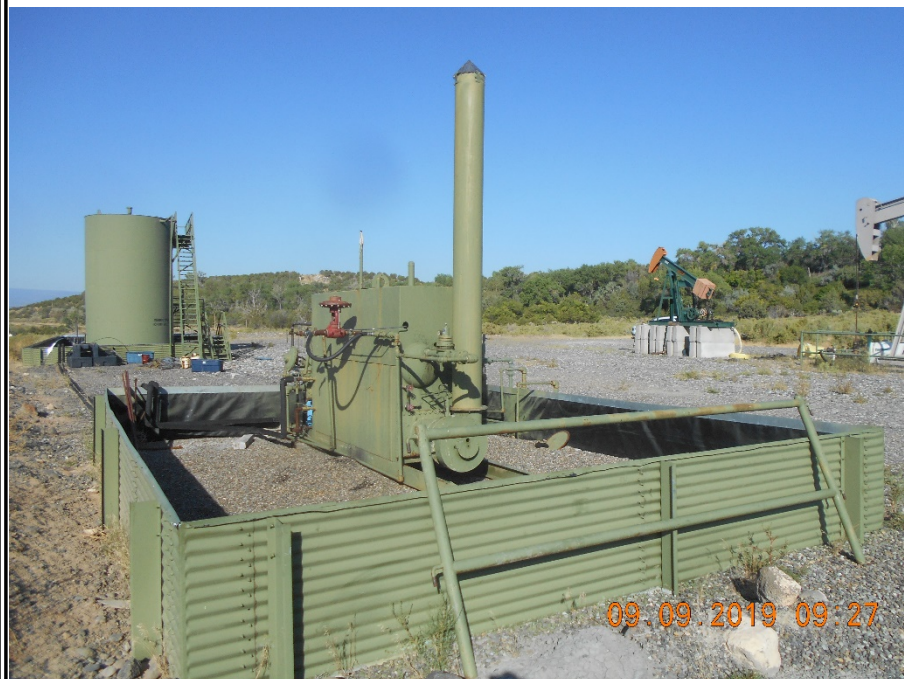
Separator with metal berm. SE corner looking NW.
Unused pipe fencing

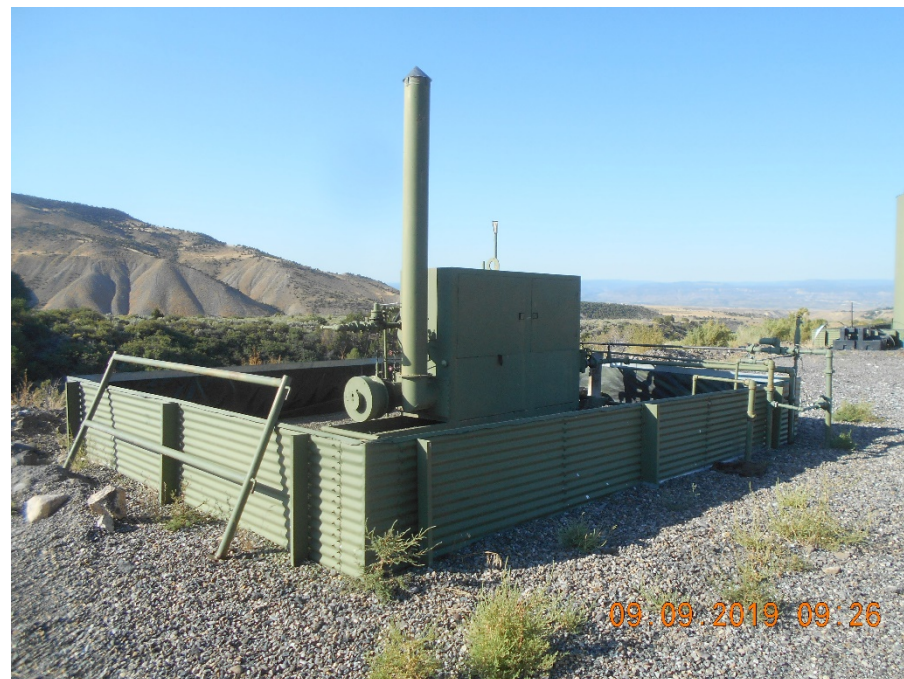
Separator with metal berm. NE corner looking SW

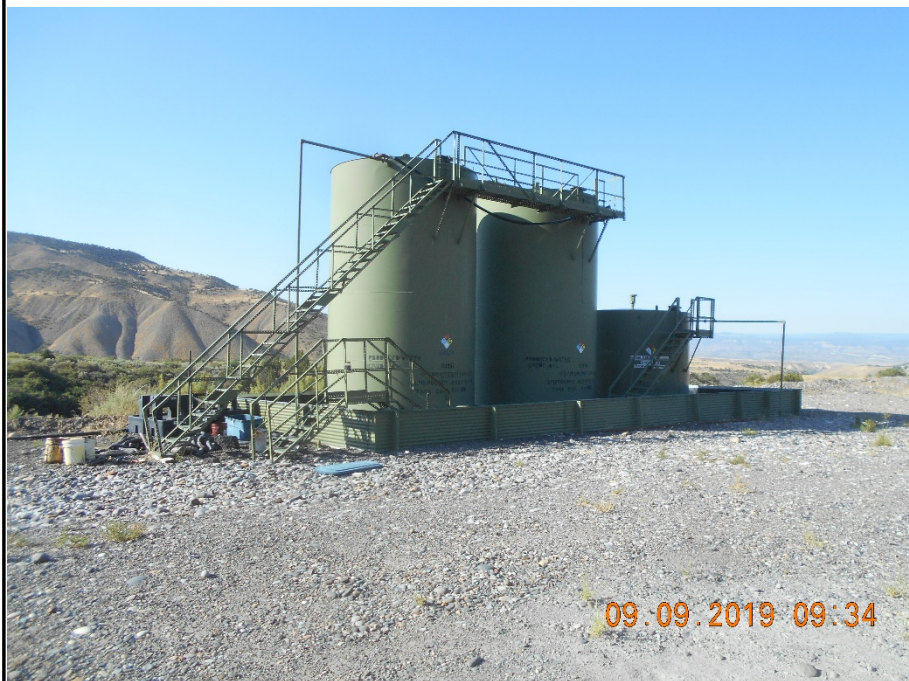
Tank Battery NE corner looking SW

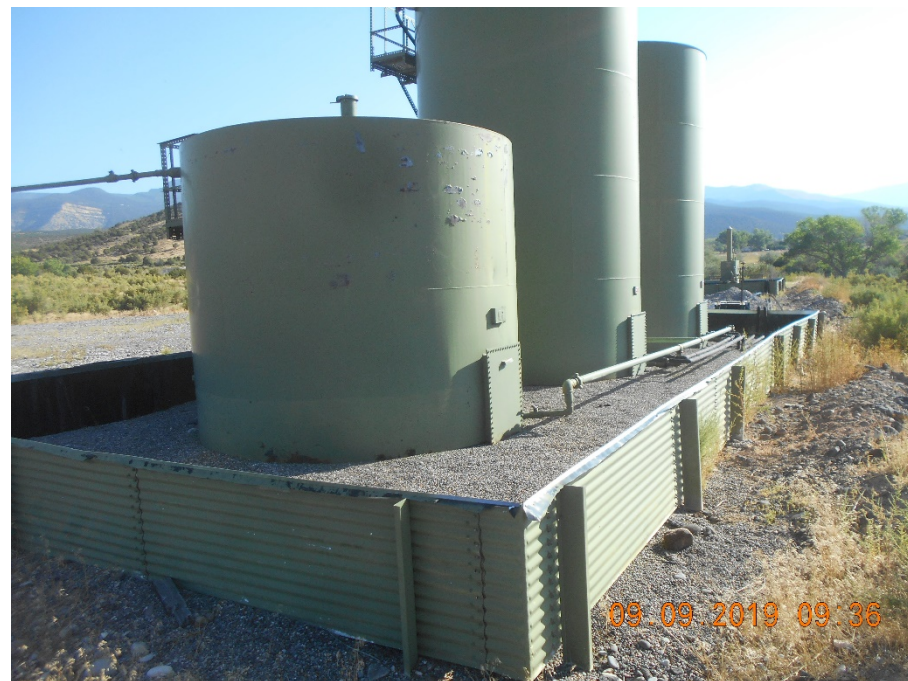
Tank Battery SW corner looking NE

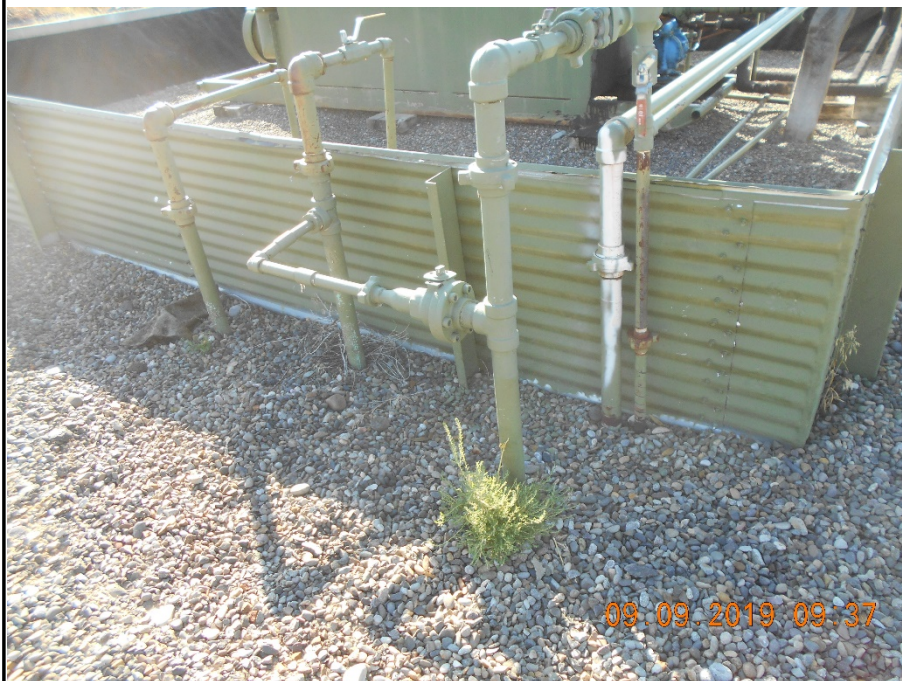
**Flowline risers on NW Corner of separator berm.
4x-2" and 1x-1"**

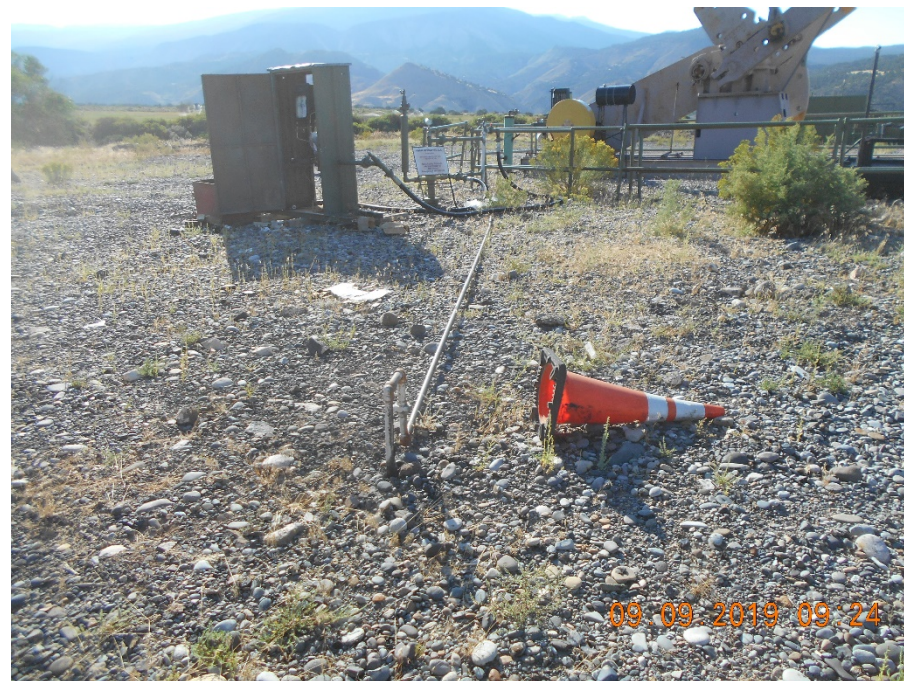
**1" flowline riser.
Fuel gas supply for 05-077-09326 Seminole 32-2-L pump jack.**

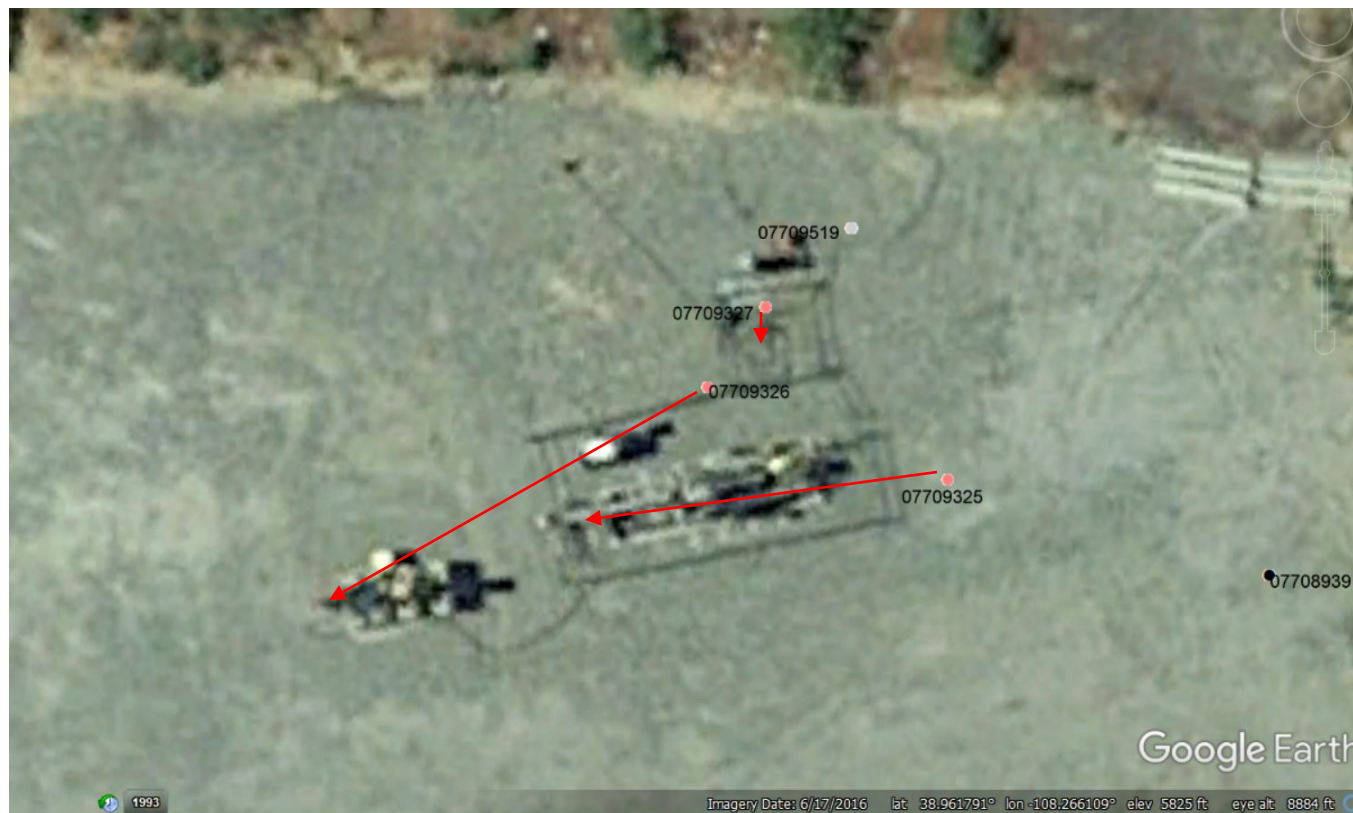
**Needs update on As-Drilled locations. Red dots are COGIS database coordinates.
Red arrows point to actual wellheads.**

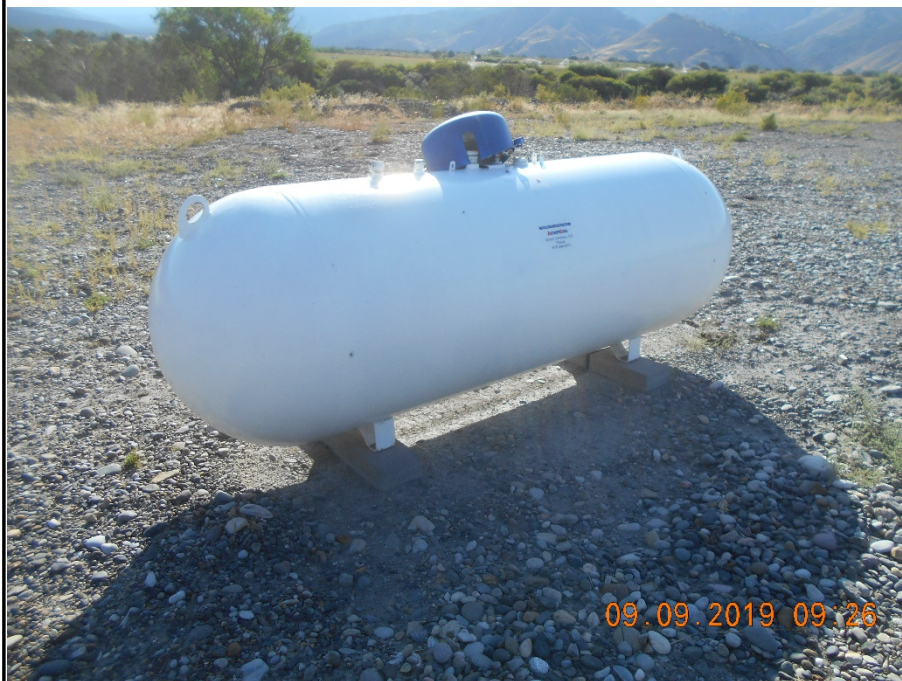
500 gal propane tank. Disconnected.

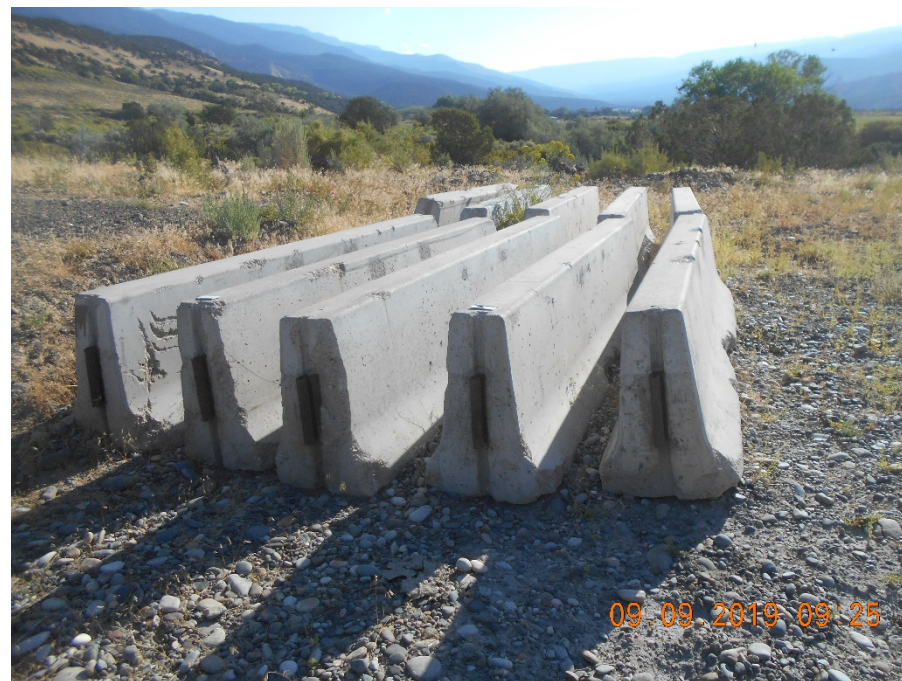
Cement barricades. Unused.

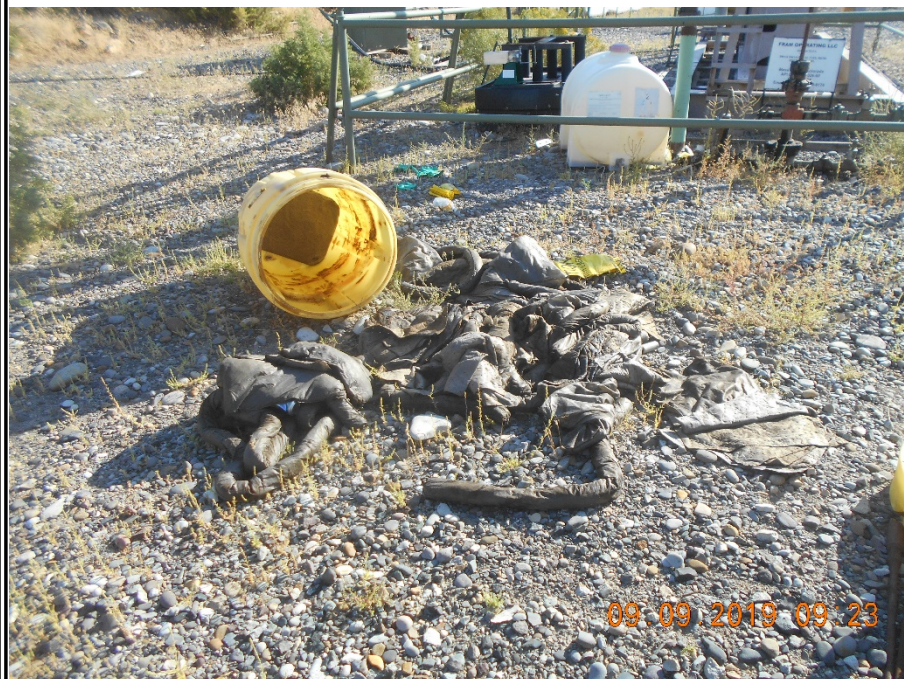
**Spill Response Kit . Contents scattered about by vandals.
05-077-09326 Seminole 32-2-L wellhead in background.**

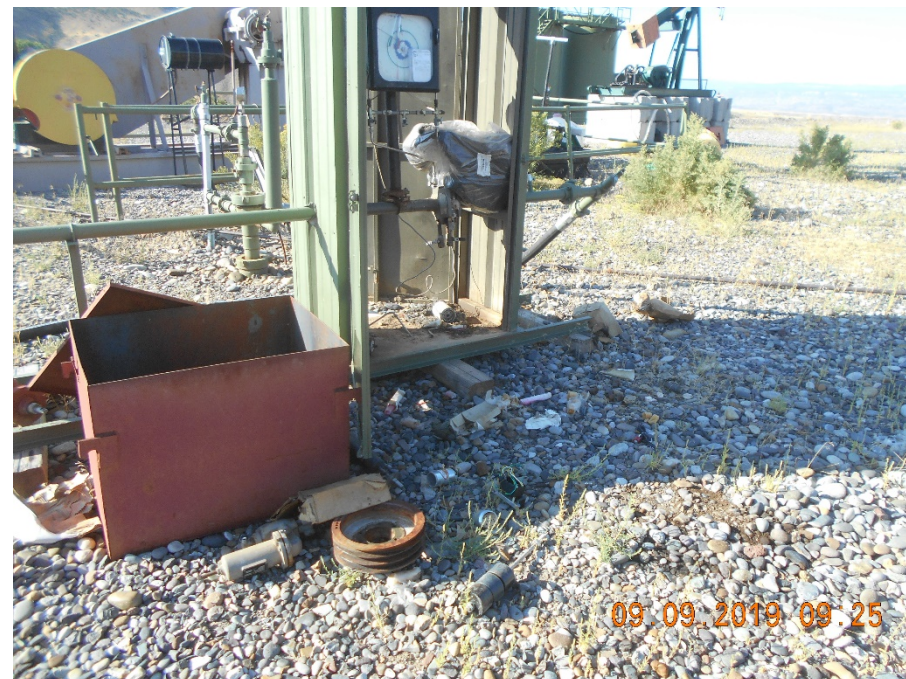
Meter house and tool box. Scattered by vandals.

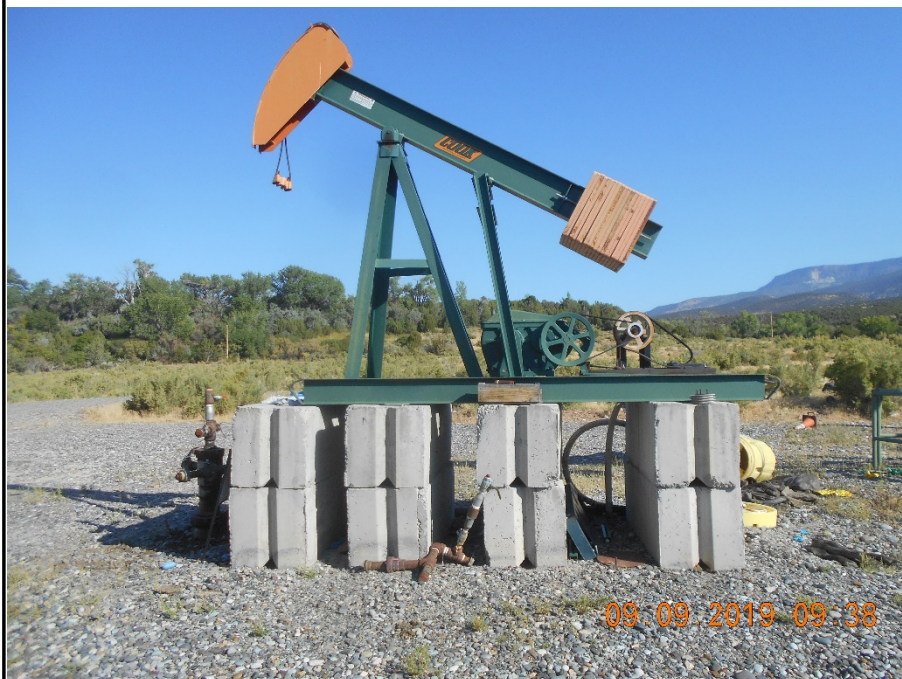
05-077-09325 Seminoe 32-2-I. Looking N
Well Temporarily abandoned. Pump Jack disconnected. Pump Jack motor removed.
Vandalized spill response kit in background.

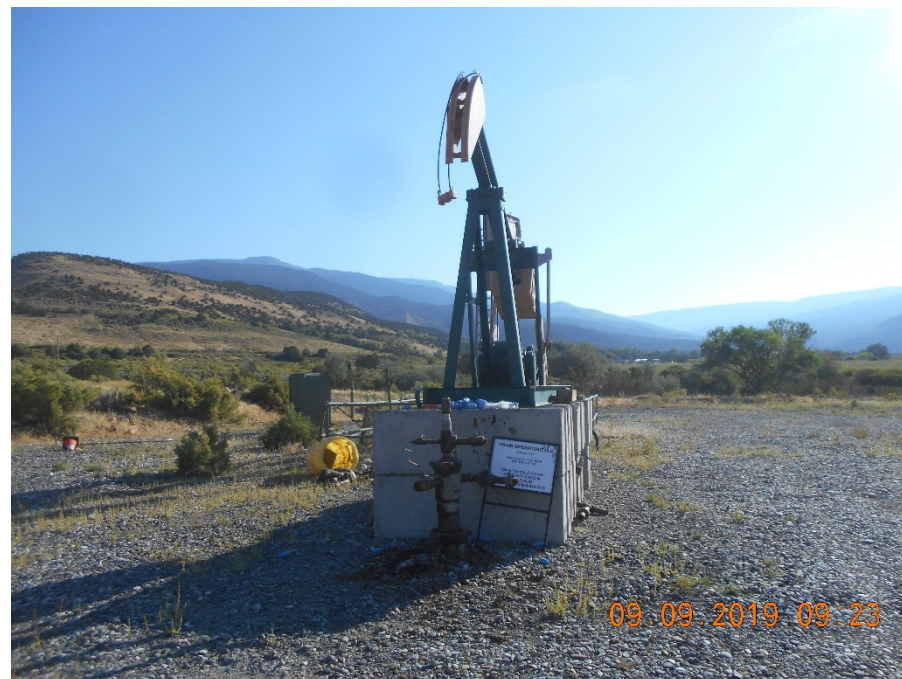
05-077-09325 Seminoe 32-2-I. Looking E
Well Temporarily abandoned. Pump Jack disconnected
Stained soil around wellhead. Vandalized spill response kit in background

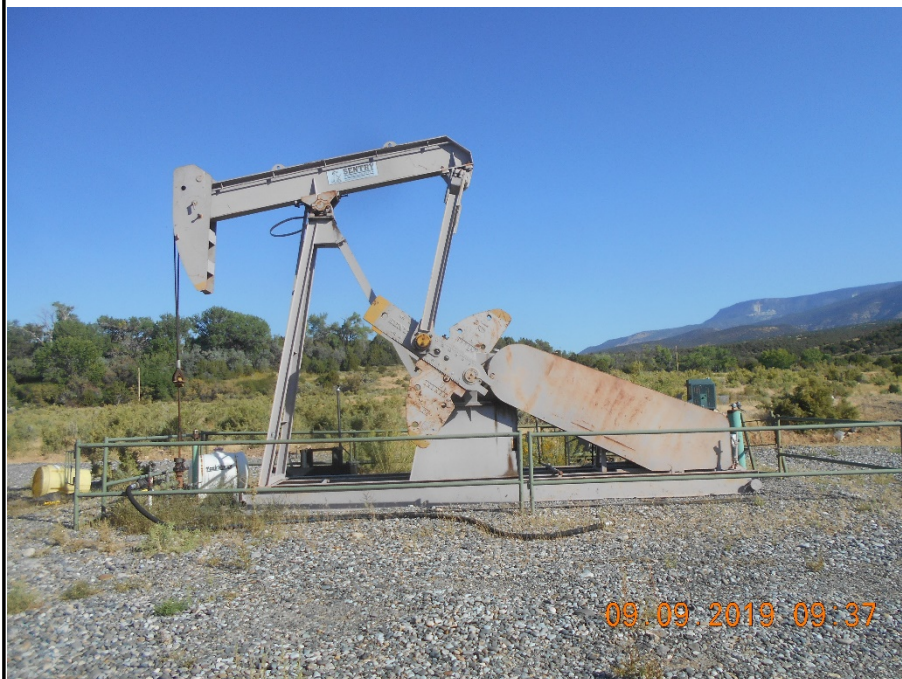
**Pump Jack with pipe fence. Looking N.
Located at 05-077-09326 Seminoe 32-2-L wellhead**

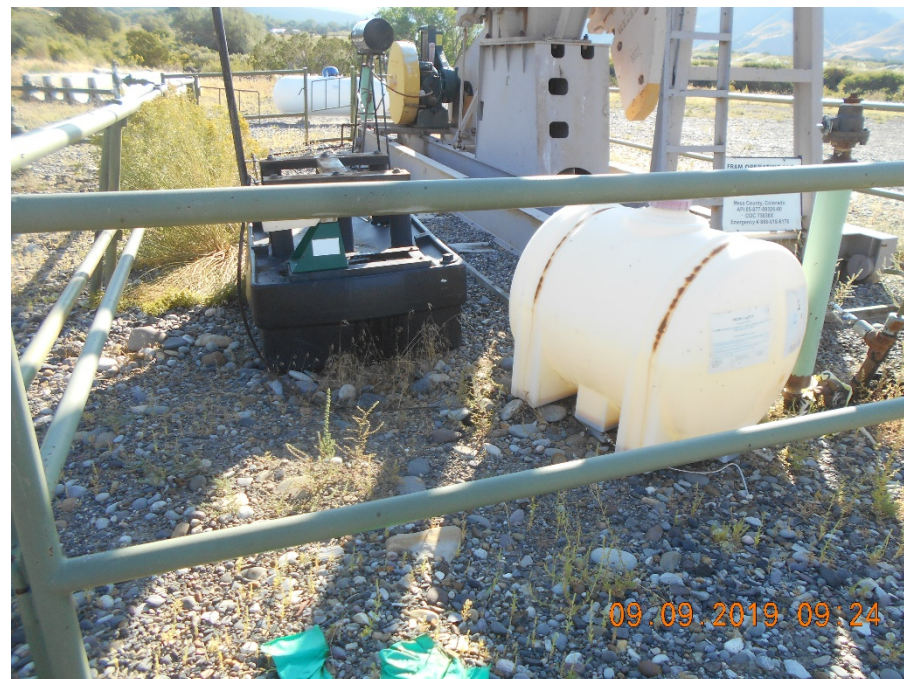
**Injection chemical tank and pump/containment unit vandalized.
Located at 05-077-09326 Seminoe 32-2-L wellhead**

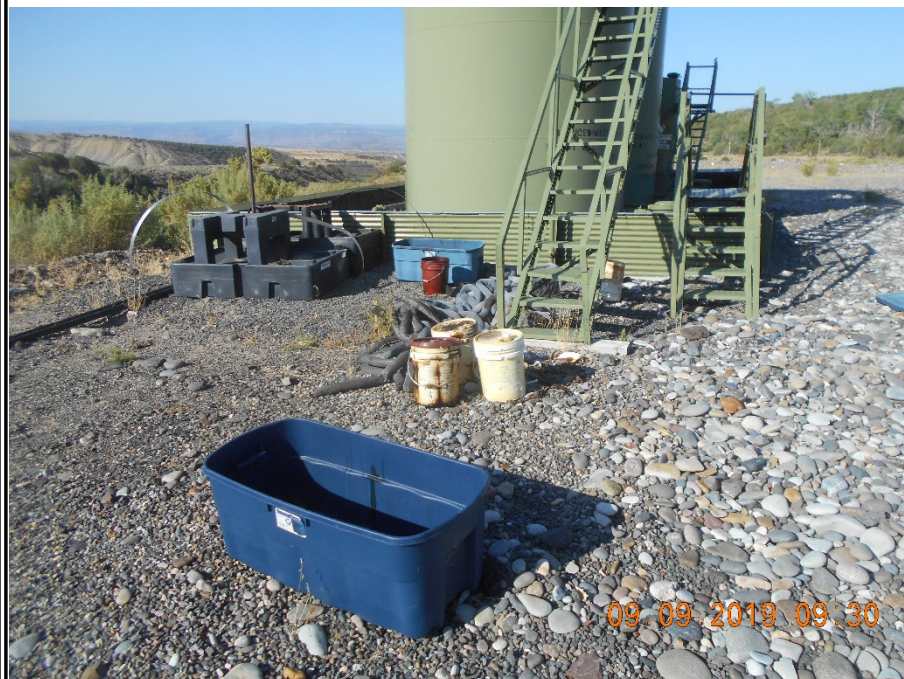
**Spill Response Kit materials at E end of tank battery, scattered/stolen by vandals.
Injection chemical tank stolen and pump/containment unit vandalized.
Oil contaminated buckets and tubs.**

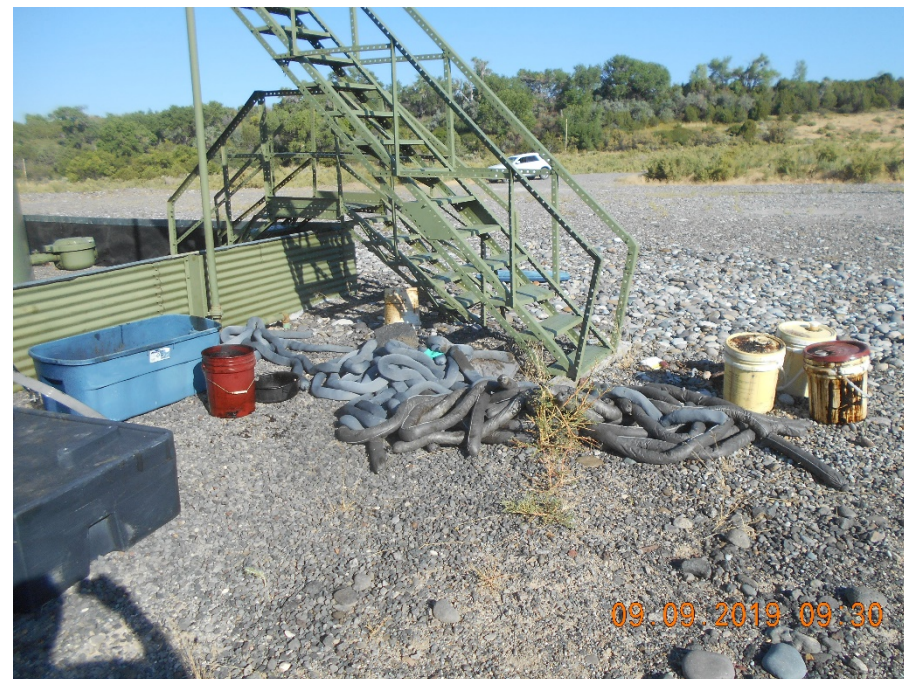
**Spill Response Kit materials at E end of tank battery,
scattered/stolen by vandals.
Oil contaminated buckets and tubs.**

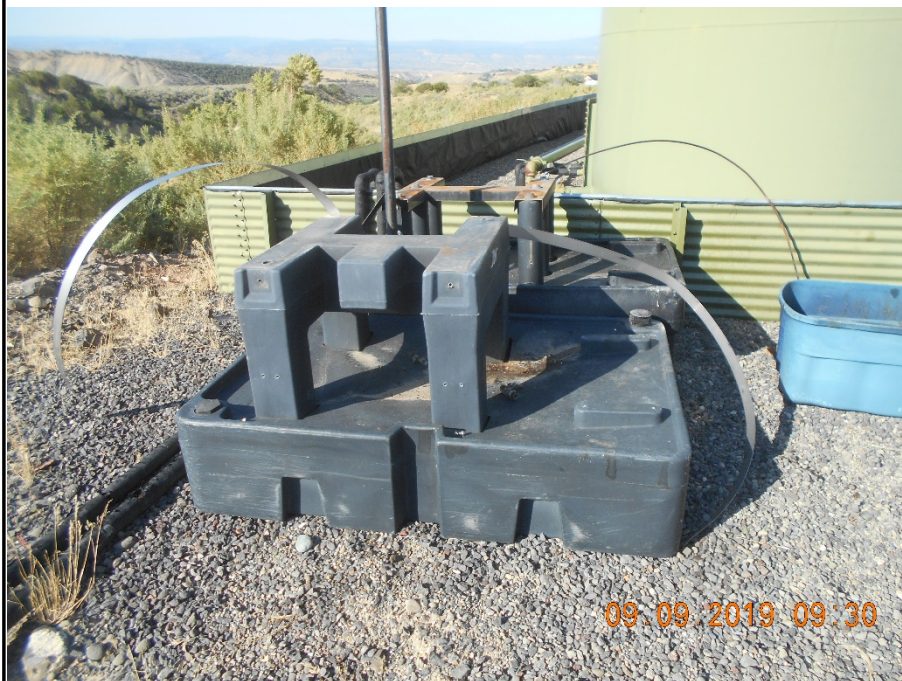
**Injection chemical tank stolen and pump/containment unit vandalized.
Oil contaminated buckets and tubs.**

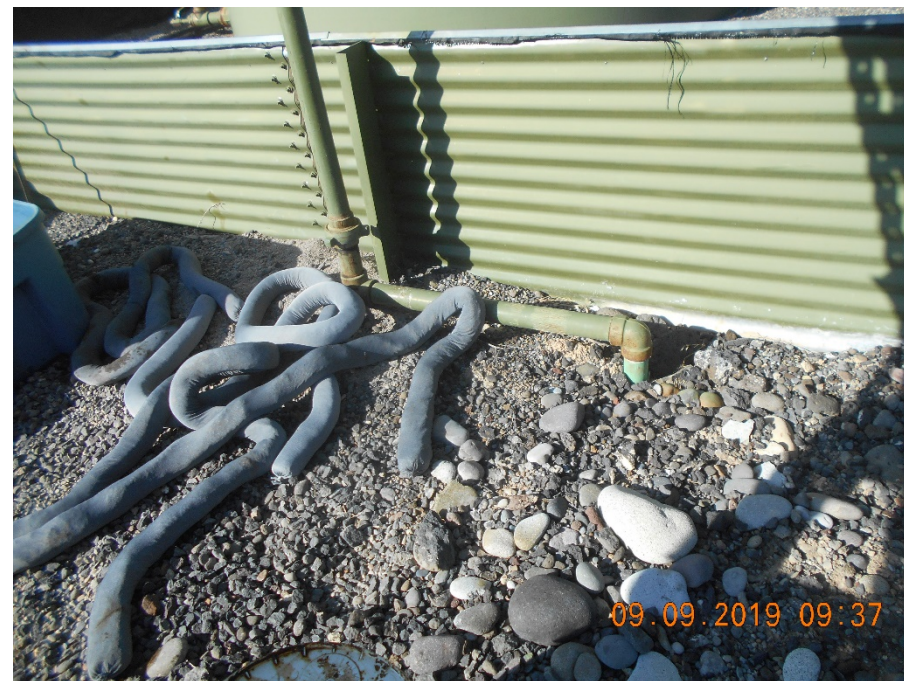
**2" Production riser to tank. Located on NE corner of tank battery.
Spill response materials scattered by vandal. Oil stained soil.**

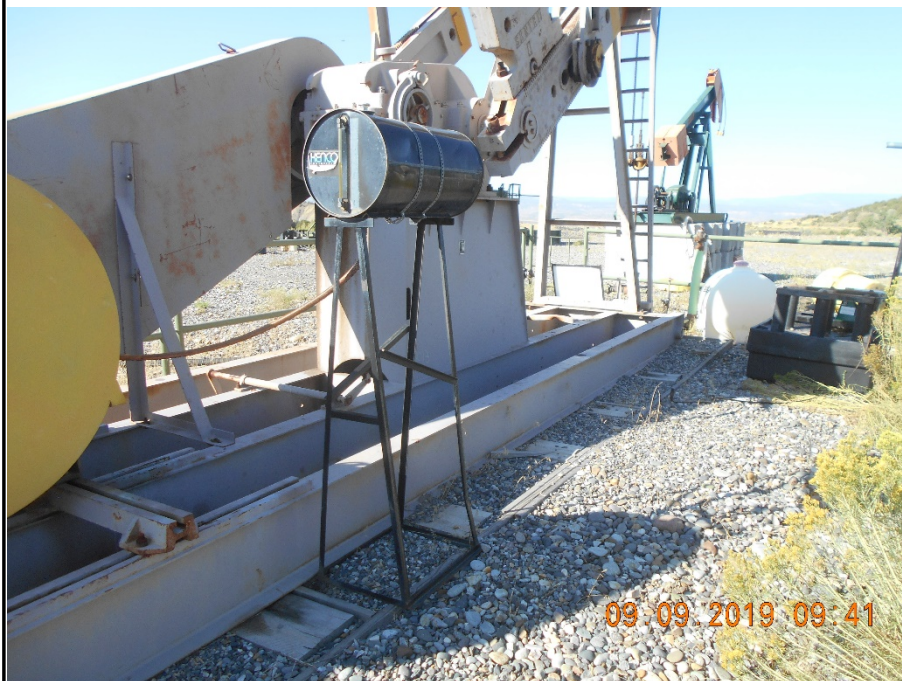
Lube oil tank for pump jack with no secondary containment.

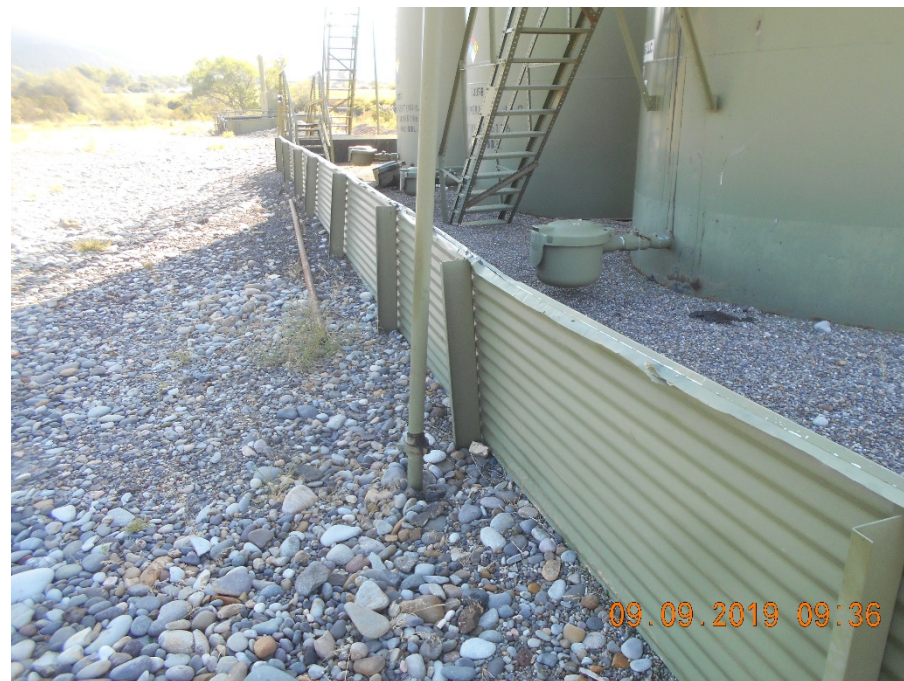
2" Production riser to tank. Located on NW corner of tank battery.
