FRAM OPERATING LLC – 10310

Location ID # 334472

API # 05-077-08922 Jensen #1-3

API # 05-077-09311 Jensen #1-3-O

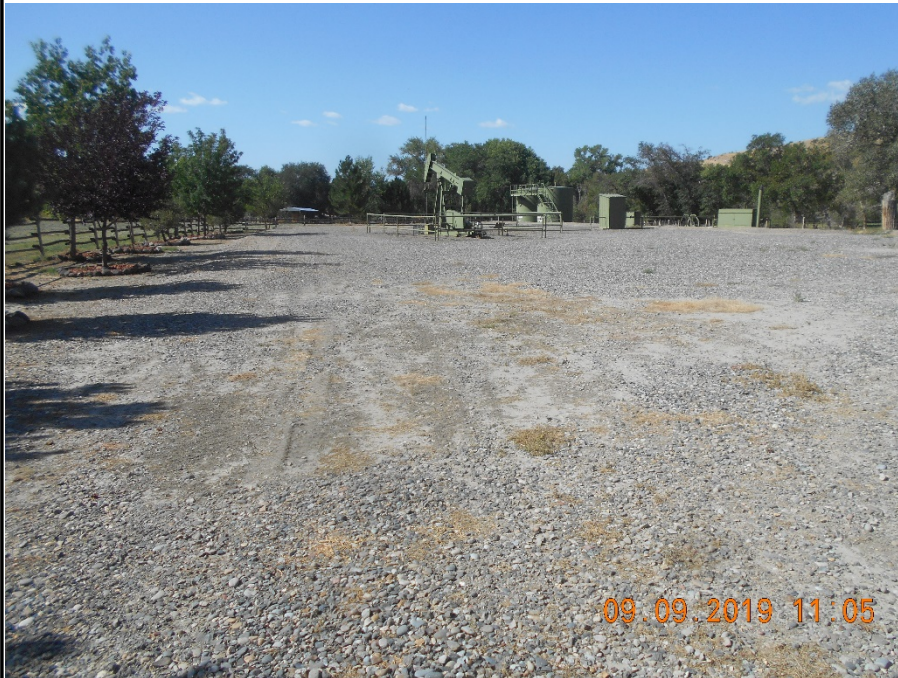
Location entrance from NE corner looking SW

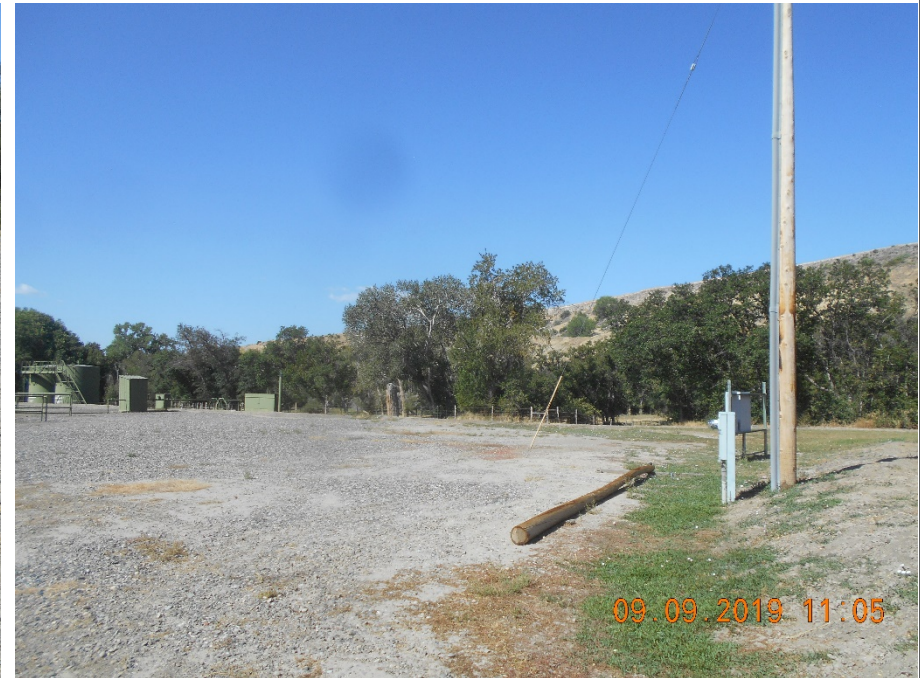
Location overview from NE corner looking W

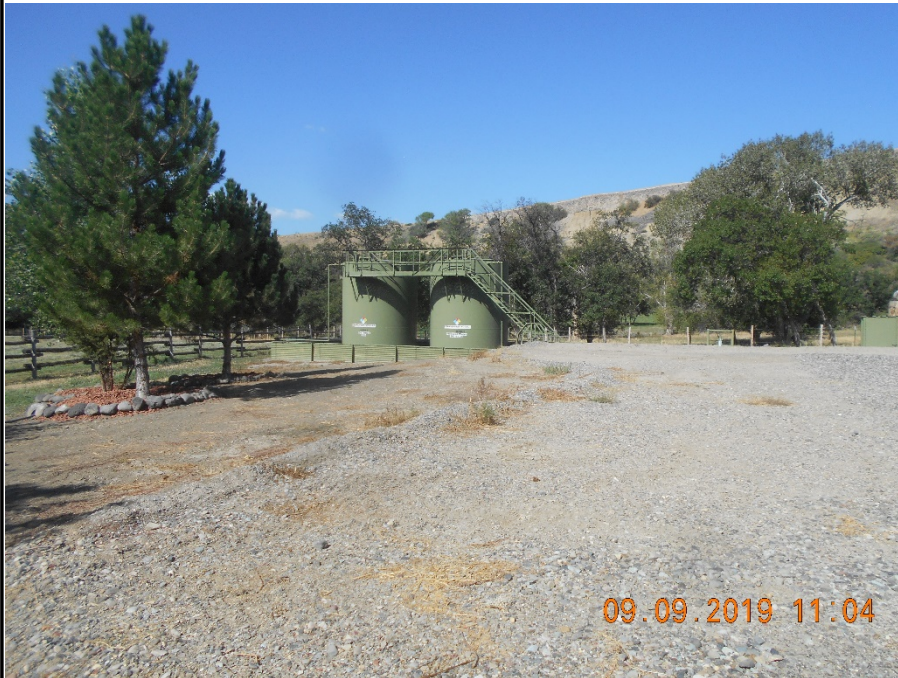
Location entrance from SE corner looking W

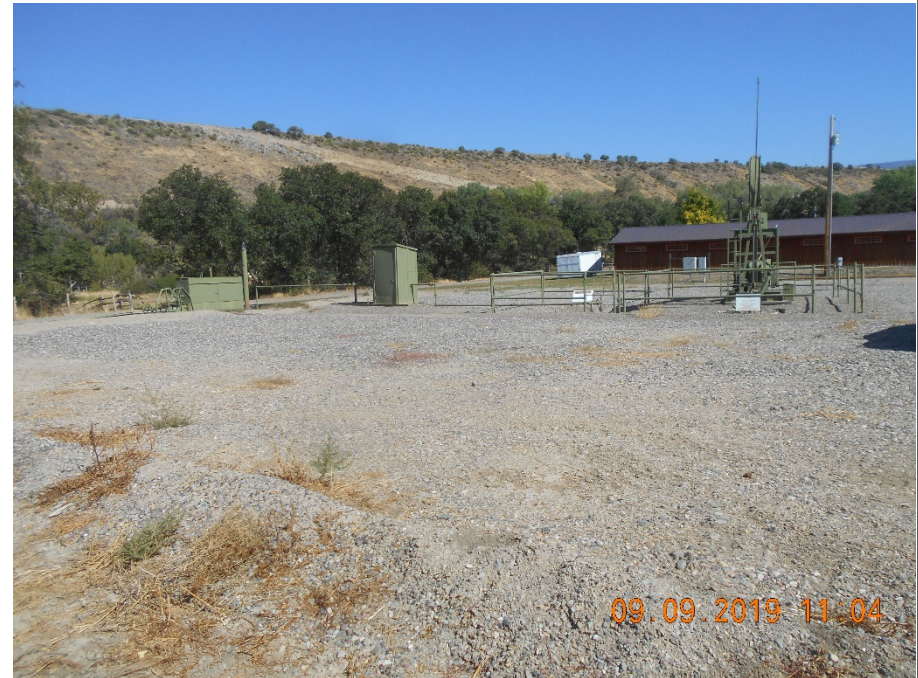
Location overview from SE corner looking N

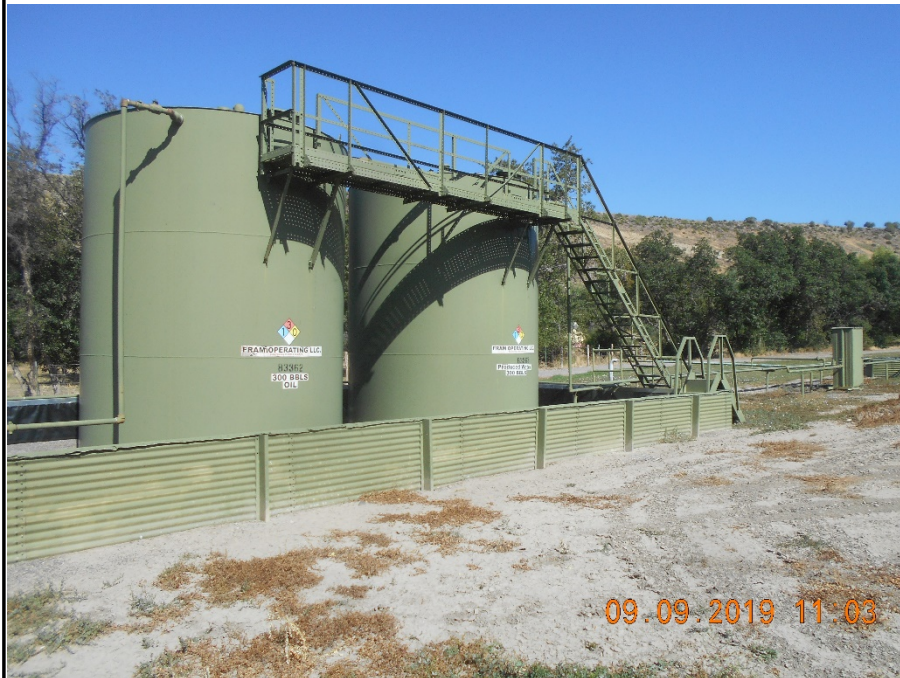
Tank Battery. Looking N.

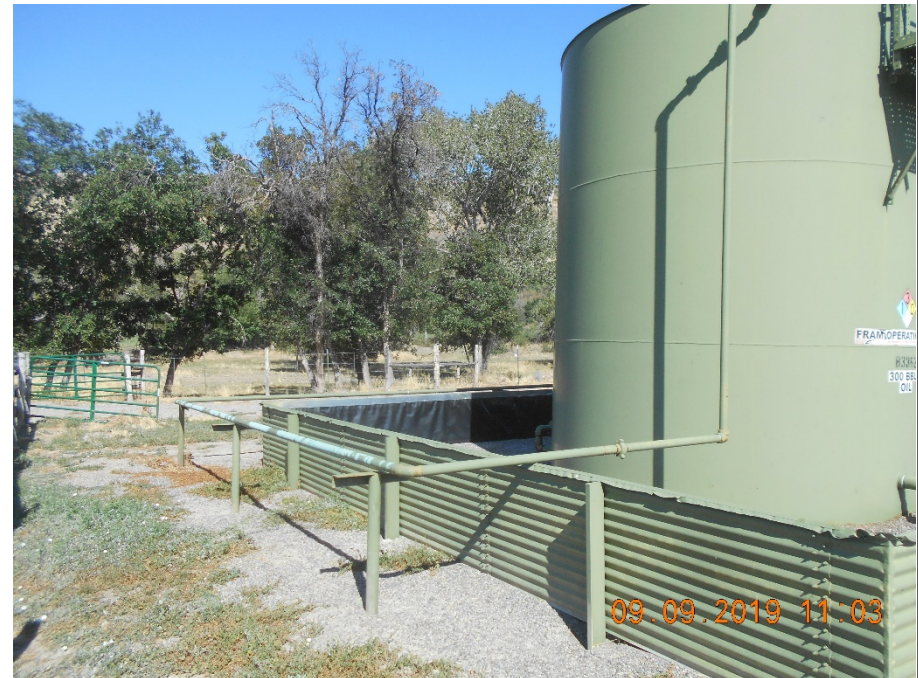
Flowline to tank batter on S side. Looking W.

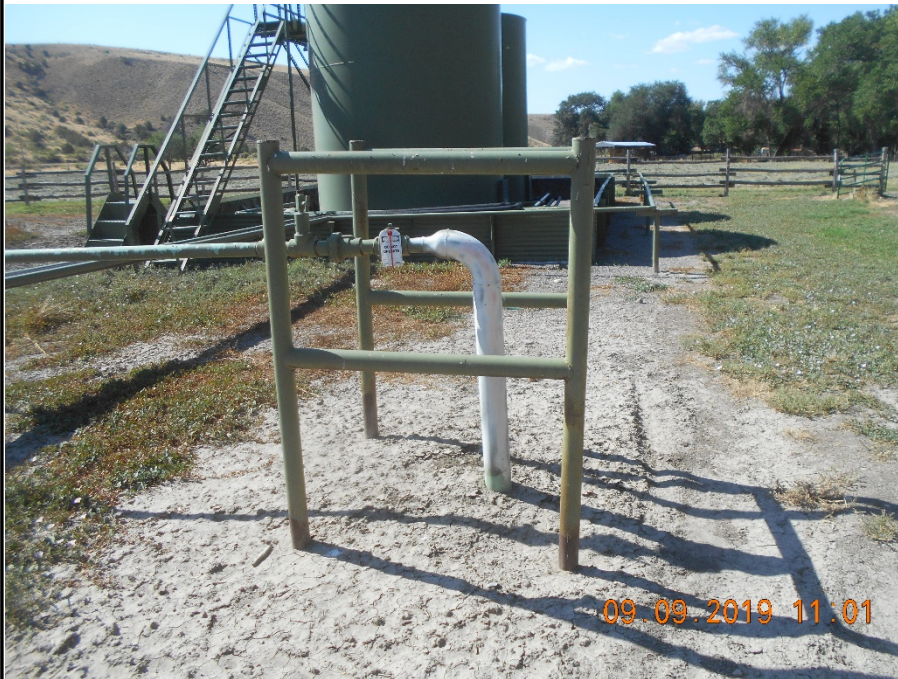
**4" gathering line riser. Locked out/tagged out.
Pipe barricade.**

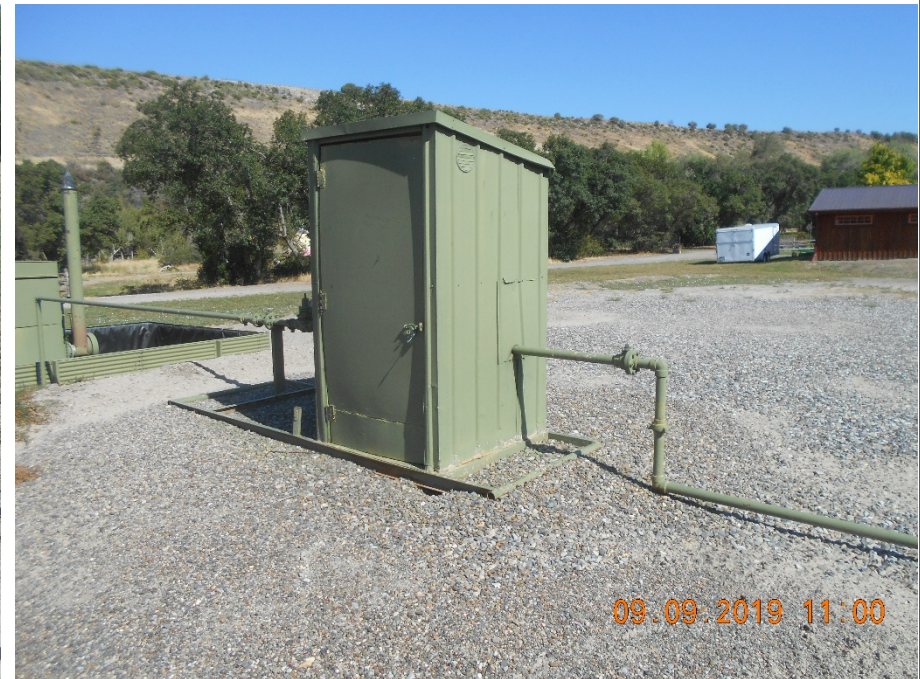
Meter housing. Looking N.

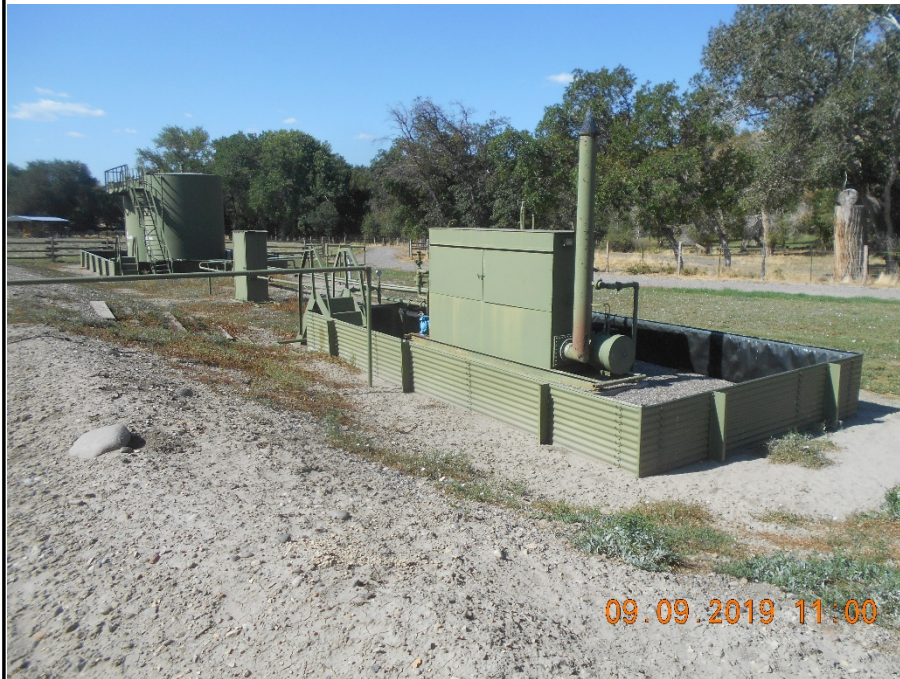
Separator with metal berms. NE corner of berm Looking SW.

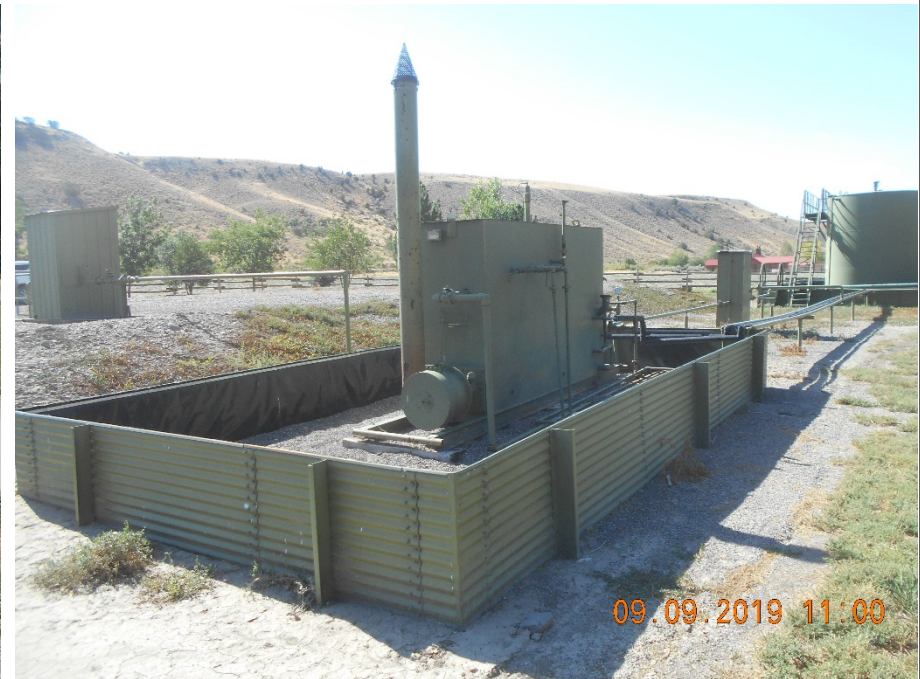
Separator with metal berms. NW corner of berm Looking SE.
