FRAM OPERATING LLC – 10310

Location ID # 312710

API # 05-077-08872 Doty #1-1

Inspection Date : 9/9/2019

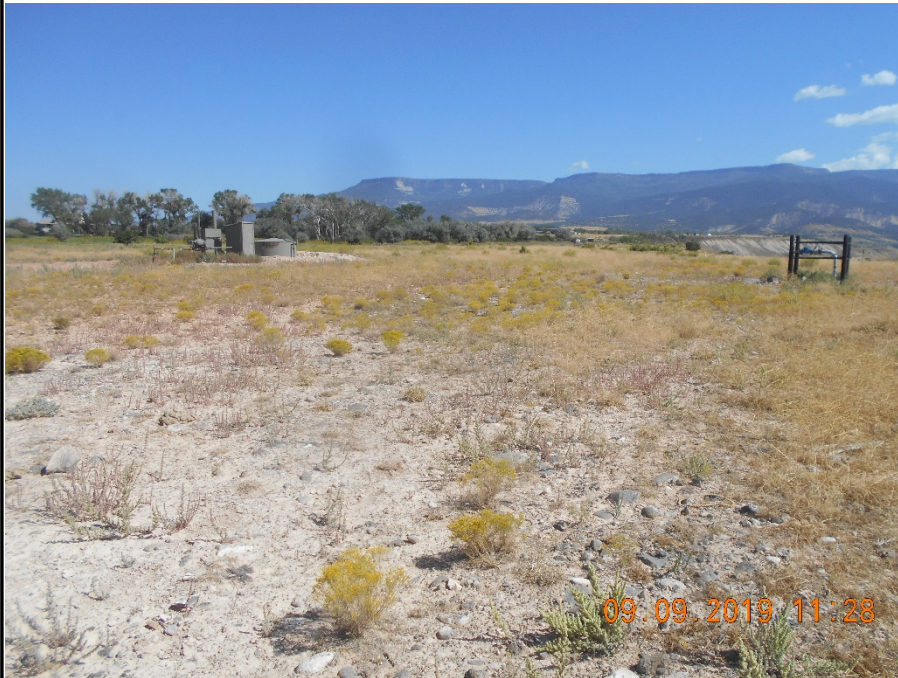
Location overview from SW entrance looking NE.

Weeds

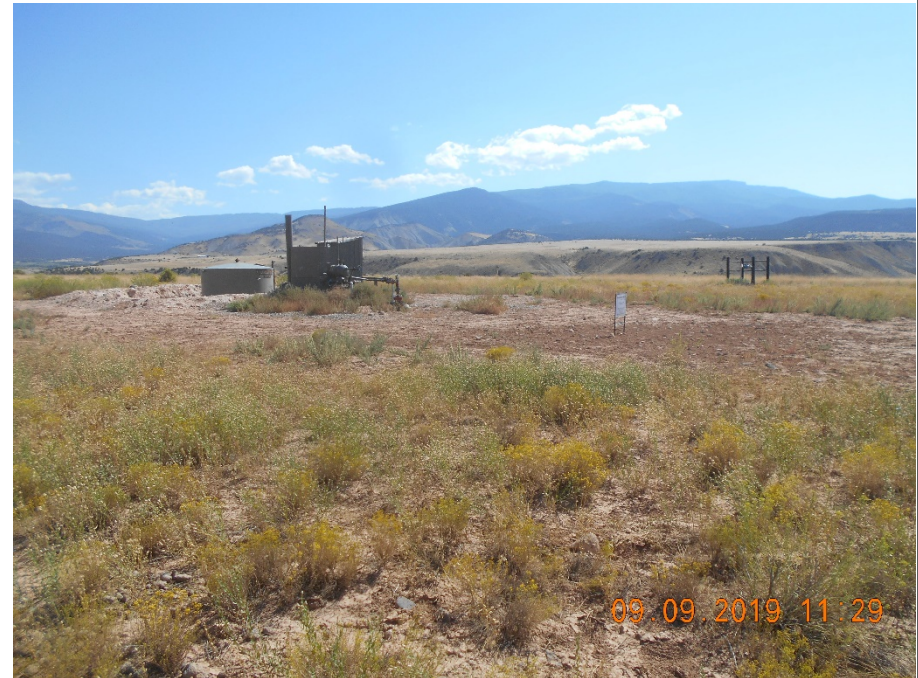
Location overview from SW corner looking NE.

Weeds

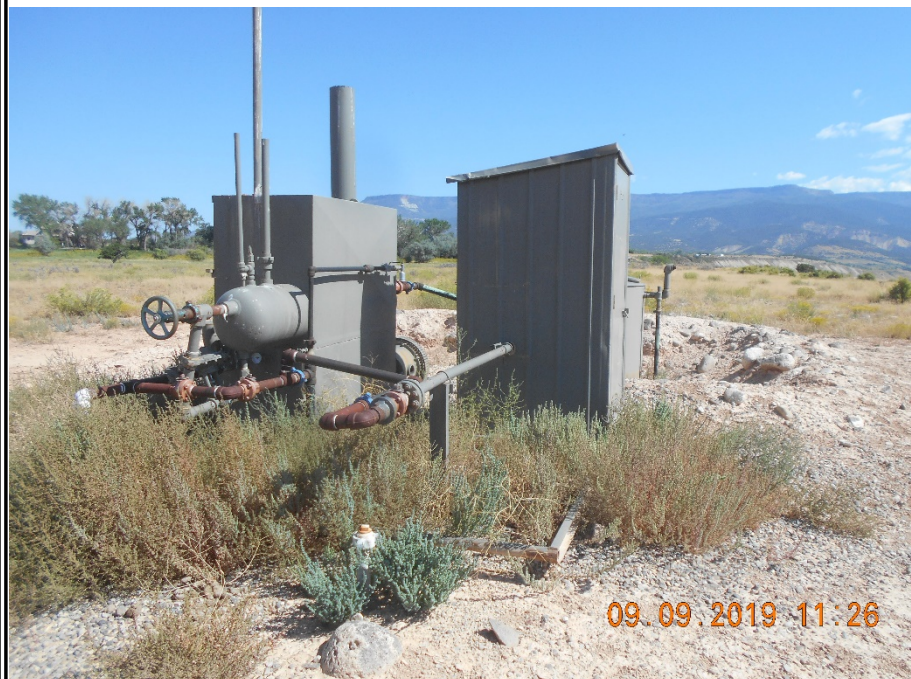
Meter housing and Separator looking NE
Weeds. 2" flowline riser w/ plug.

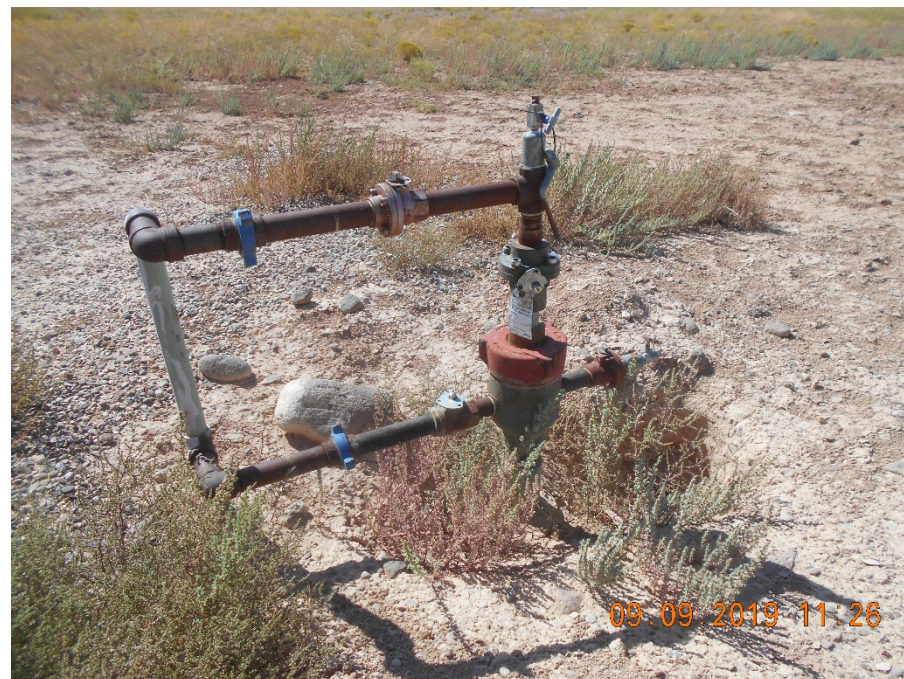
Wellhead. Locked out / tagged out.
Weeds

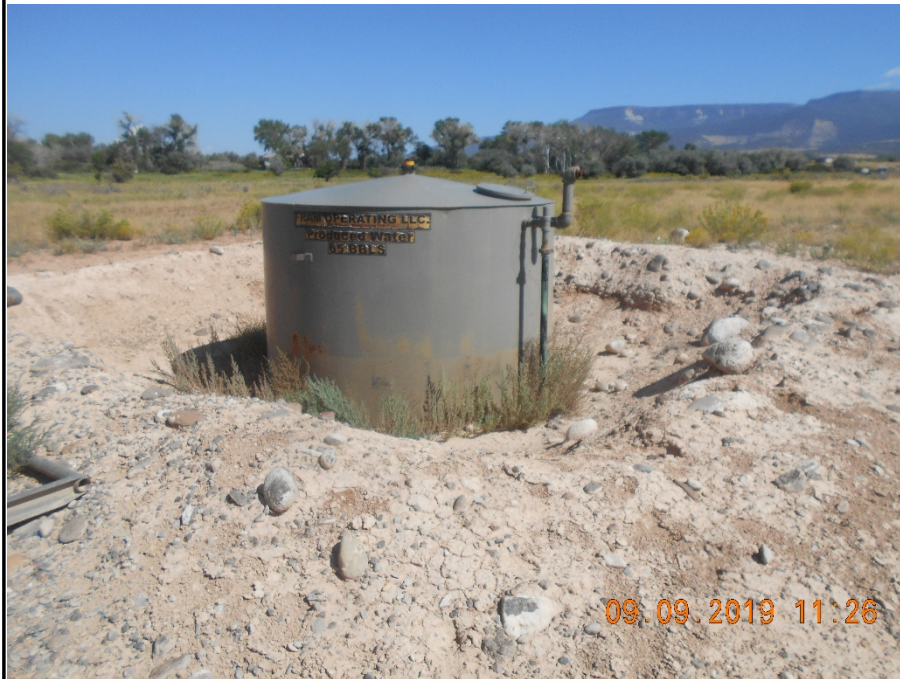
**Tank with earth berms looking N.
Weeds**

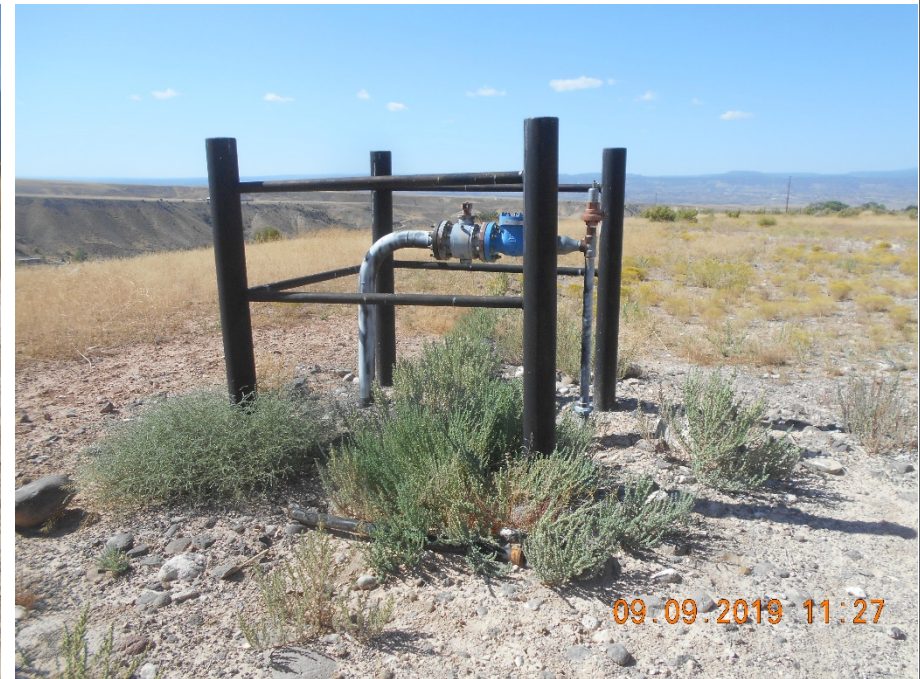
**2"x 4" gather line riser w/ pipe barricade. LO/TO. Looking SW
Weeds**
