Inspection Photos
Location Name: Mcelwain 12-17
Location ID: 320419

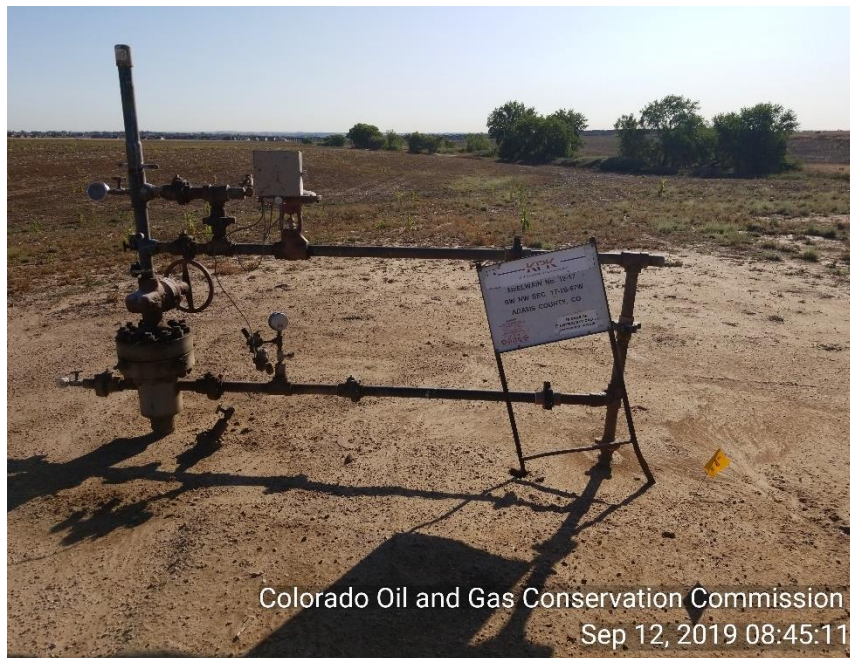
Photo 1 WH and WH sign

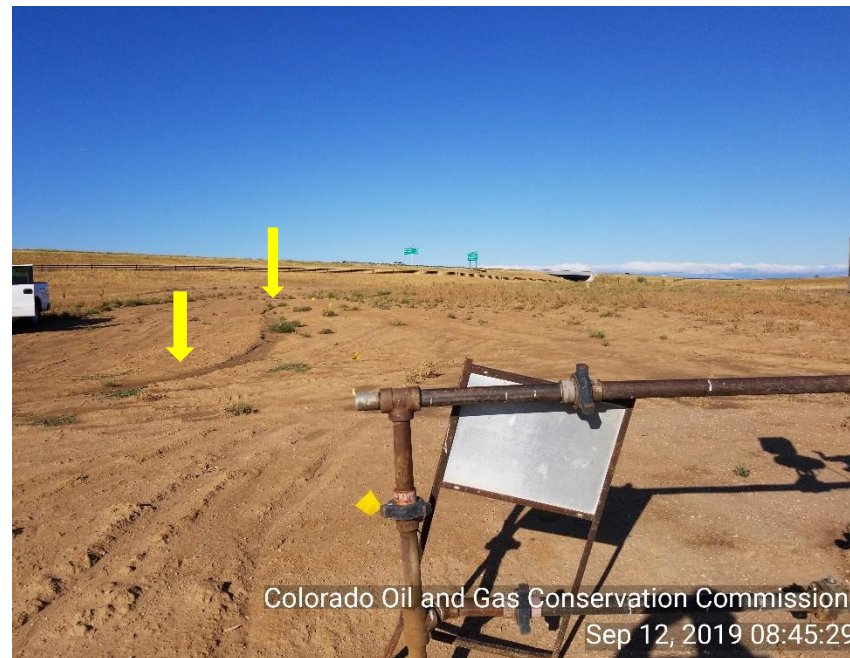
Photo 2 Entrance to location visible erosion running down road into location.

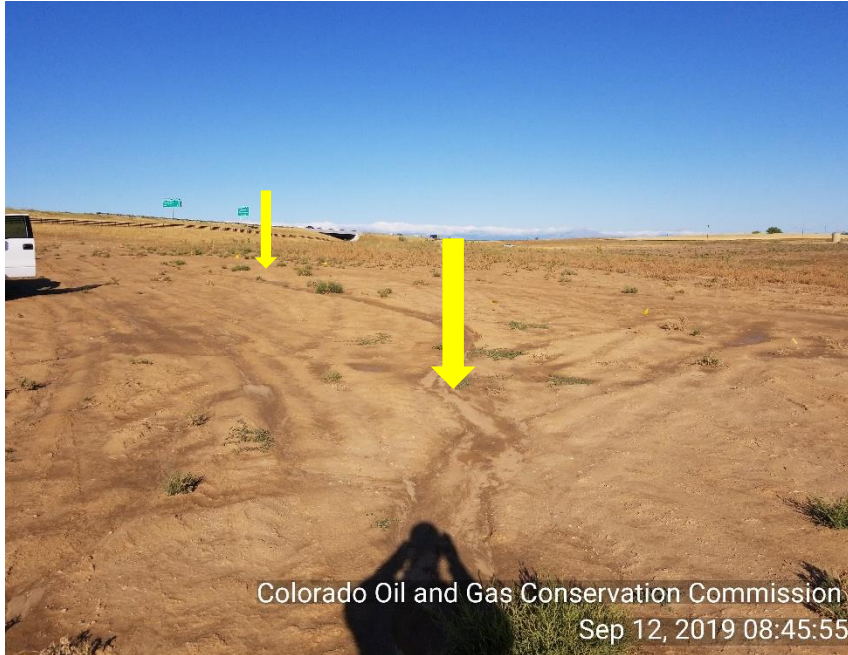
Photo 3 Visible erosion at entrance of location into and off location.

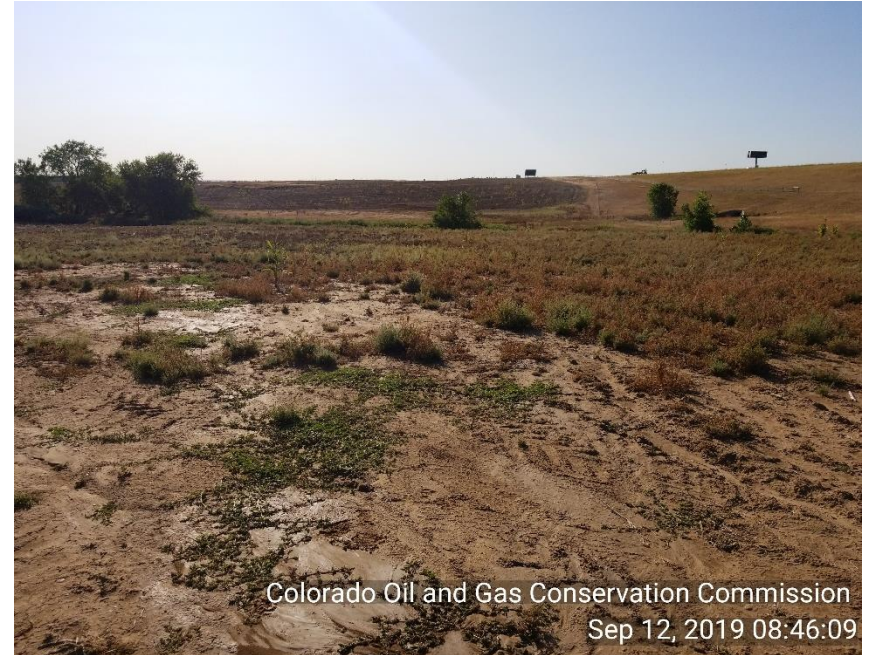
Photo 4 Sediment being carried off location from erosion from road entrance.

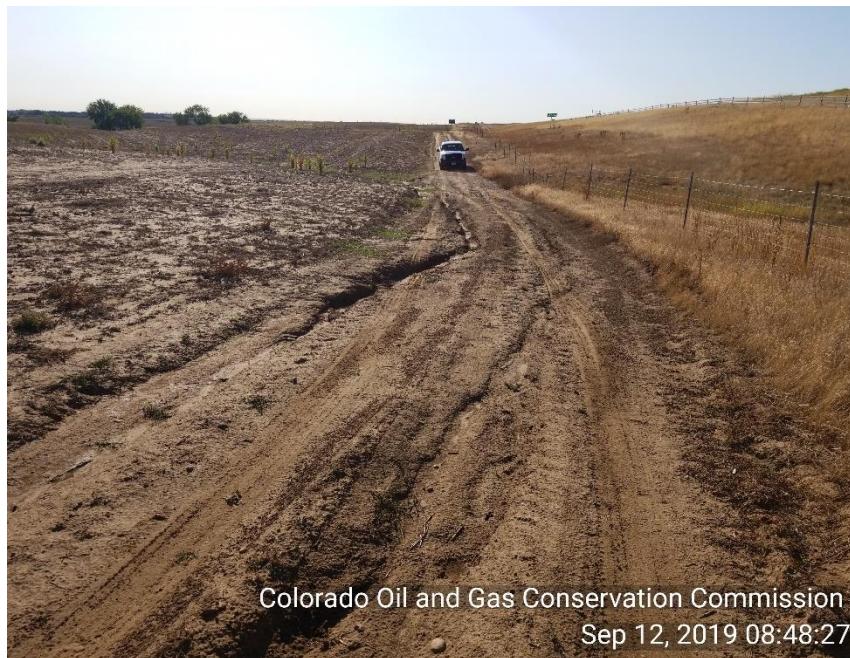
Photo 7 access road to location. Deep ruts and erosion in road.

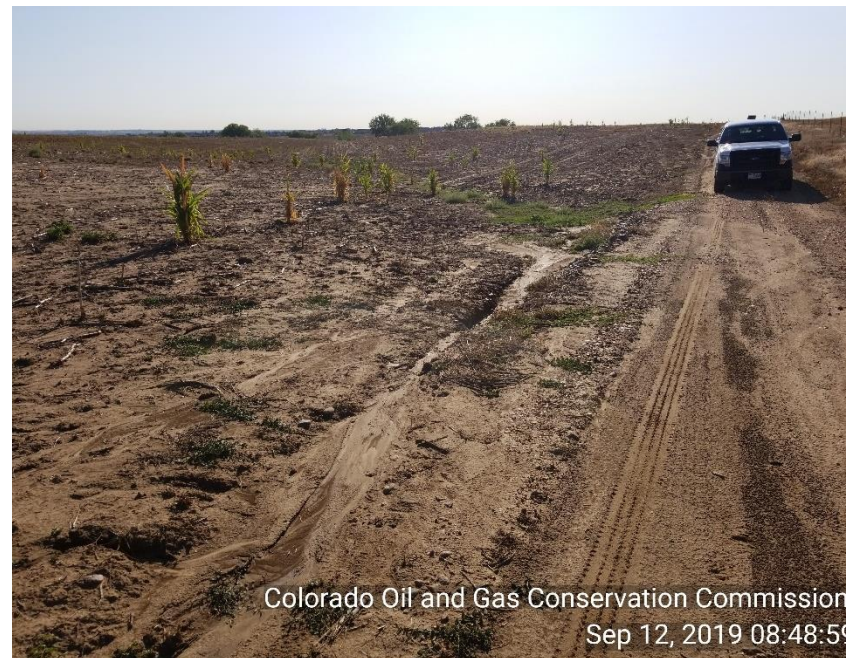
Photo 8 Sediment from erosion on access road being carried off access and into drainage.

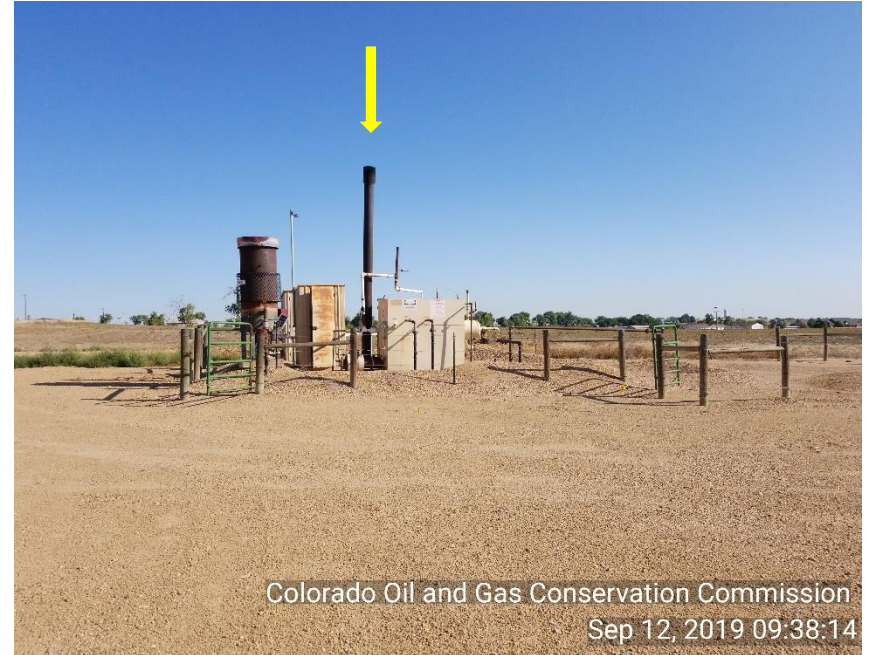
Photo 10 Sep/ meter house and ECD. Separator exhaust appears to be venting see video.

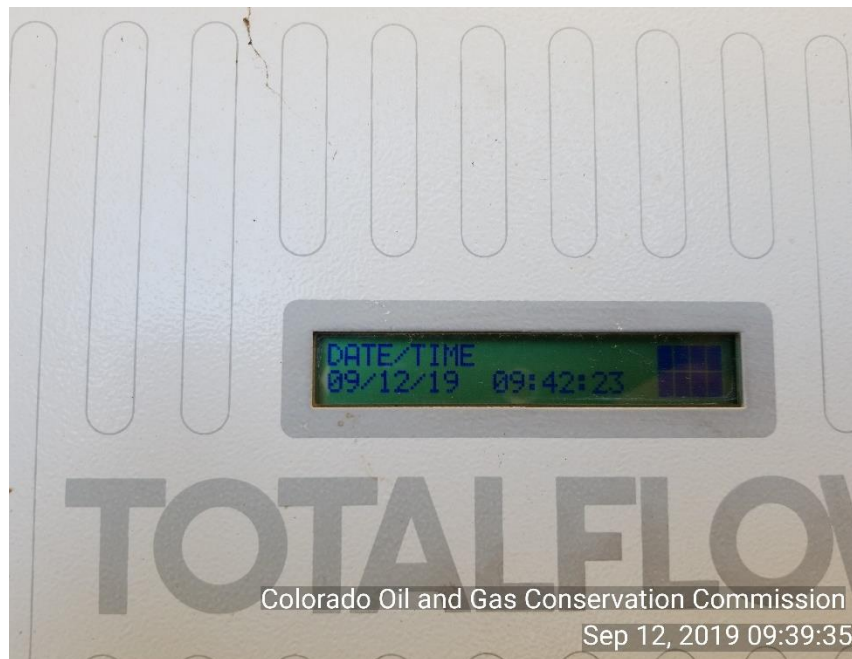
Photo 11 Meter time and date

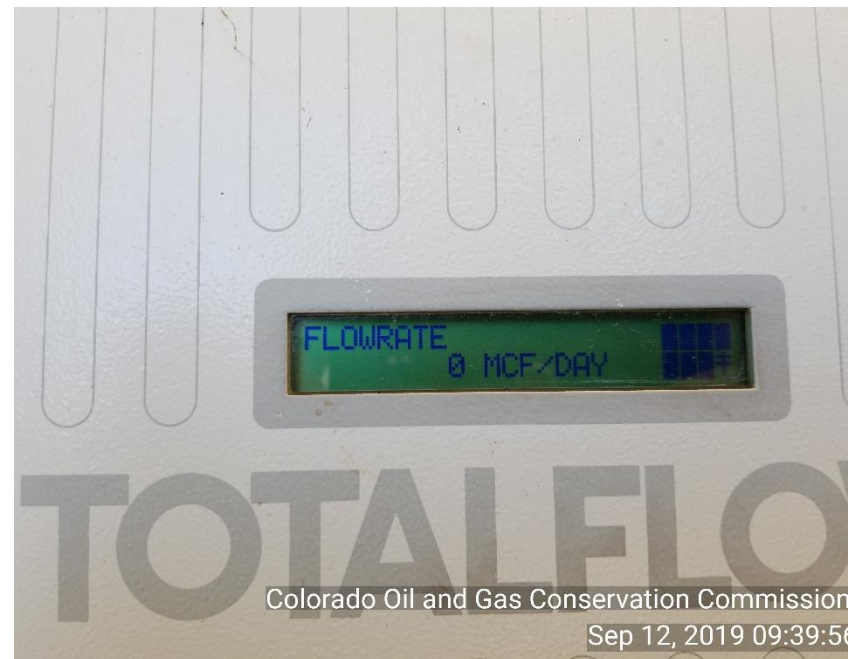
Photo 12 meter current flow rate.

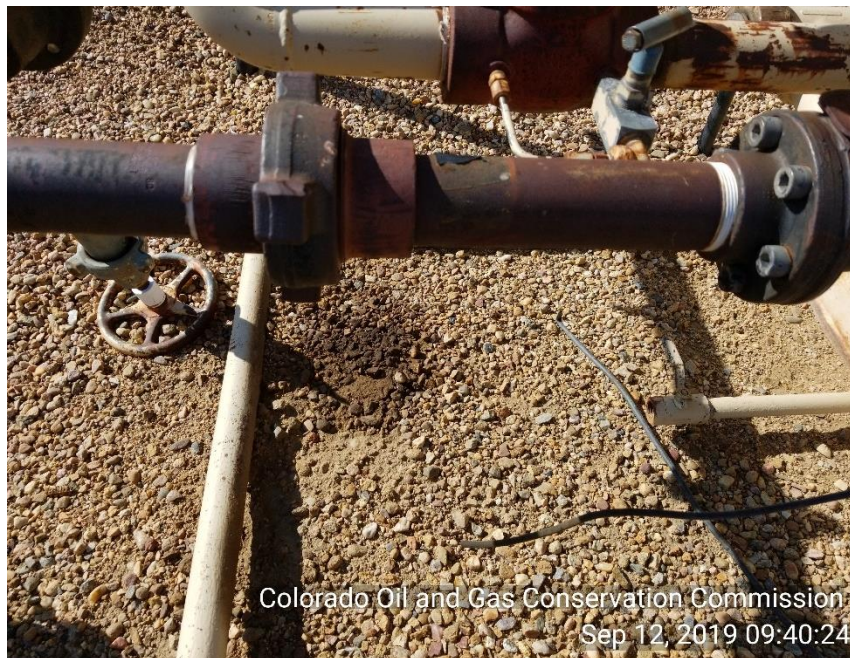
Photo 13 Stained soil under piping out side of separator

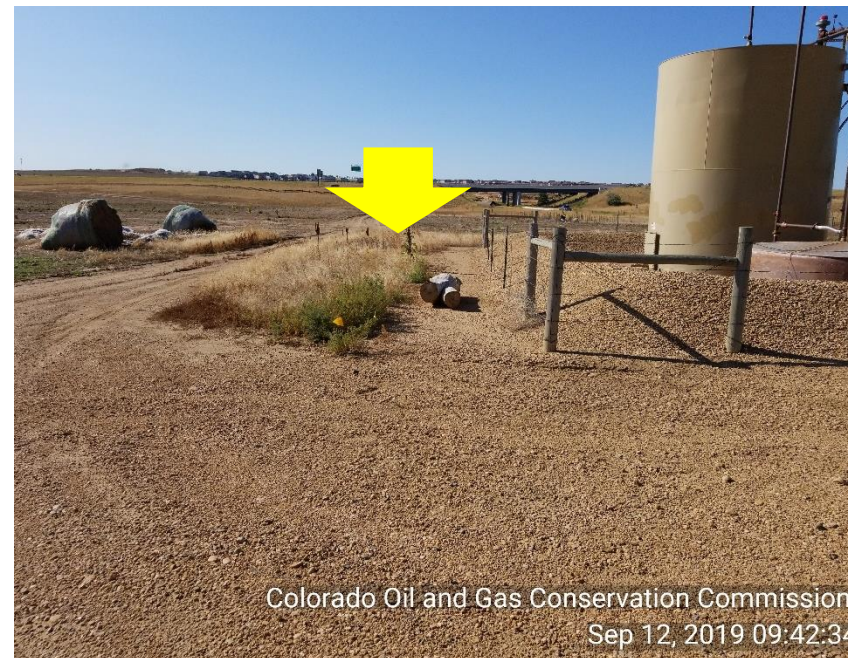
Photo 14 Debris: Log and dead weeds between access road to well site and TNK BTRY.

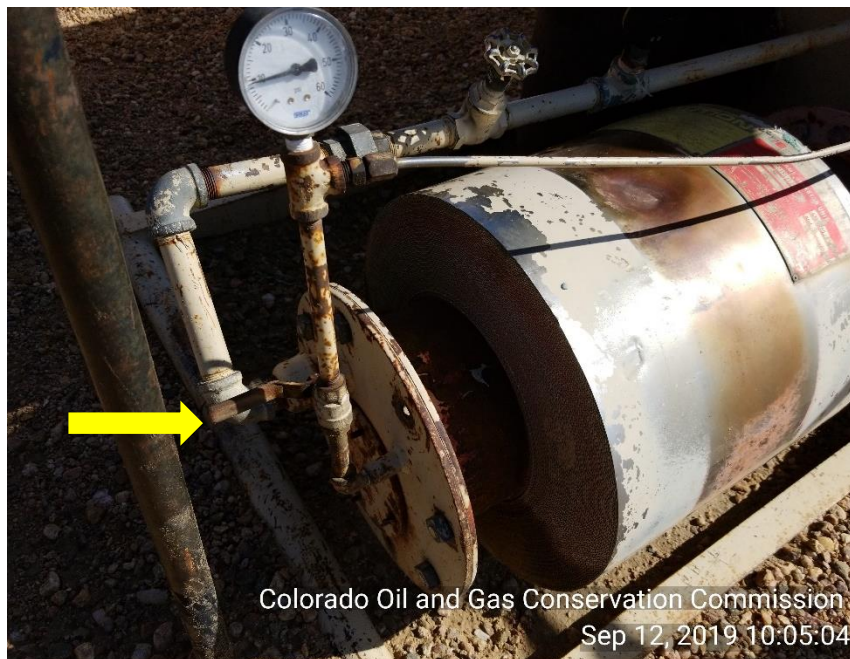
Photo 15 Fuel gas to burner is closed

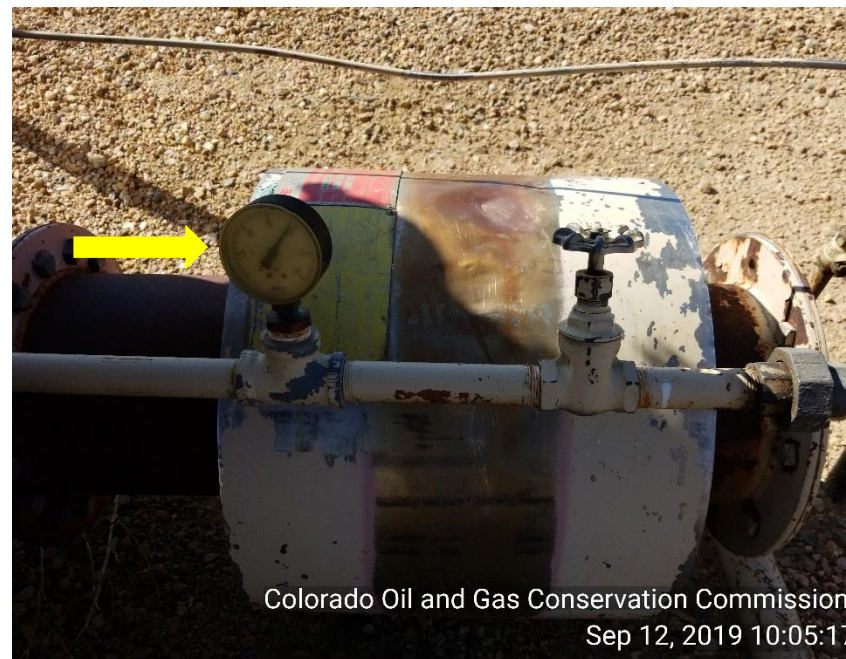
Photo 16 gas supply to burner appears to read 19 pounds.
