FRAM OPERATING LLC – 10310

Location ID # 334484

API # 05-077-08886 Eberly #23-4

Inspection Date : 9/9/2019

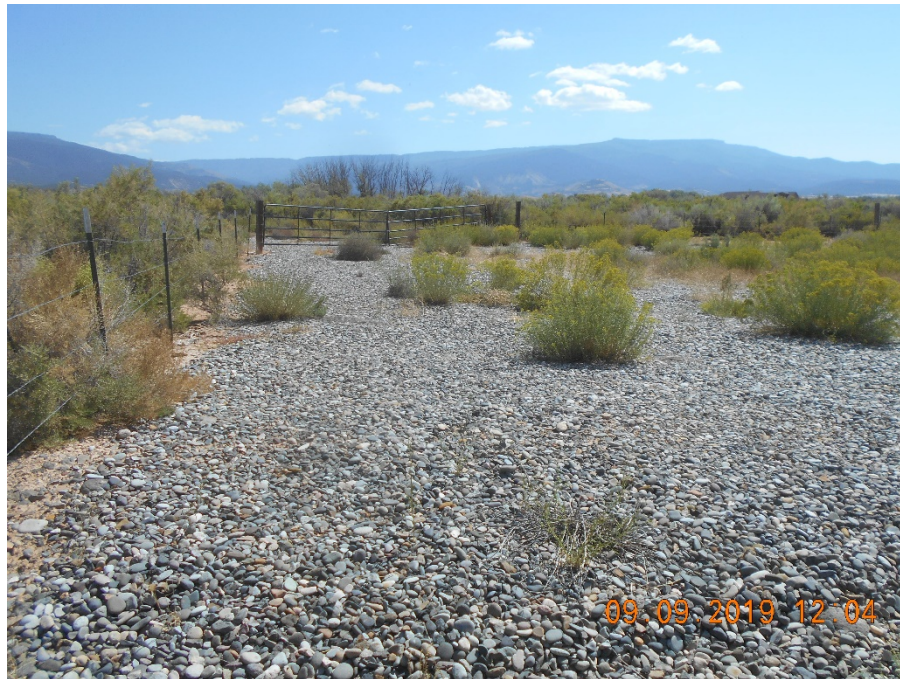
Gate at location entrance. Looking E.

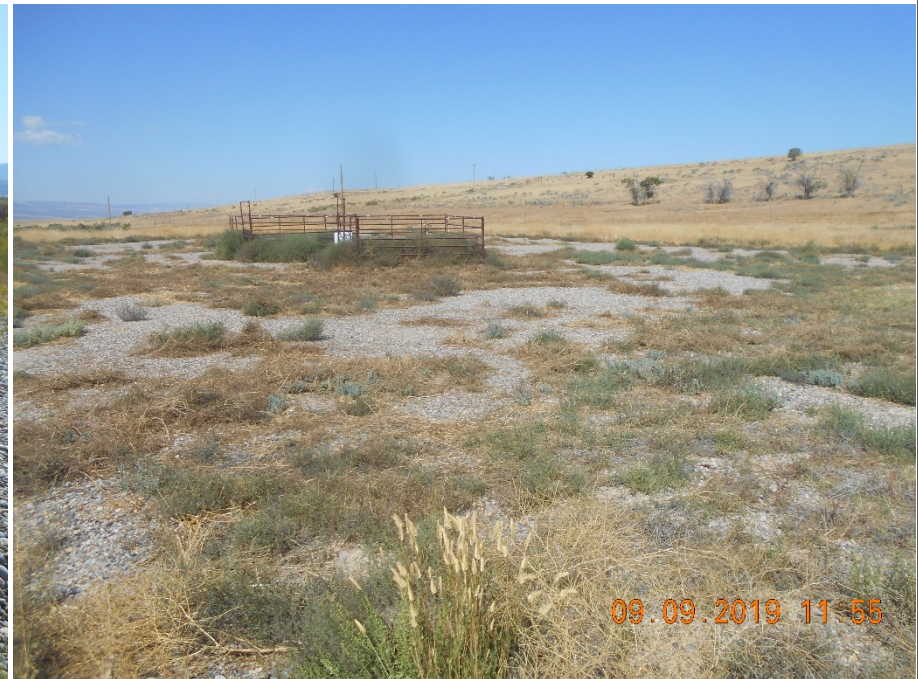
**Location overview from SE corner looking NW.
Weeds.**

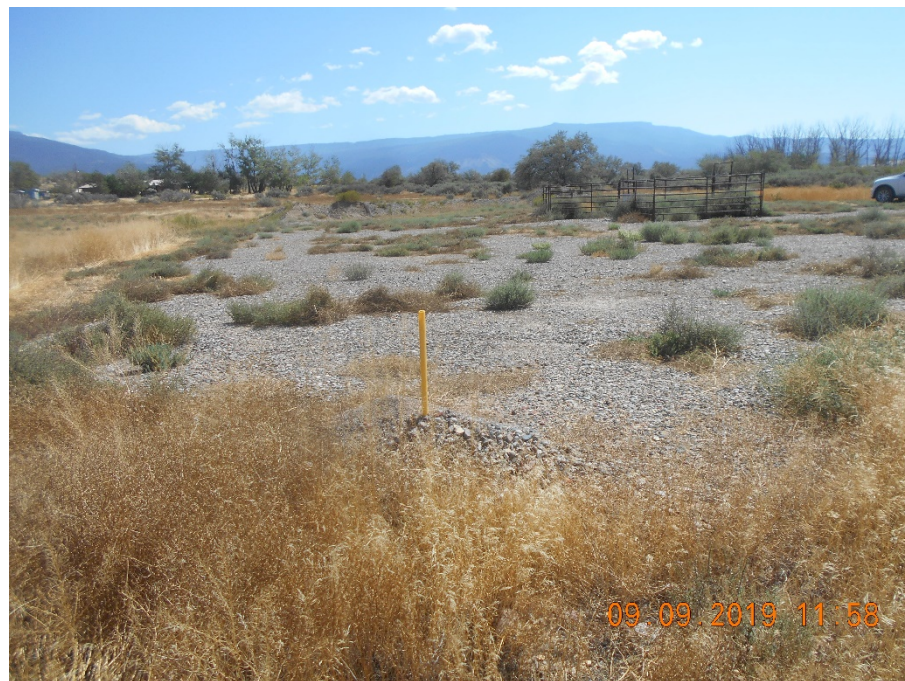
View from NW corner looking E.

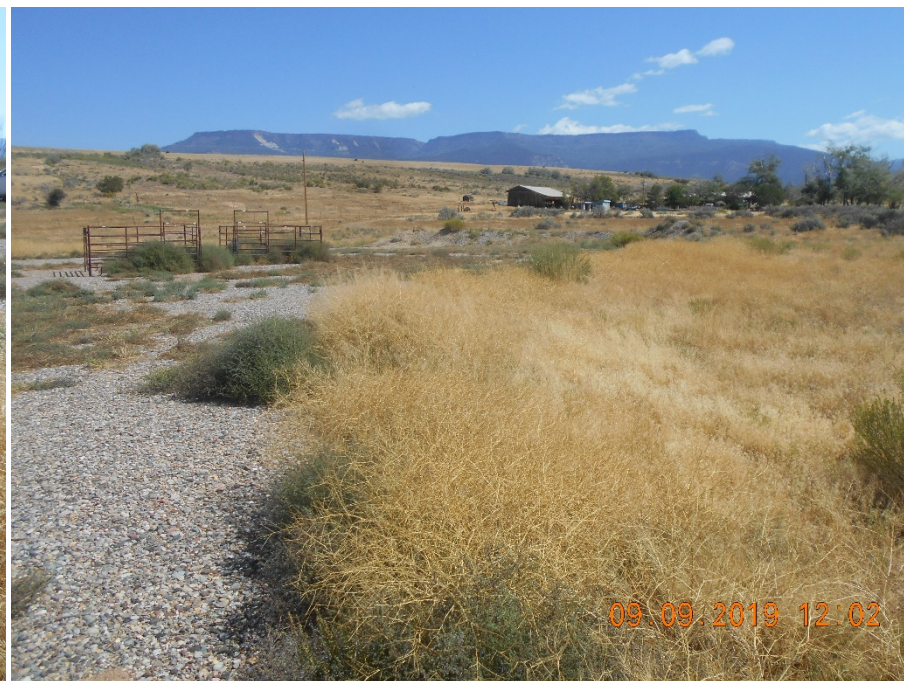
View from SW corner looking NE

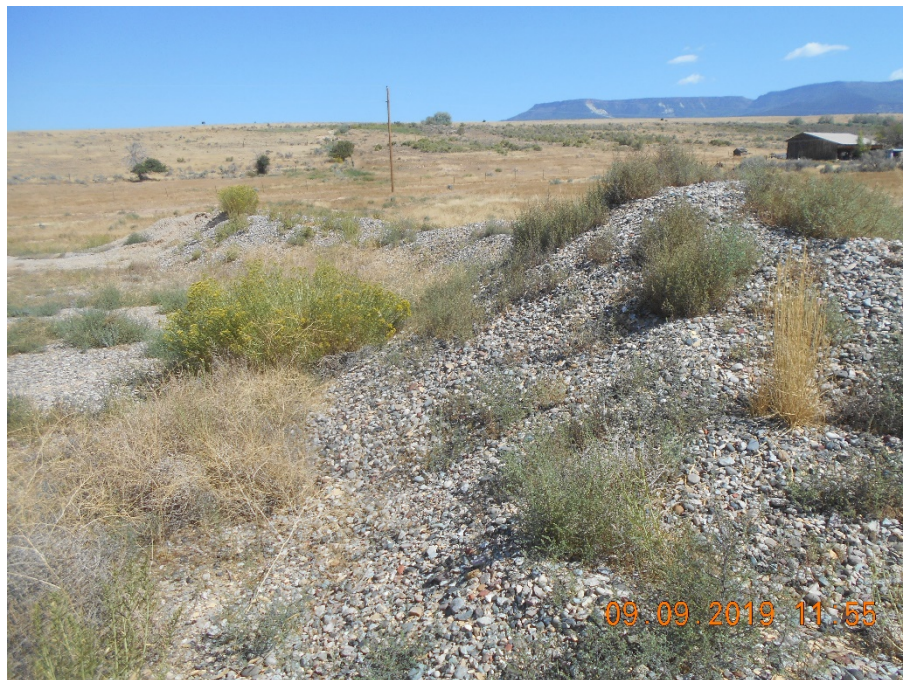
**Large pile of road base material along E edge of location.
View from SE corner looking N.
Weeds**

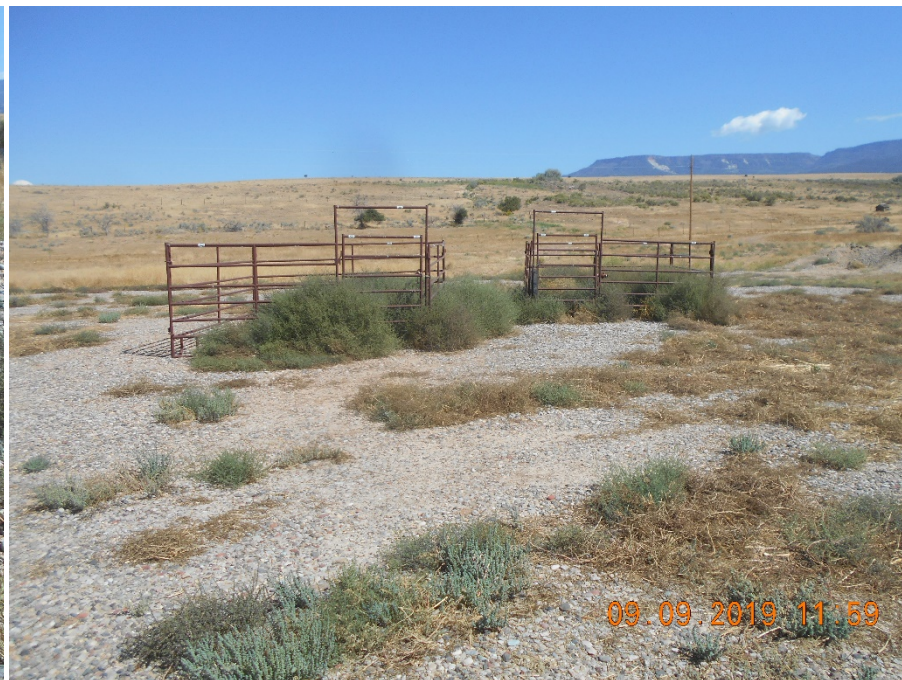
**Fencing around wellheads looking N.
Weeds.**

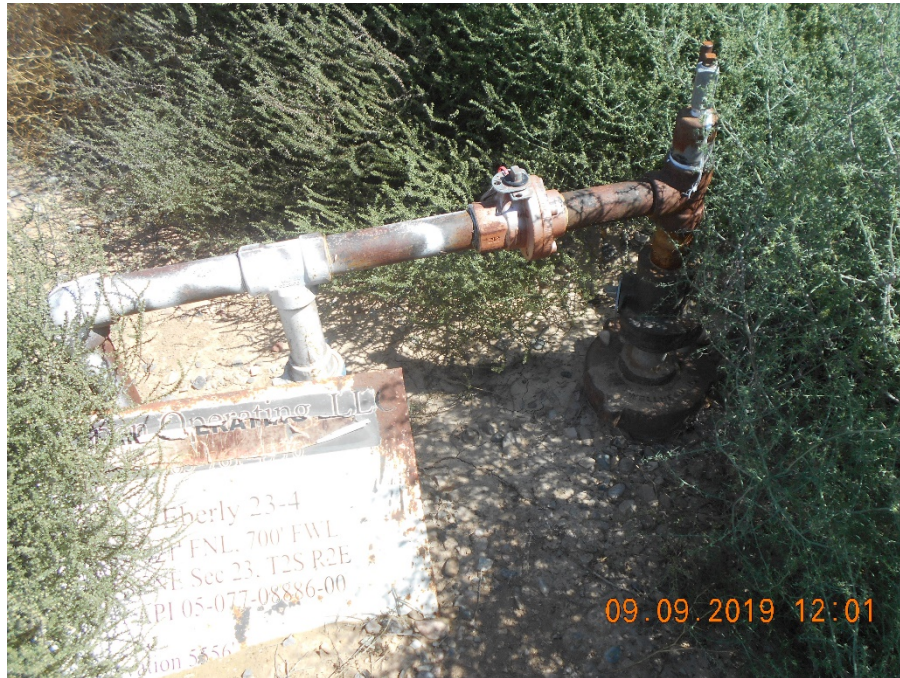
**API #05-077-08886 Wellhead with sign.
Temporarily abandoned.
Overgrown with weeds.**

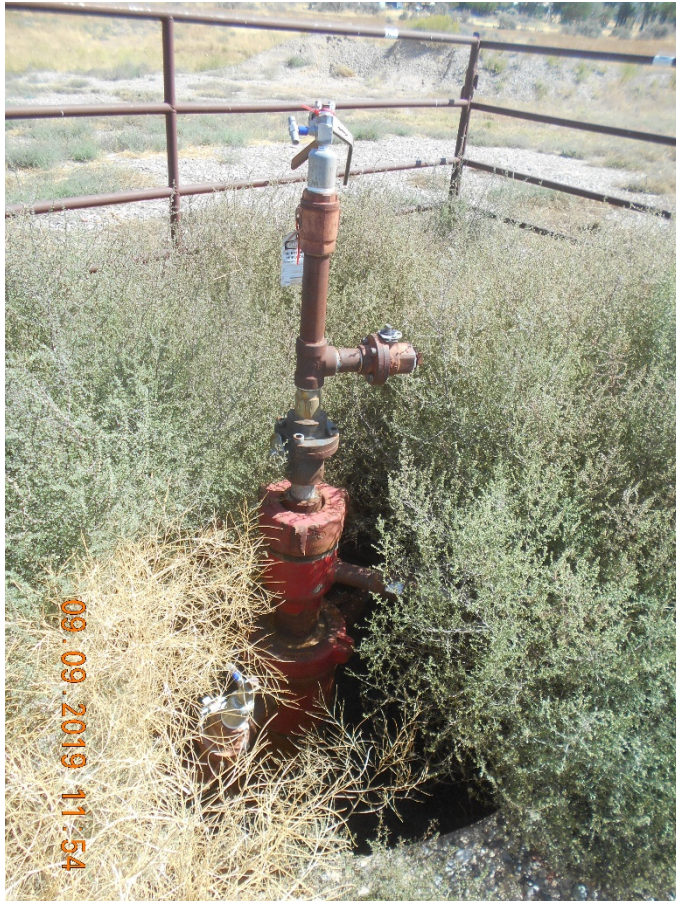
**API #05-077-09314 Wellhead.
Overgrown with weeds.**

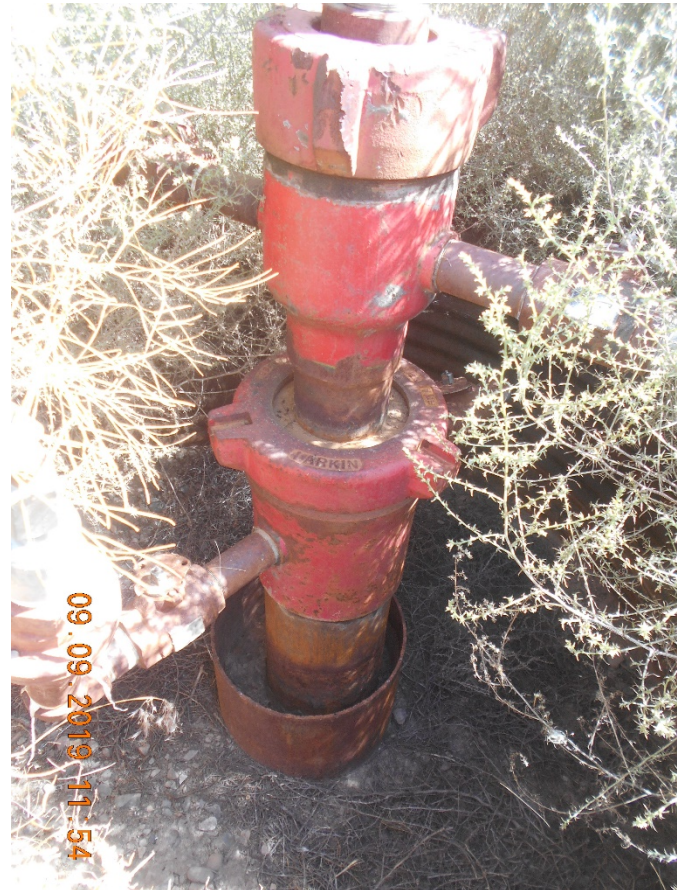
API #05-077-09314 Wellhead. Temporarily abandoned.
