**FRAM OPERATING LLC – 10310**

**Location ID # 311749**

**API # 05-077-09459 Kelly #23-2-B**

**Inspection Date : 9/9/2019**

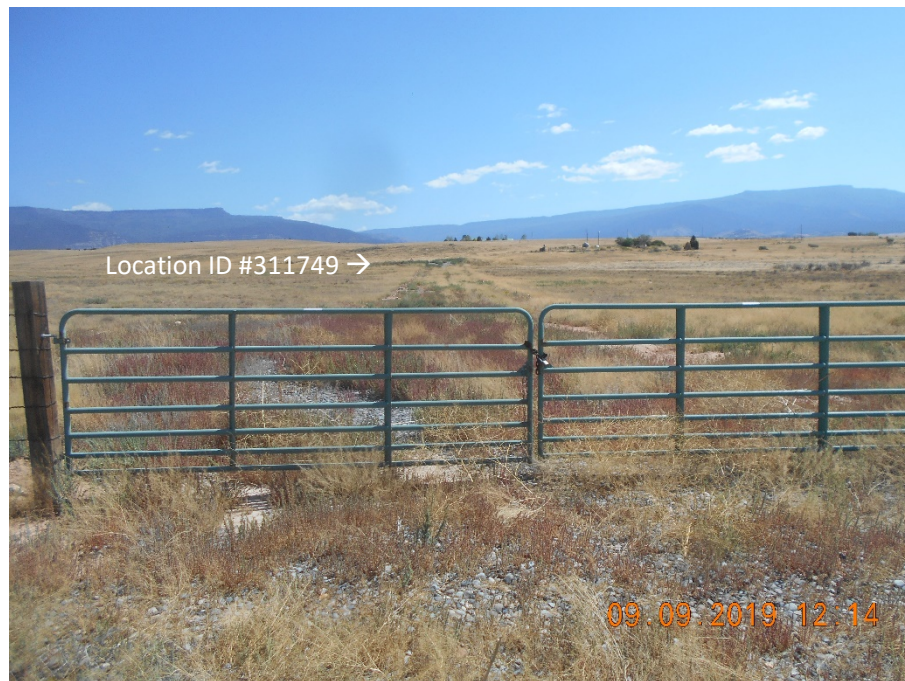
**Gate at location entrance. Looking E.**

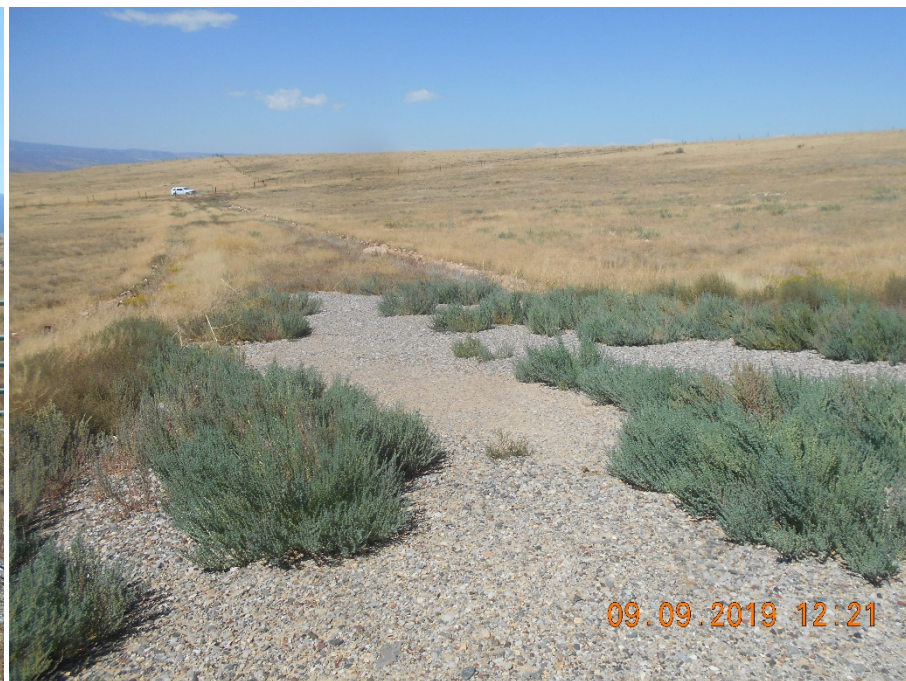
**Access road from SW corner of location looking W at entrance gate.  
Weeds.**

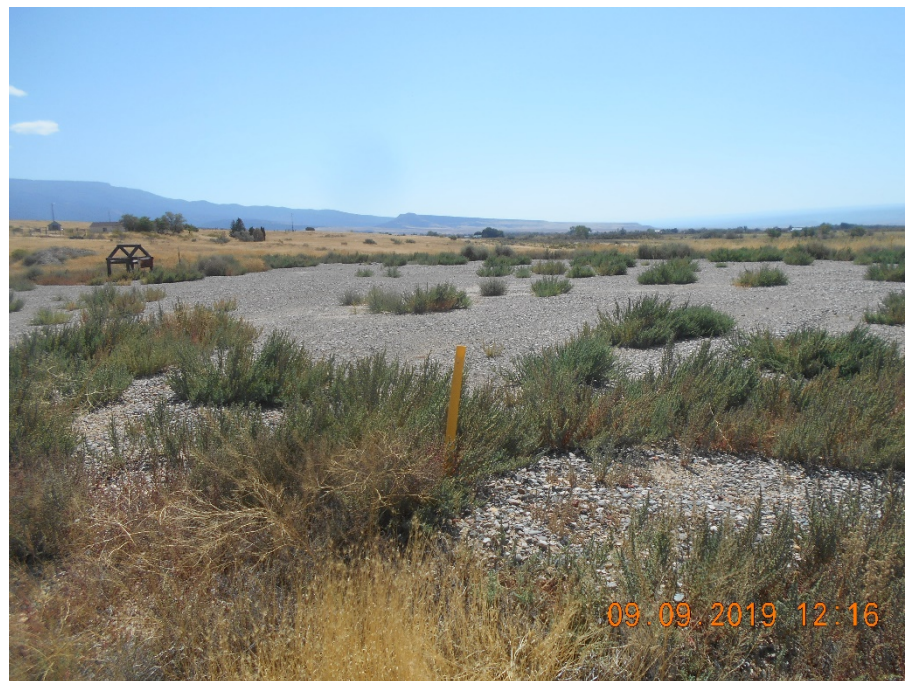
**Location overview from NW corner looking SE.  
Weeds.**

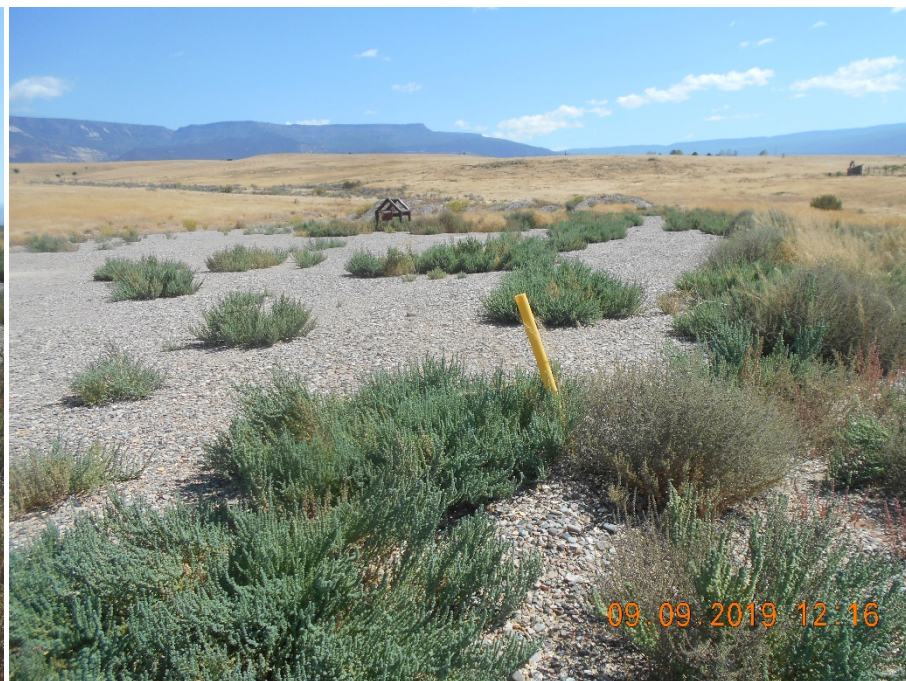
**Location overview from SW corner looking E.  
Weeds.**

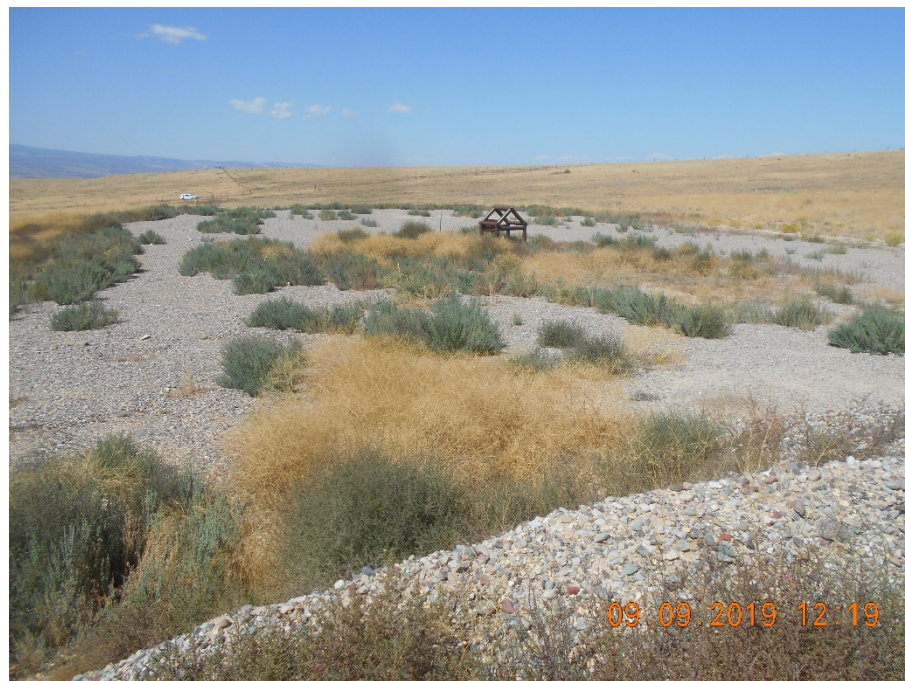
**Location overview from SE corner looking NW.  
Large pile of road base material along E edge of location.  
Weeds.**

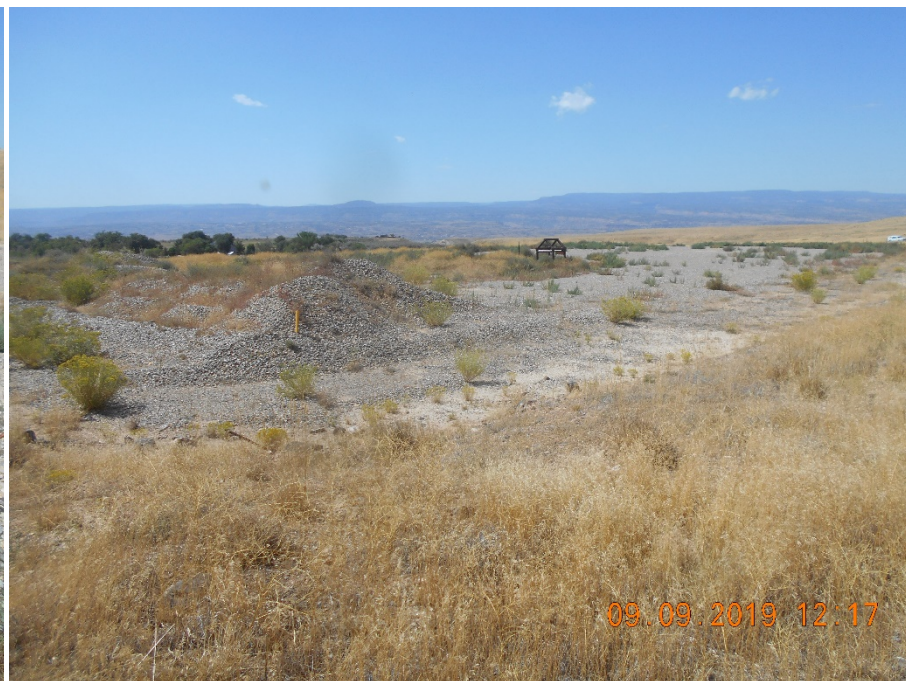
**Location overview from NE corner looking SW.  
Large pile of road base material along E edge of location  
Weeds.**

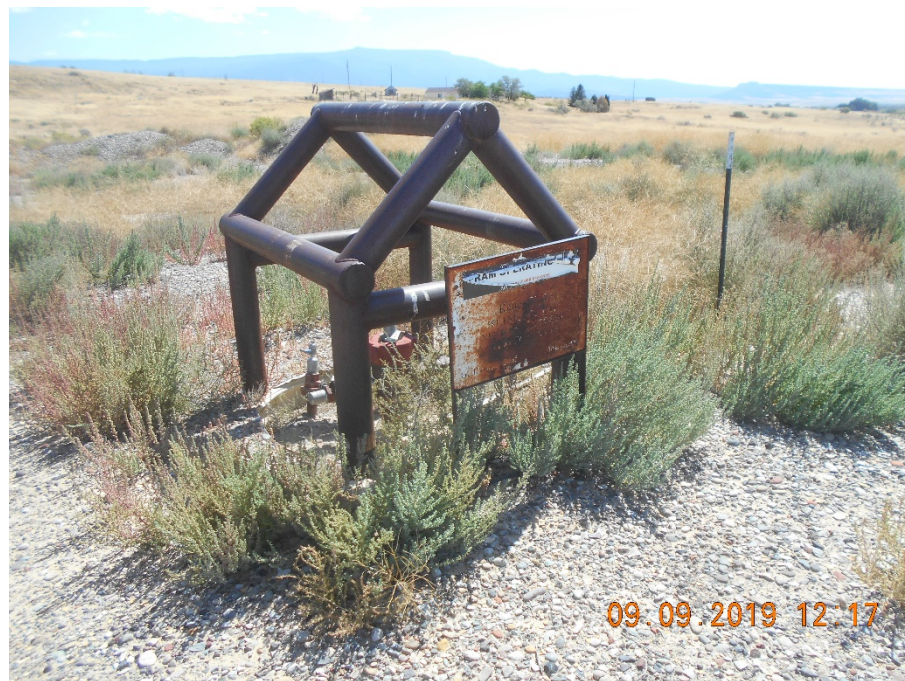
**API # 05-077-09459 Kelly #23-2-B**  
**Wellhead with sign and pipe barricade looking SE**  
**Temporarily abandoned. Weeds,**

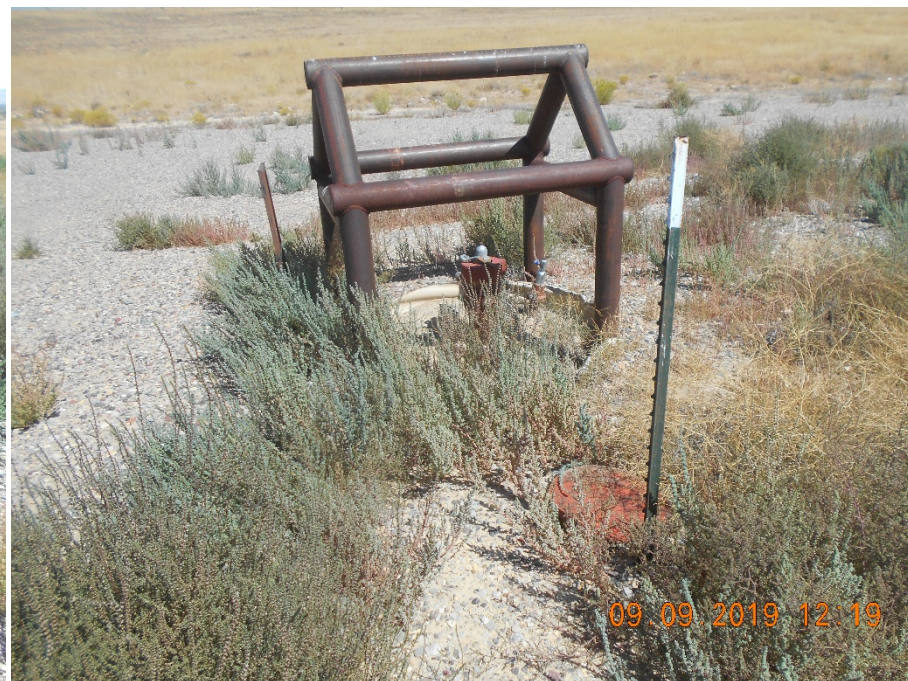
**API # 05-077-09459 Kelly #23-2-B**  
**Wellhead with sign and pipe barricade looking N.**  
**Rat hole with cover next to T-post in foreground.**

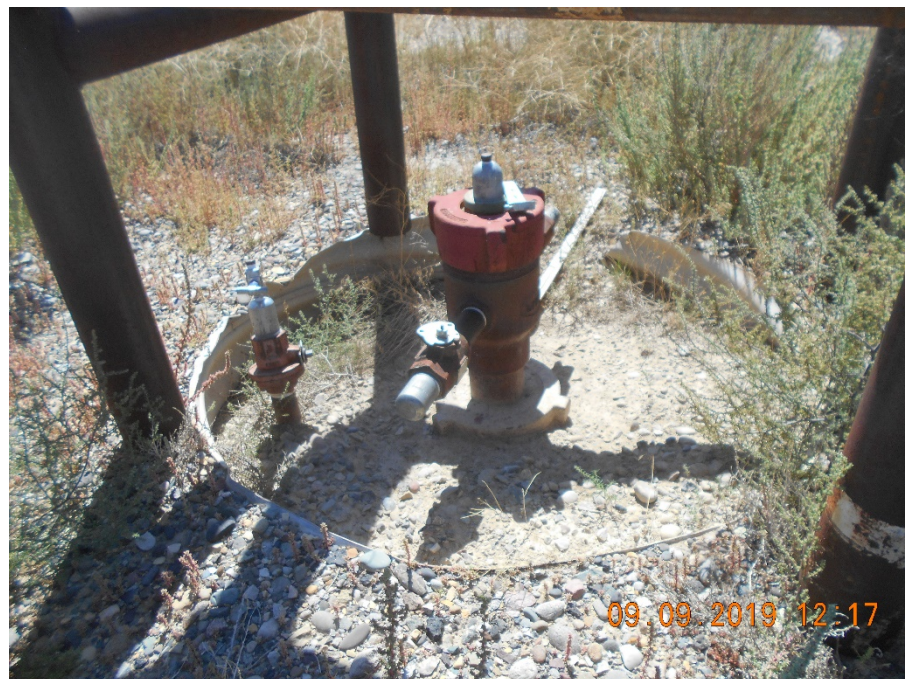
**API # 05-077-09459 Kelly #23-2-B**

**Wellhead with bradenhead valve to surface.**

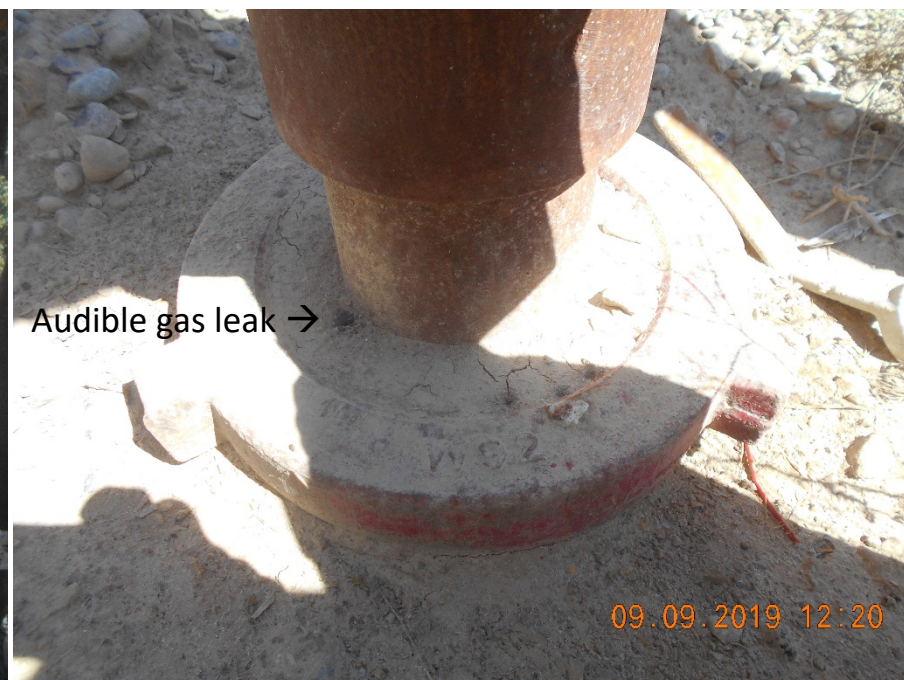
**API # 05-077-09459 Kelly #23-2-B**

**Wellhead showing area of audible gas leak at  
Surface Casing and Production Casing seal.**

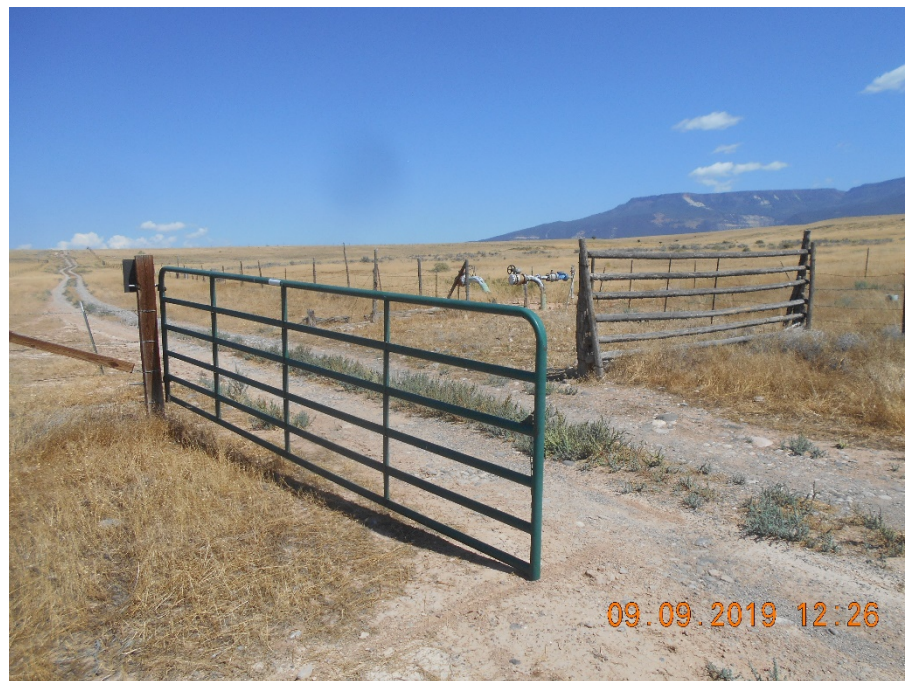
**South Gate on access road looking NE.  
Gathering Line risers in background**

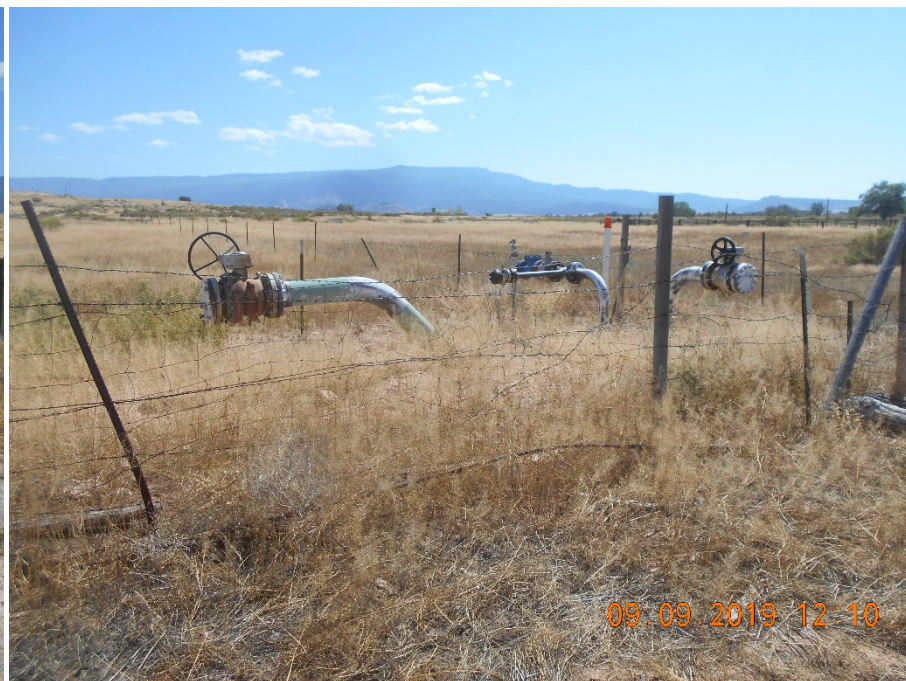
**Gathering Line risers. 4", 6" & 8"  
Locked out/ tagged out with blind flange.**
