FRAM OPERATING LLC – 10310

Location ID # 334471

API # 05-077-08794 Lough #36-1

API # 05-077-09249 Lough #36-1-P

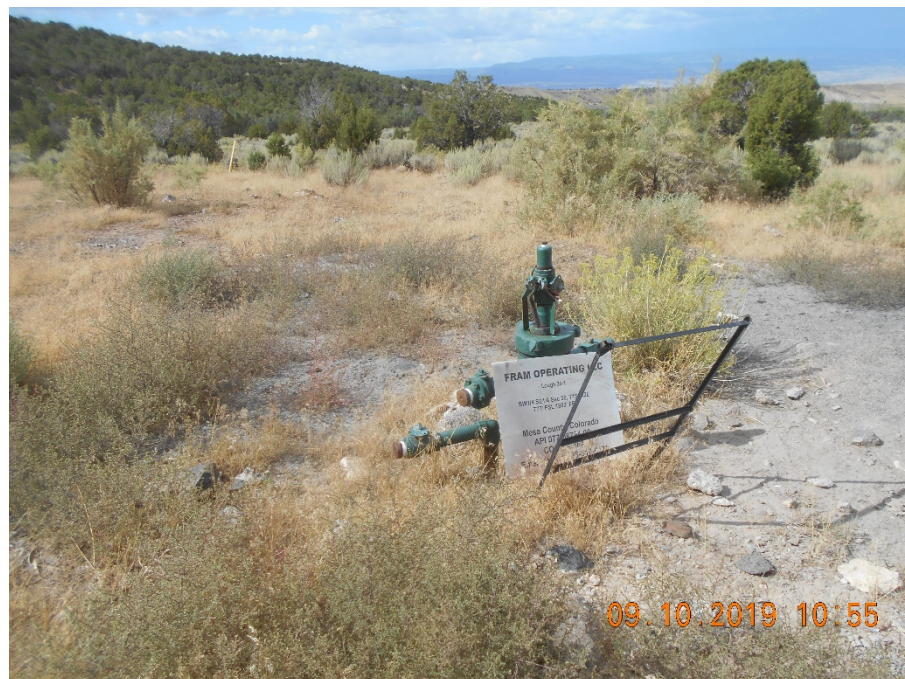
**API # 05-077-08794 Lough #36-1 with sign.
Looking S.**

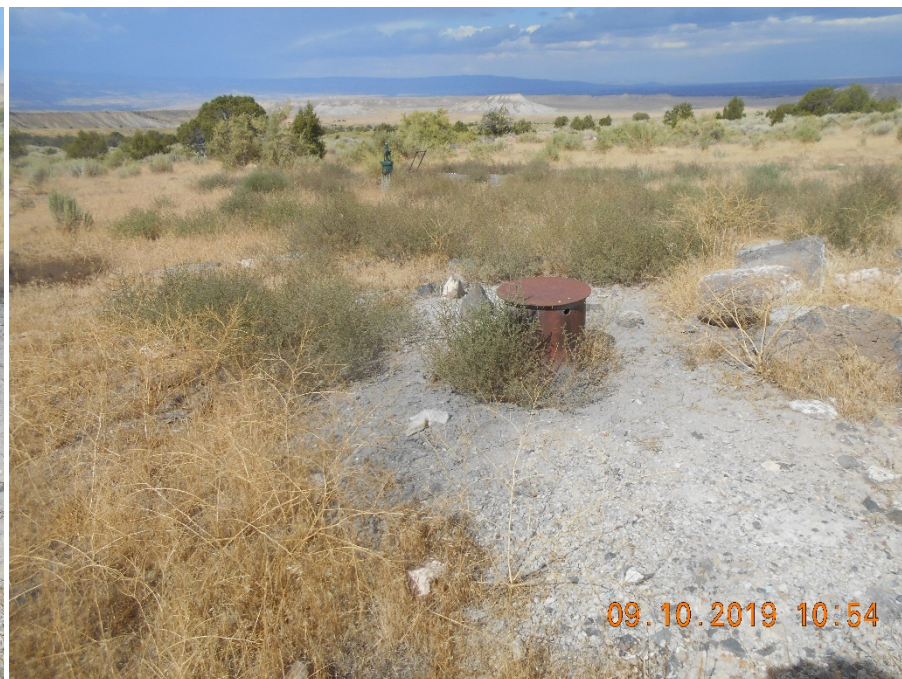
**API # 05-077-09249 Lough #36-1-P
13 3/8" casing with welded plate (Sfc Csg / PA?)
Looking W.**

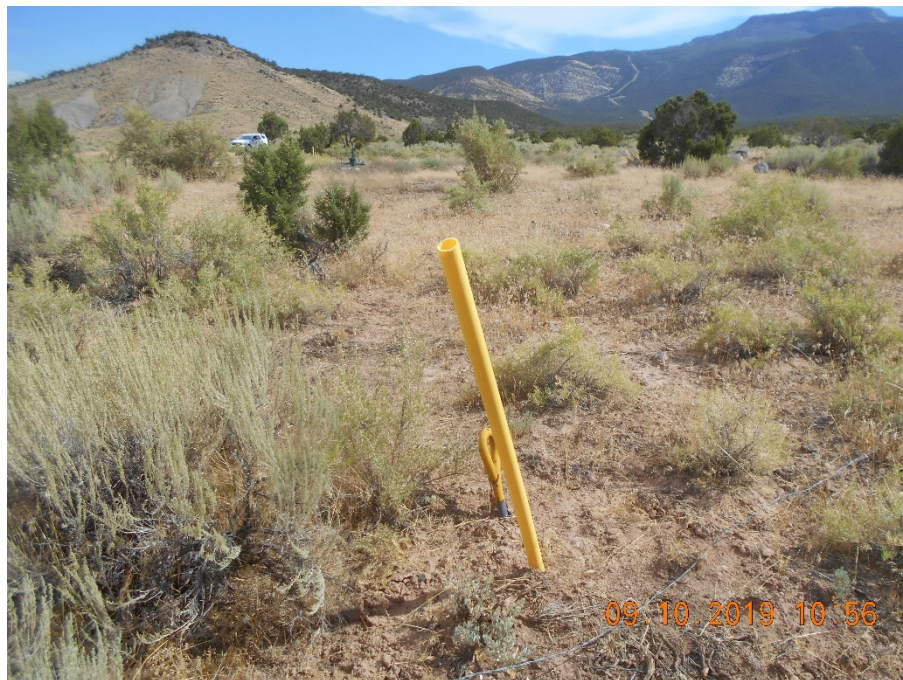
SW corner anchor marker looking N.

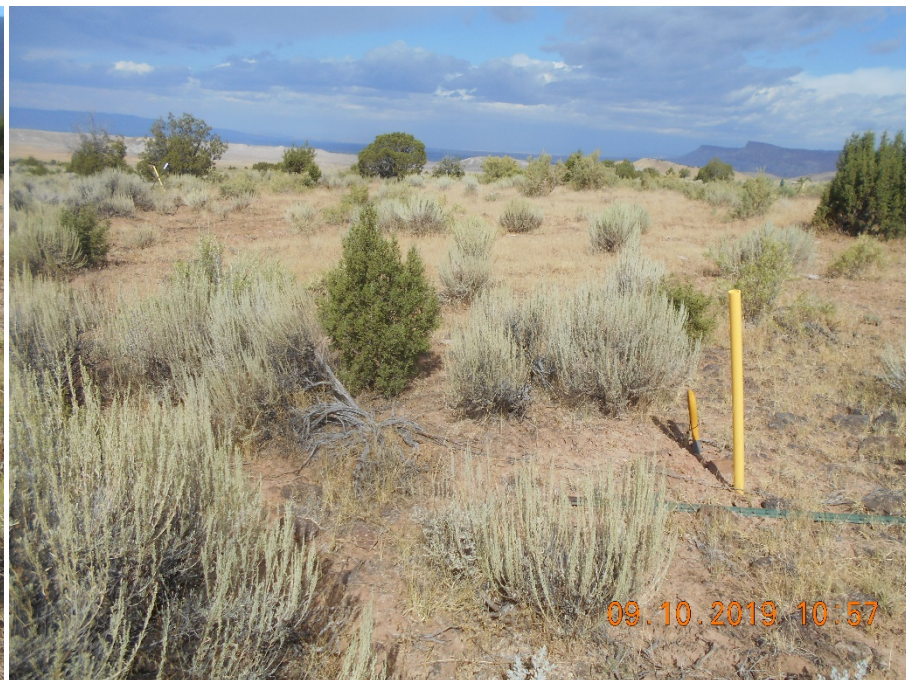
NE corner anchor marker looking W

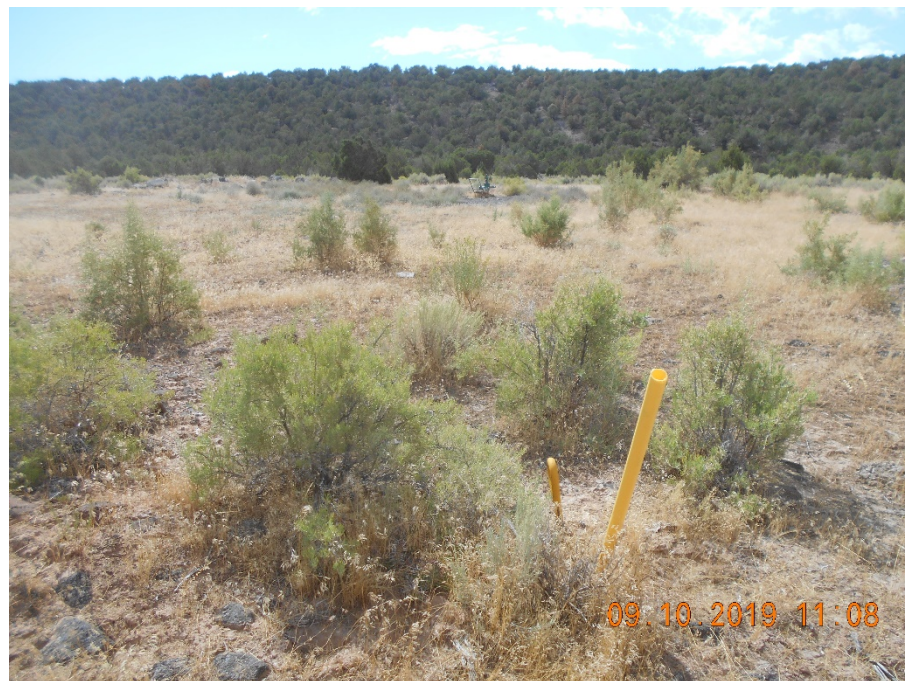
NW corner anchor marker looking SE.

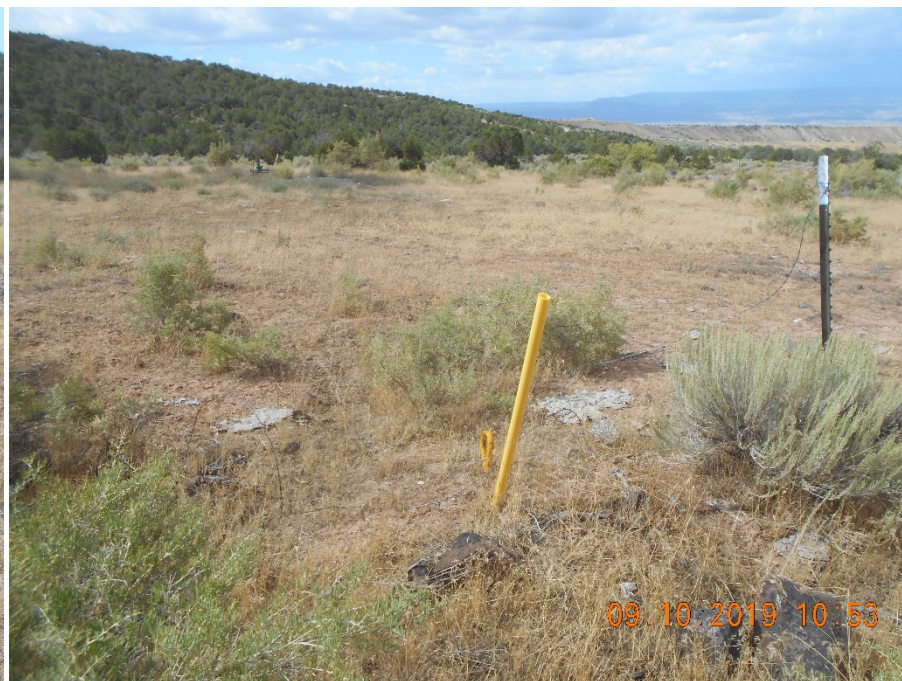
NE corner anchor marker looking S
