Inspection Photos
Location Name: MERLOT 34-13
API#: 05-071-08082
INSP. #: 695101331

Colorado Oil & Gas Conservation Commission
37.07892, -104.62168, 1985.0m, 228°
2019/09/12 10:35:35

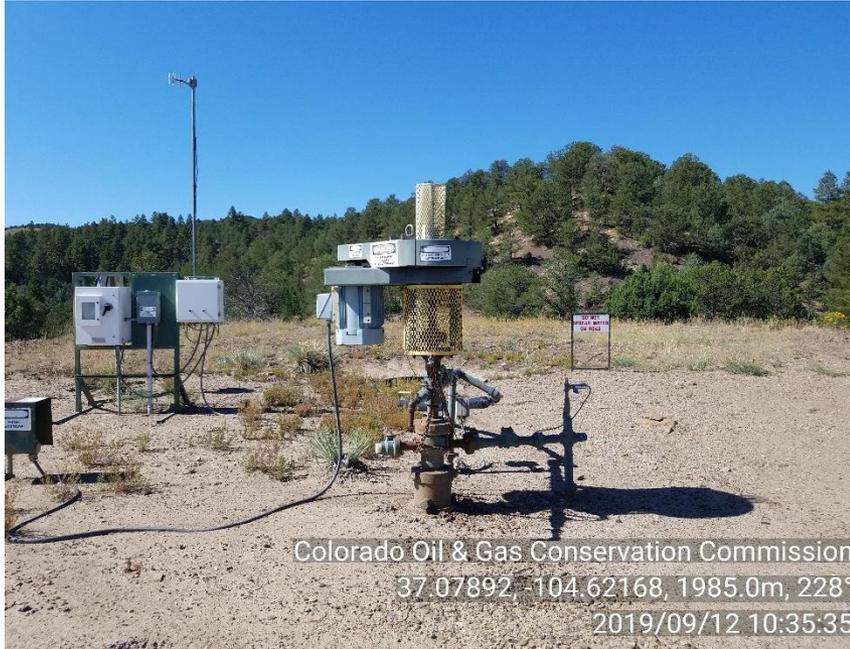
PHOTO 1: WELLHEAD

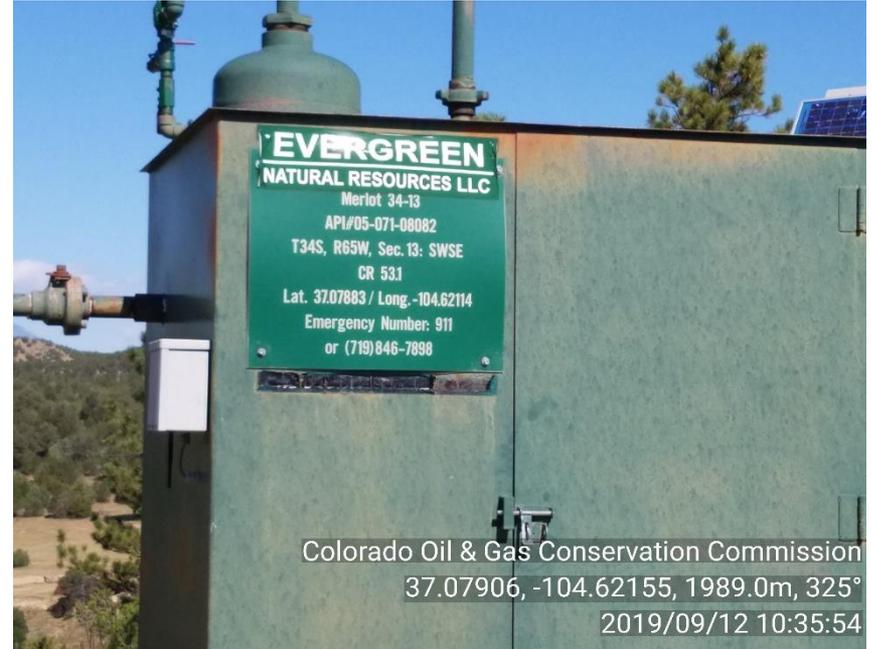
PHOTO 2: WELL SIGN

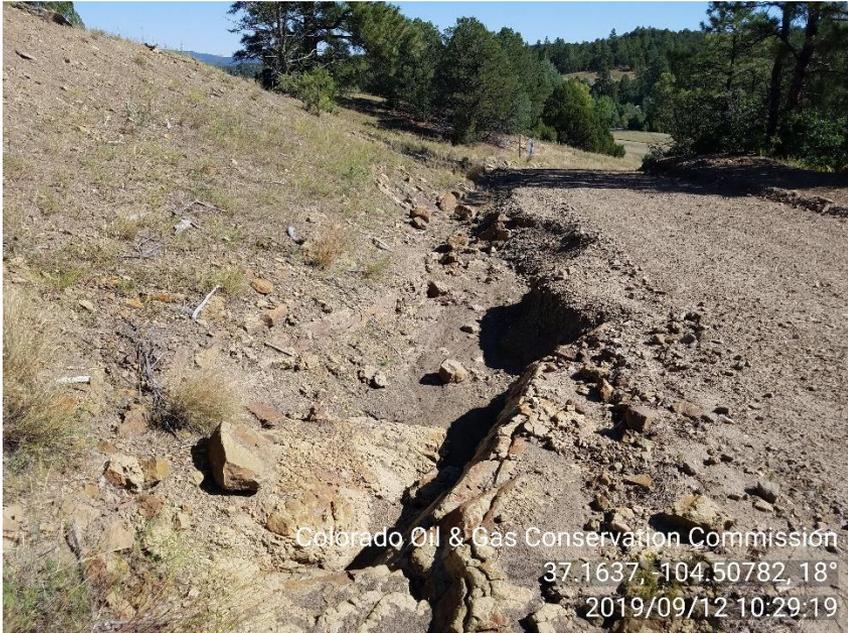
PHOTO 3: DITCH ON ROW NORTHEAST OF LOCTION IS ERODING NO BMP'S IN PLACE TO PREVENT DITCH FROM ERODING. REPAIR EROSION AND INSTALL BMP'S TO PREVENT MORE EROSION, COMPLY WITH RULE 1002.f. CA DATE 10-12-19

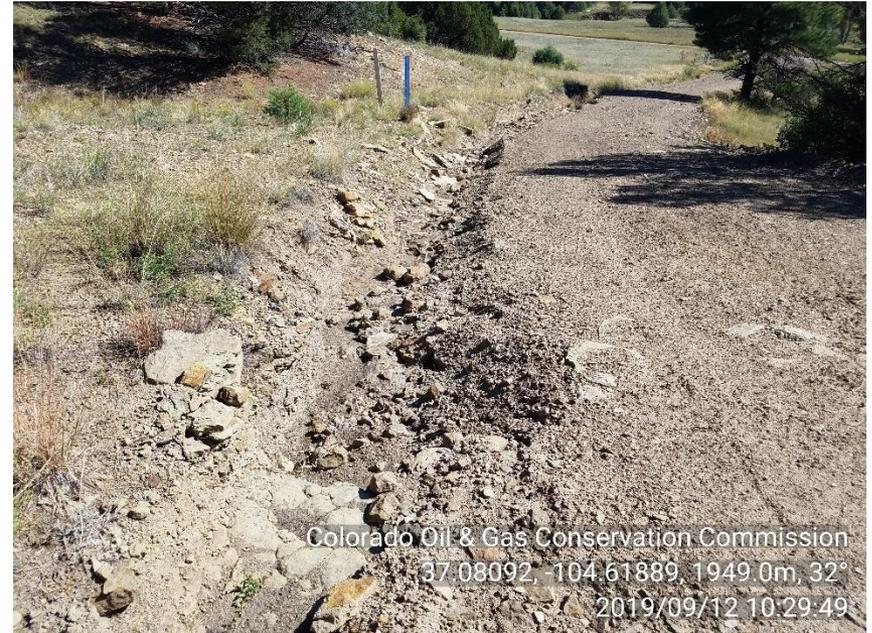
PHOTO 4: IMAGE OF OTHER IMPACTED AREAS ALONG ROW PERTAINING TO CA NOTED IN PHOTO 3.

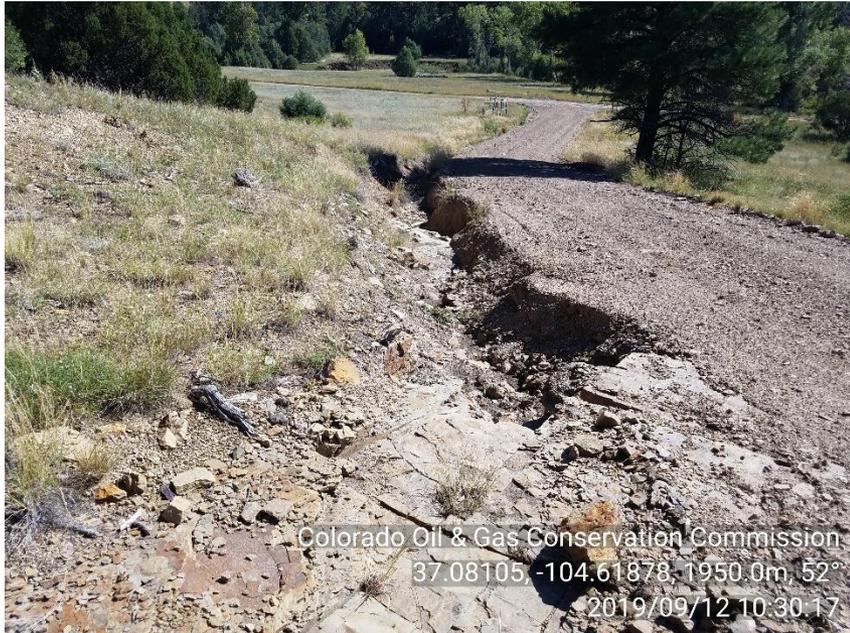
PHOTO 5: IMAGE OF OTHER IMPACTED AREAS ALONG ROW PERTAINING TO CA NOTED IN PHOTO 3.

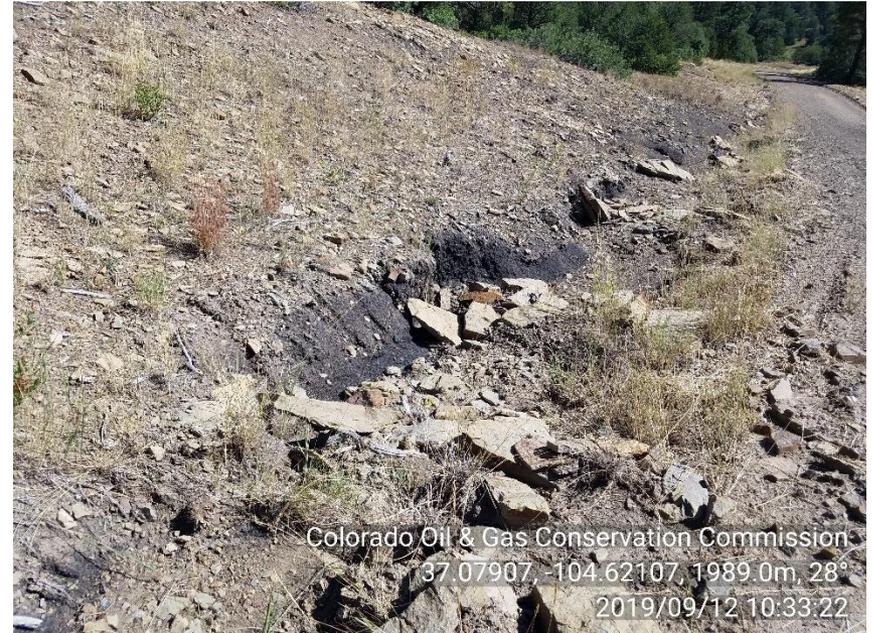
PHOTO 6: BMP'S HAVE FAILED AND APPEARS TO HAVE BEEN INSTALL IMPROPERLY. REPAIR EROSION REPAIR THE BMP'S THAT HAVE FAILED AND INSTALL MORE BMP'S TO COMPLY WITH RULE 1002.f. CA DATE 10-12-19

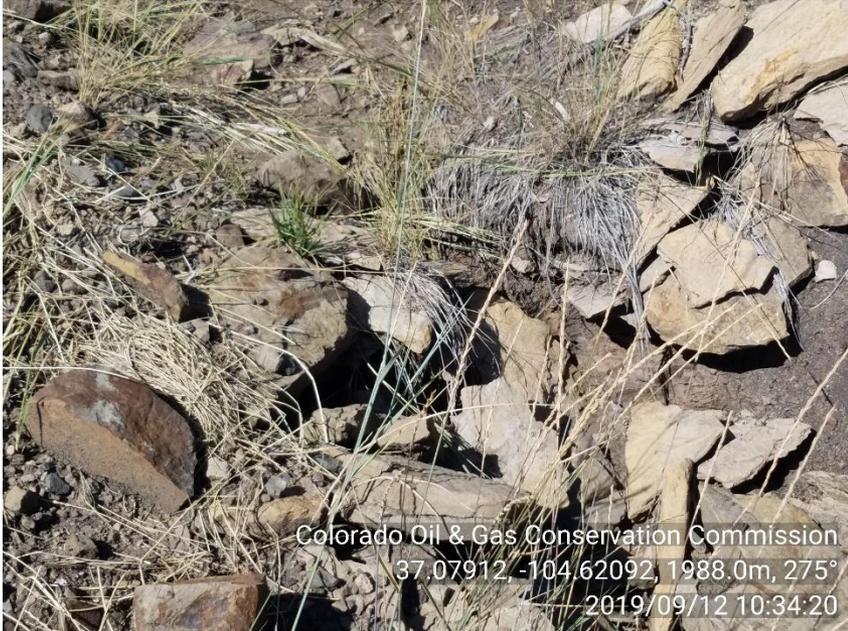
PHOTO 7: IMAGE OF OTHER IMPACTED AREAS ALONG ROW PERTAINING TO CA NOTED IN PHOTO 6.

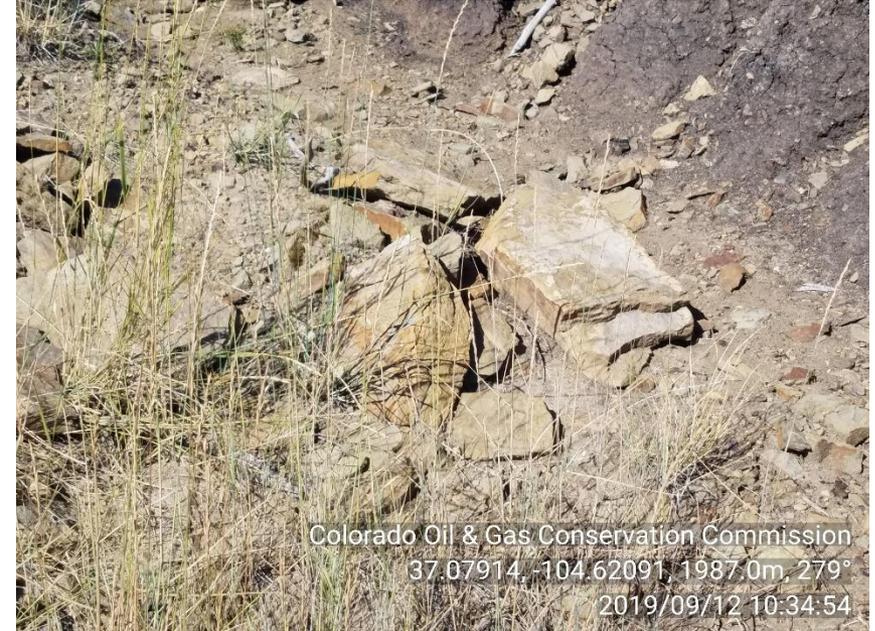
PHOTO 8: IMAGE OF OTHER IMPACTED AREAS ALONG ROW PERTAINING TO CA NOTED IN PHOTO 6.

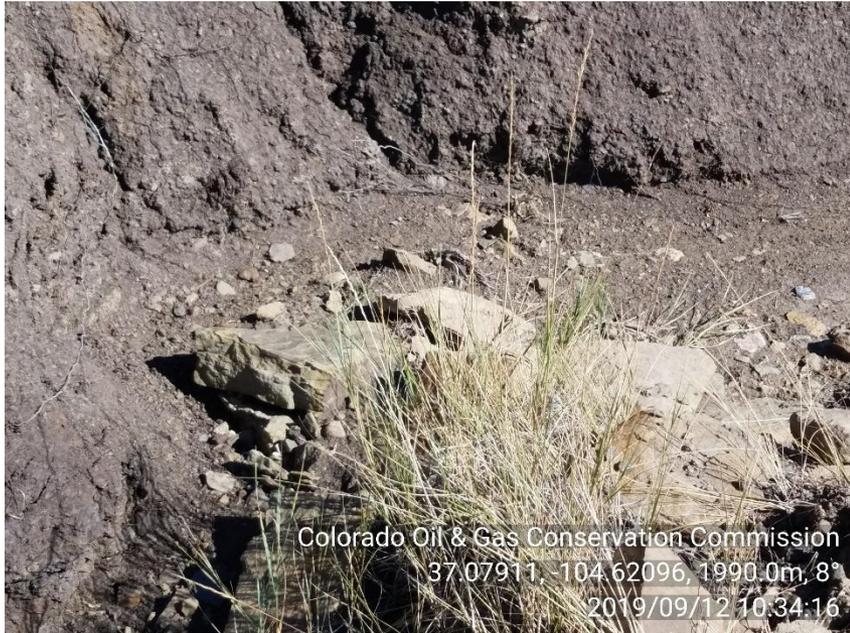
PHOTO 9: IMAGE OF OTHER IMPACTED AREAS ALONG ROW PERTAINING TO CA NOTED IN PHOTO 6.

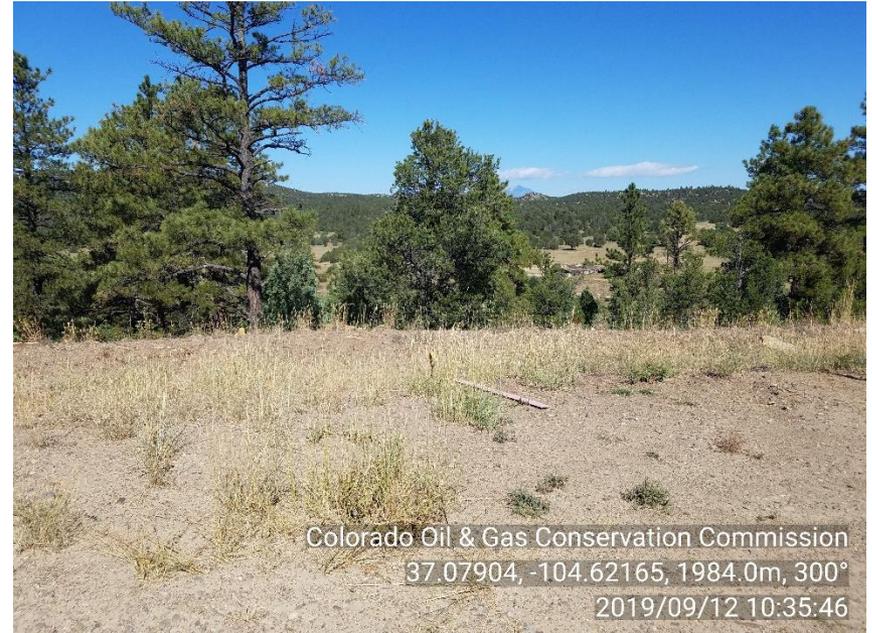
**PHOTO 10: GUY LINE ANCHOR MARKER IS DOWN.
Install proper guy line markers per Rule 1003.a**
