# Inspection Photos

API: 05-071-08887

Operator: TIMBER CREEK OPERATING LLC

Inspection Date: 9/12/2019

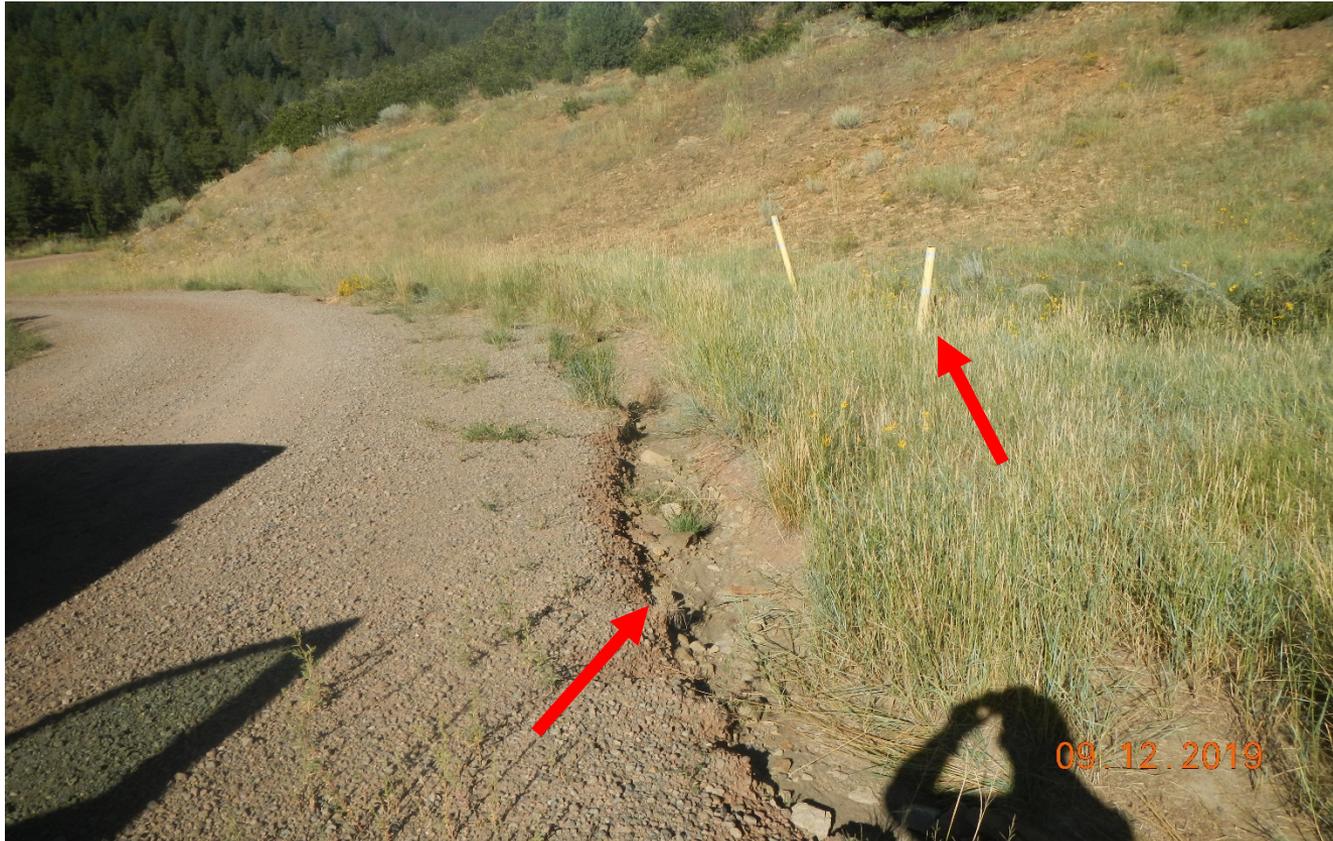
**Photo 1.** Stormwater is draining down the access road and not towards the culvert shown by red arrows.

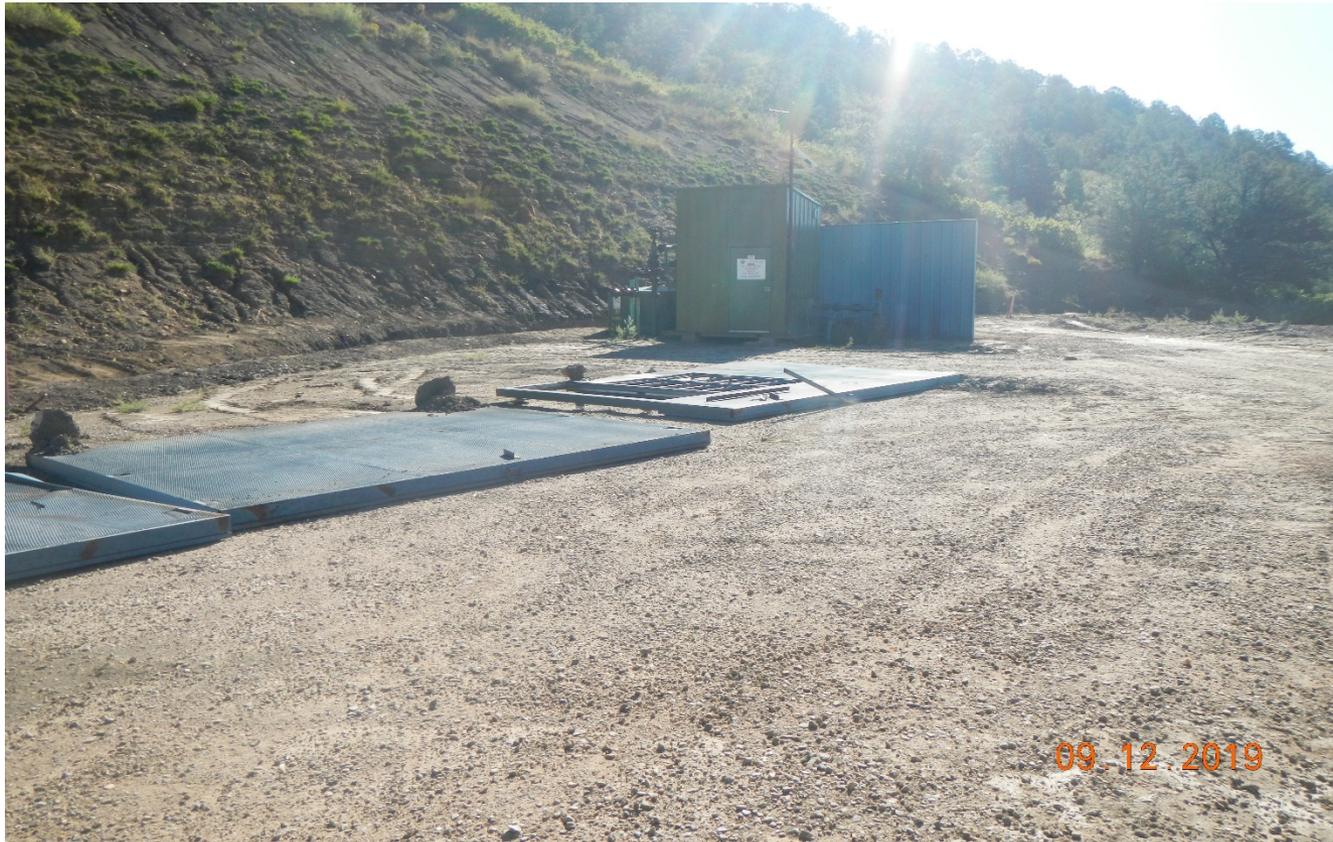
**Photo 2.** Facing toward the location. There is sections of panels laying on the ground which is unused equipment.
