Inspection Photos

09/11/2019

Operator: OMIMEX PETROLEUM INC - 66190

Location ID: 304893

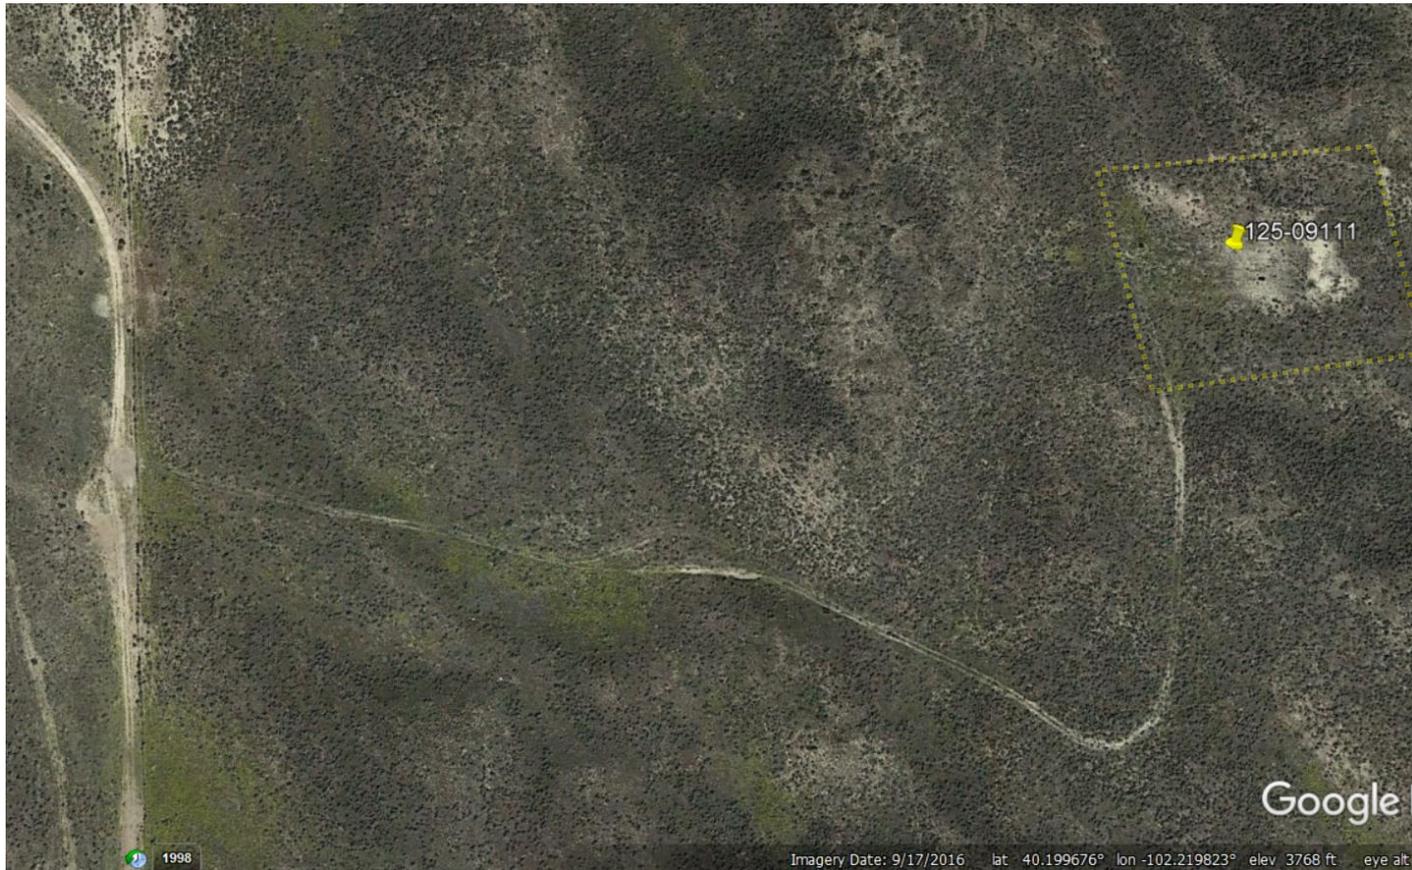
Photo 1: Most recent Google Earth aerial imagery (2016). Photo shows location and access road. Majority of access road has revegetated and is not immediately obvious in the field. Yellow dotted line shows area of initial pad disturbance based on the aerial image.

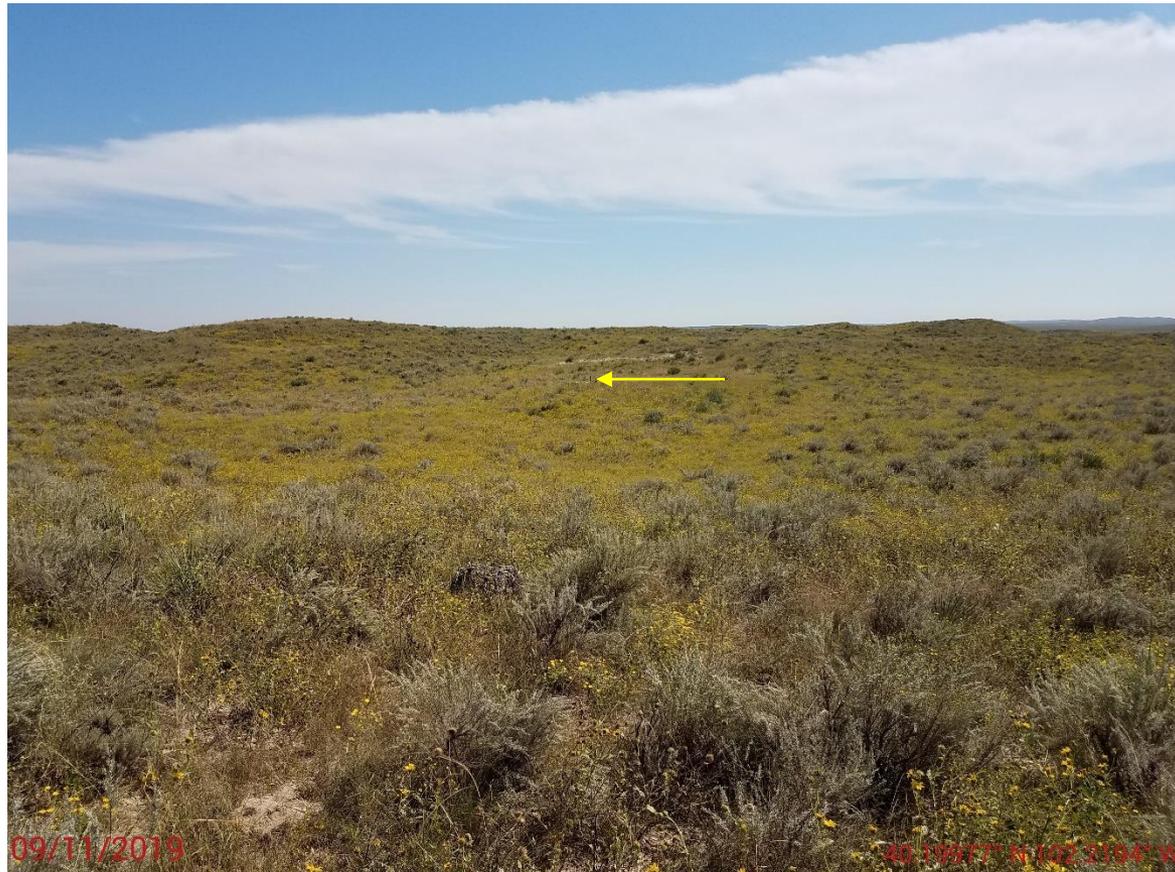
Photo 2: Photo taken from the west of the location, facing east. Photo provides an overview of the location. Arrow shows well location.

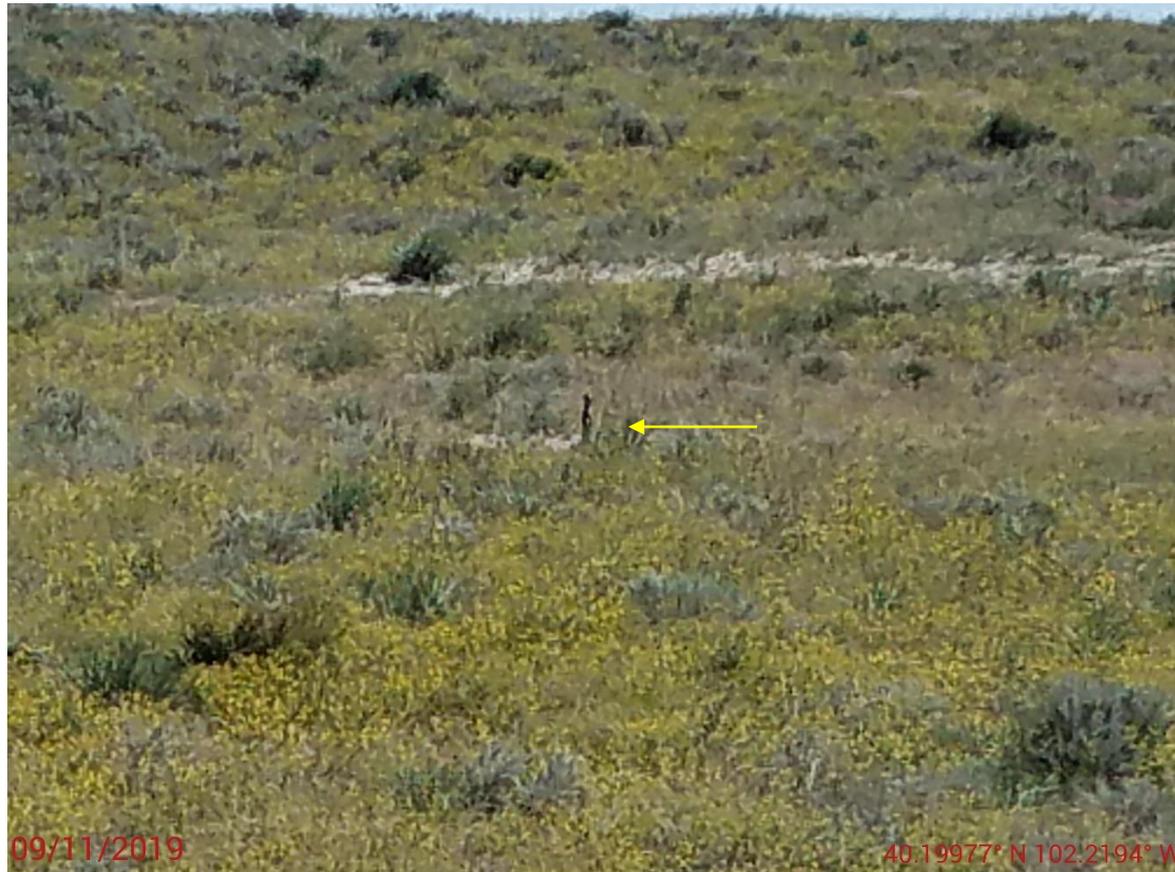
Photo 3: Continued from photo 2. Zoomed in photo to show well.

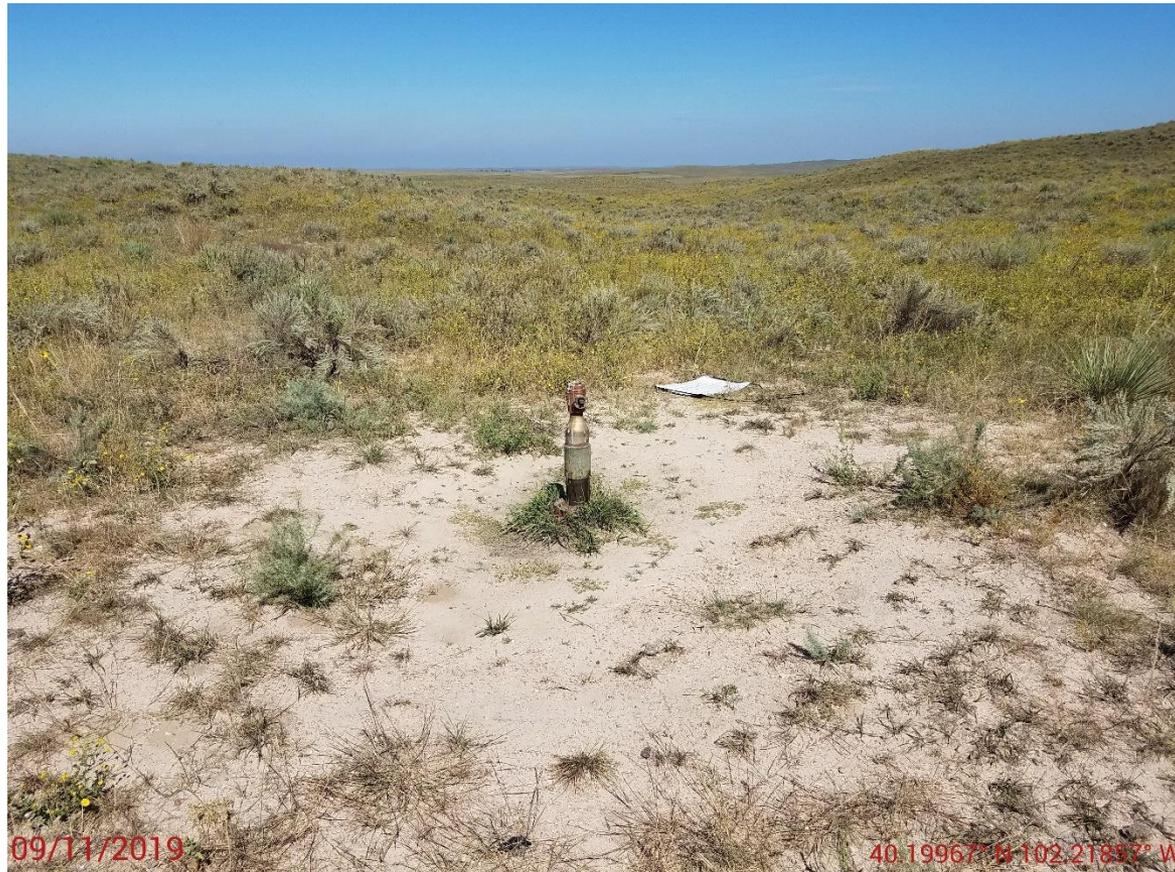
Photo 4: Photo taken from the south of the well, facing north. Photo shows well and pad. With exception to areas east and southeast of the well, the majority of the initial disturbance area has revegetated.

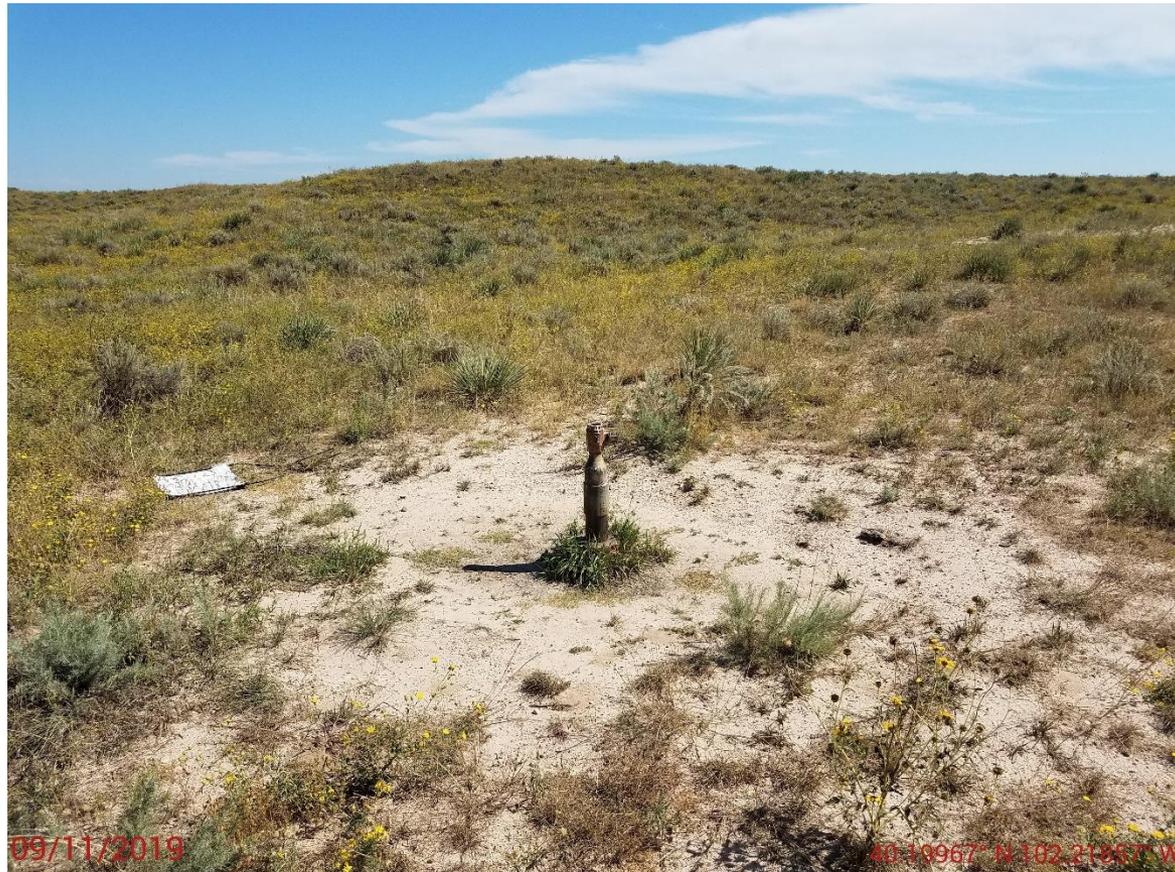
Photo 5: Photo taken from the south of the well, facing east. See comments under photo 4.

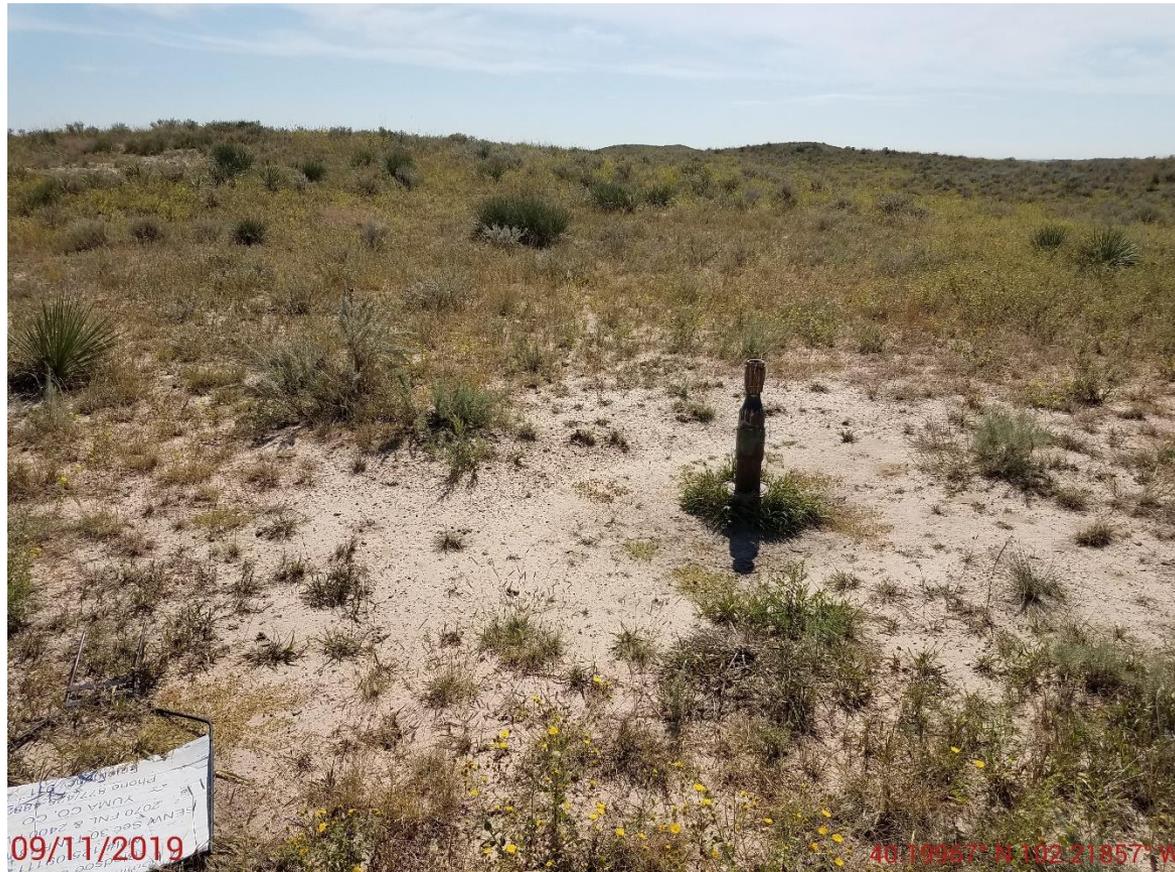
Photo 6: Photo taken from the south of the well, facing south. See comments under photo 4.

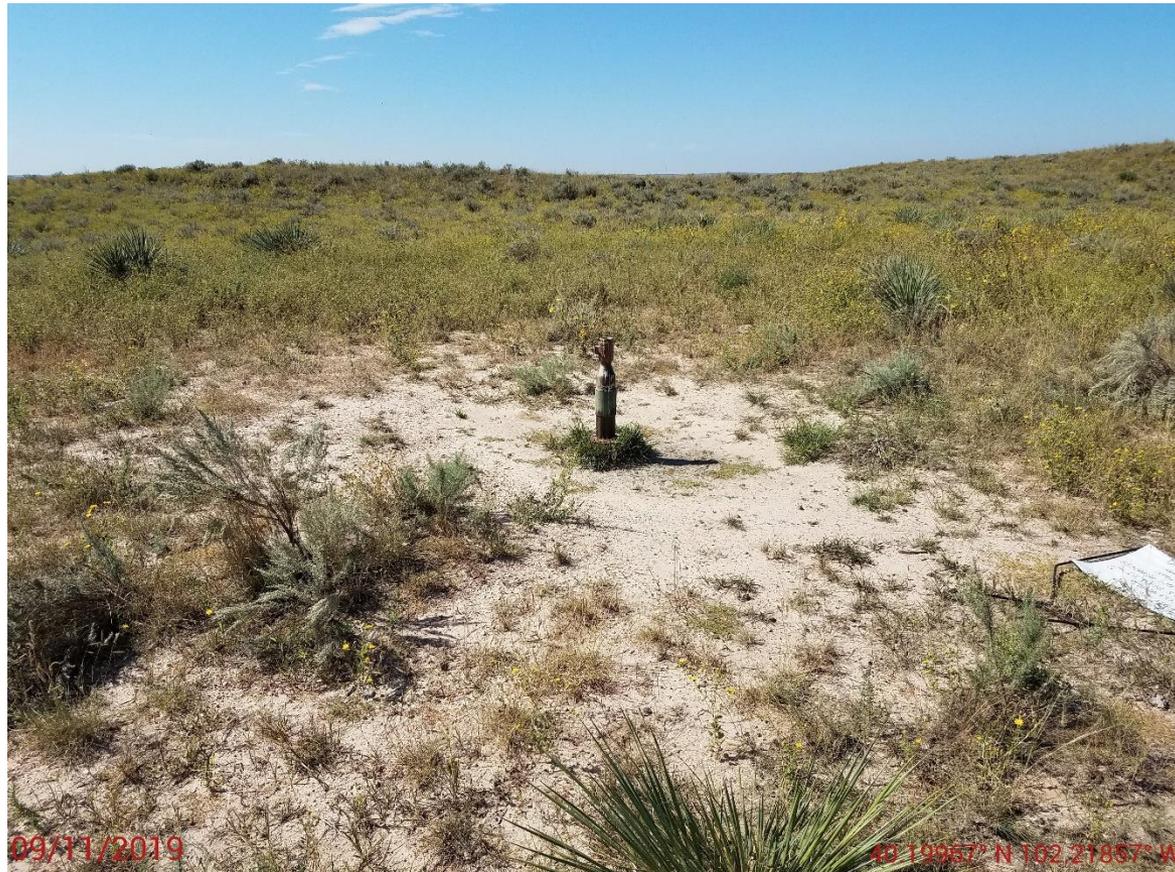
Photo 7: Photo taken from the south of the well, facing west. See comments under photo 4.

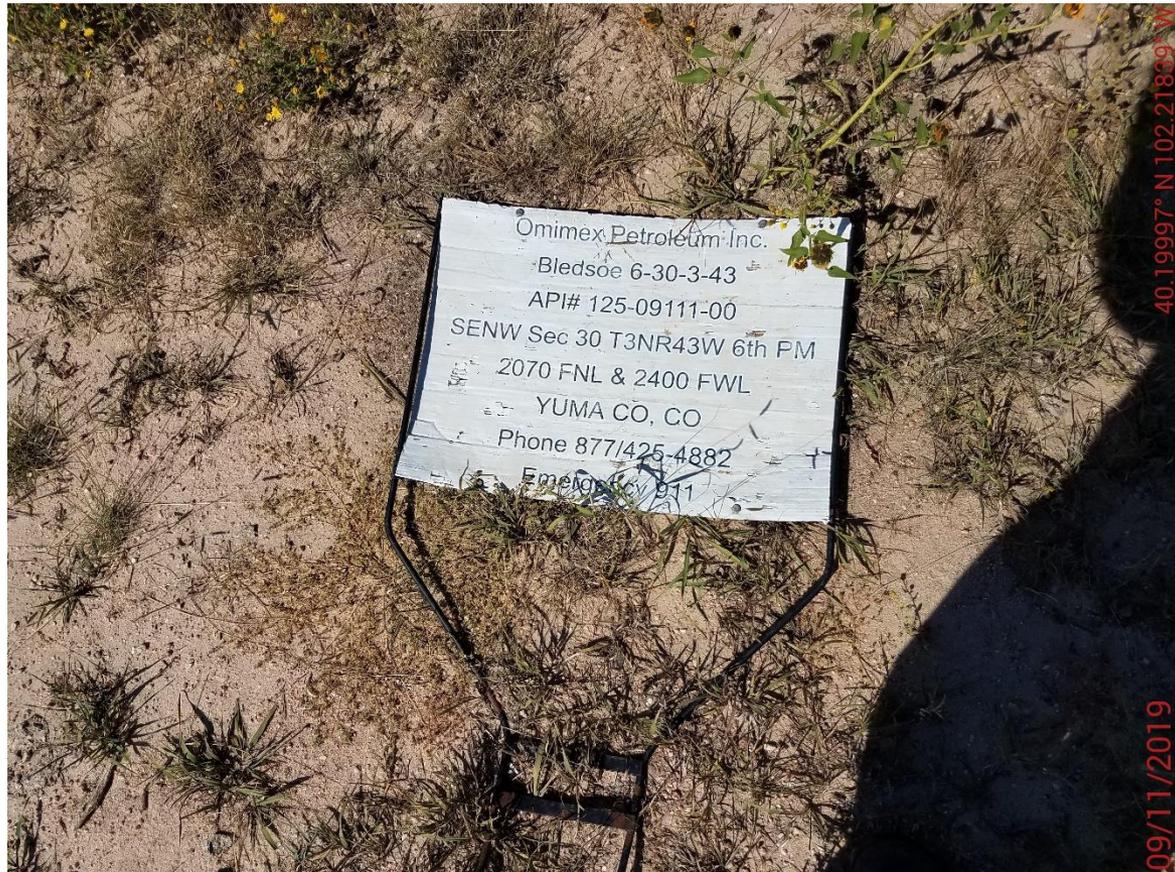
Photo 8: Photo of sign next to well.

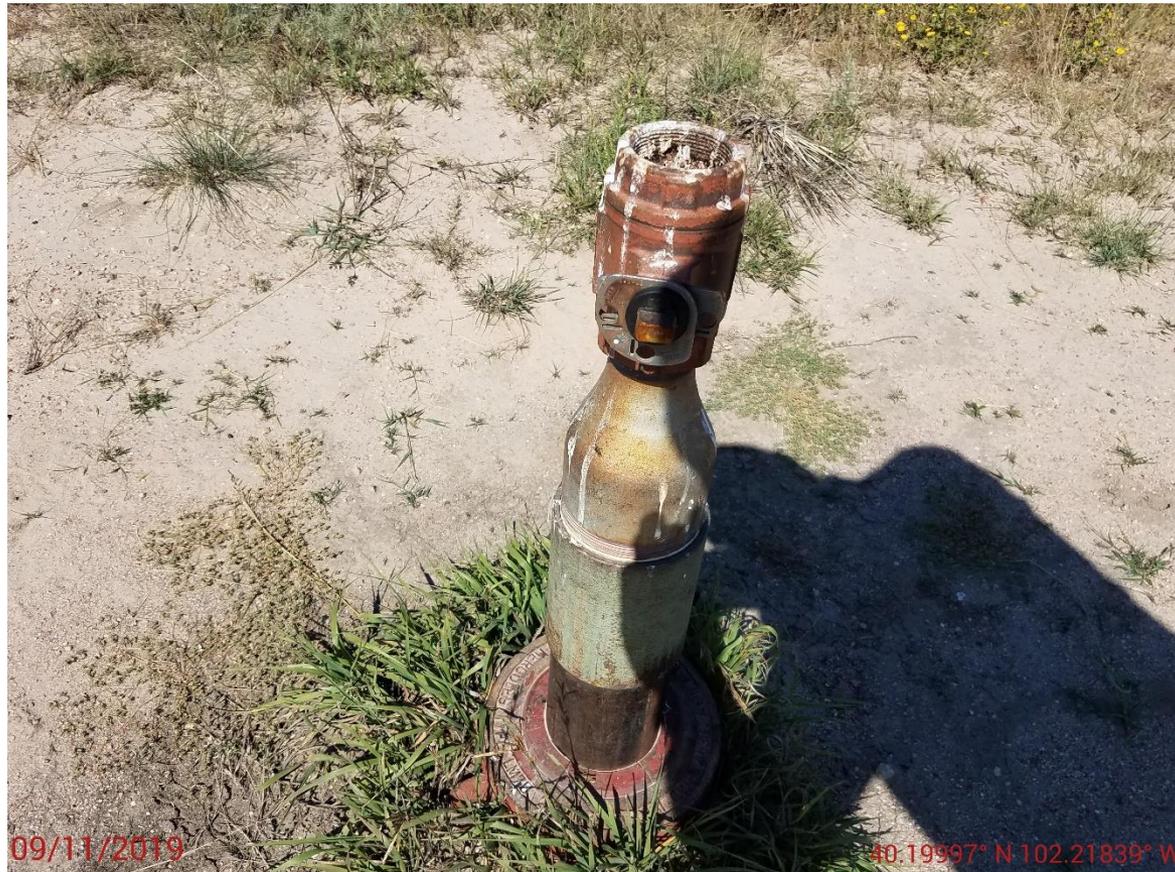
Photo 9: Photo of well.

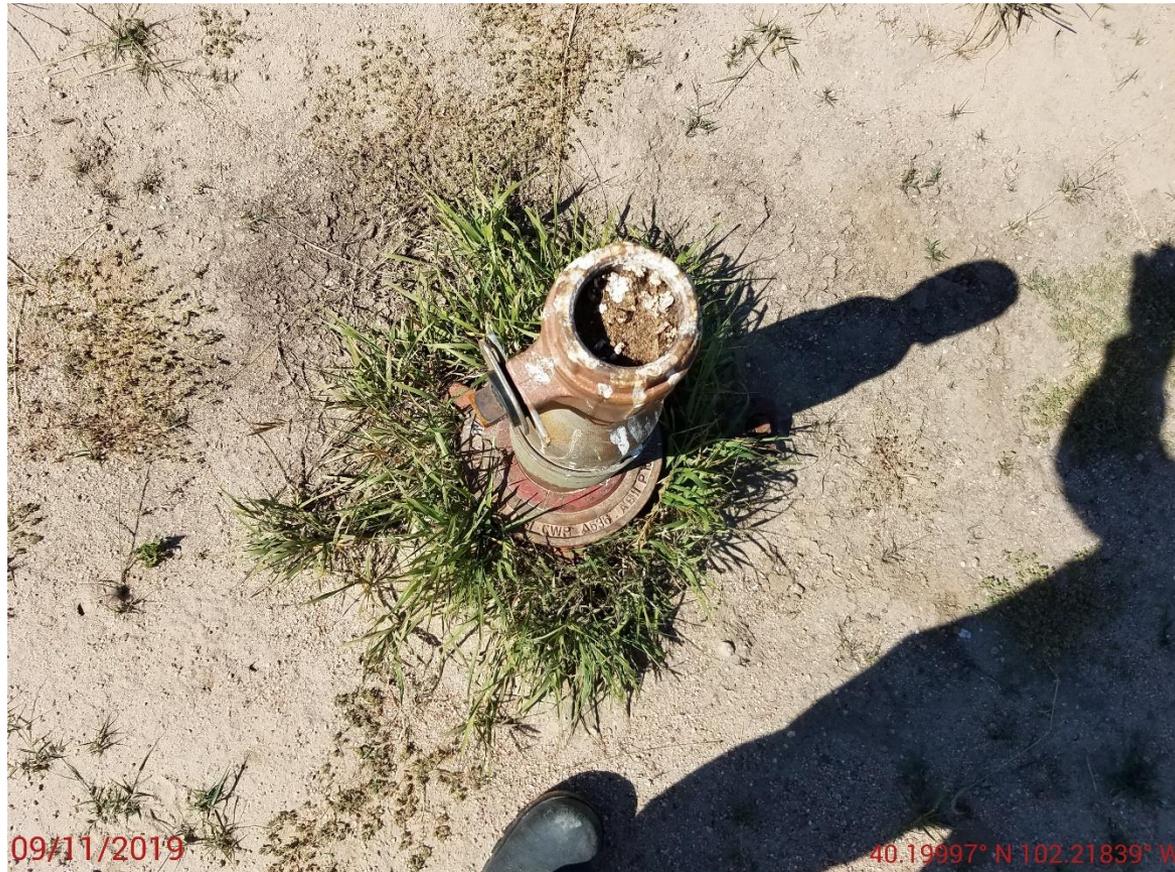
Photo 10: Continued from photo 9.

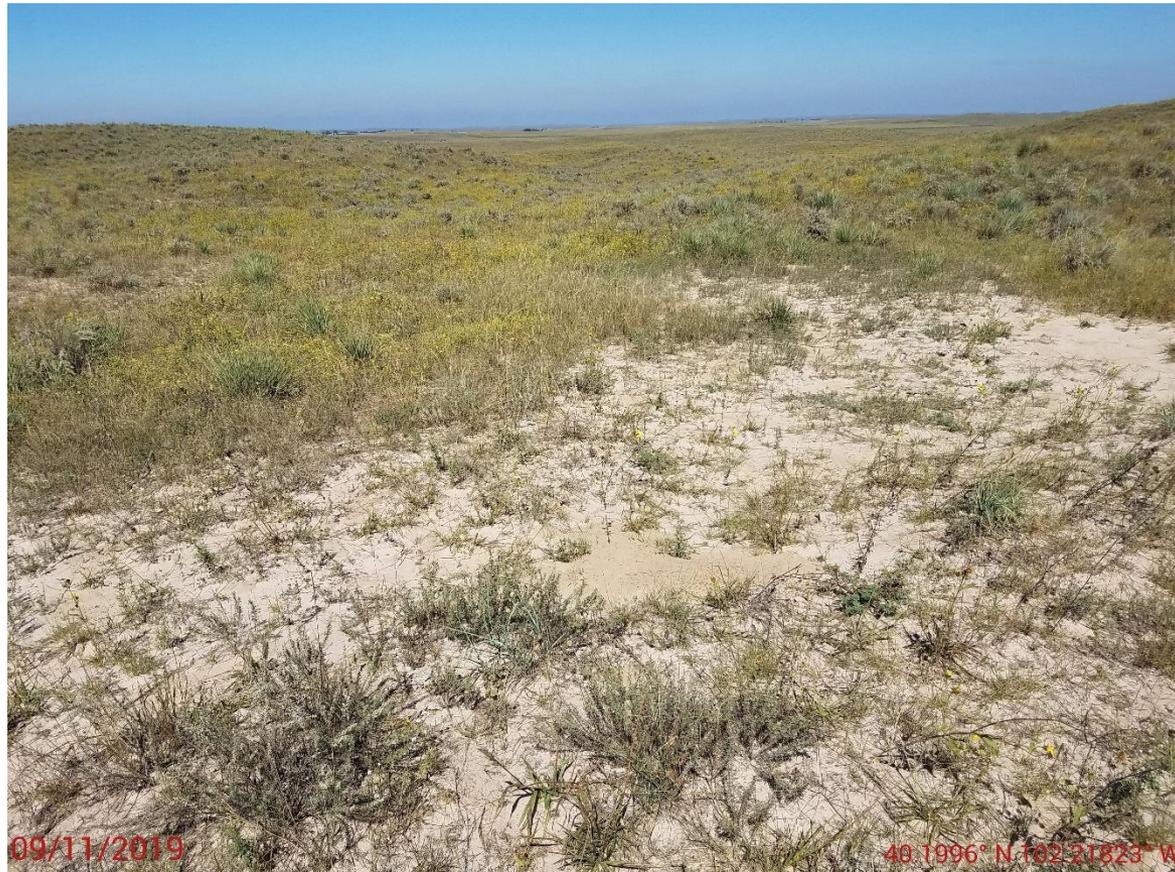
Photo 11: Photo taken from the southeast areas of the location. Photo shows areas where vegetation has not re-established as uniformly as the rest of the location. Areas to the east are predominantly exposed soils.

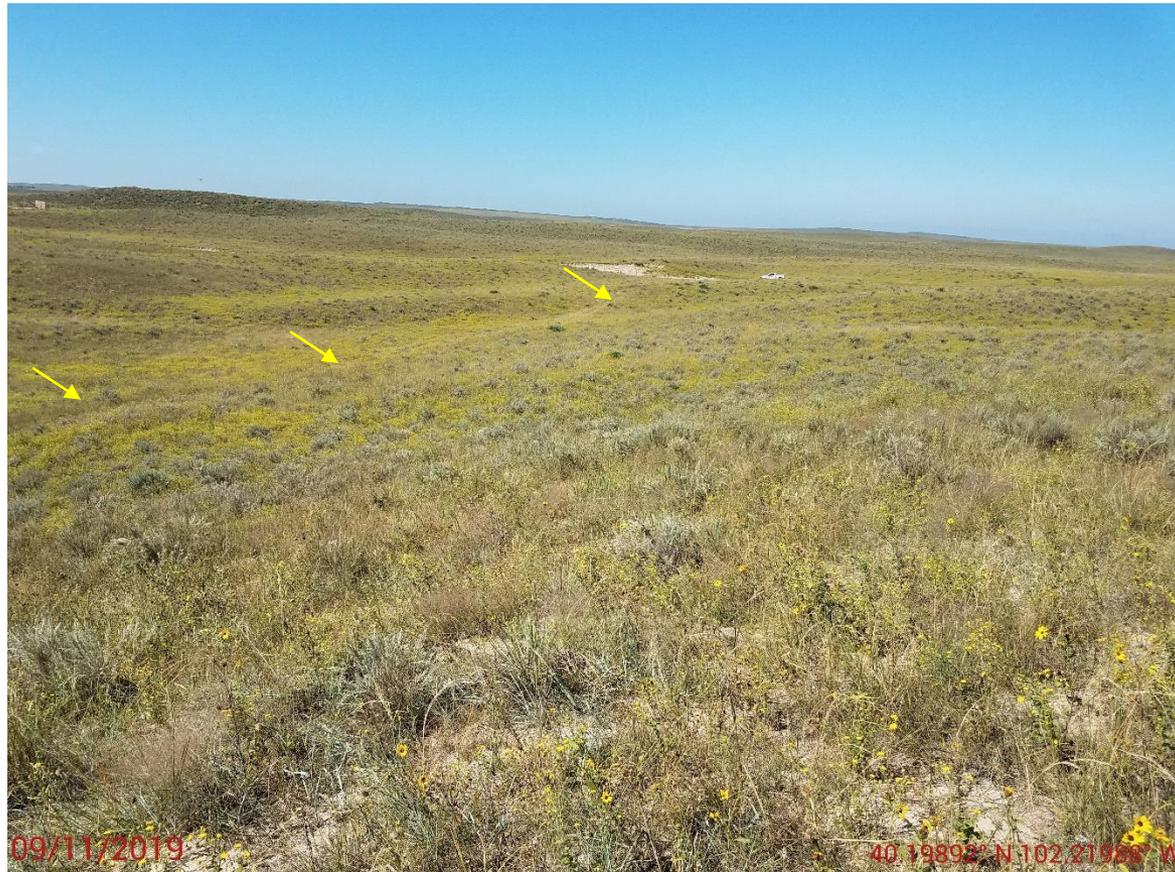
Photo 12: Photo taken from the adjacent lands west of the location. Photo shows the access road (yellow) to the location. Majority of access road has revegetated and was not immediately obvious in the field.

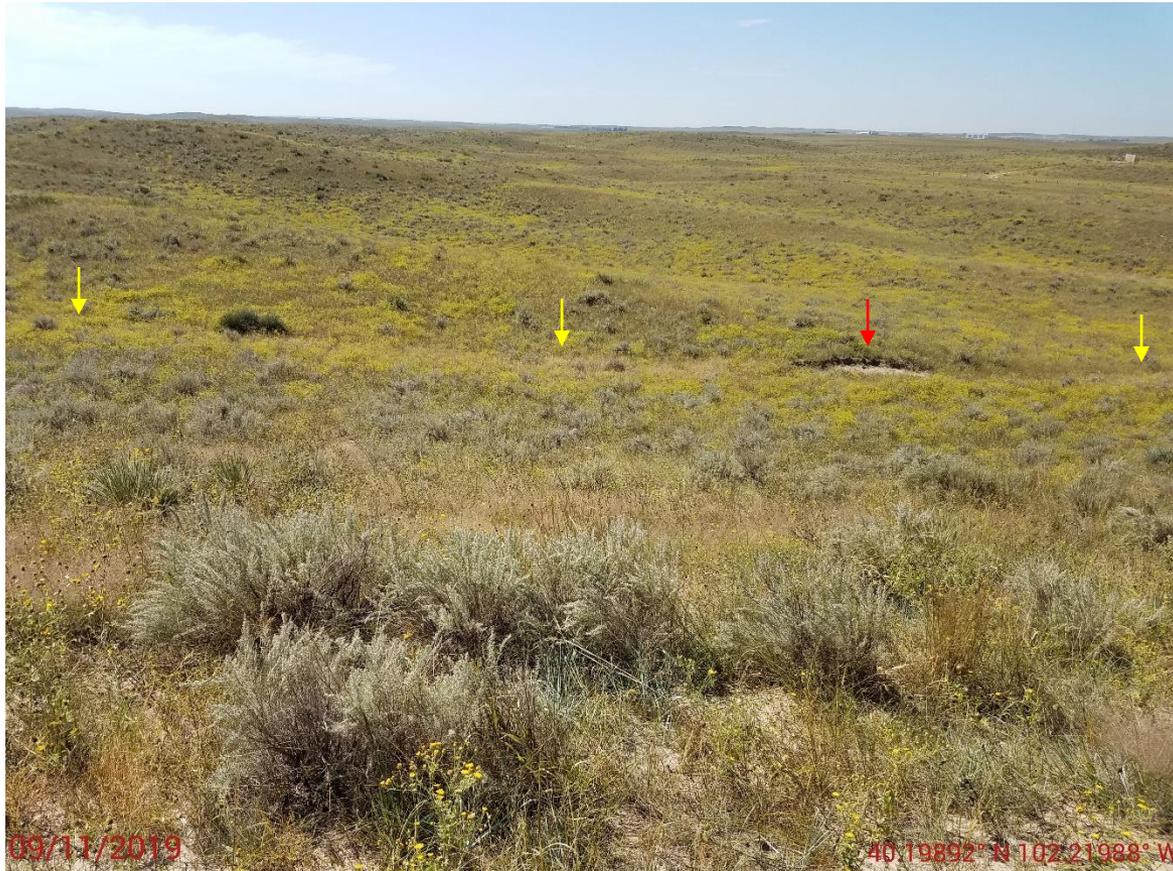
Photo 13: Photo taken from the adjacent lands west of the location, facing south. Photo shows the access road (yellow arrow) to the location. Photo also shows areas where erosion is evident along access road (red arrow).

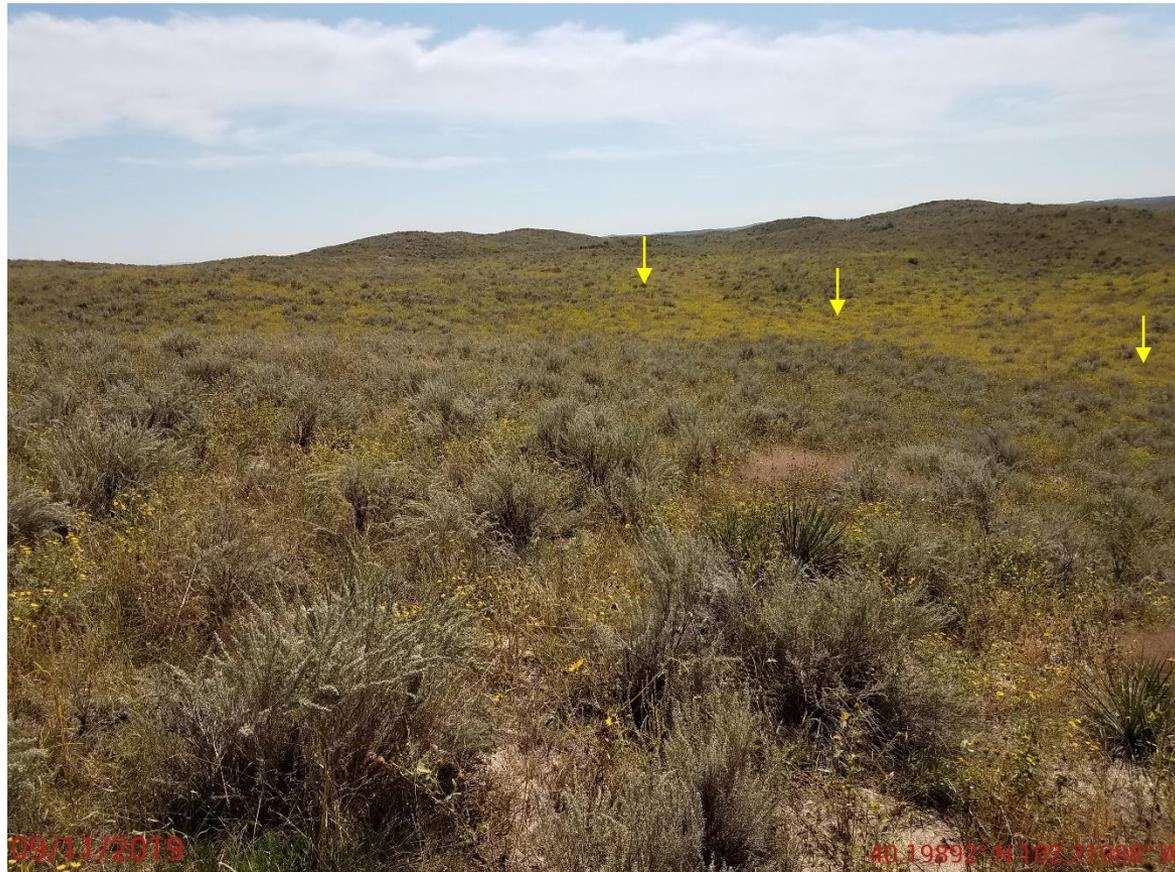
Photo 14: Photo taken from the adjacent lands west of the location. Photo shows the access road (yellow) to the location. Majority of access road has revegetated and was not immediately obvious in the field.

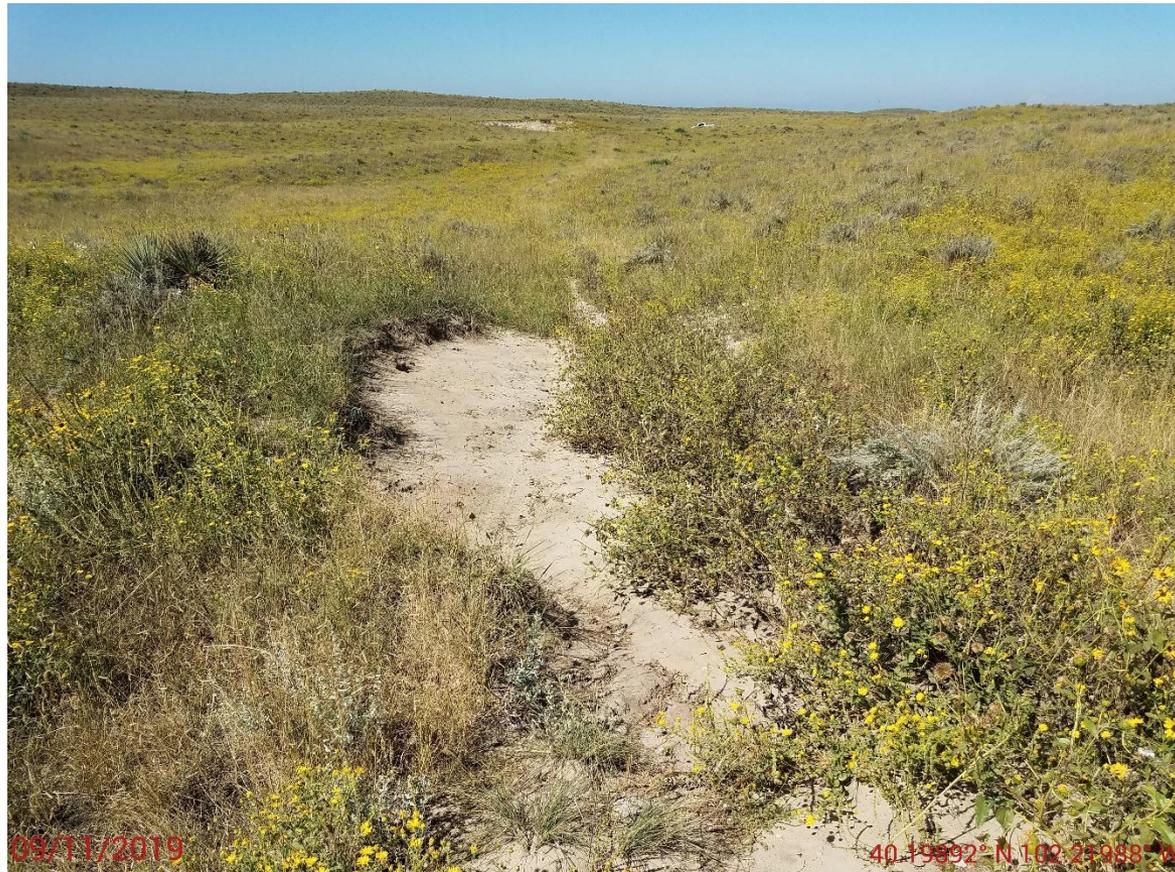
Photo 15: Photo taken from the access road, facing west. Photo shows erosion degradation along access road. See photo 13.

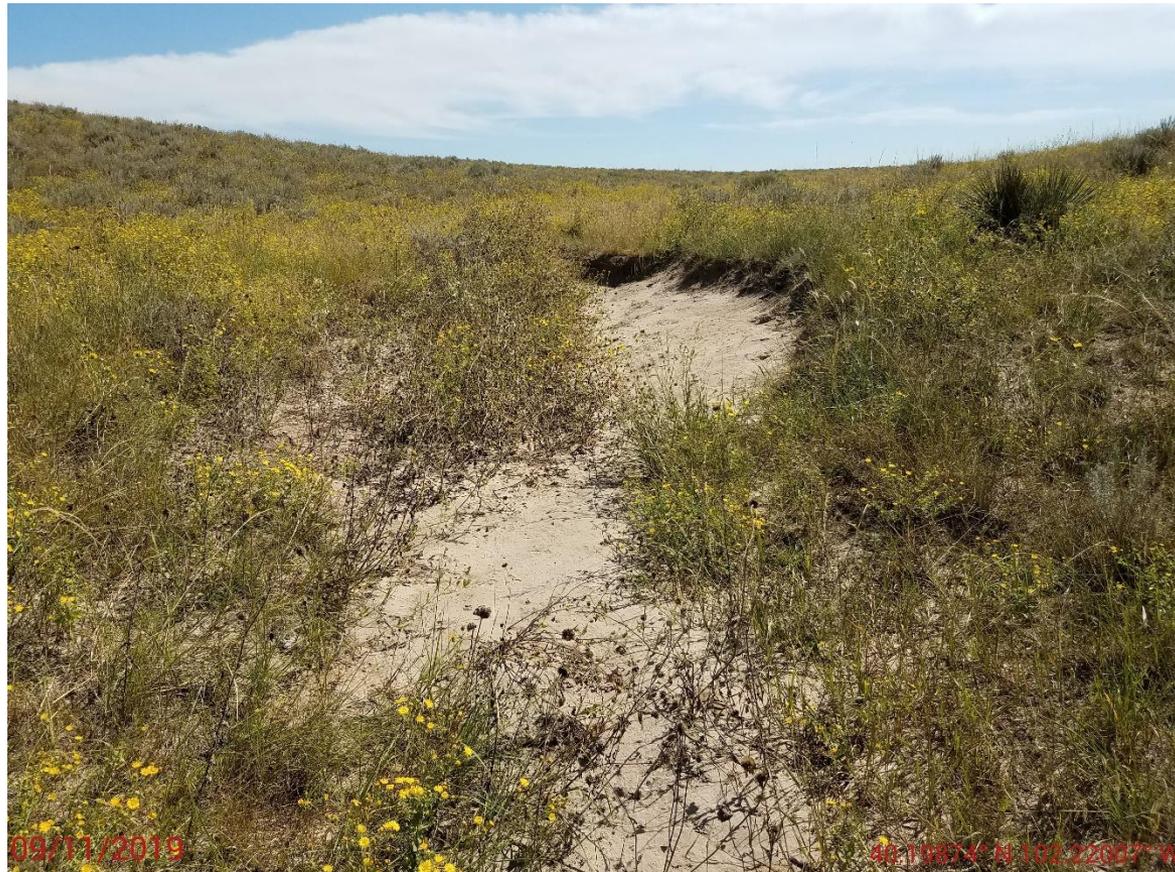
Photo 16: Photo taken from the access road, facing east. Photo shows erosion degradation along access road.

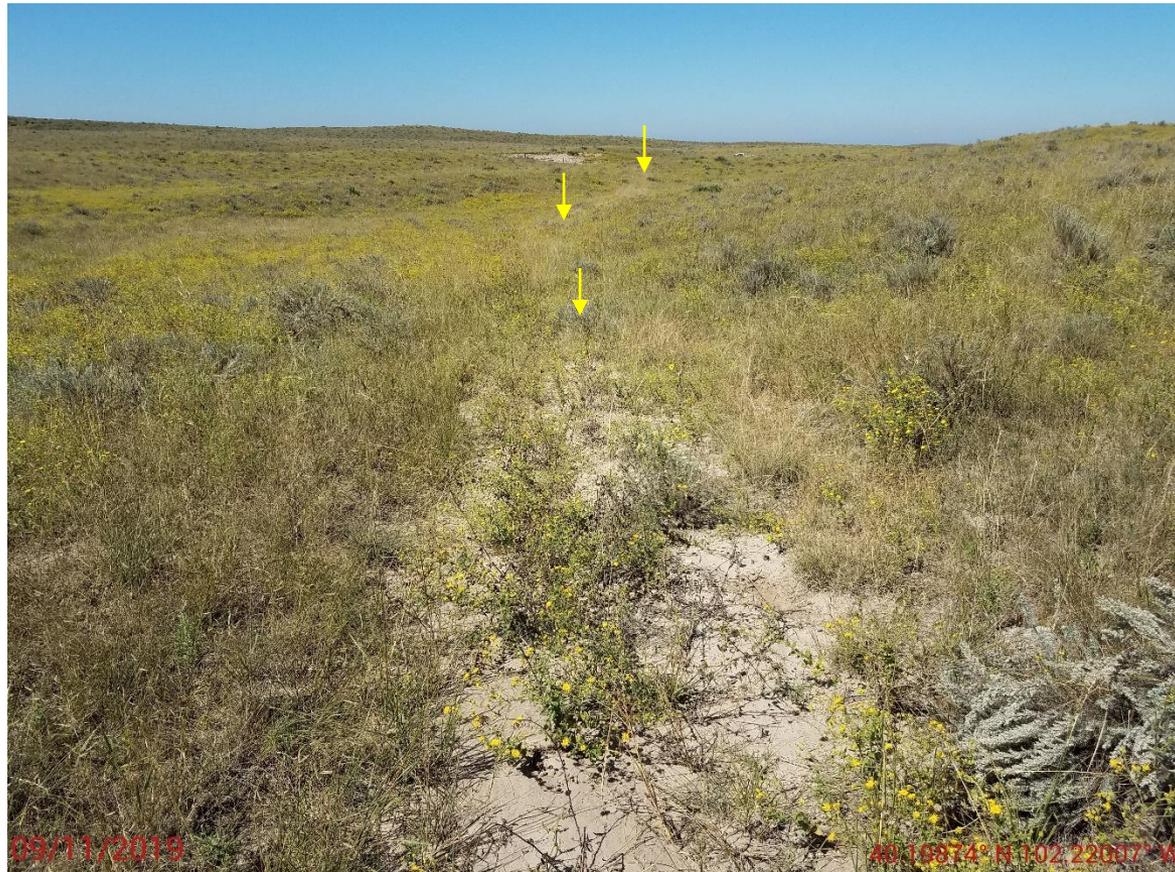
Photo 17: Photo taken from the access road, facing east. Photo shows the access road (yellow) to the location. Majority of access road has revegetated and was not immediately obvious in the field.

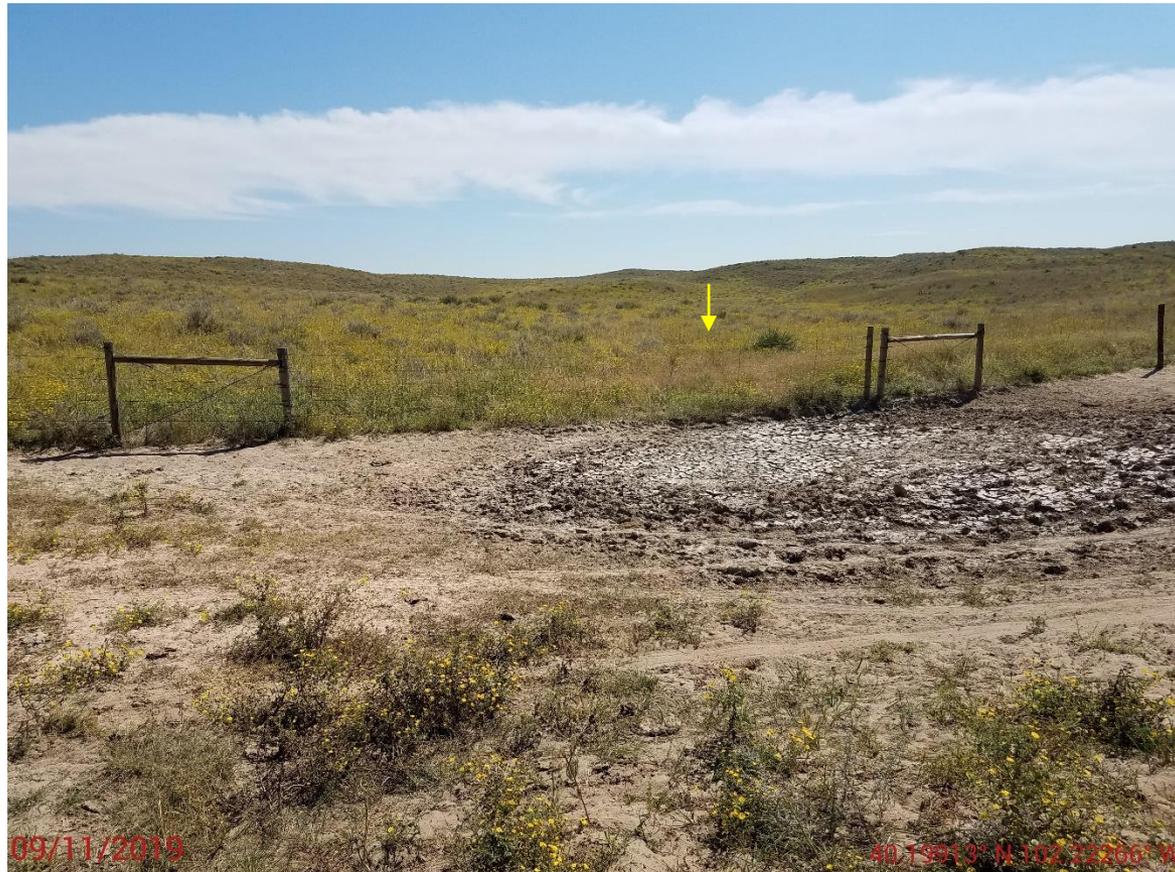
Photo 18: Photo shows area where the location's access road intersect with the main north/south access road.

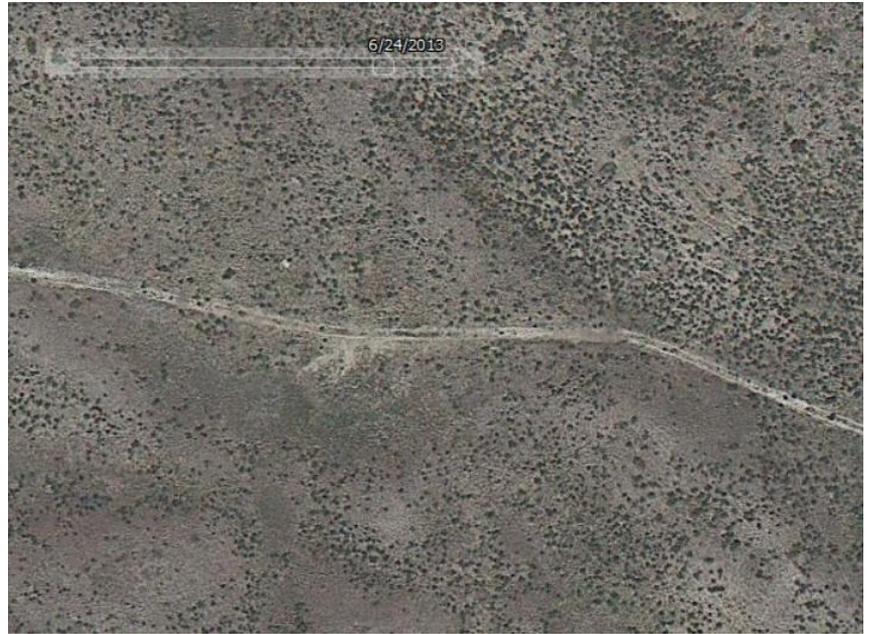
Photo 20: 2013 Google earth Aerial imagery. Photo shows access road, and area where erosion degradation was observed. See photo 15,16.
