FRAM OPERATING LLC – 10310

Location ID # 312681

API # 05-077-08780 Federal #12-2

Inspection Date : 9/10/2019

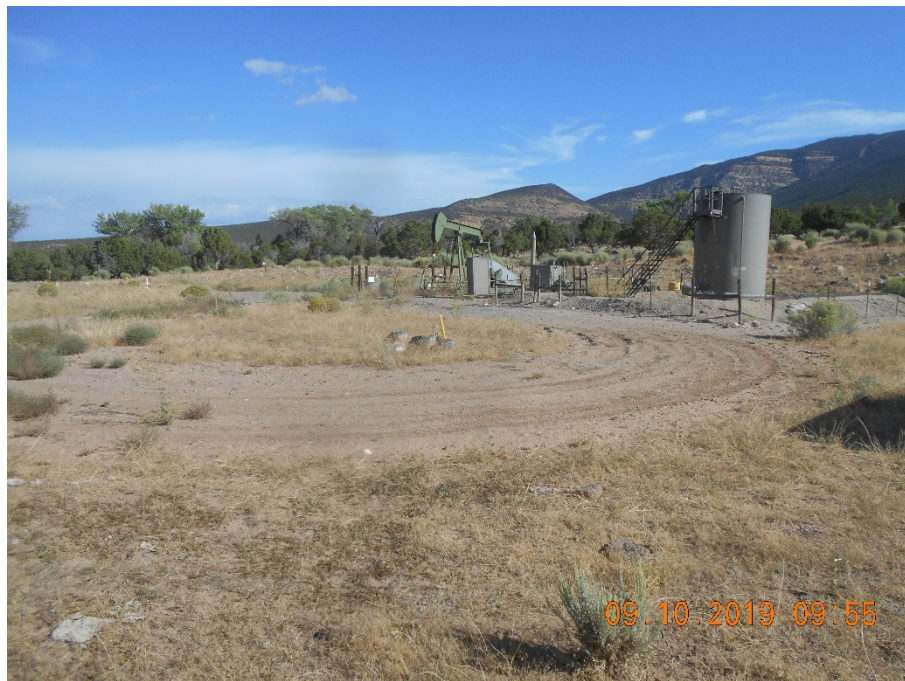
Location overview from SW corner looking NW.

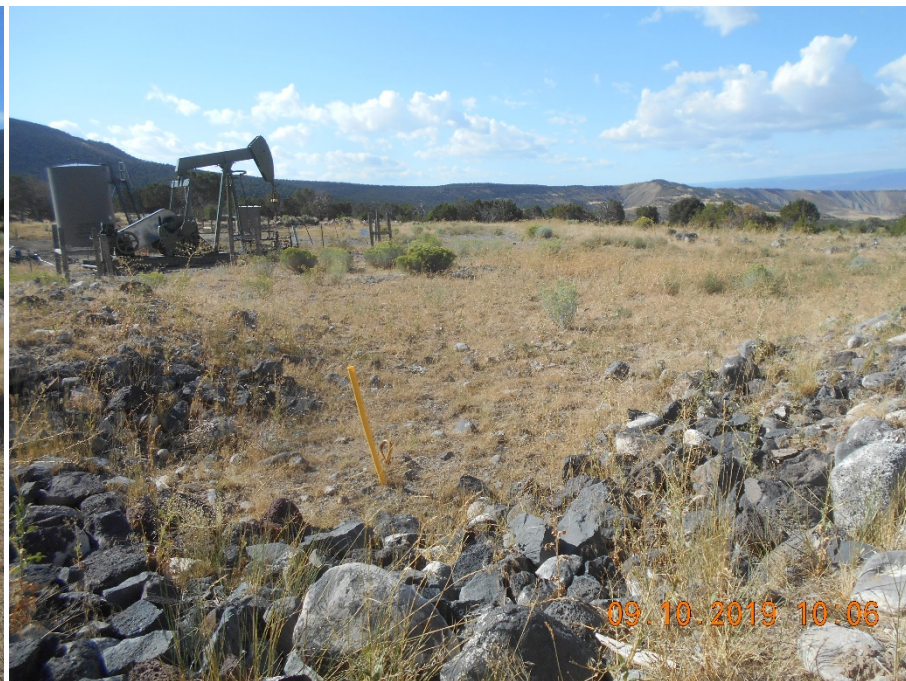
Location overview from NE corner looking SE.

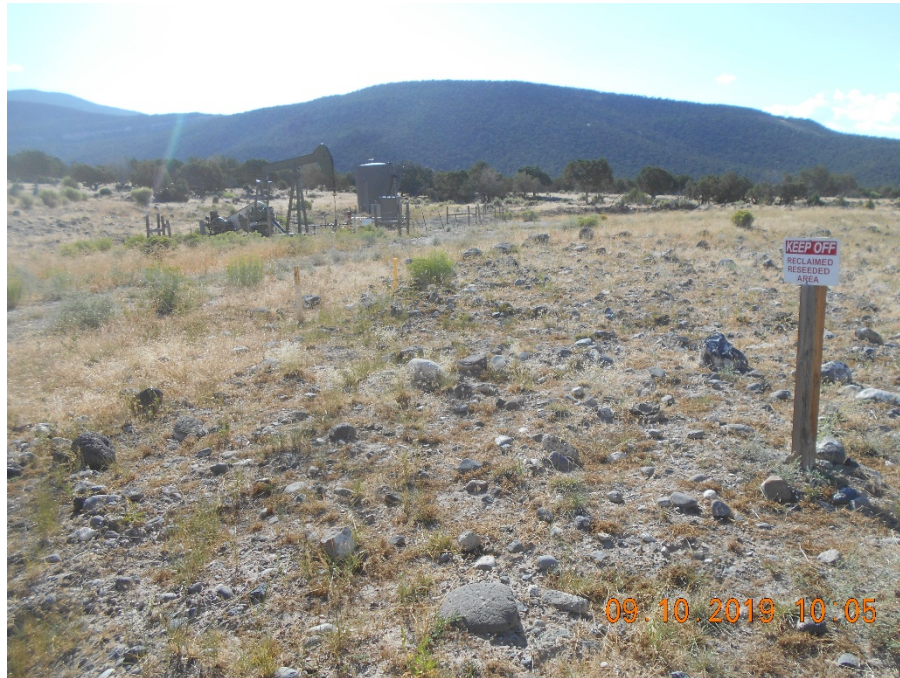
Location overview from NW corner looking SE.

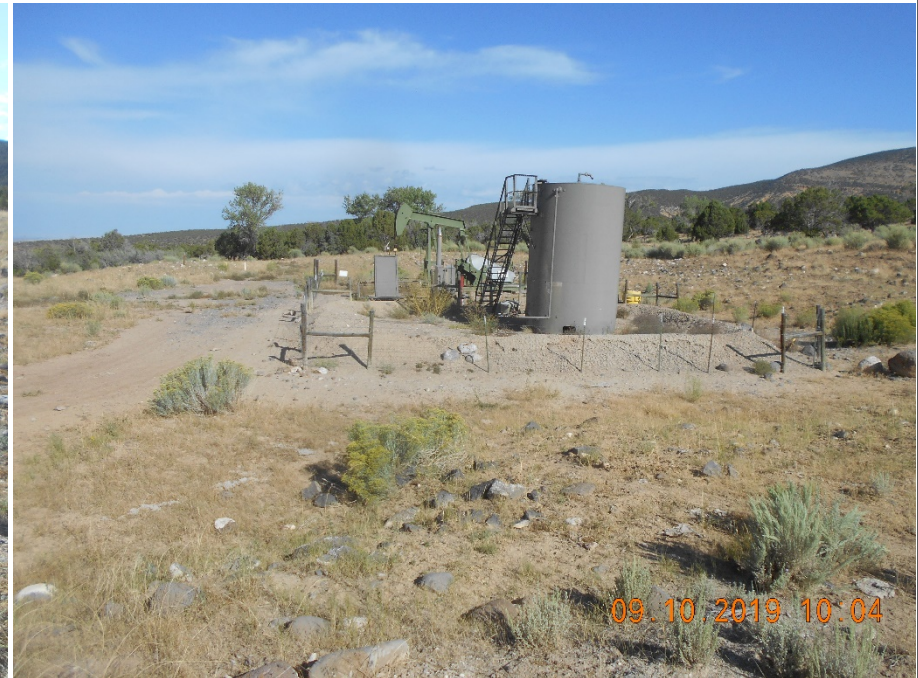
Location overview from SE corner looking NW.

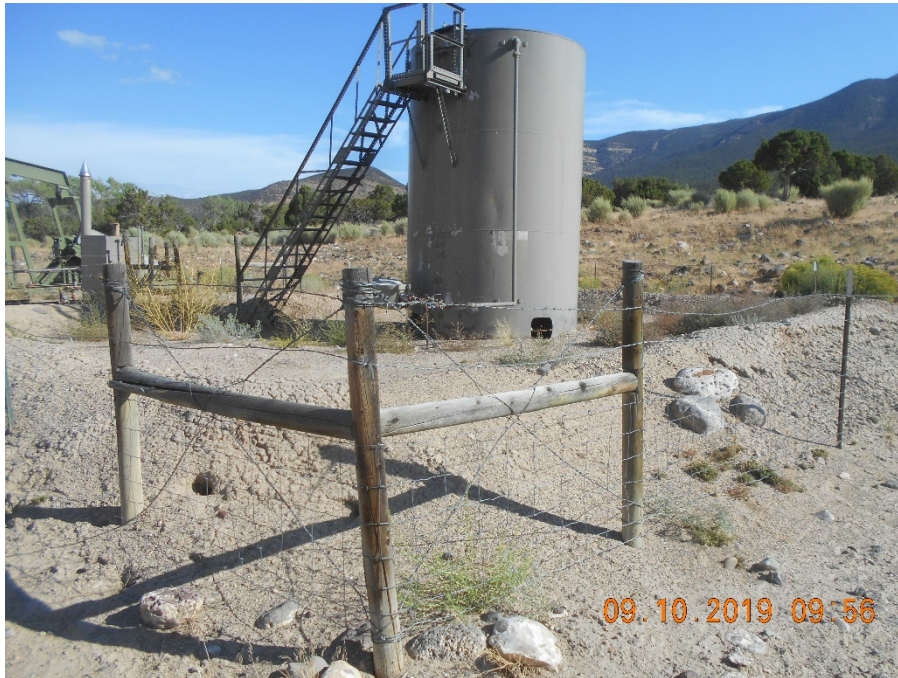
**Tank battery with earth berms and fence.
Looking N.**

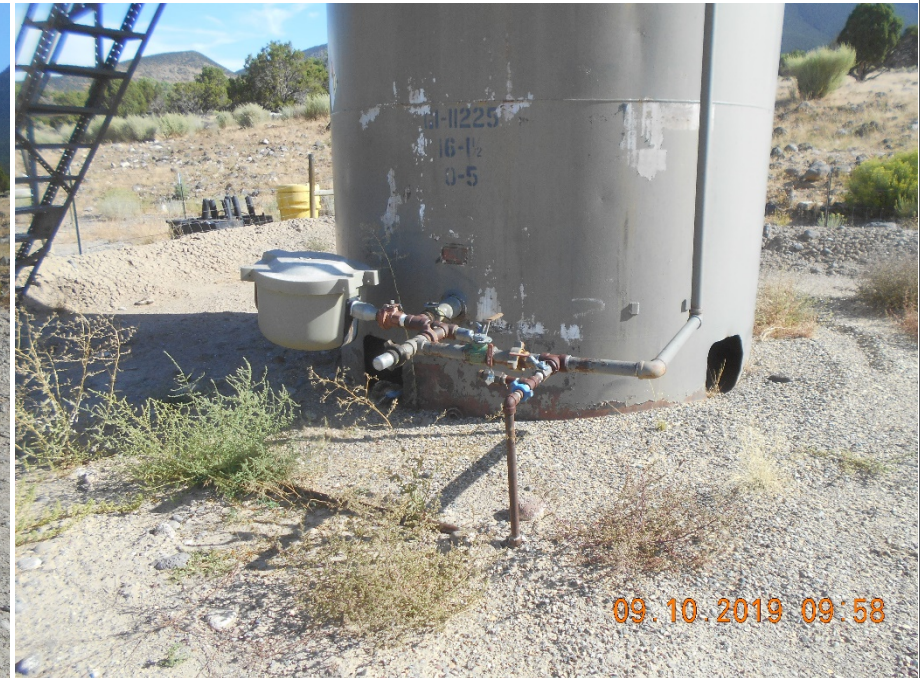
Weeds inside tank berms.

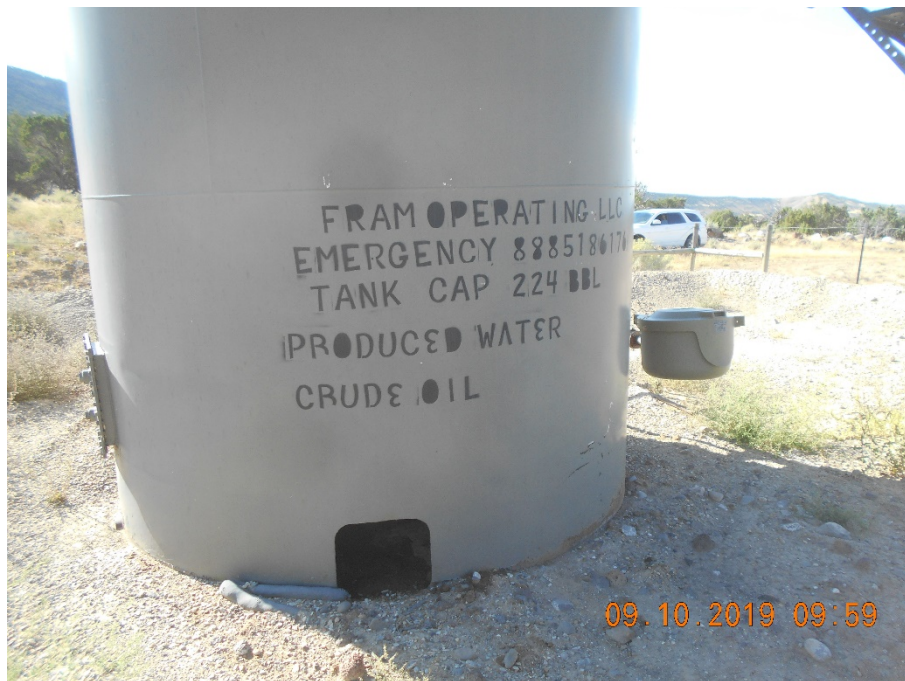
Tank battery label and inspection opening

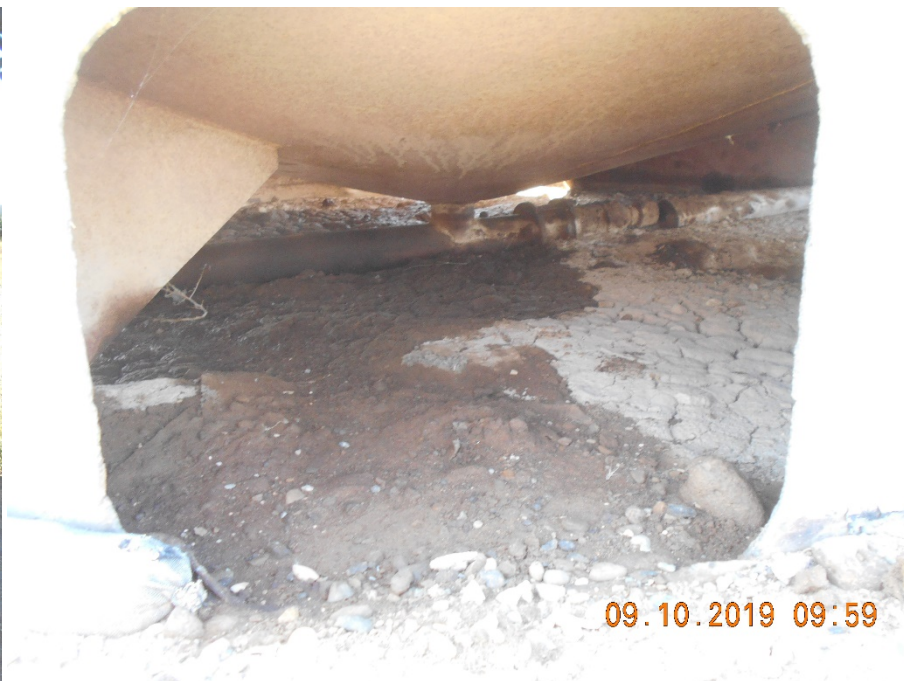
Leaking fitting at base of tank. Looking into inspection opening.

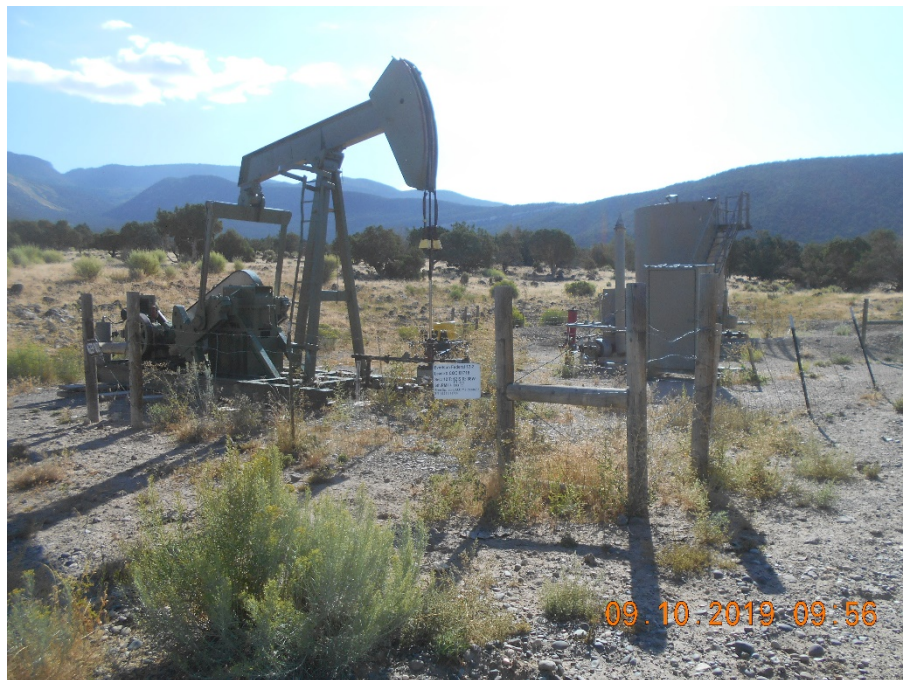
Wellhead with Pump jack, fencing and sign.

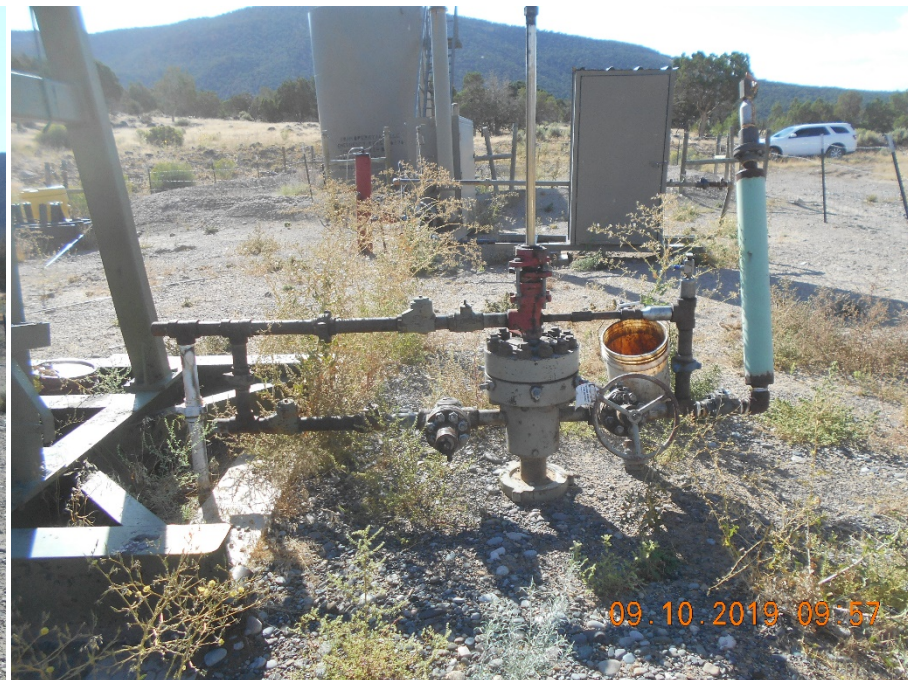
Wellhead configuration.

Weeds. Open top 5 gal bucket with oil hanging on wellhead.

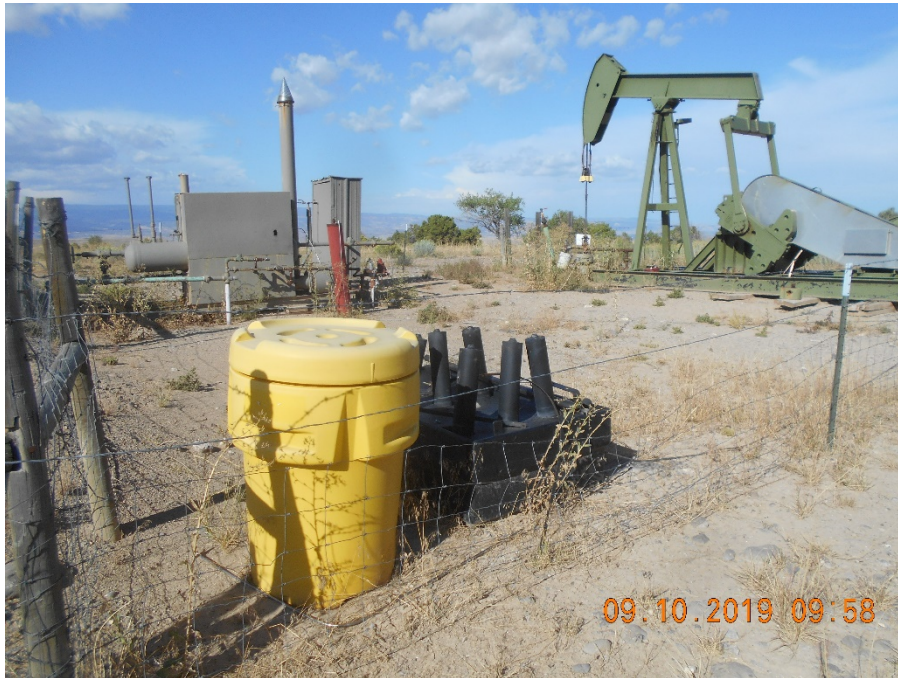
**Spill response kit and
chemical injector secondary containment (unused)**

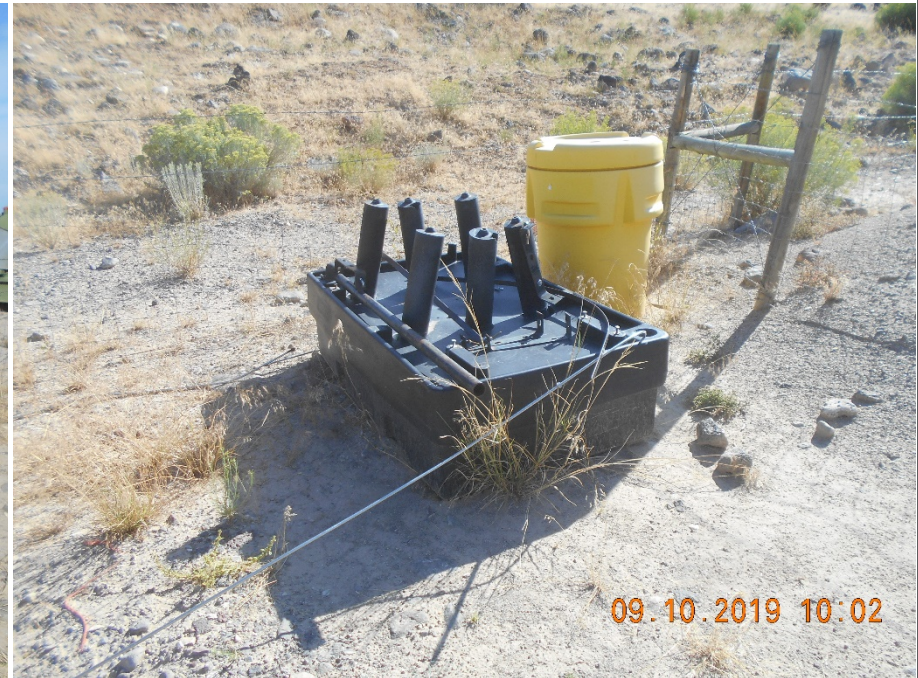
**Spill response kit and
chemical injector secondary containment (unused)**

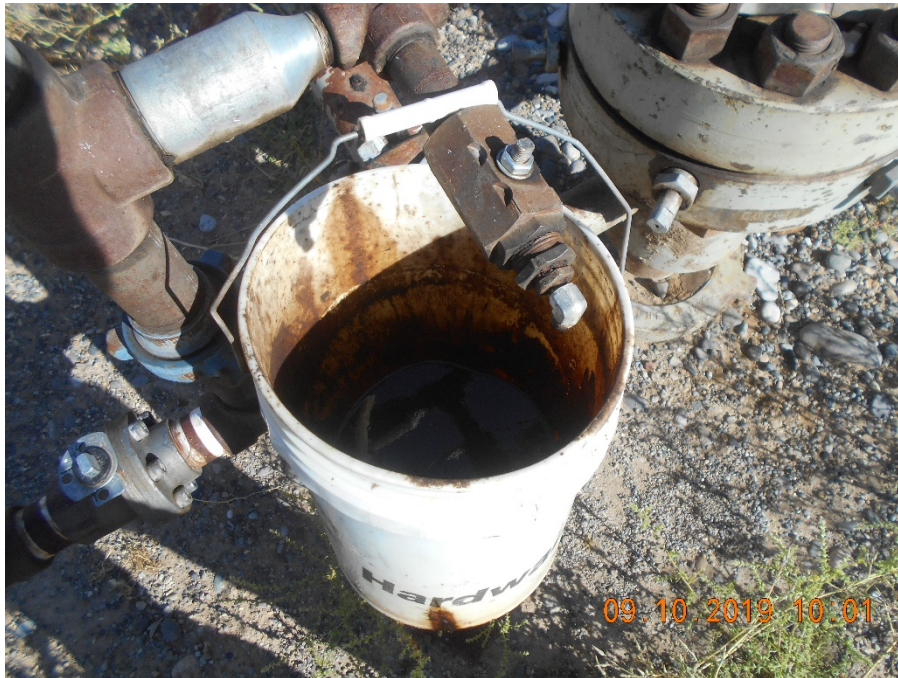
09.10.2019 10:01

Open top 5 gal bucket with oil hanging on wellhead.

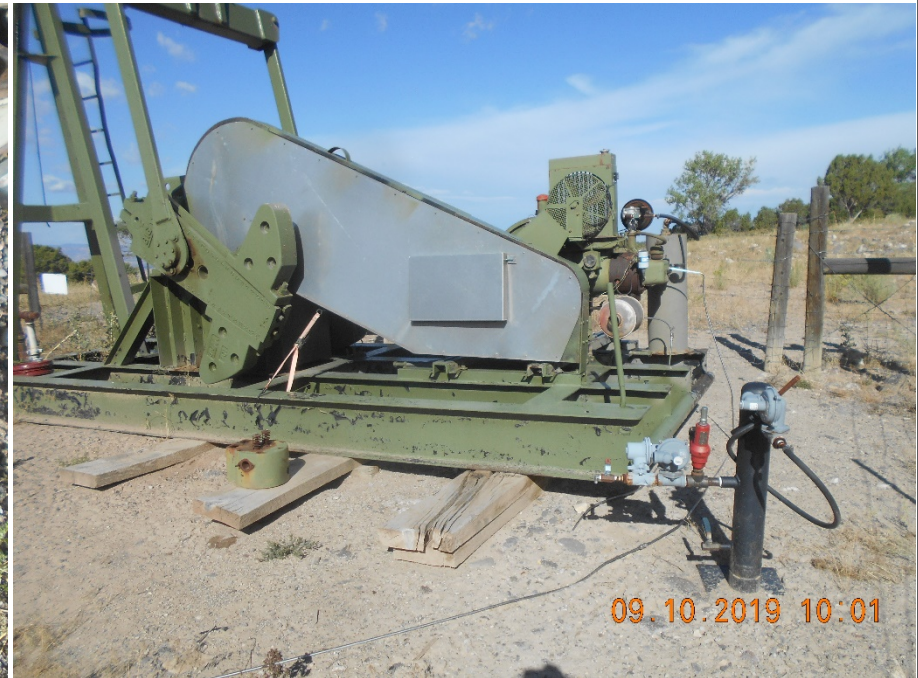
09.10.2019 10:01

Unused equipment and parts around pump jack.

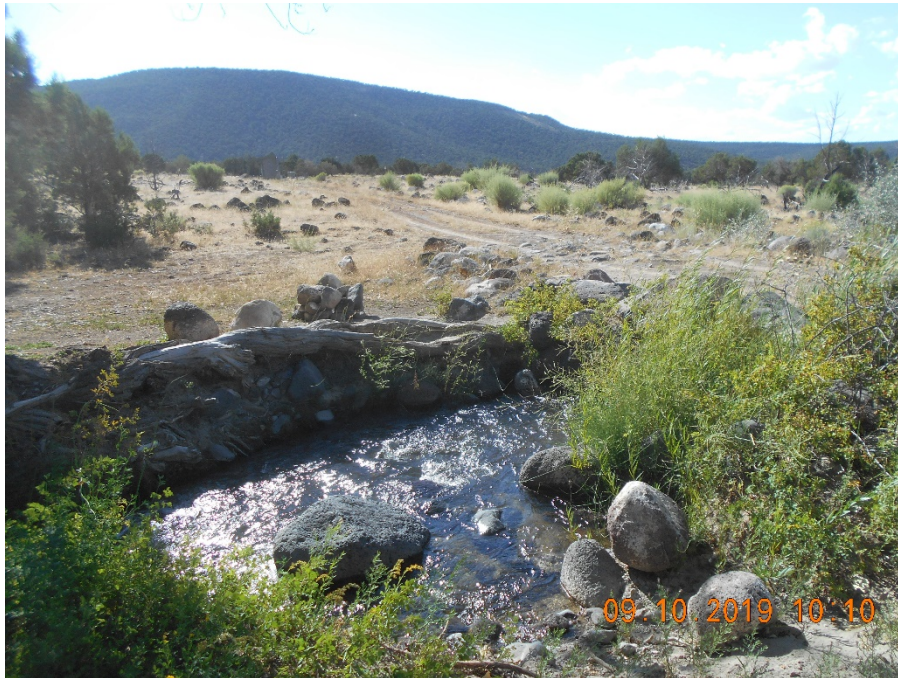
Access Road crossing irrigation ditch. Looking SE

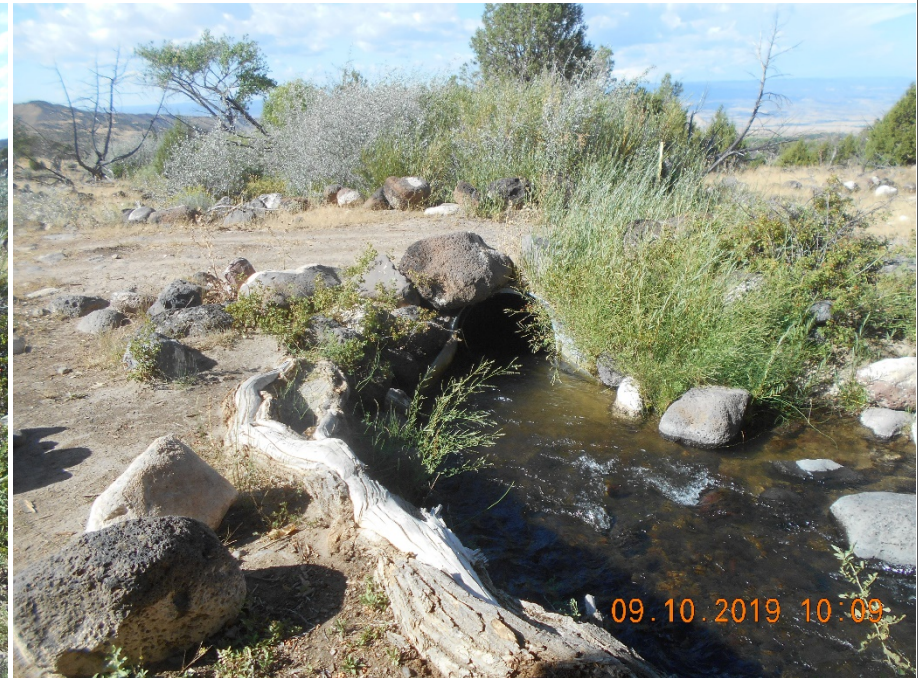
Culvert for irrigation ditch looking SW
