Inspection Photos

API: 05-071-07204

Operator: TIMBER CREEK OPERATING LLC

Inspection Date: 9/12/2019

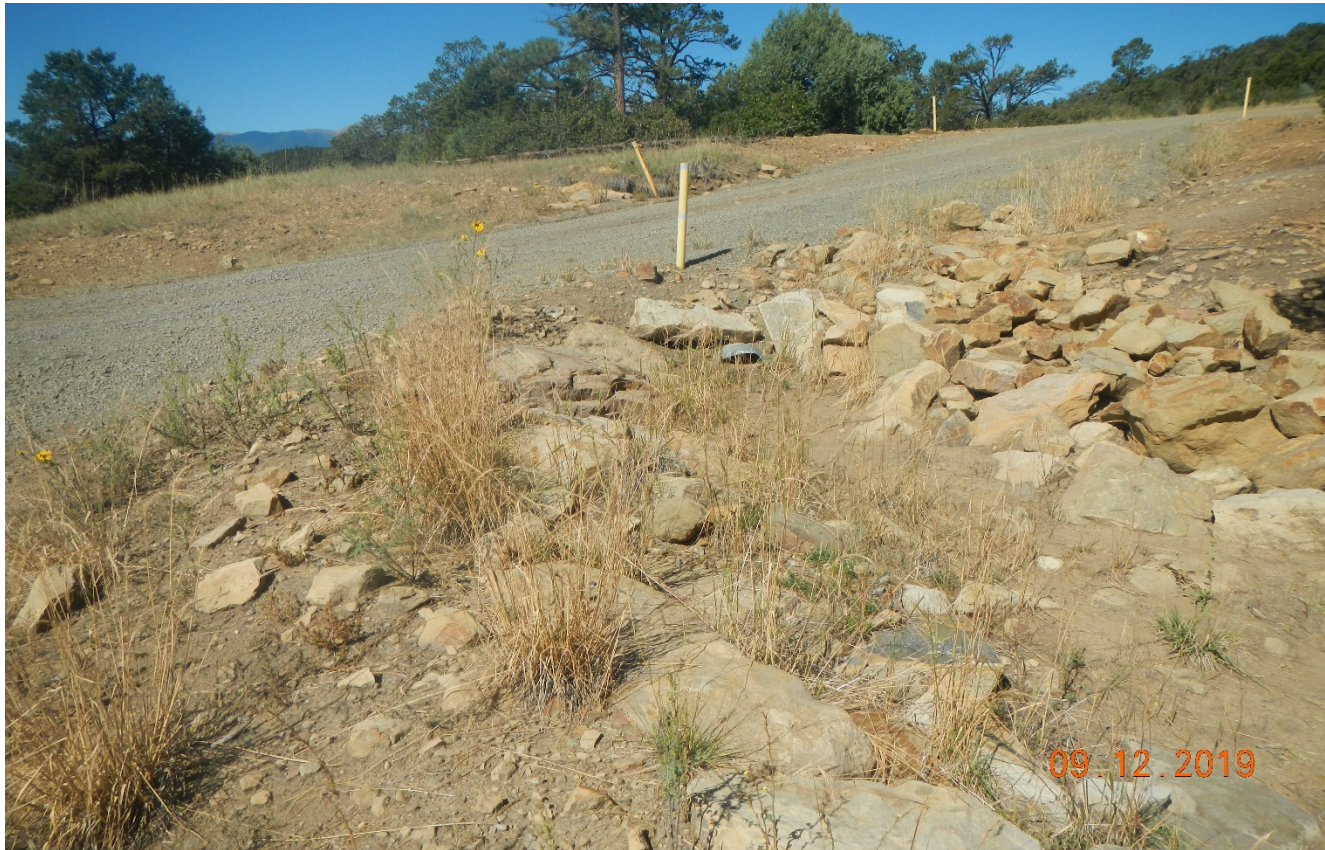
Photo 1. The culvert is full of sediment at outlet at the location. Corrective action of previous inspection not performed.

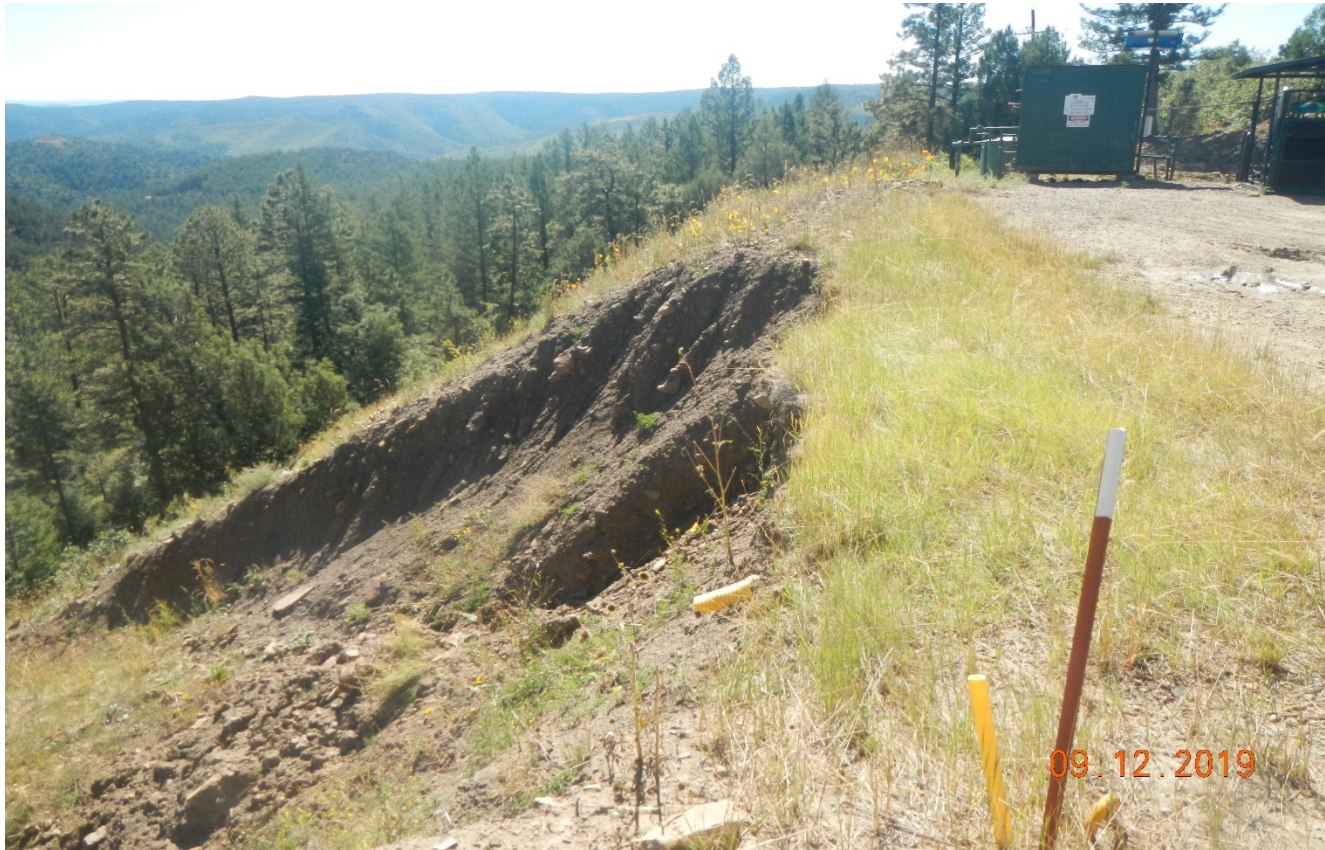
Photo 2. There is soil sloughing that occurred at the east side of the location. Corrective action of previous inspection not performed.

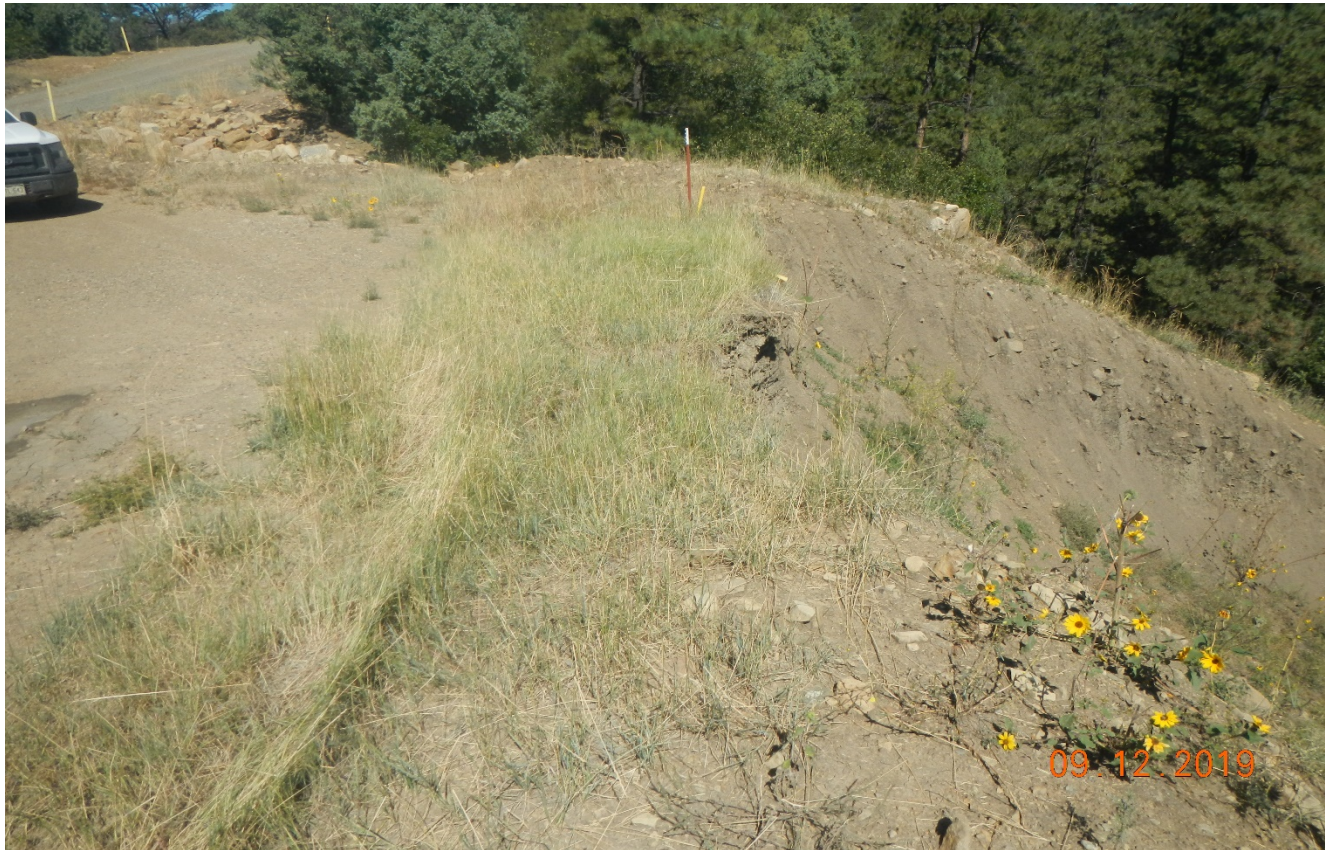
Photo 3. View of soil material that moved down the hill side.

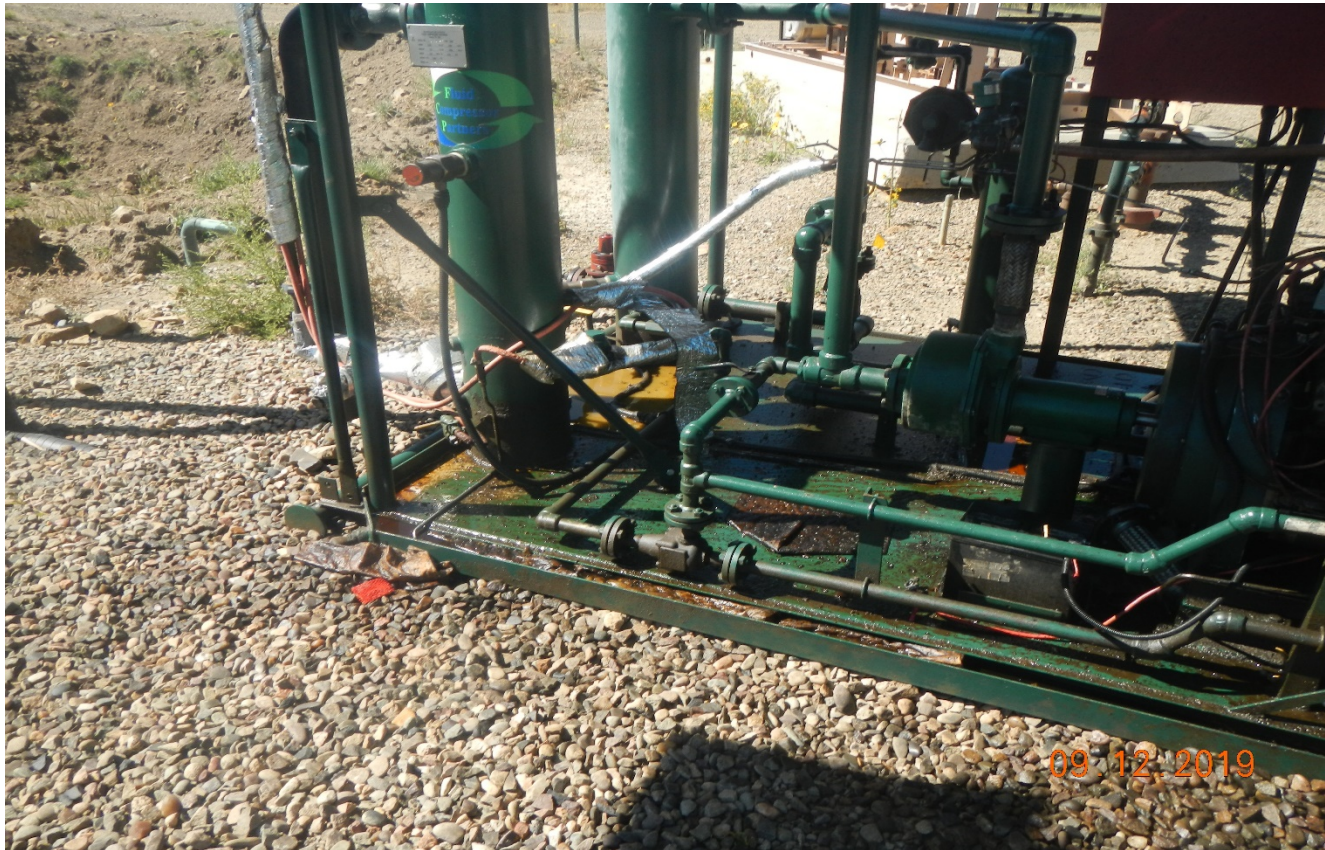
Photo 5. There is oily waste on the skid.
