Inspection Photos  
Location Name: Linnebur 6-13  
Location ID: 320469

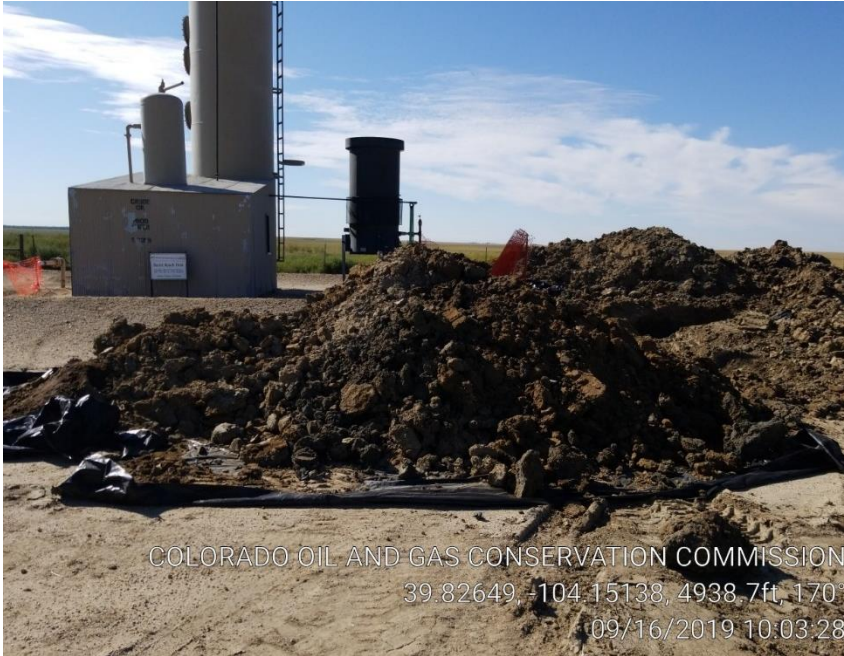
Pic 1 excavation of spill site

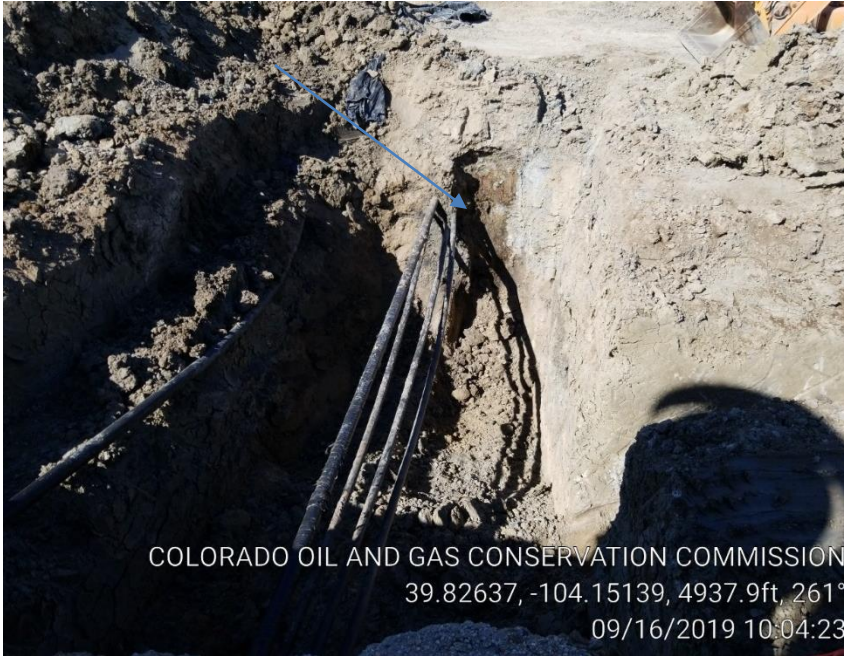
**Pic 3 excavation**

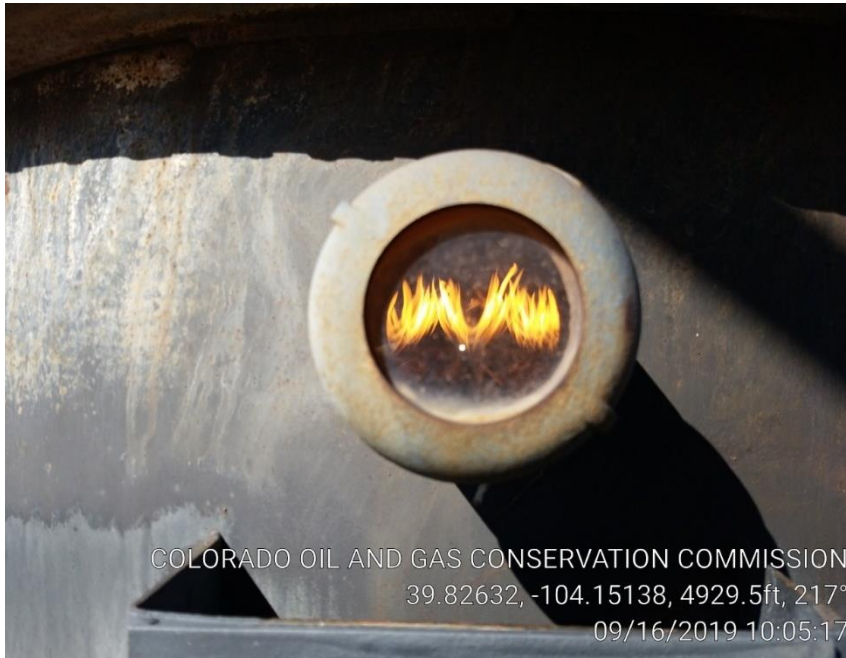
**Pic 5 flame inside ECD**

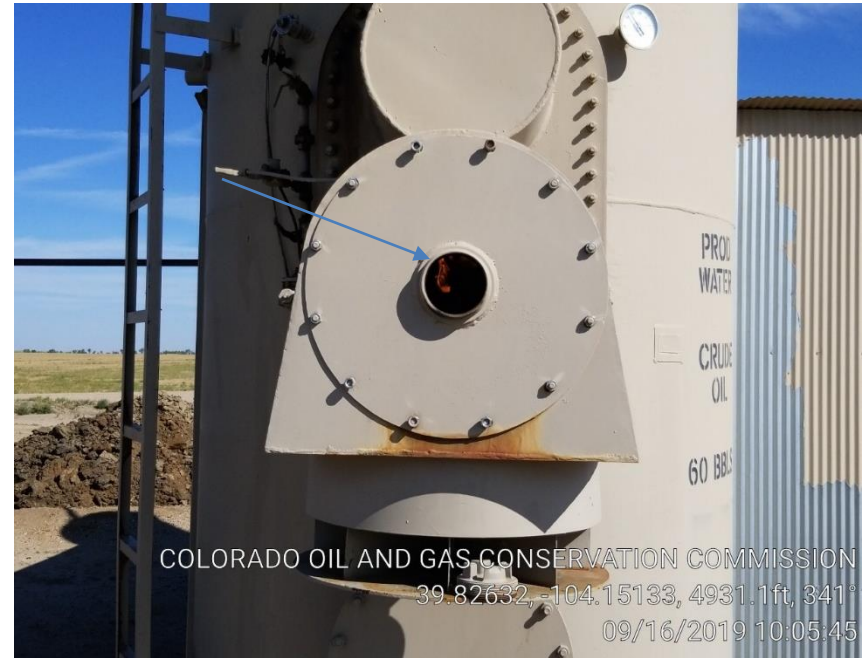
**Pic 6 no cover on Vertical Heated Separator flange**

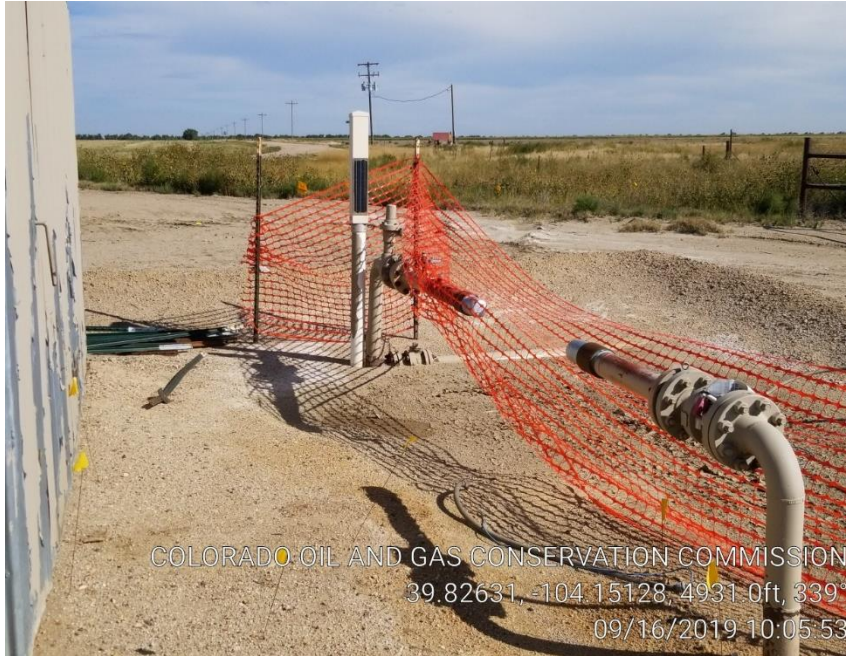
**Pic 7 Midstream equipment de-commissioned**

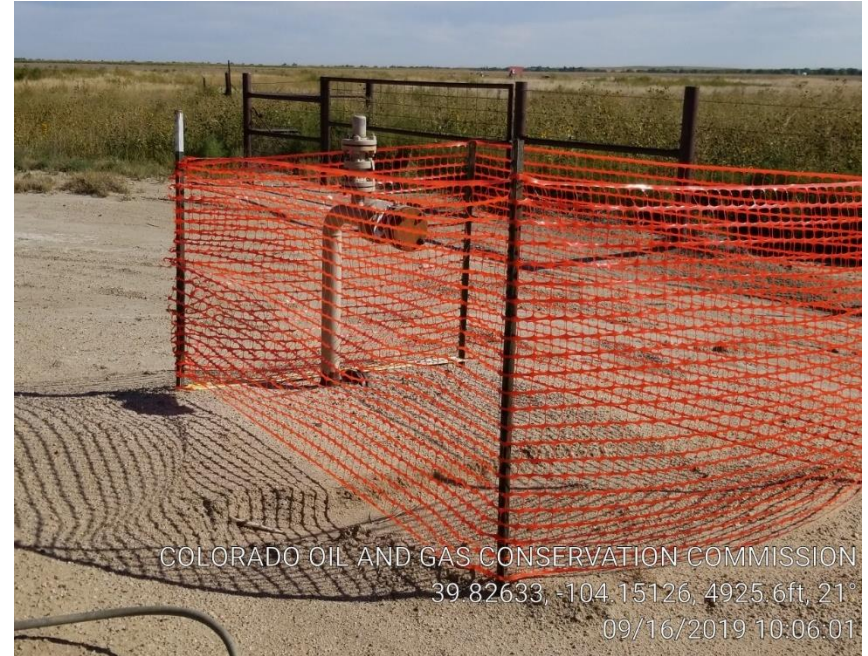
**Pic 8 Midstream equipment de-commissioned**

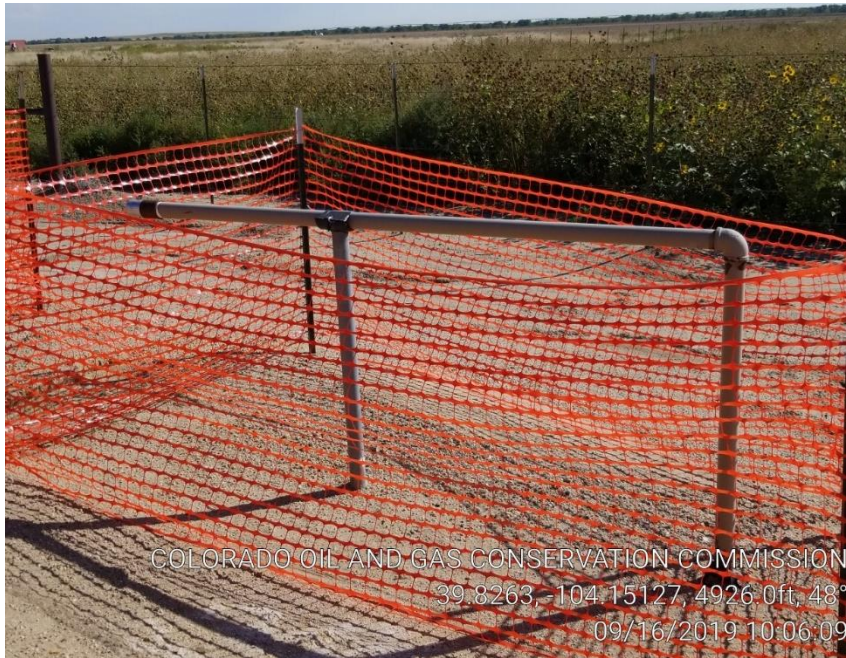
**Pic 9 Midstream equipment de-commissioned**

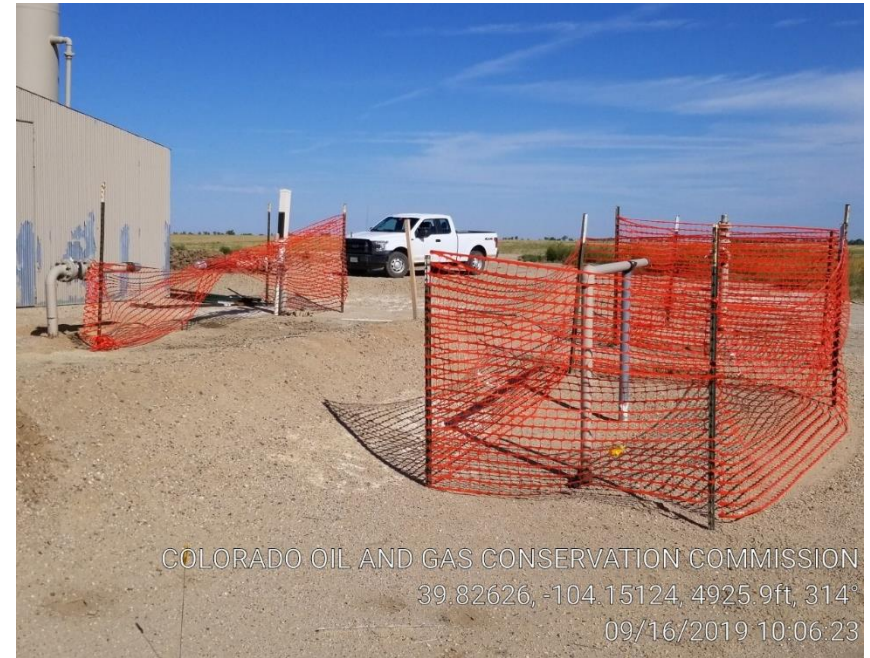
**Pic 10 Midstream equipment de-commissioned**

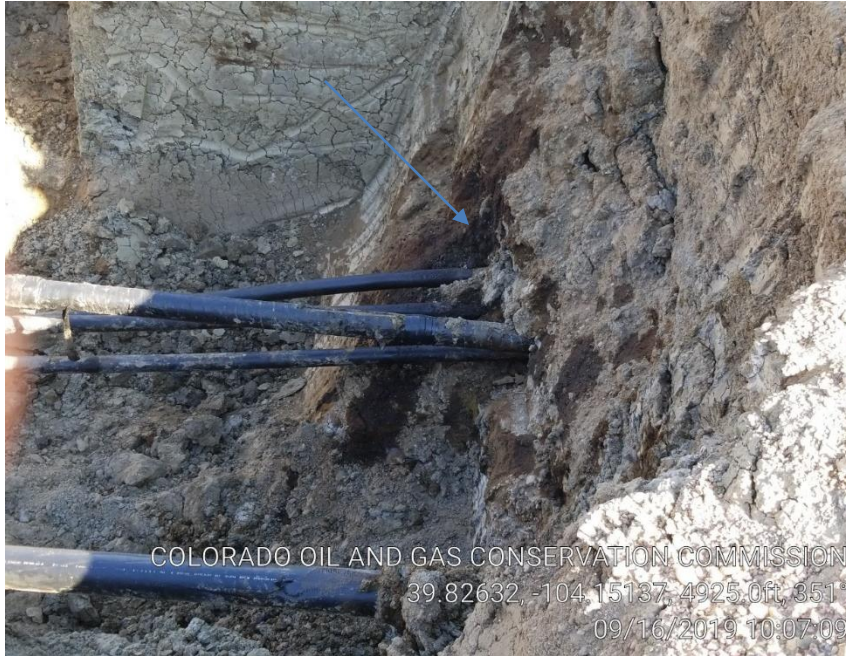
**Pic 11 excavation**

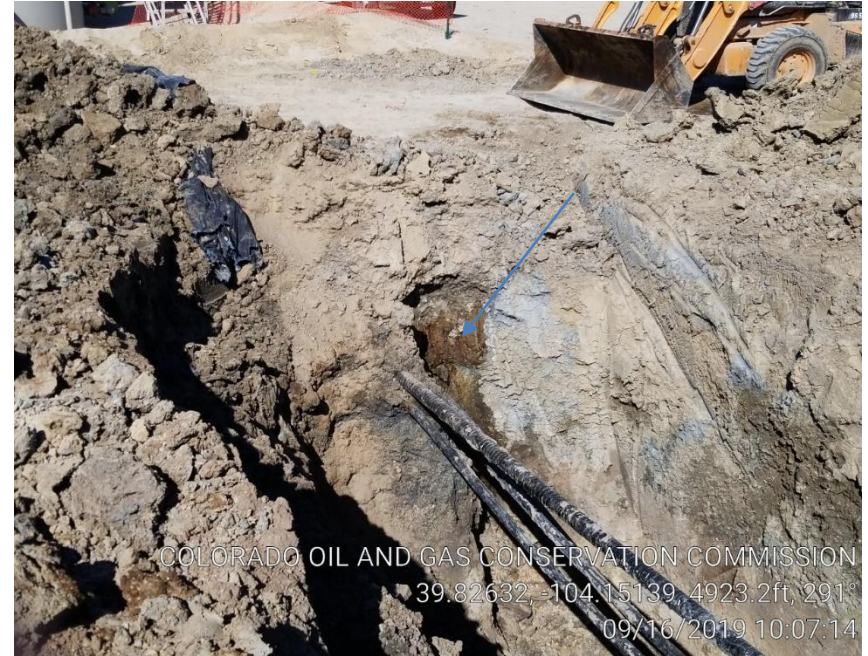
**Pic 12 excavation**

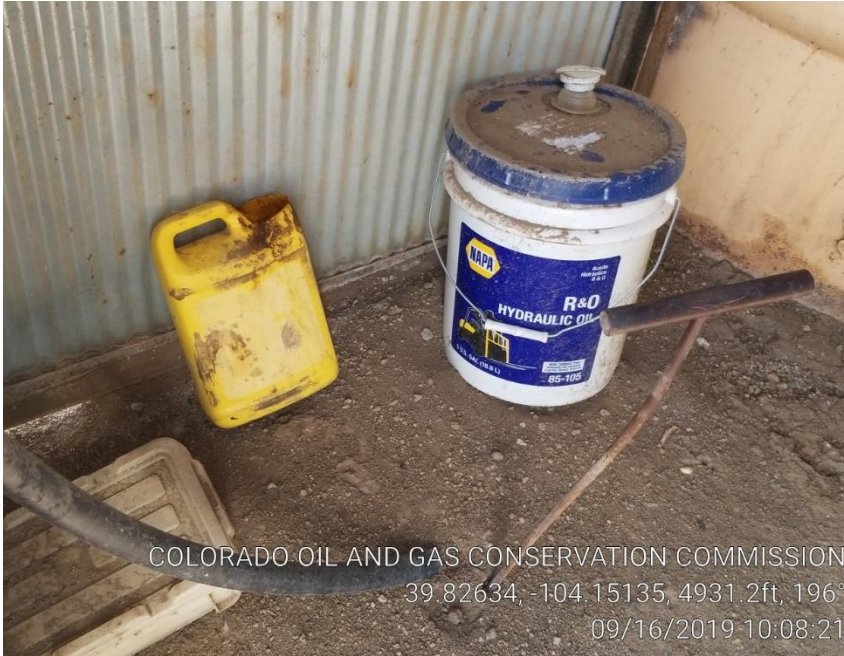
**Pic 13 Trash inside separator house**

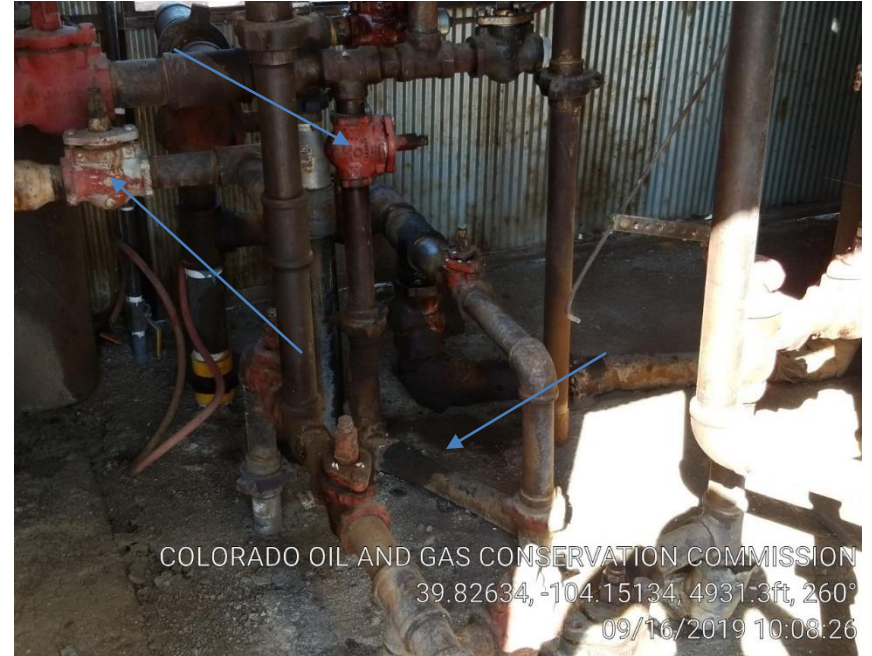
**Pic 14 mechanical conditions/stained soil in separator house**

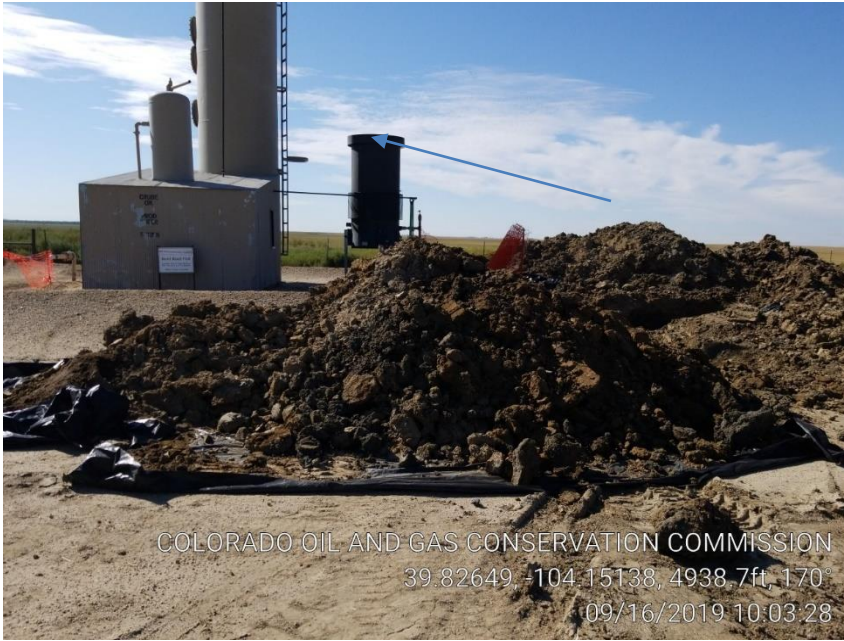
**Pic 15 ECD, and vertical separator.**

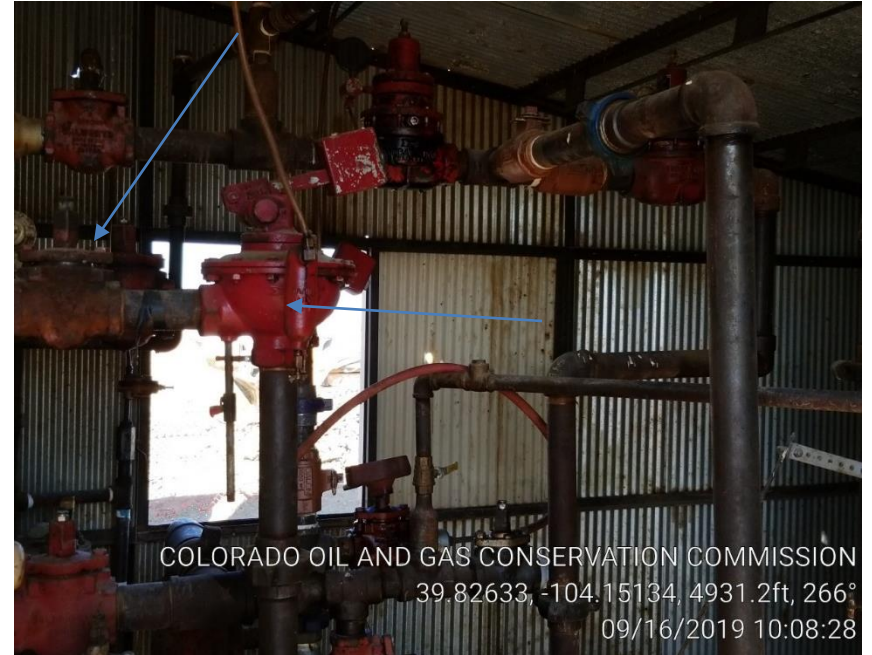
**Pic 16 mechanical conditions in separator house**
