Stormwater Inspection Report

Operator:	Laramie Energy, LLC
Project:	Cascade Creek Project Area
Location:	CC 697-16D & CC 604-41-32 Pads
Date:	Monday, September 9, 2019
Weather:	Clear, Light Wind, Hi 84°, Lo 51°

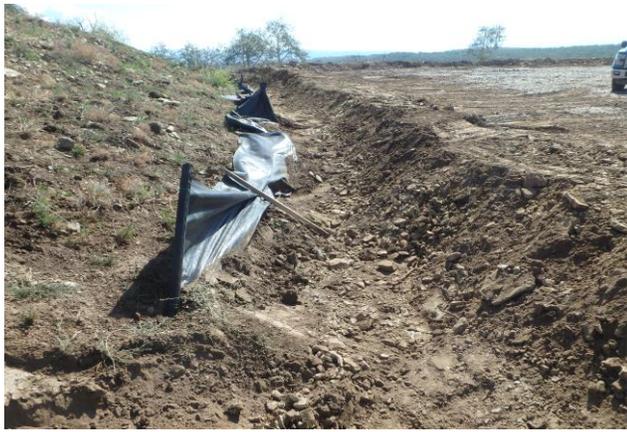
Photo 1

Silt Fence Damaged while Installing Earthen Berm

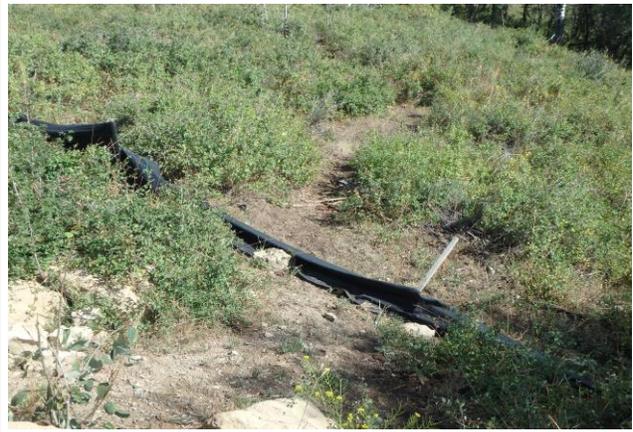
Photo 2

Silt Fence Damaged at Cattle Trail Crossing
