Stormwater Inspection Report

Operator:	Laramie Energy, LLC
Project:	Cascade Creek Project Area
Location:	CC 604-41-32 Pad & Access Road
Date:	Tuesday, September 10, 2019
Weather:	Scattered T-Storms, Windy, Hi 80°, Lo 59°

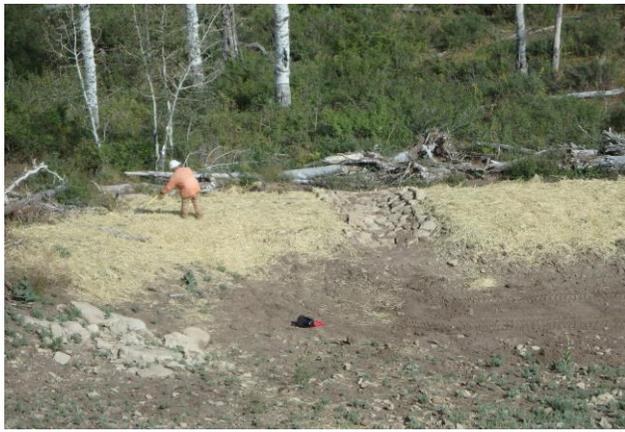
Photo 1

Hand Crimping Mulch on North Outlet

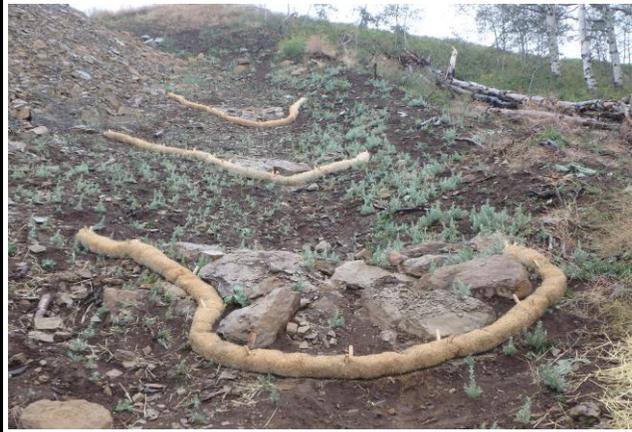
Photo 2

Wattle Installed below Existing Rock Checks

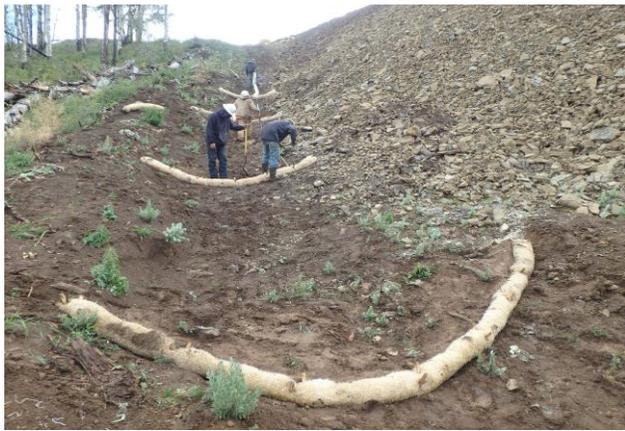
Photo 3

Installing Wattle in Channel on North Side of Pad

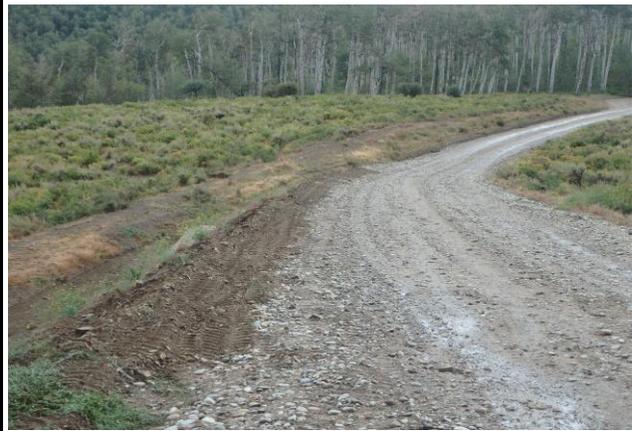
Photo 4

Berm Installed along Access Road
