**Inspection Photos**  
**Operator: BP America**  
**Location/API #: 067-07009**  
**Date: 9-6-2019**

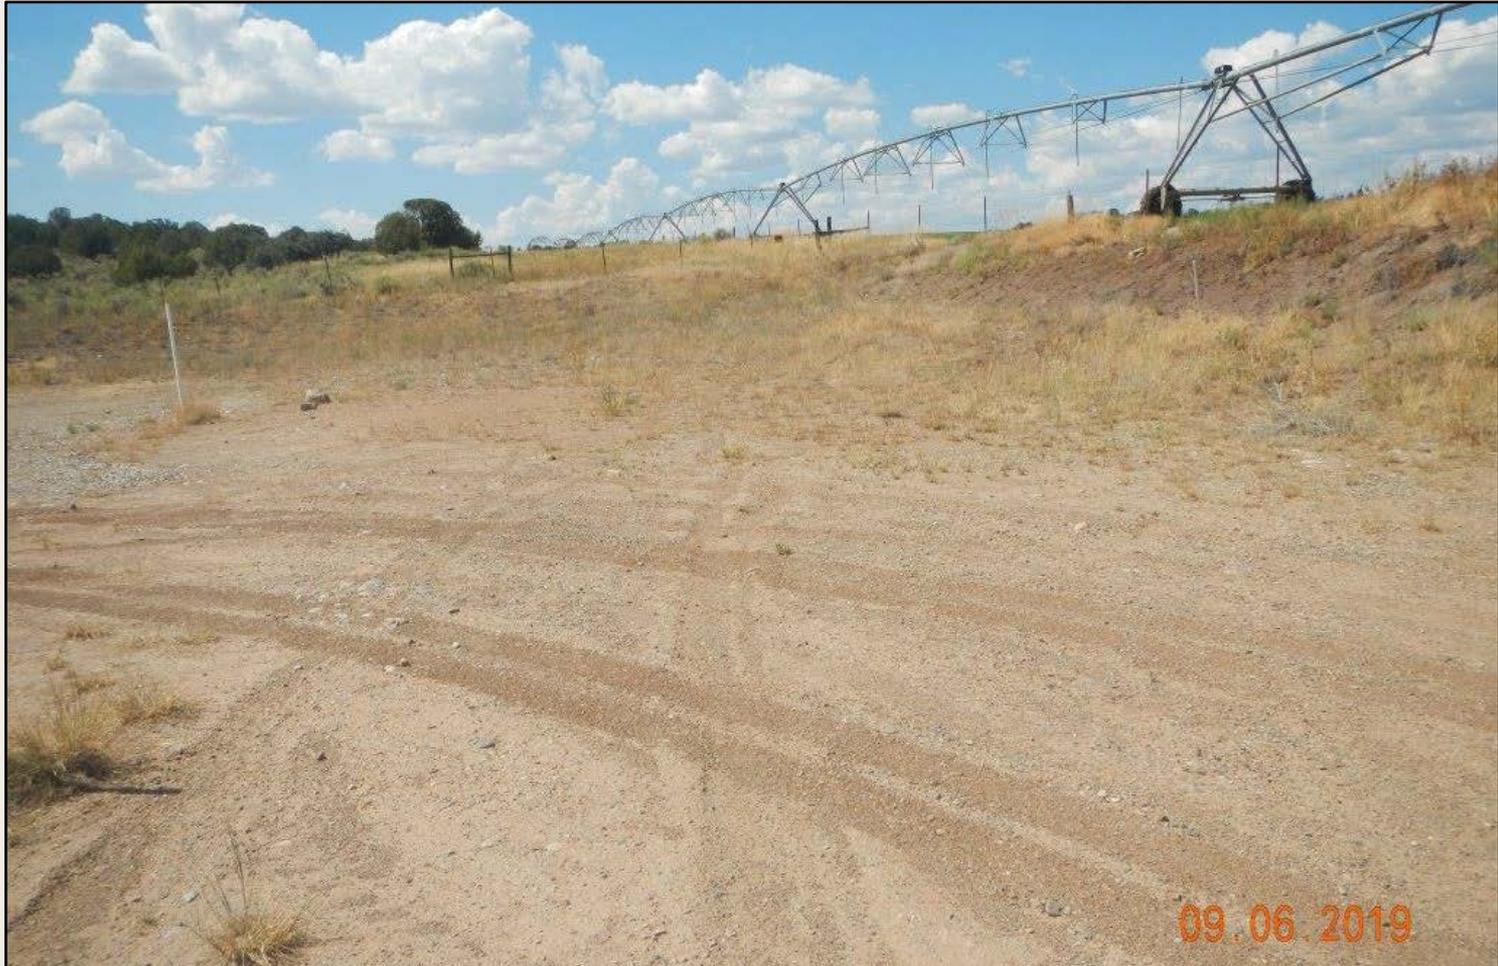
Photo 1. View of northern portion of project area fencing material identified during May inspection is no longer present.

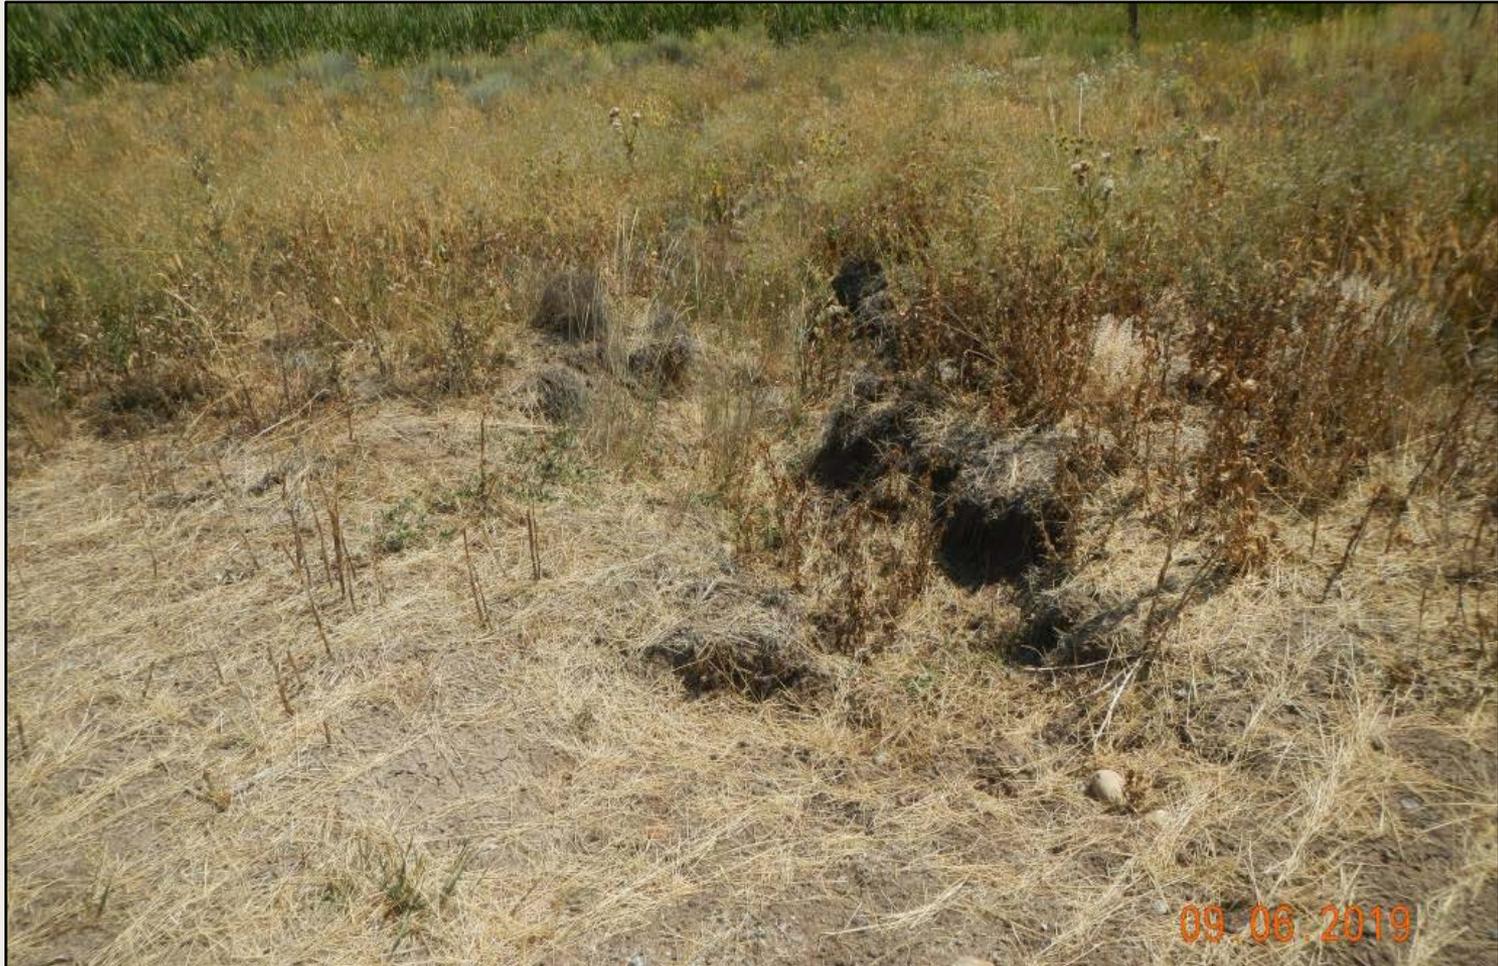
Photo 2. View of area along edge of revegetation area, where Canada thistles are treated.

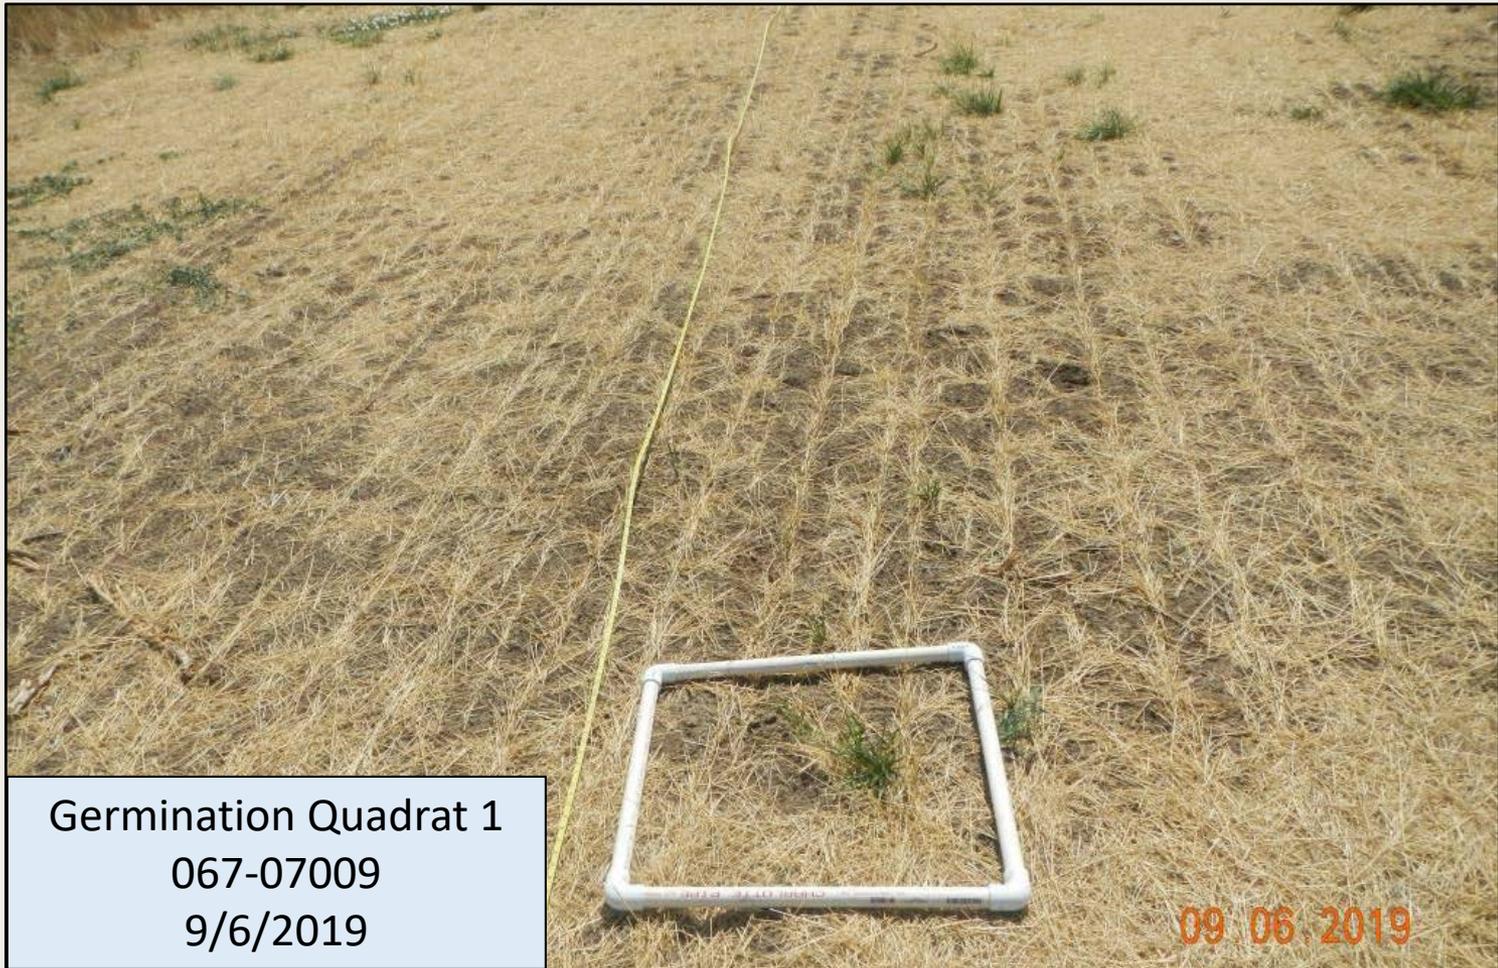
Photo 3. View of the beginning of germination transect within the eastern project area. Revegetation is recently conducted. Straw mulch is crimped into the soil, and some germination observed, although sparse.

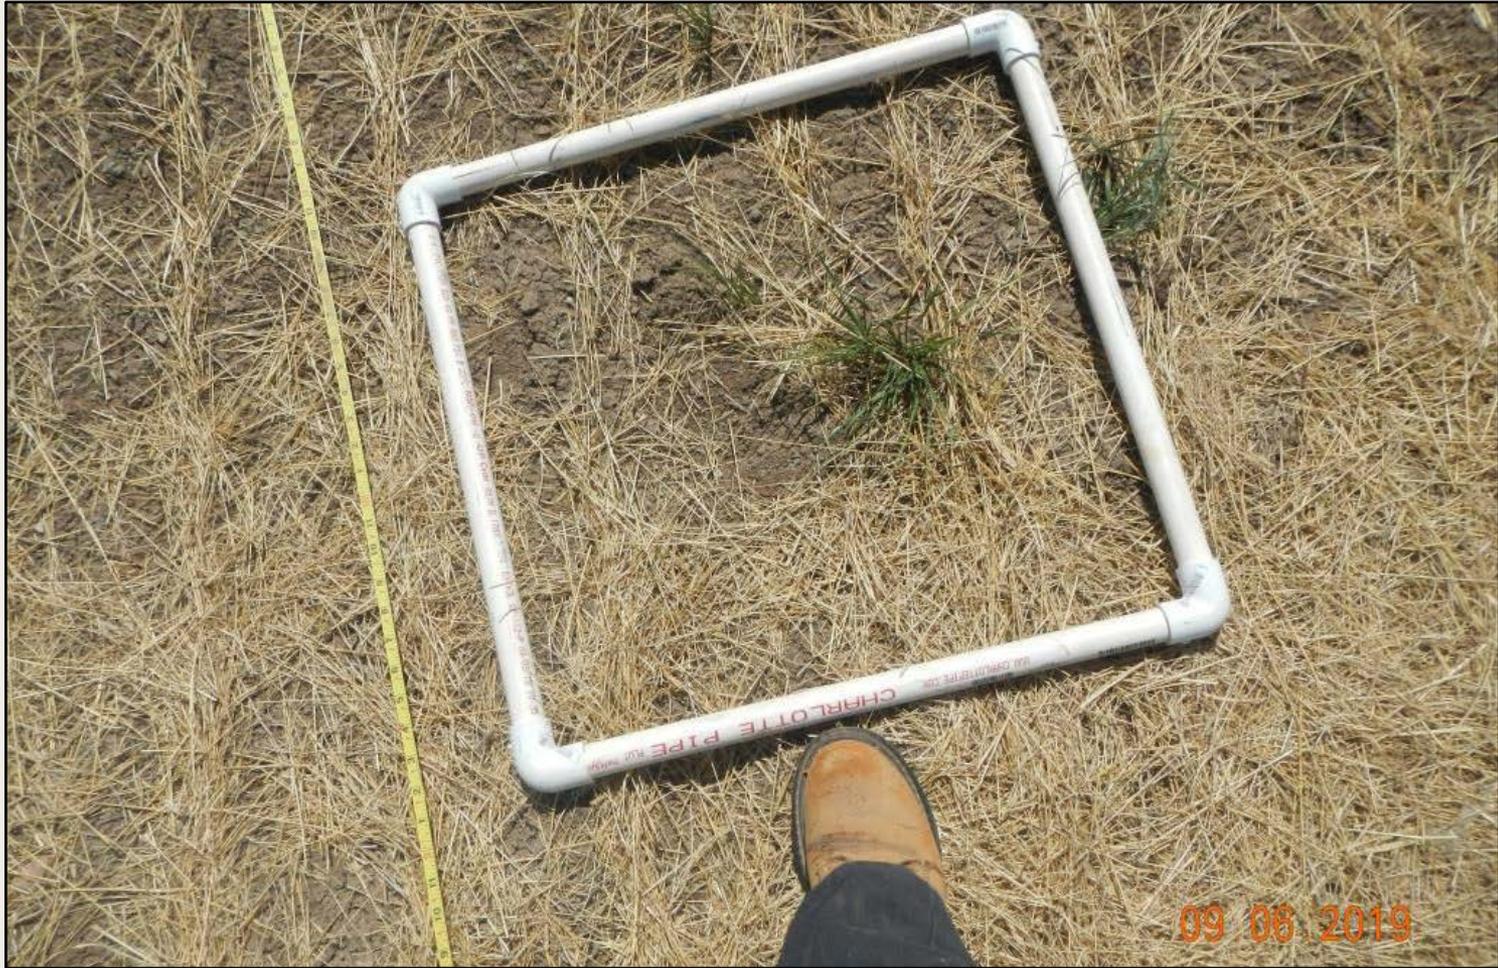
Photo 4. Birsdeye view of vegetation within germination quadrat.
