Inspection Photos

API: 05-071-06397

Operator: TIMBER CREEK OPERATING LLC

Inspection Date: 9/16/2019

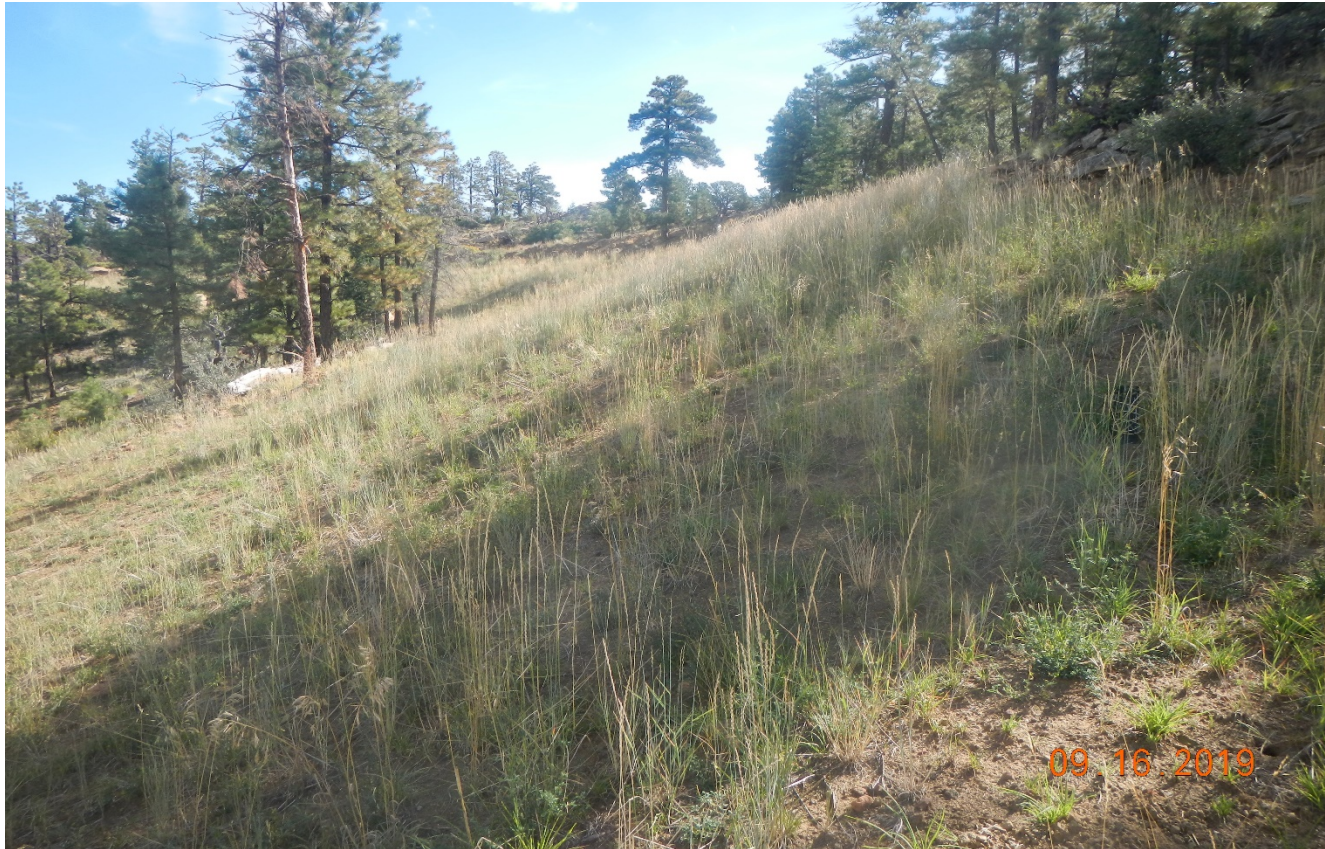
Photo 1. Facing northeast along the reclaimed access road. Perennial vegetation is well established.

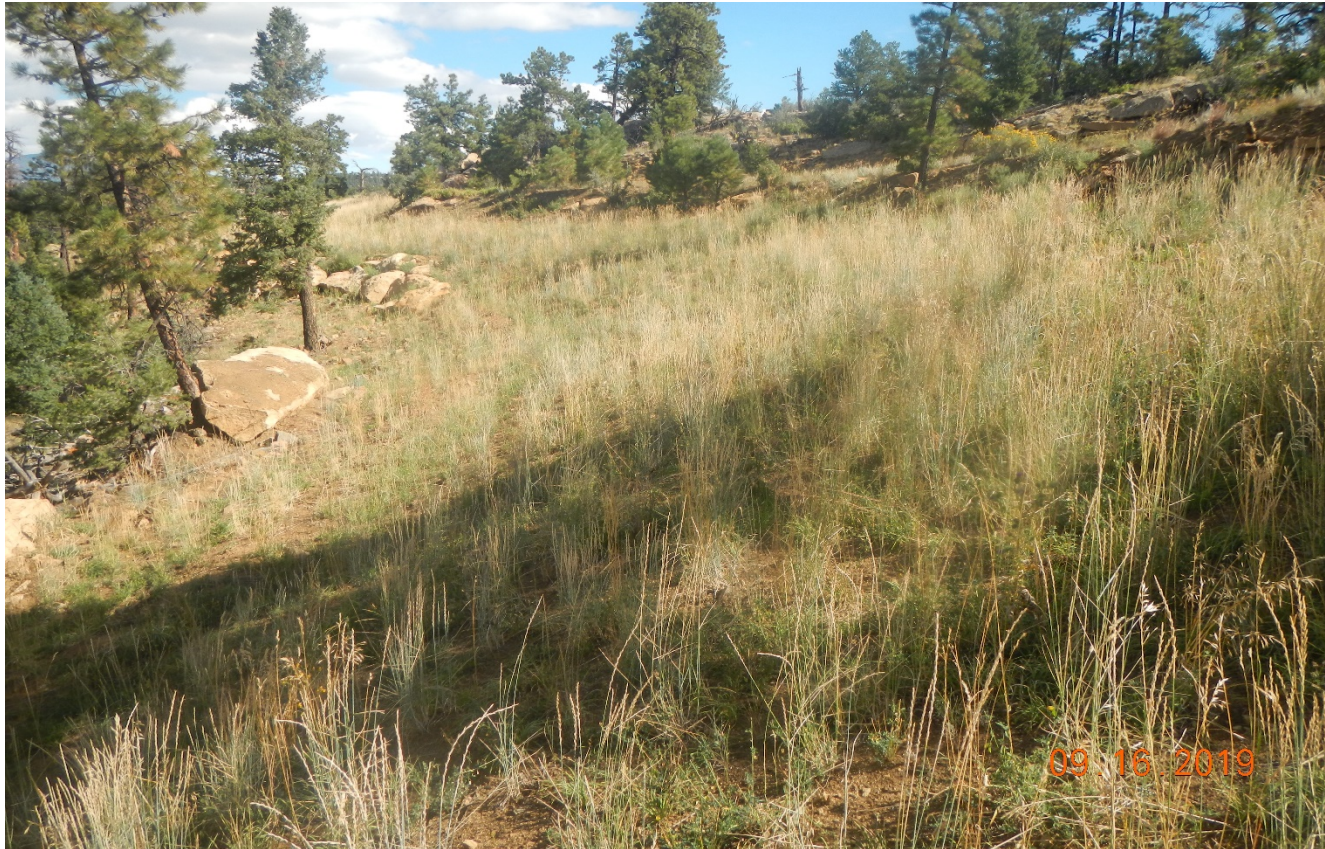
Photo 2. Facing northeast along the reclaimed access road. Perennial vegetation is well established.

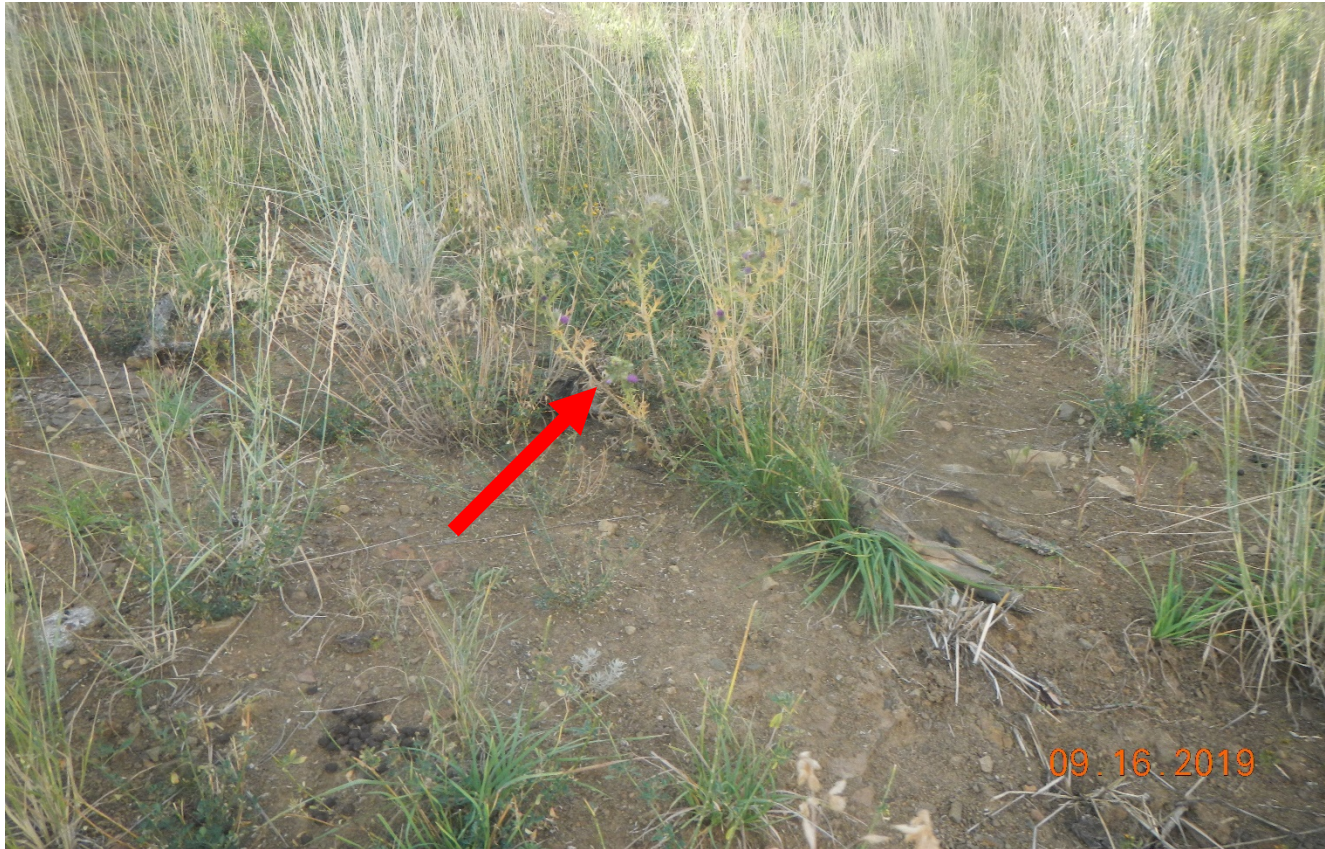
Photo 3. There were several noxious weeds (Bull thistle).

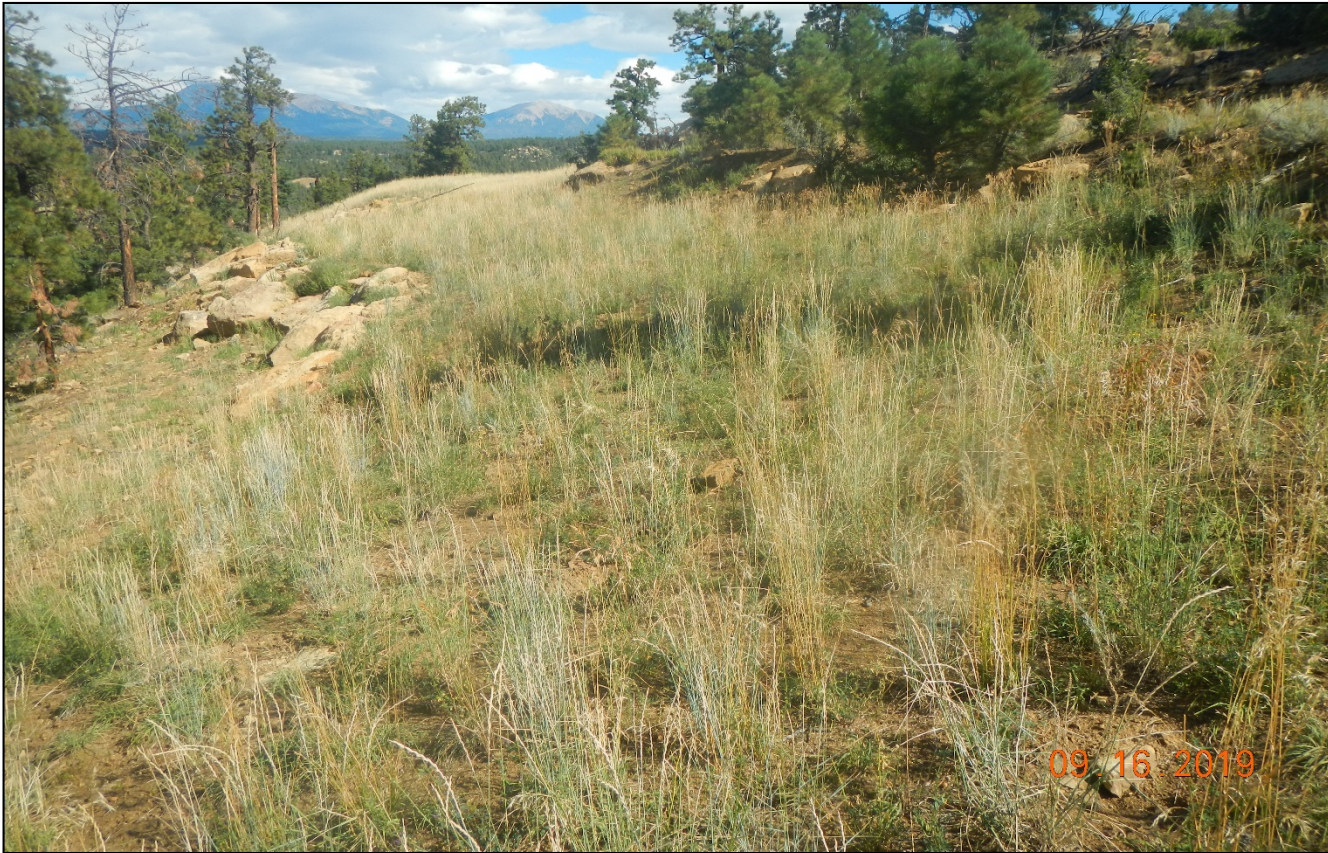
Photo 4. Facing north along the reclaimed access road. Perennial vegetation is well established.

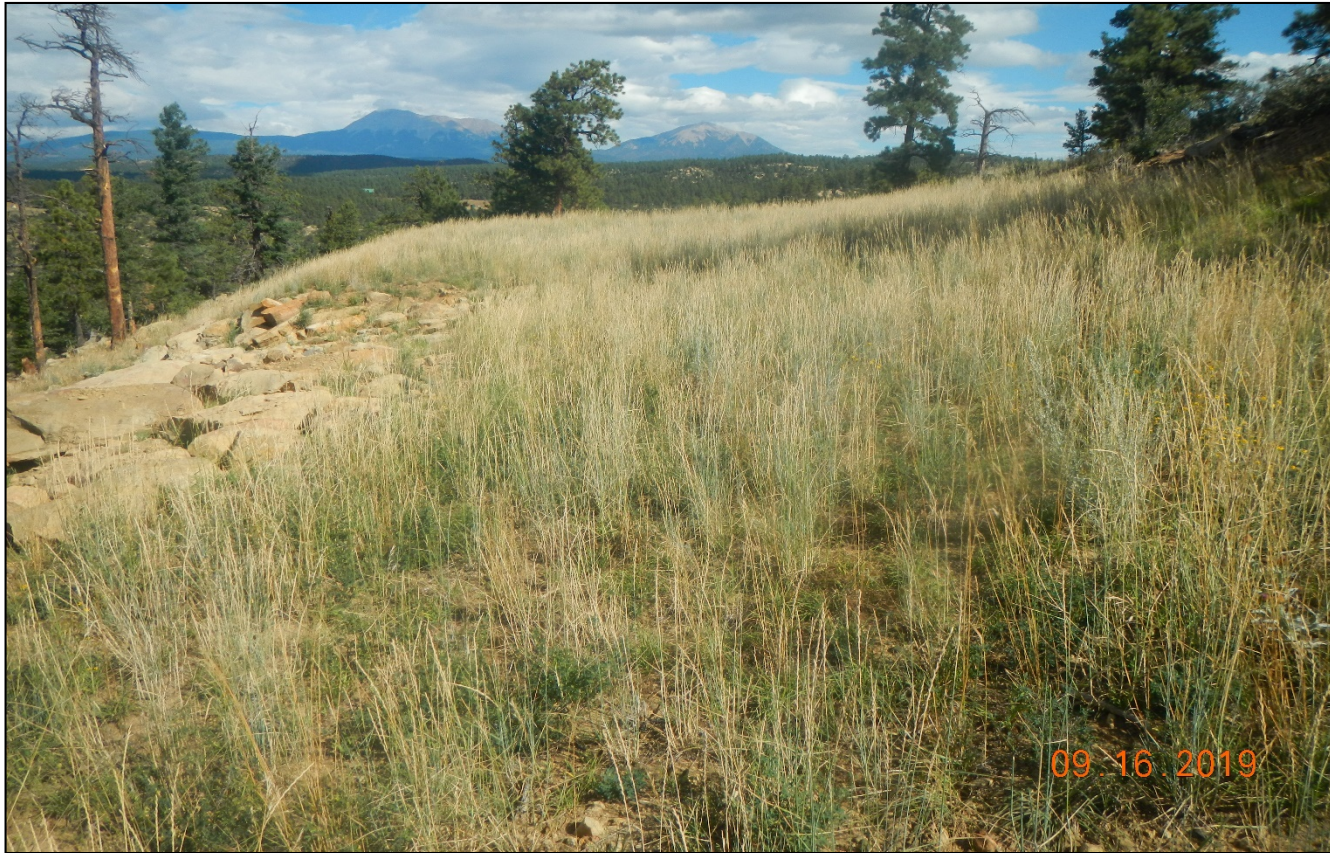
Photo 5. Facing north at the location. Perennial vegetation is uniformly established.
