# Inspection Photos

API: 05-071-06456

Operator: TIMBER CREEK OPERATING LLC

Inspection Date: 9/16/2019

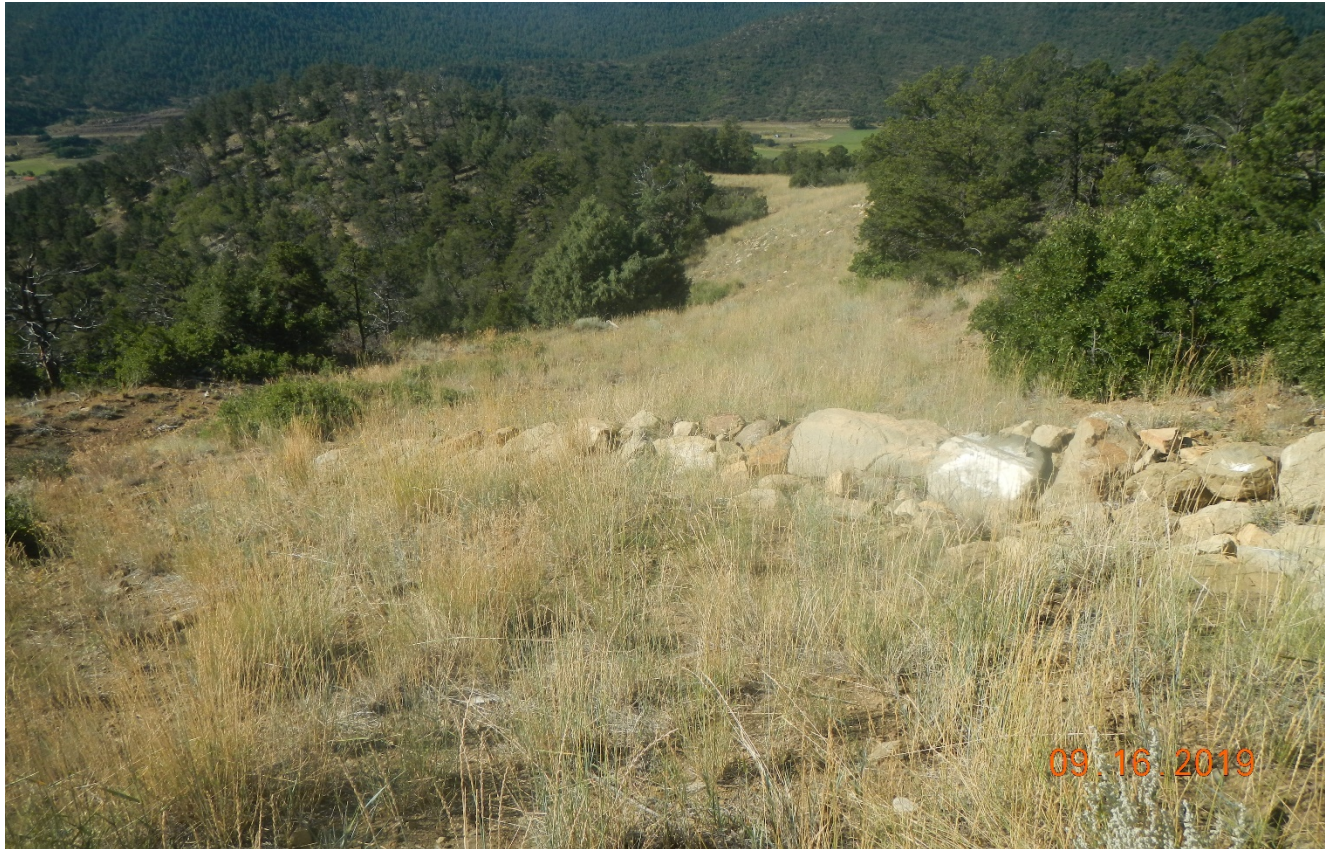
**Photo 1.** Facing southwest along the reclaimed access road. Perennial vegetation is uniformly established. Rock rip/rap was placed in drainage area.

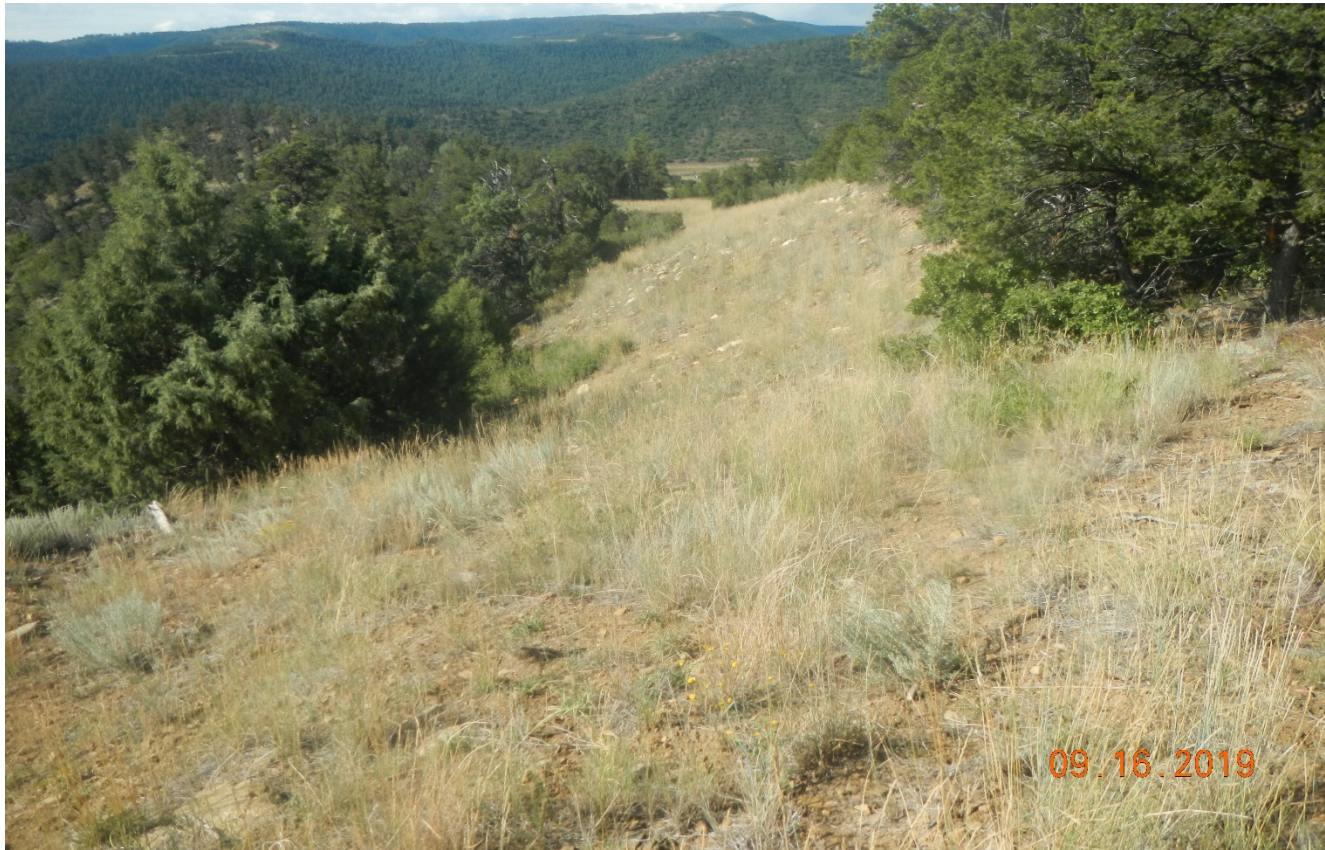
**Photo 2.** The access road is recontoured and reclaimed.

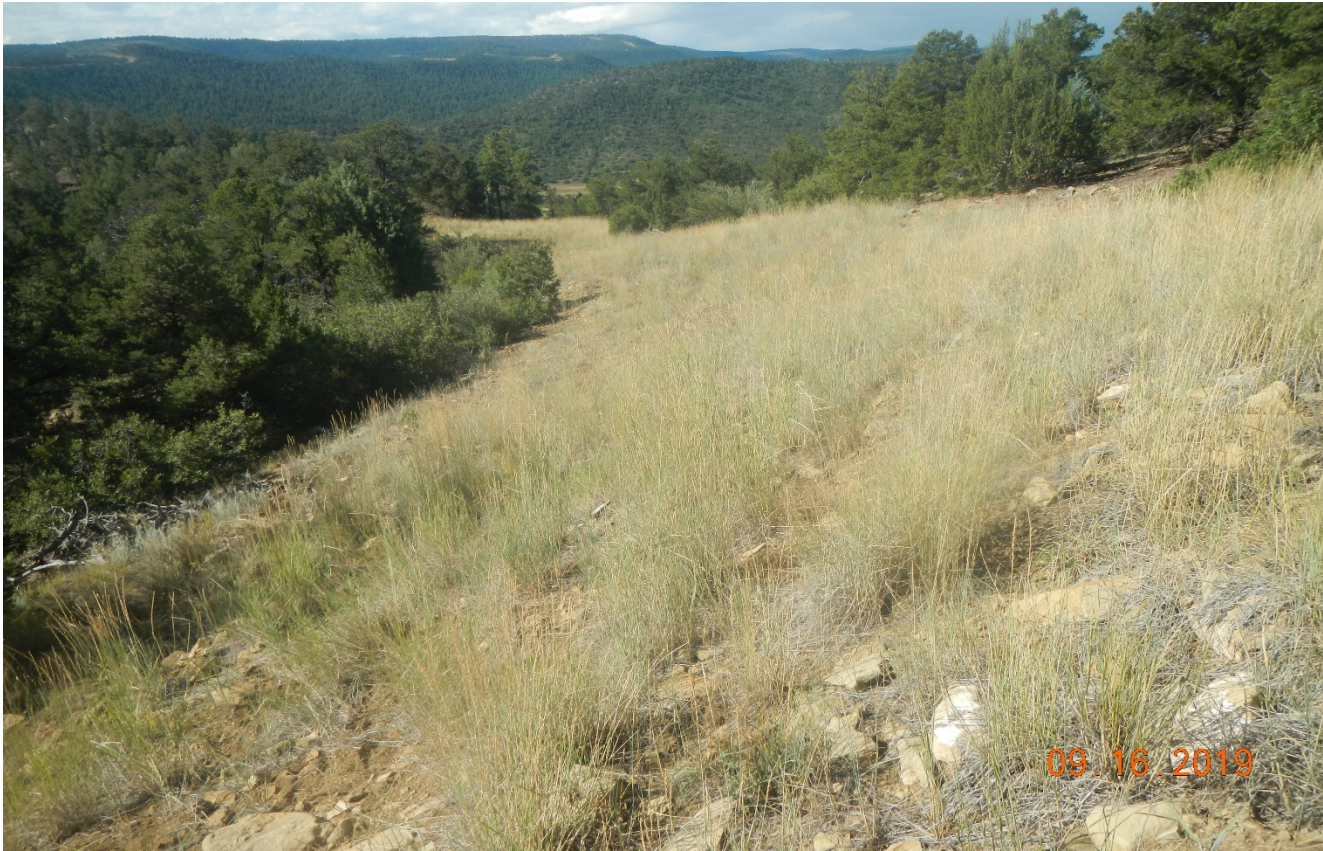
**Photo 3.** Facing southwest along the reclaimed access road. Perennial vegetation is uniformly established.

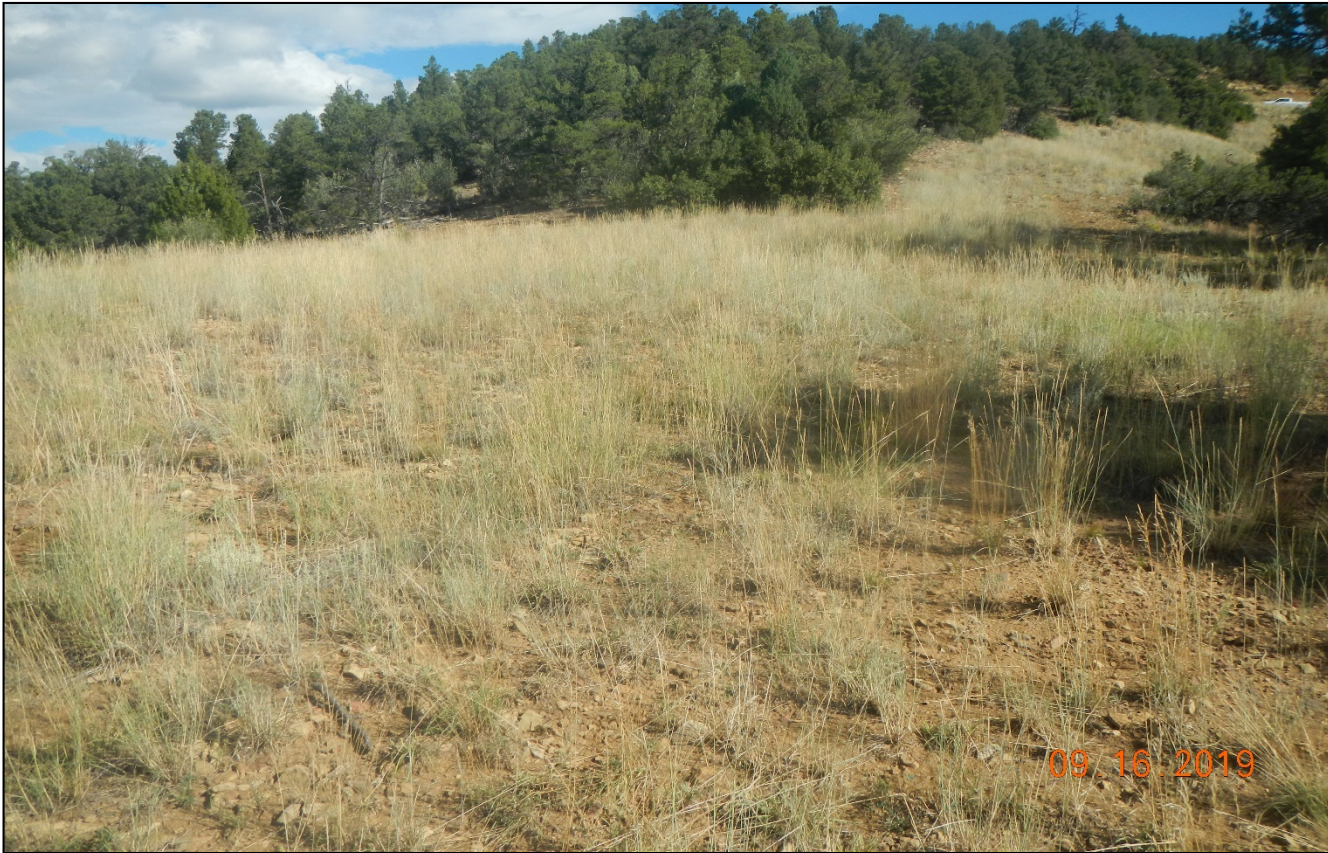
**Photo 4.** Facing north at the location. Perennial vegetation is uniformly established.

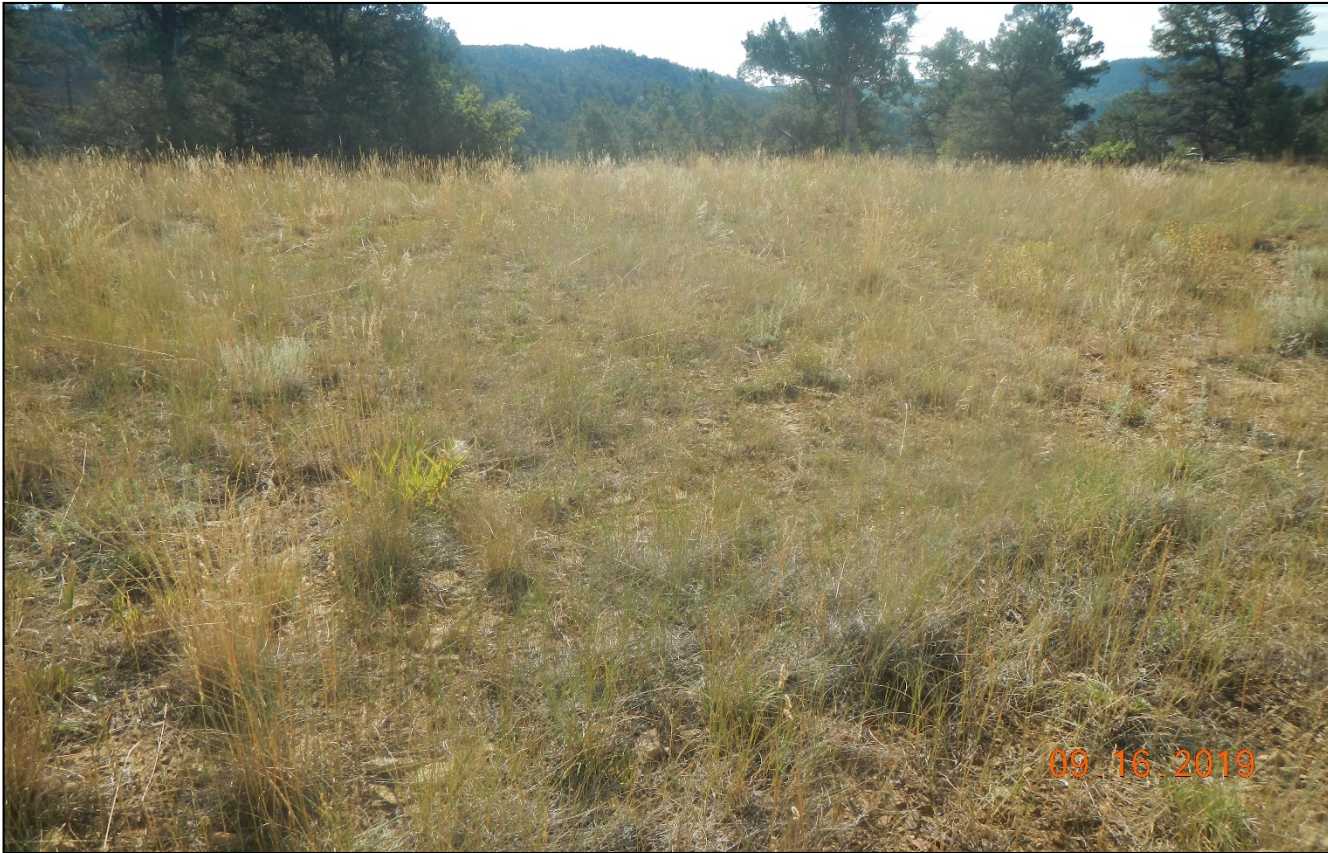
**Photo 5.** Facing east at the location. Perennial vegetation is uniformly established.
