Inspection Photos
Operator: BP America
Location/API #: 067-07546
Date: 9-10-2019

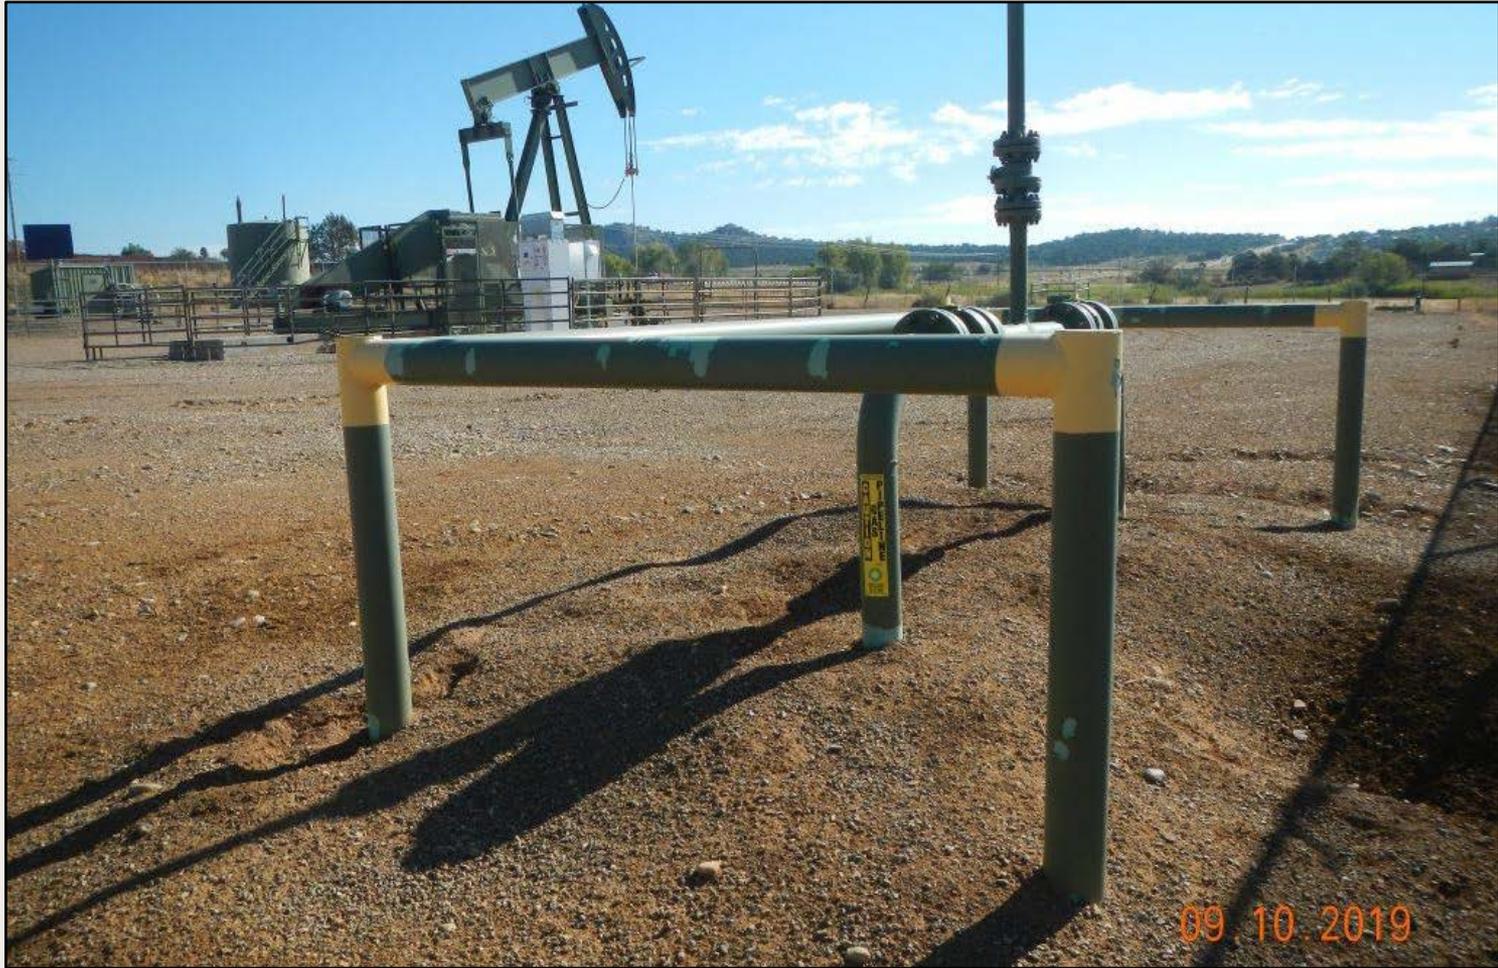
Photo 1. View of the project area from the southwestern edge facing center.

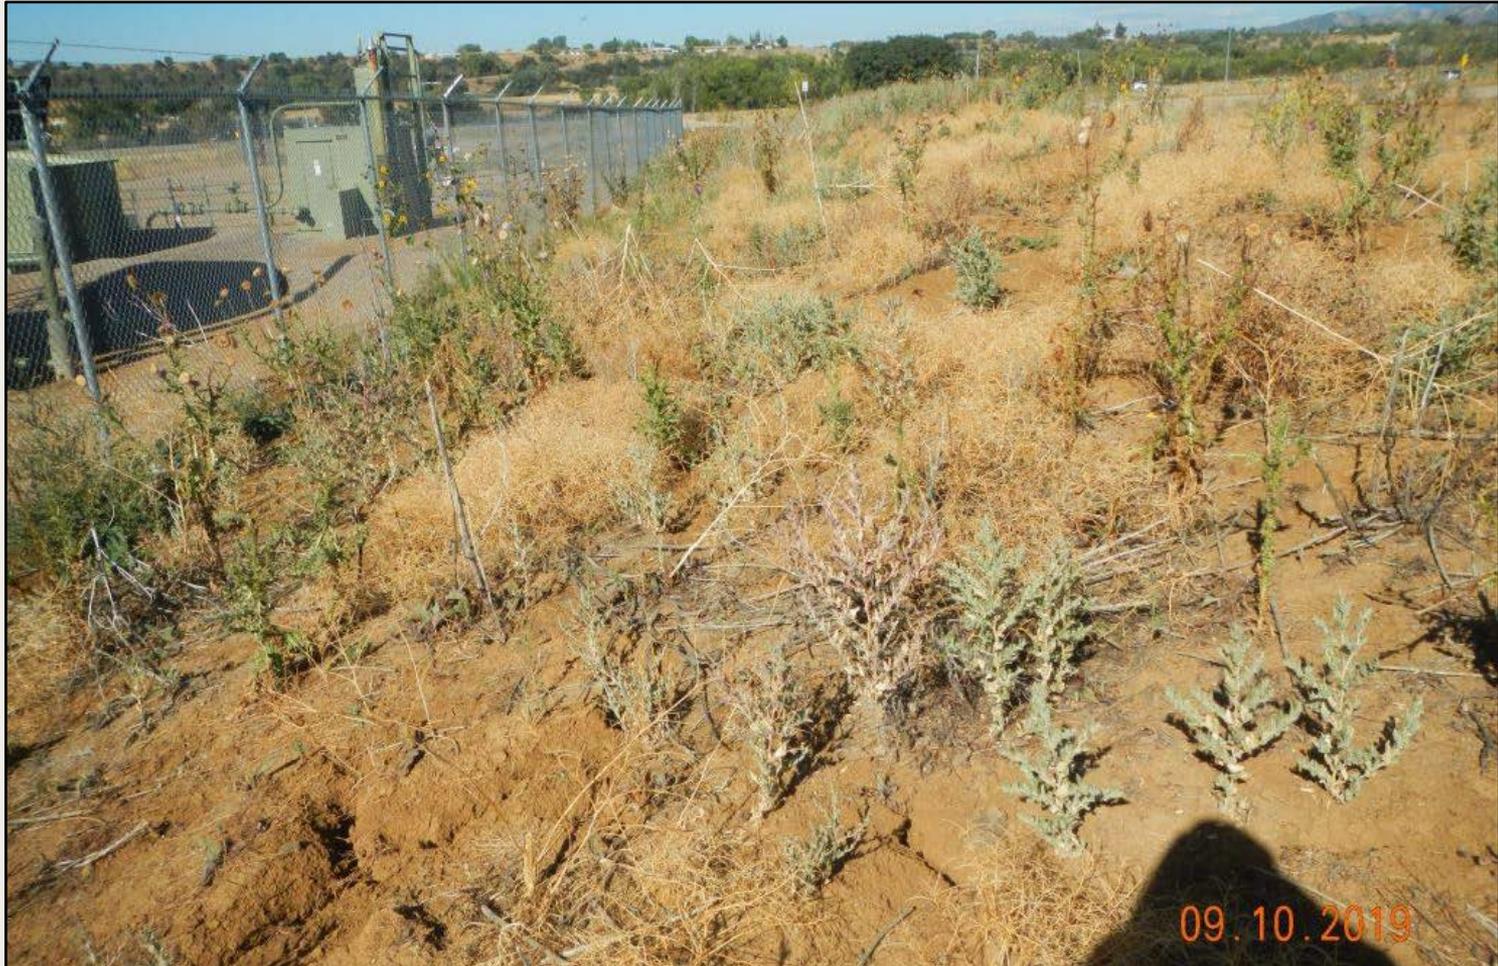
Photo 2. View of the northern project area from the northeastern edge facing westward. Outer revegetation areas are infested with noxious weeds, including musk thistle, Scotch thistle, houndstongue, and Russian knapweed.

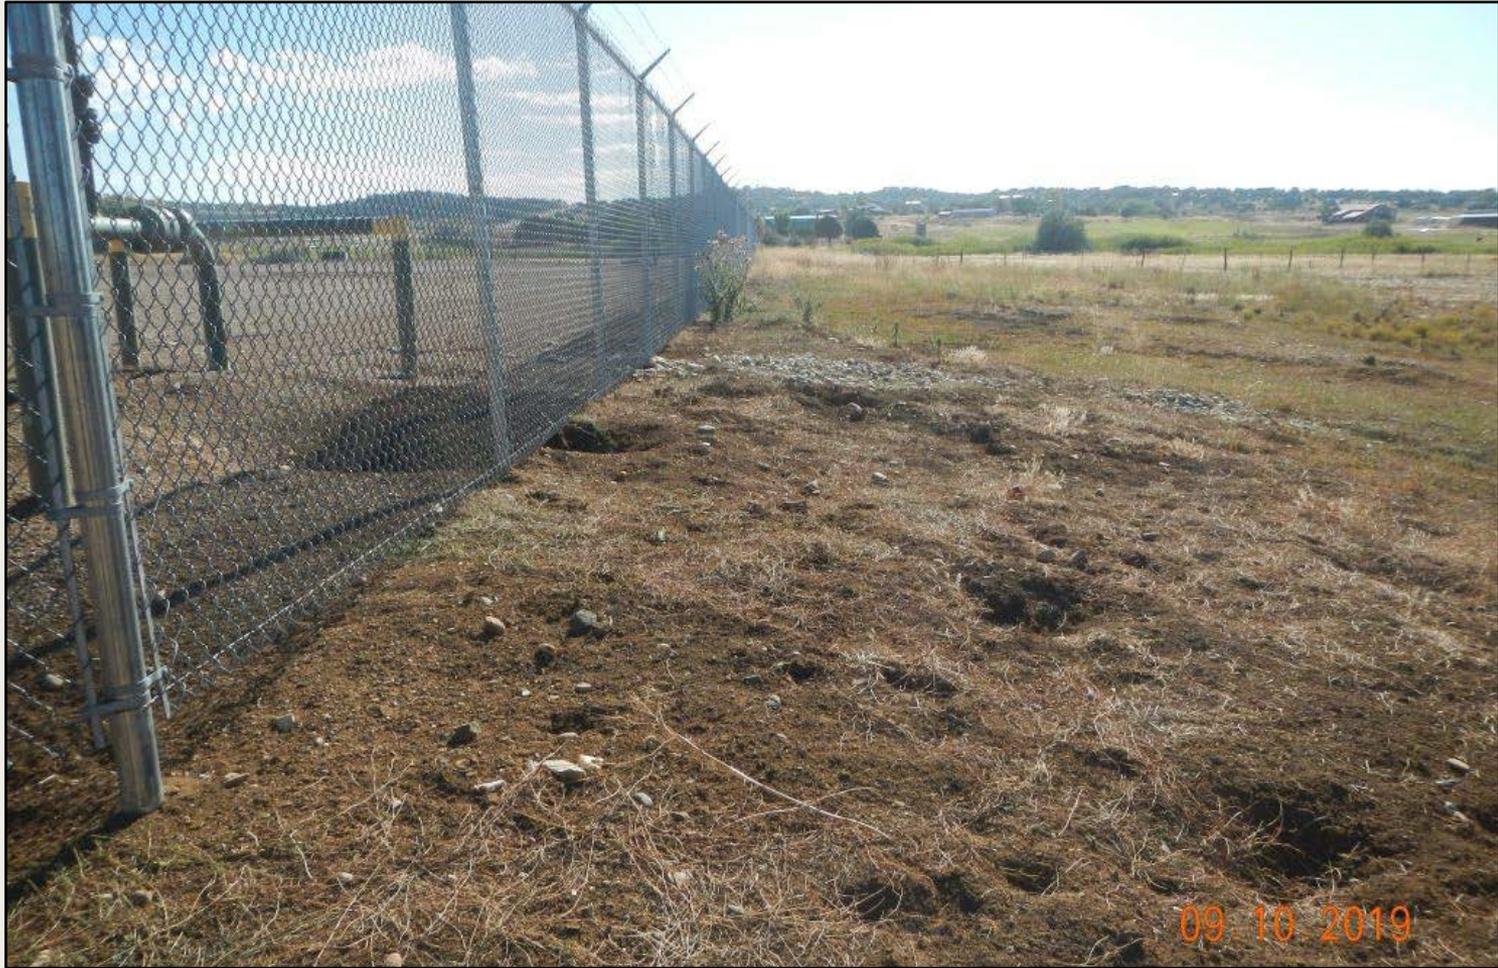
Photo 3. View of the southern project area from the southwestern edge facing eastward. Little desirable vegetation is present. Vegetation in foreground is largely annual weeds such as prostrate knotweed (*Polygonum arenastrum*).

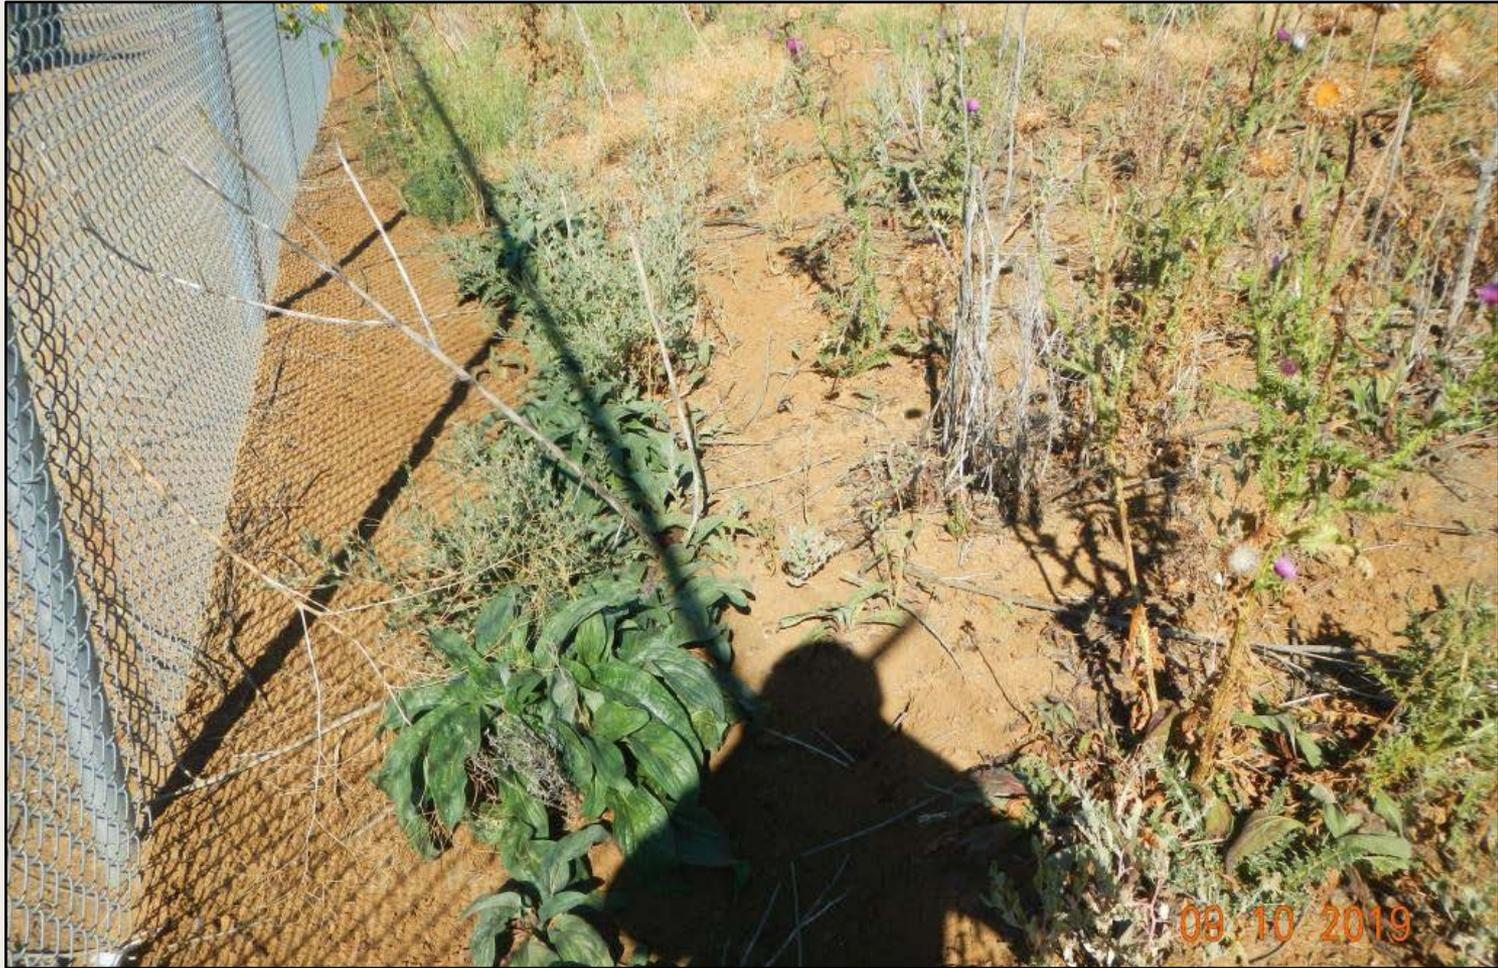
Photo 4. Closeup view of musk thistles, houndstongues, and Scotch thistles within the outer revegetation area.

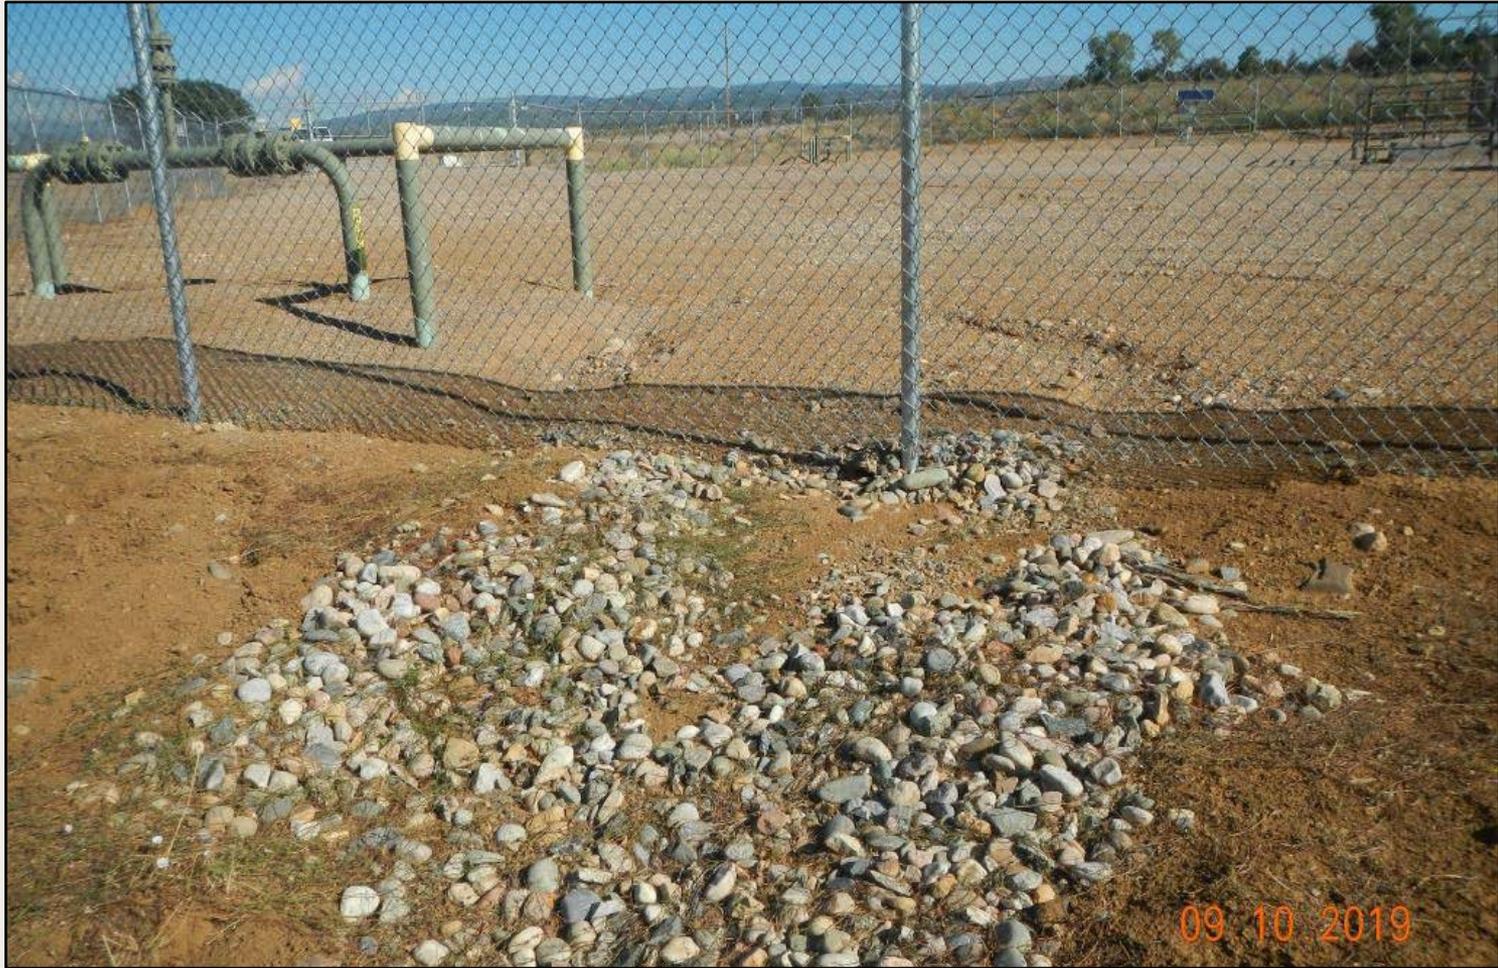
Photo 5. View of area where concentrated stormwater flows off of the southern project area. This stormwater BMP is not adequate here as bare soils throughout the revegetation area are not stabilized.

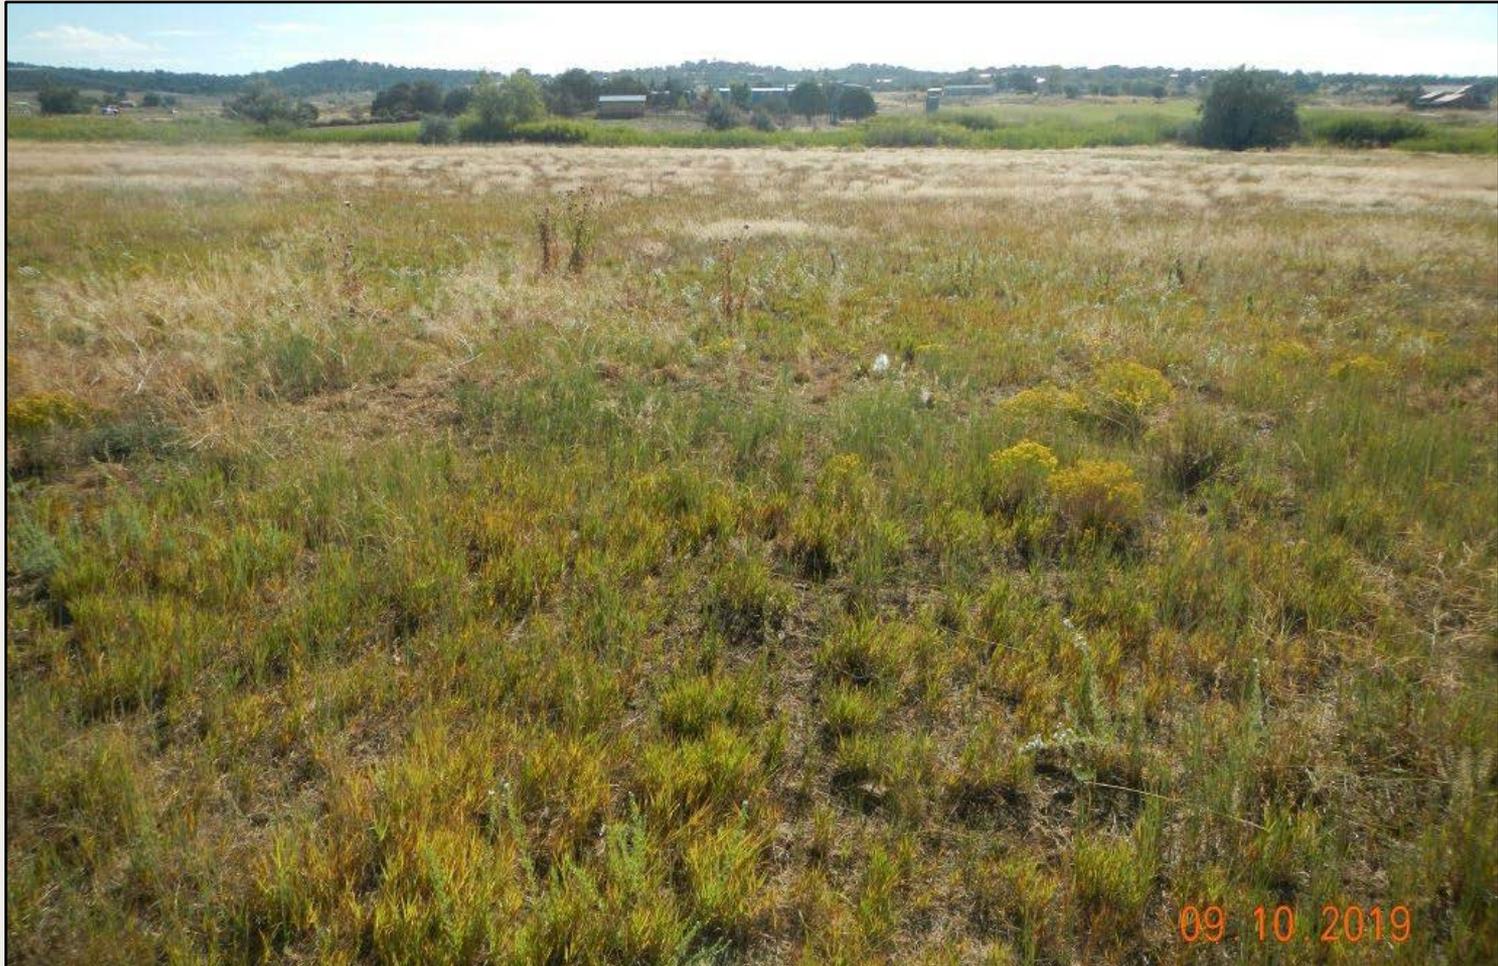
Photo 6. View of reference area east of project area, comprised of grassland field vegetation such as smooth brome and western wheatgrass.
