Inspection Photos
Location Name: Harry Ewing C #1
Location ID: 311352

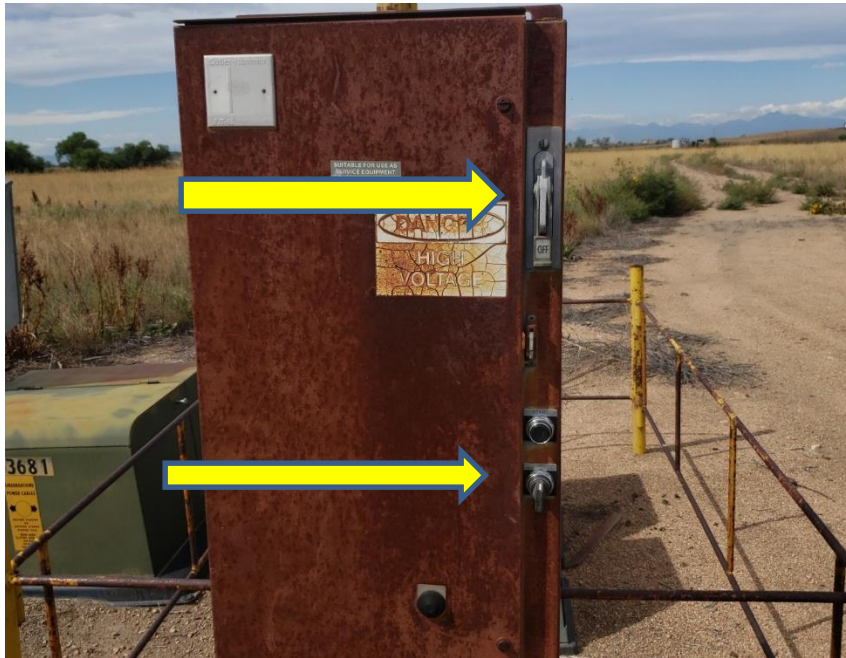
Photo #1 Electric panel appears to be shut off

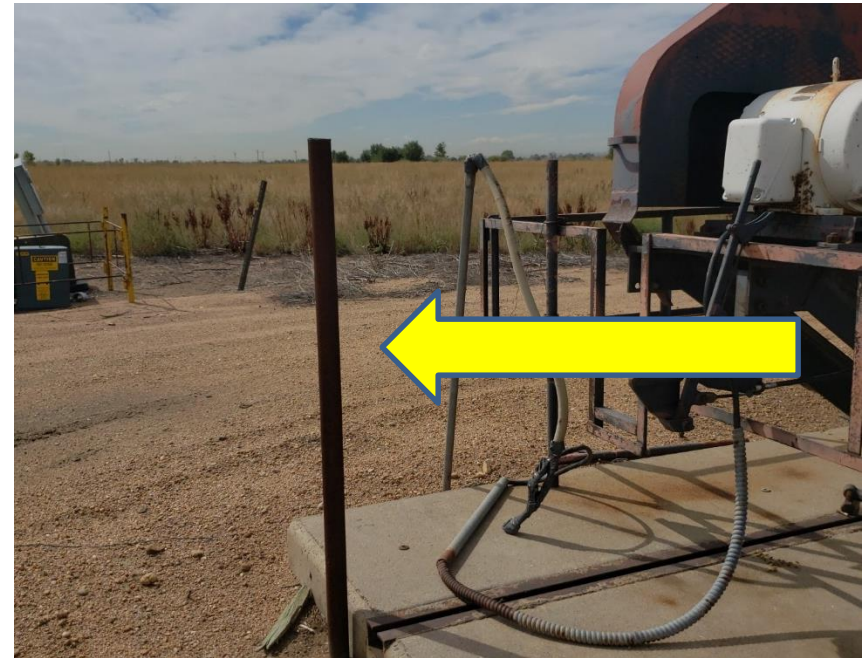
Photo #2 unused unmarked no LOTO flow line riser
