Inspection Photos
Location Name: Carl a Miller B7
Location ID: 336068

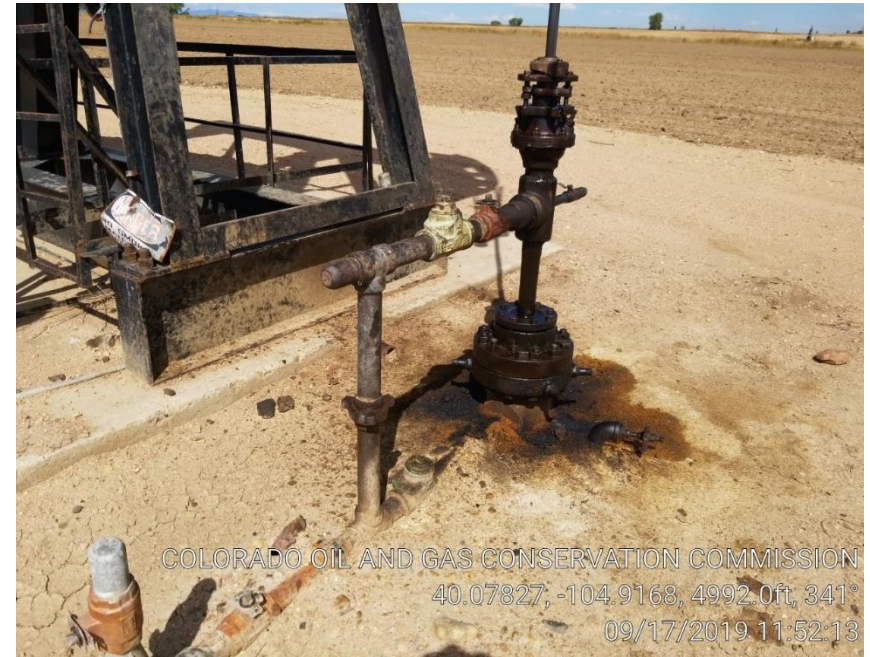
Pic 2 stained soil/mechanical conditions

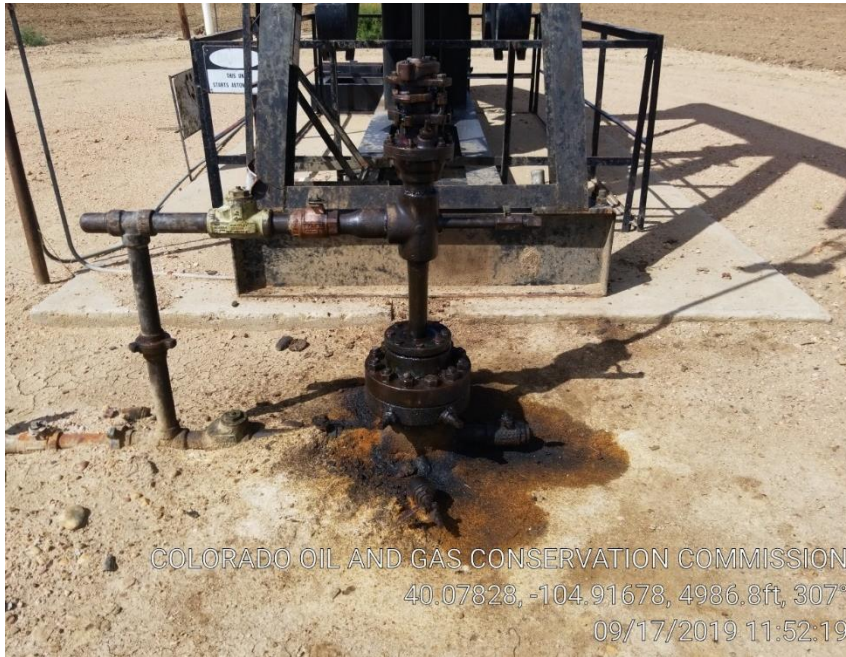
Pic 3 stained soil/mechanical conditions

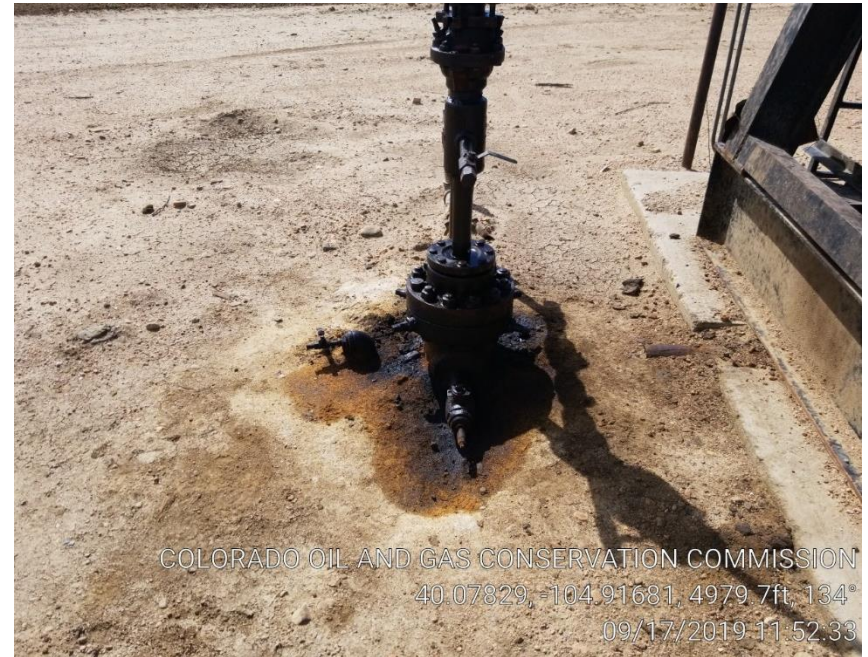
Pic 4 stained soil/mechanical conditions
